## **NATIONAL TRANSPORTATION SAFETY BOARD**

### **Weather Study**

# **METEOROLOGY**

ERA17FA073

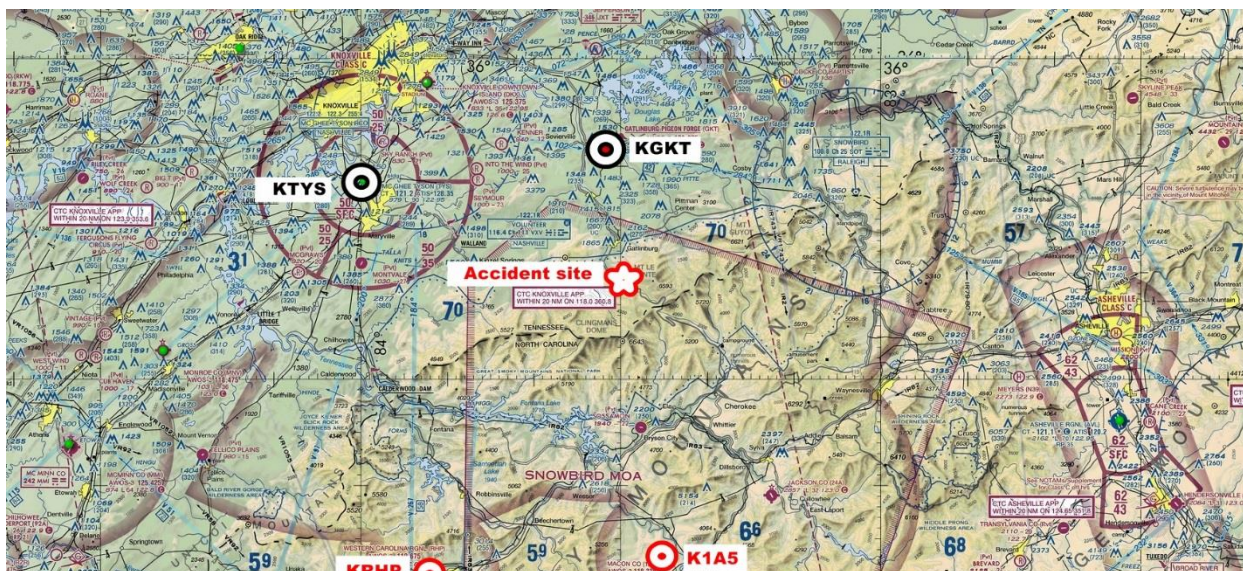
**Figure 7 – Sectional chart of accident area with the location of the accident site and surface observation sites**

The area surrounding the accident site was documented utilizing official NWS Meteorological Aerodrome Reports (METARs) and Specials (SPECIs). The following observations were taken from standard code and are provided in plain language. Figure 7 is a sectional chart with the accident site and the closest weather reporting locations marked.

Given the area of responsibility described at Knoxville ATCT/TRACON<sup>21</sup> and the information provided in the interviews, it would likely be beneficial for Knoxville ATCT/TRACON to review or be aware of weather information south of the Appalachian Mountains (such as K1A5 and KRHP, figure 7) when soliciting for PIREPs in their airspace.
