**Factual Report – Attachment 3**  
**Radar Figures and ERAM Screen Captures**

**AIR TRAFFIC CONTROL**

ERA17FA136

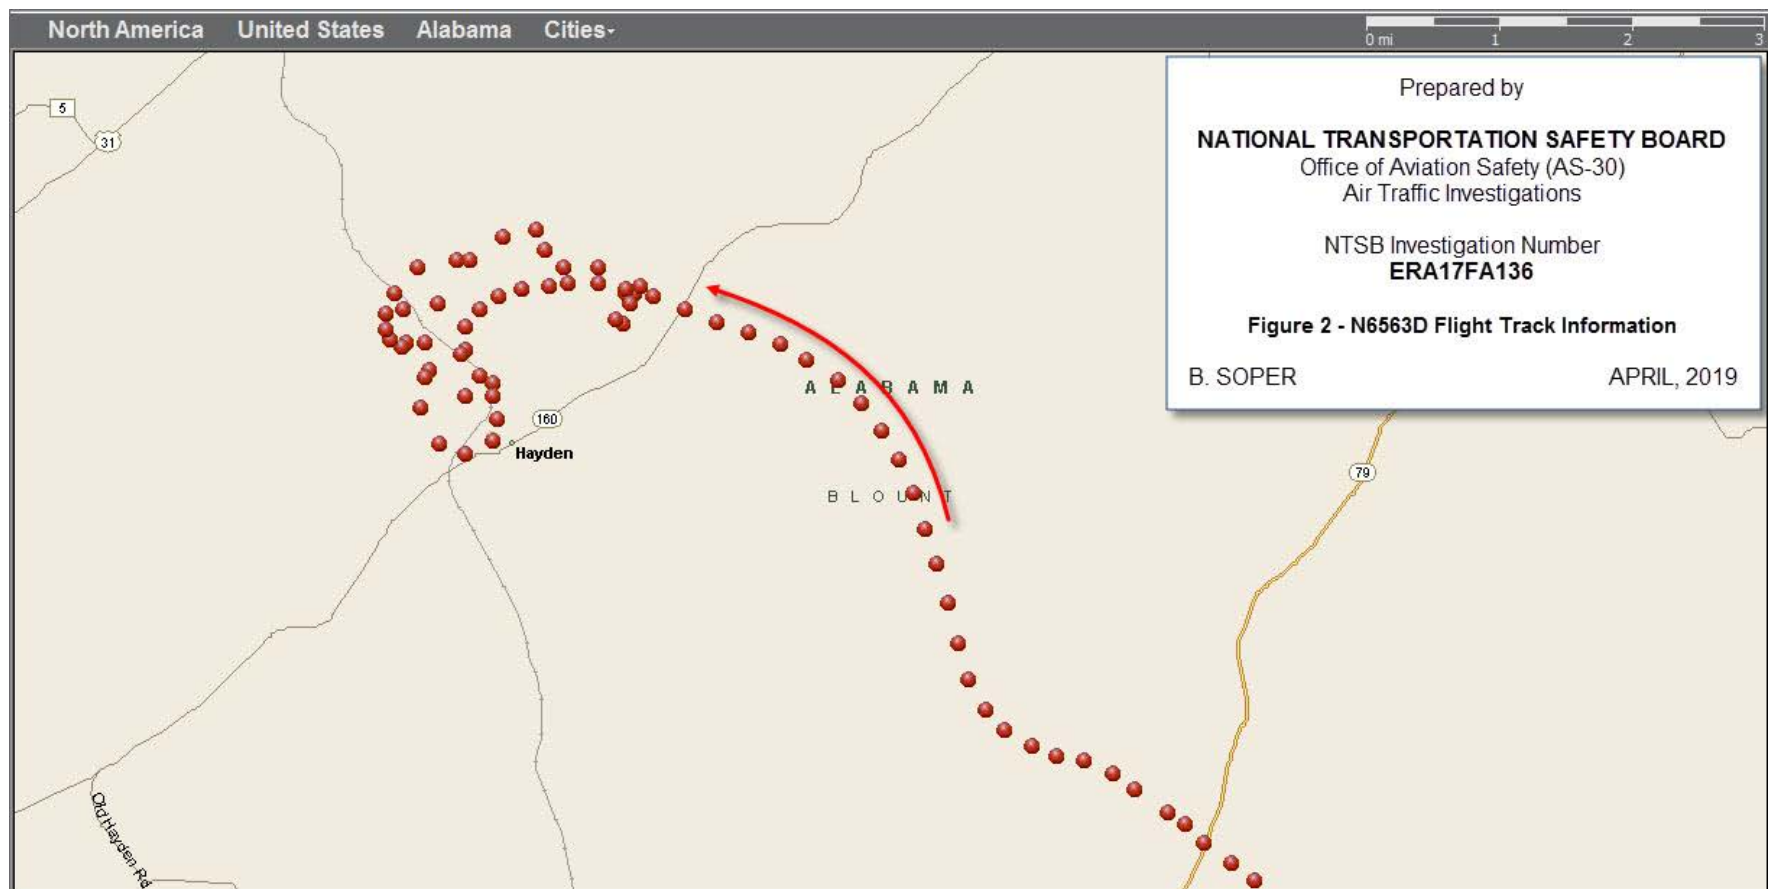
Figure 2 - Zoomed overview of the last several minutes of the accident flight of N6563D as it encountered hazardous weather until radar contact was lost.

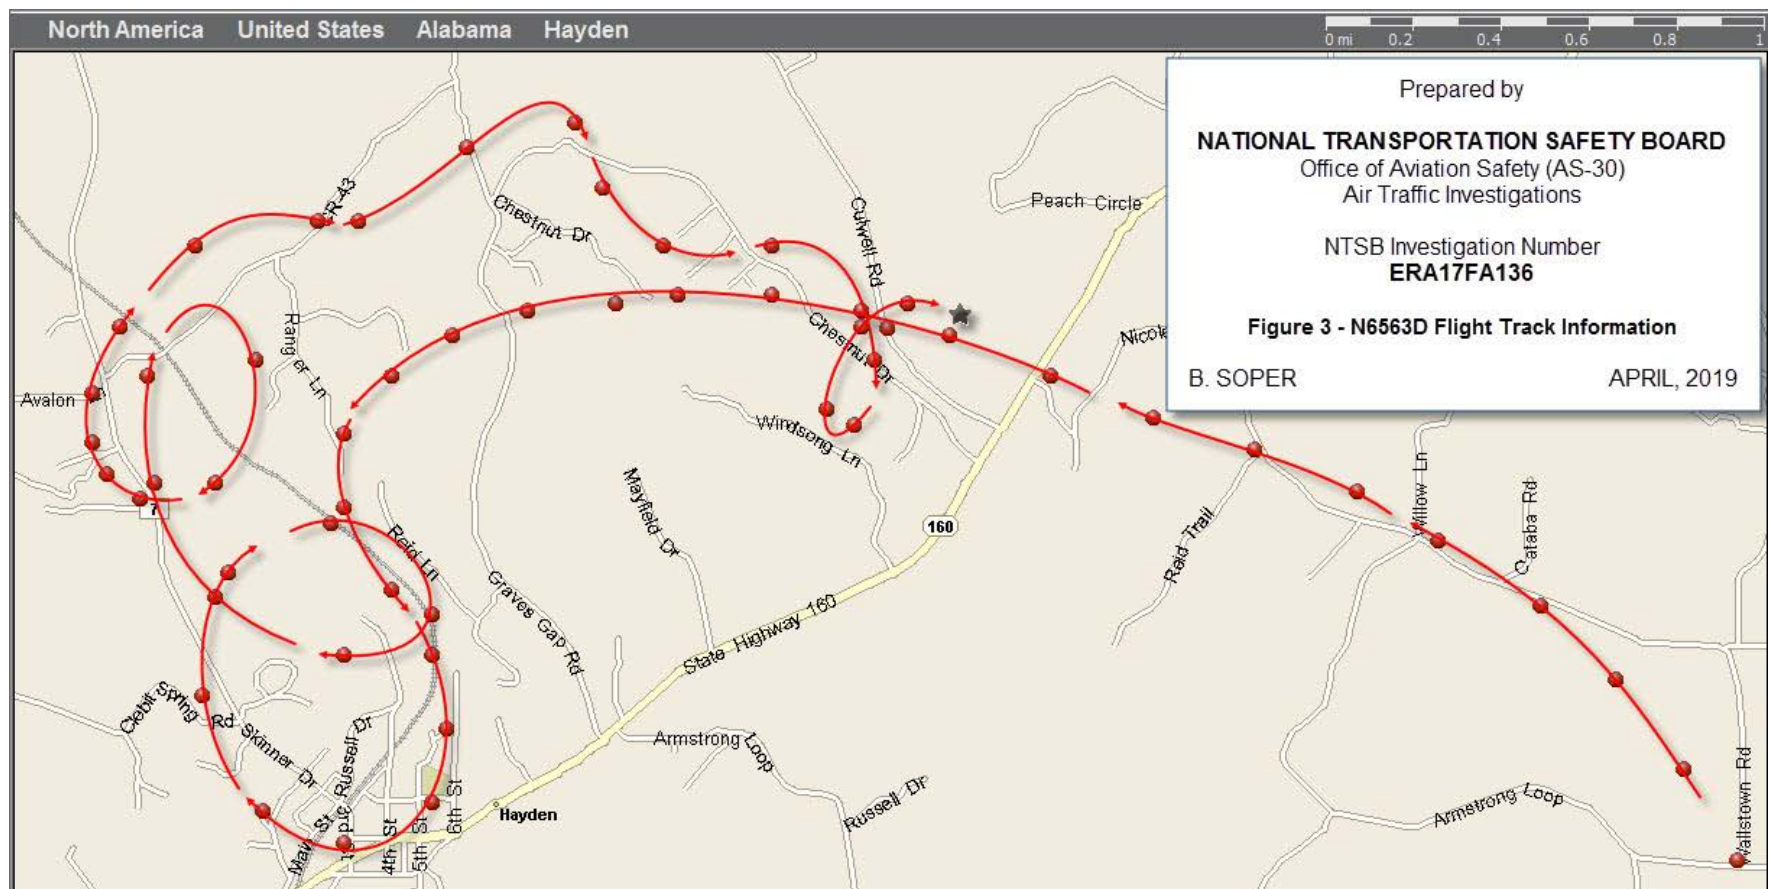
Figure 3 - Zoomed overview of the final segment of the accident flight track of N6563D after encountering hazardous weather until radar contact was lost. Arrows are included for visual reference only and do not indicate actual flight track

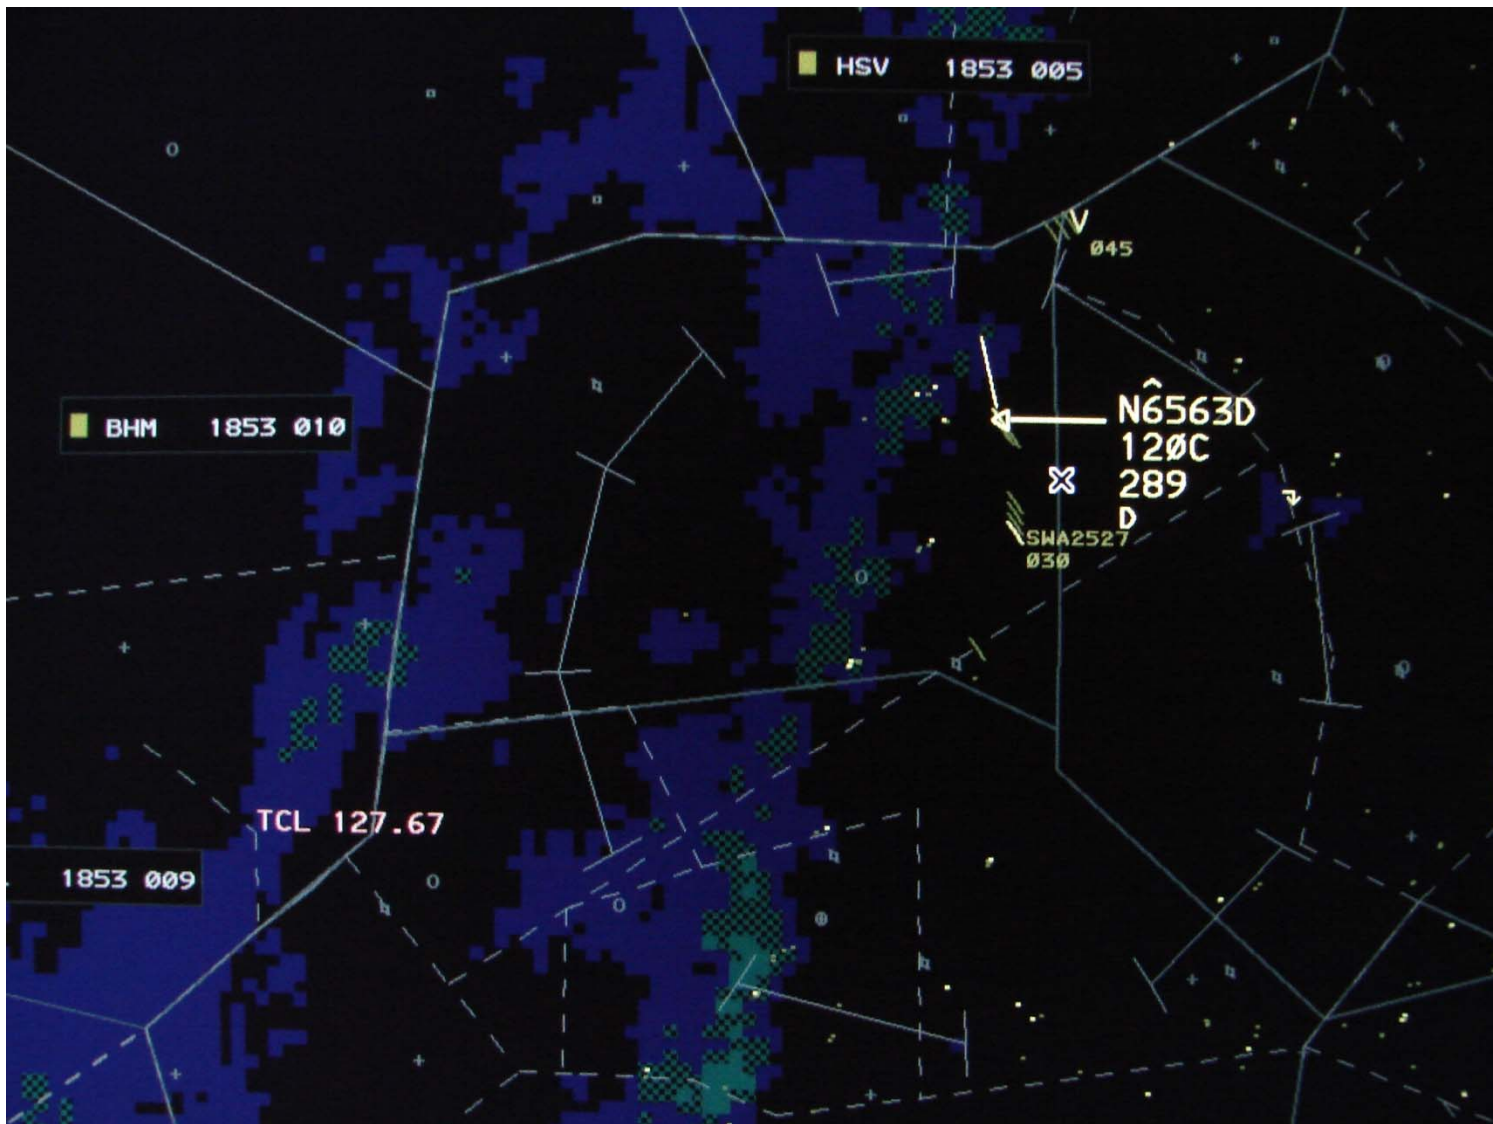
Figure 4 – ERAM screen capture taken at 1428 CDT and illustrating the weather that was being displayed to the ZTL radar controller just minutes before the accident.

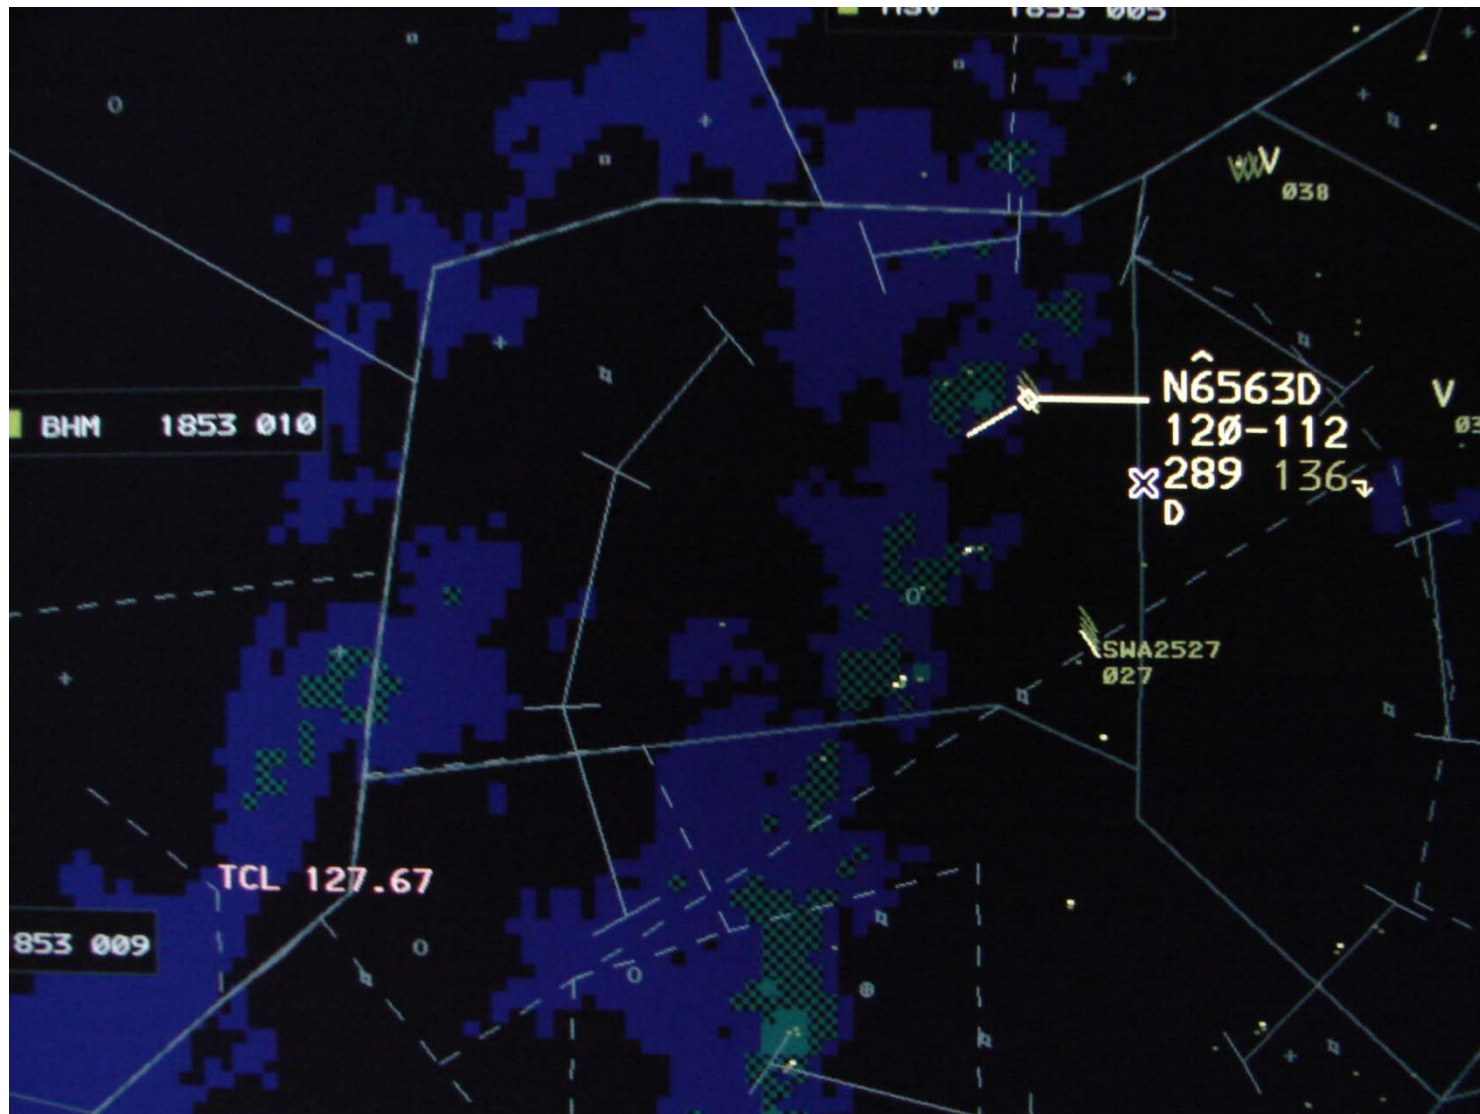
Figure 5 - ERAM screen capture taken at 1430 CDT and illustrating the weather that was being displayed to the ZTL radar controller just minutes before the accident.
