## **NATIONAL TRANSPORTATION SAFETY BOARD**

### **Group Chairman's Factual Report**

# **METEOROLOGY**

ERA17FA313

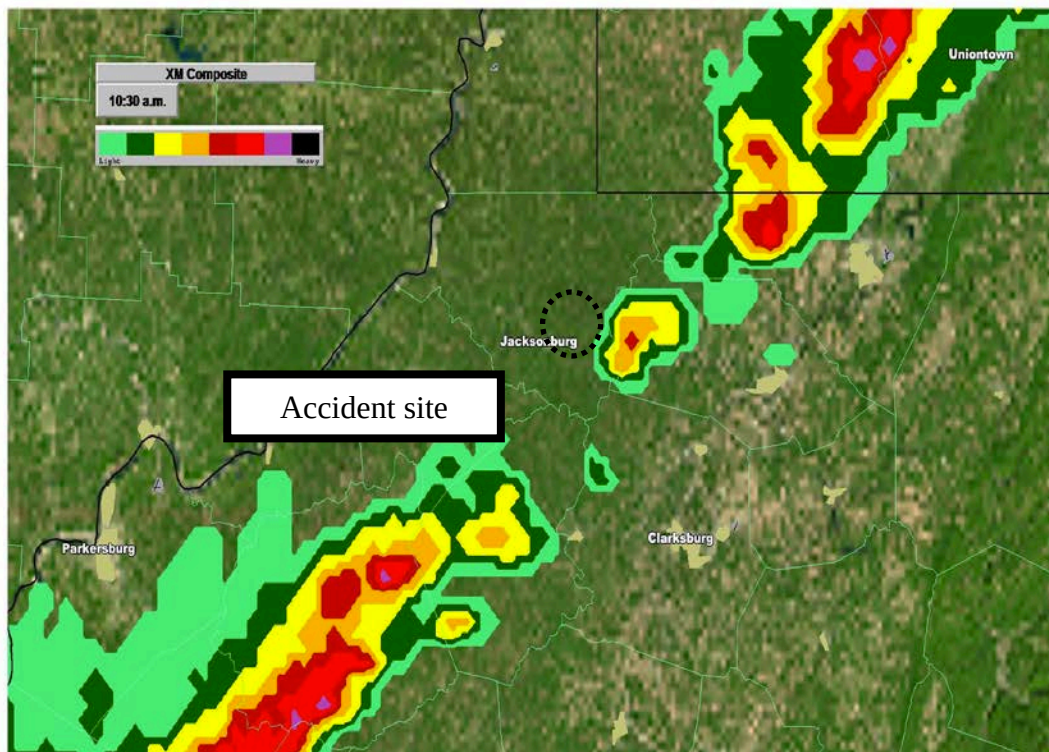
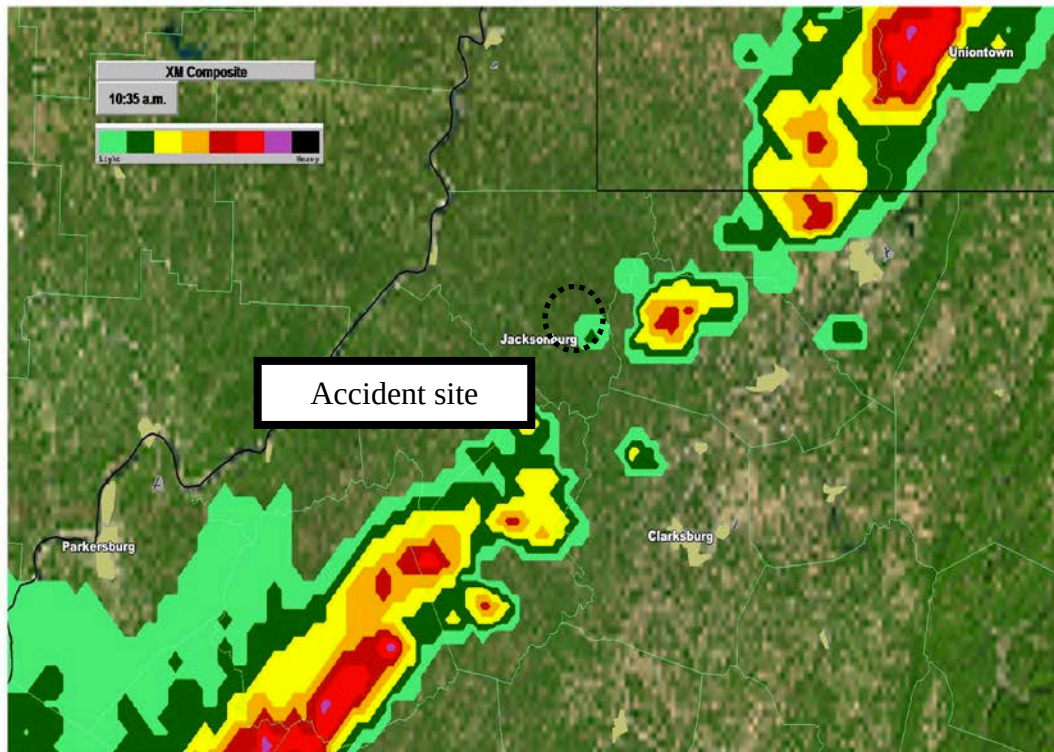
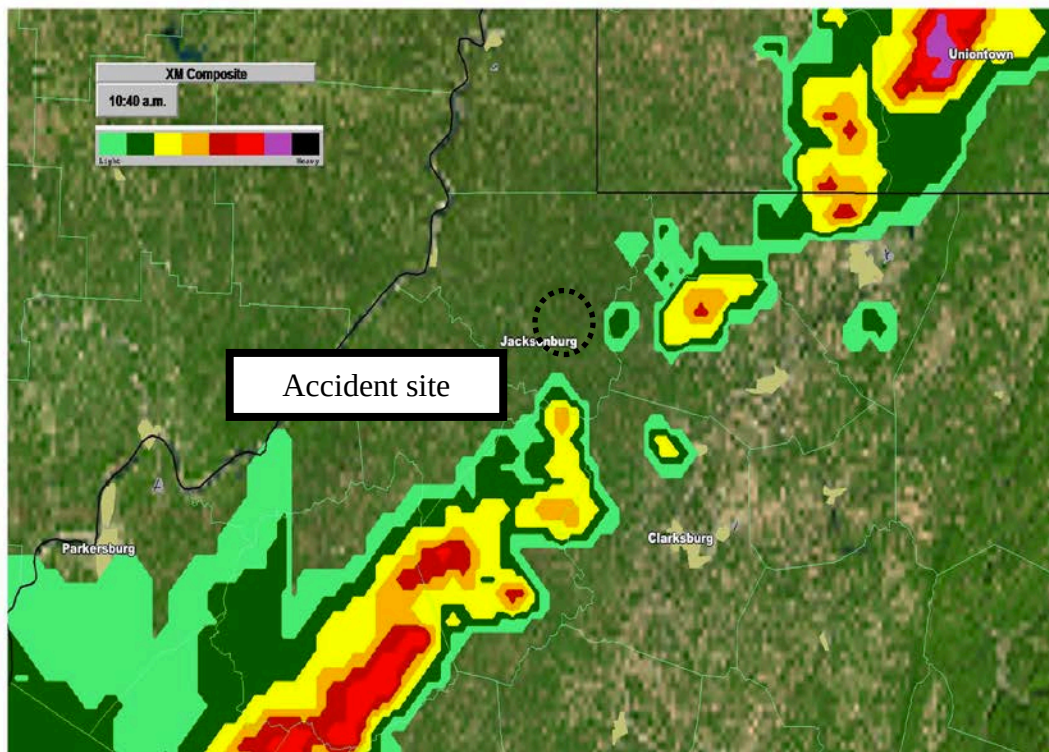
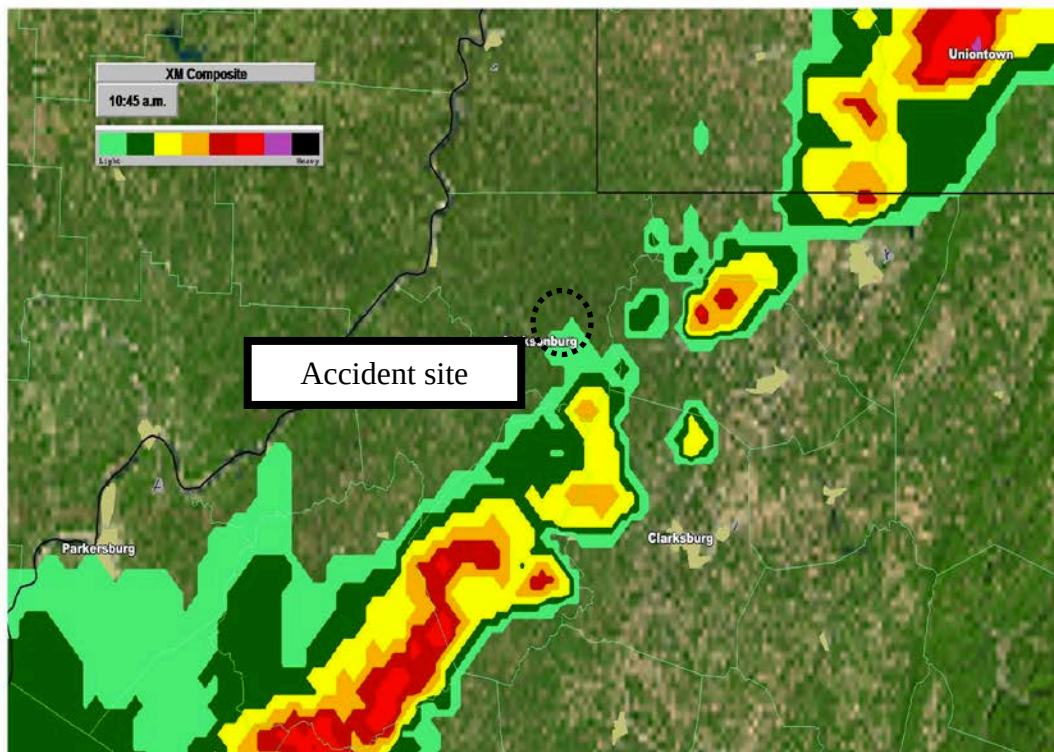
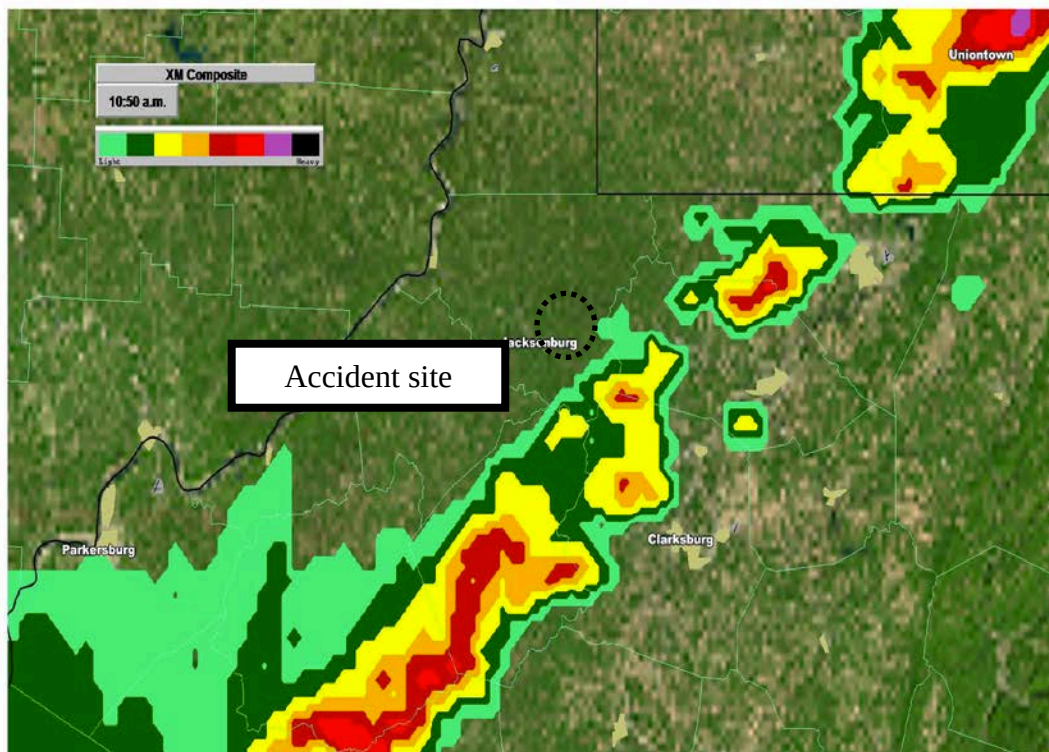
The airplane was equipped with a Garmin<sup>35</sup>, which could be fitted to display XM Weather information with a subscription. It is unknown if the pilot had a subscription to view XM Weather information. If the accident pilot had been viewing XM Weather composite radar information he would have had a chance to view something similar to figures 26 through 30, which was XM Weather composite radar information available from 1130 to 1150 EDT. The scale used in the XM Weather composite radar information is located in figure 31. The XM Weather composite radar images from at both 1135 and 1145 EDT displayed dBZ values less than 20 dBZ above the accident site (figures 27 and 29). For additional information regarding the XM Weather composite radar data please see attachment 8.

**Figure 26 –XM Weather Radar from 1130 EDT**

**Figure 27 – XM Weather Radar from 1135 EDT**

**Figure 28 – XM Weather Radar from 1140 EDT**

**Figure 29 – XM Weather Radar from 1145 EDT**

**Figure 30 – XM Weather Radar from 1150 EDT**

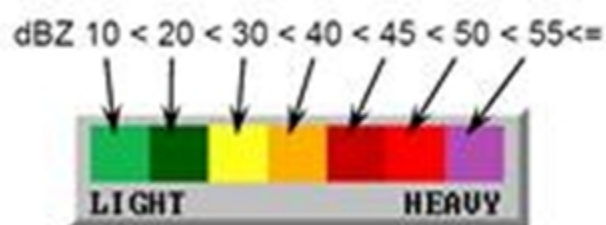
**Figure 31 – XM Weather Radar scale for figures 26 through 30**
