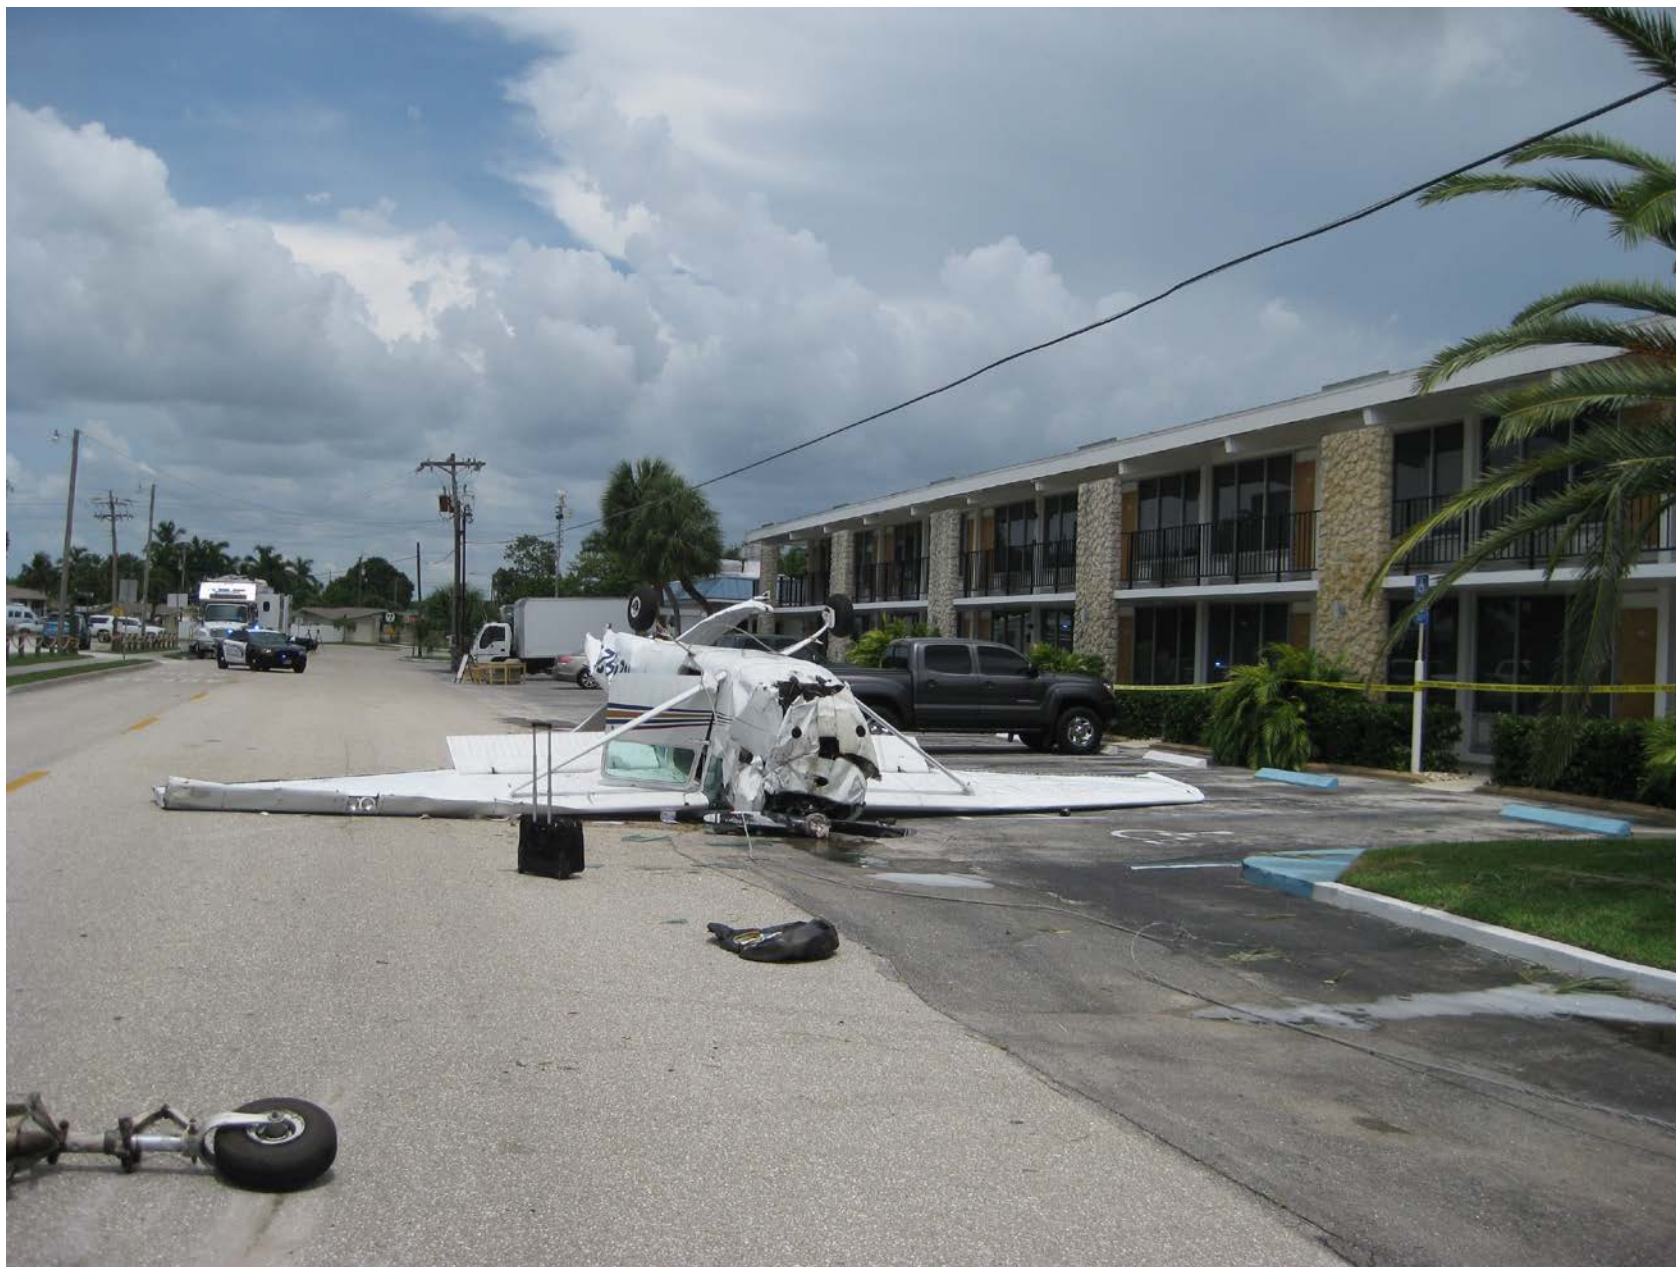
**Photo 1 – View of main wreckage inverted in parking lot showing nose damage. (Courtesy of the FAA)**

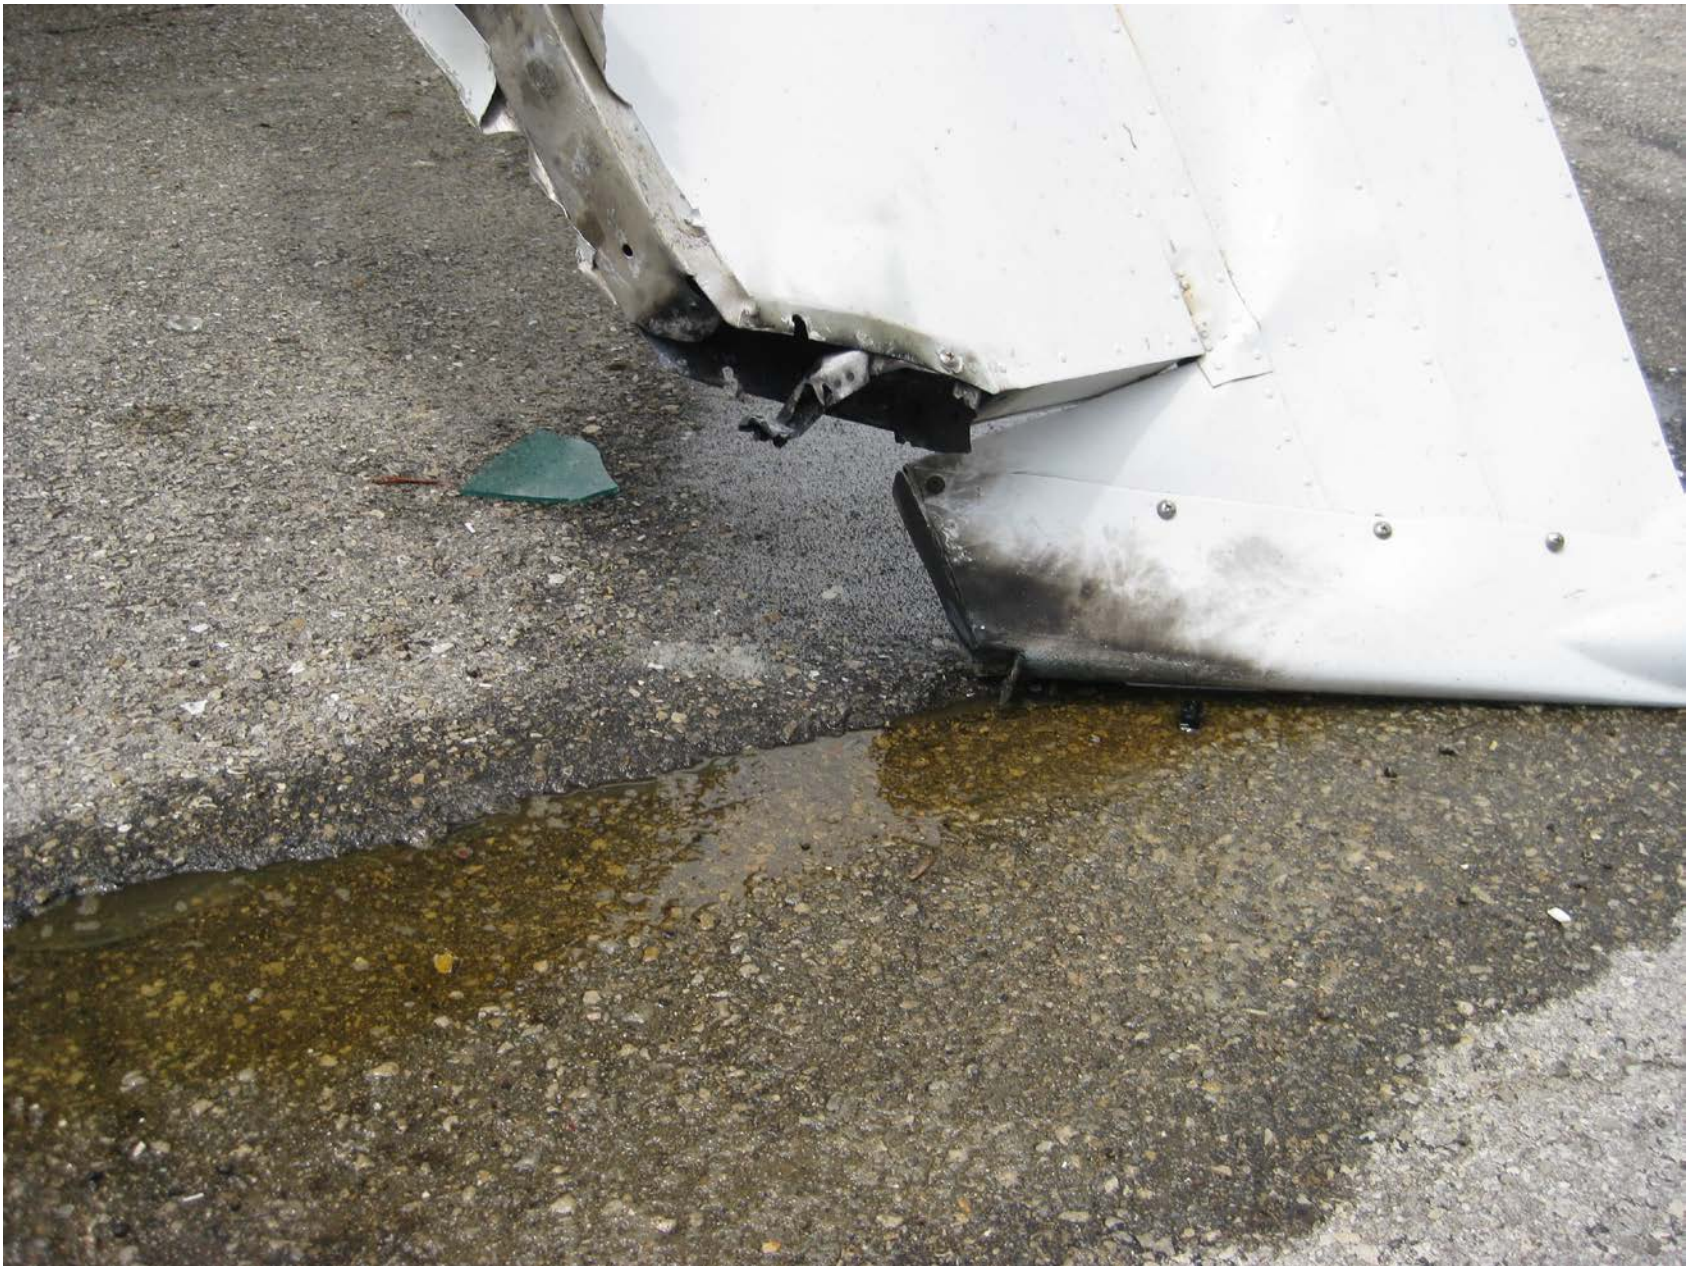
**Photo 2 – View of fuel and water mixture that leaked from right wing.(Courtesy of the FAA)**
