# Continental Motors

## ENGINE EXAMINATION REPORT

| ENGINE MODEL | C90-8F |
| FILE NUMBER | 17-112 |

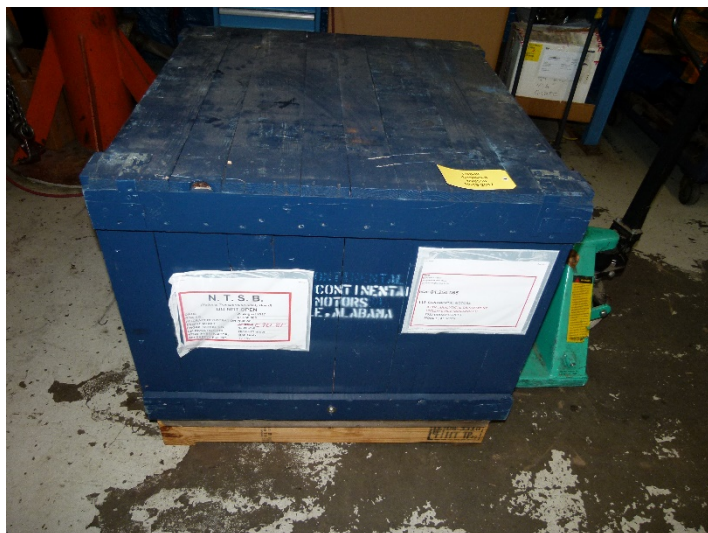
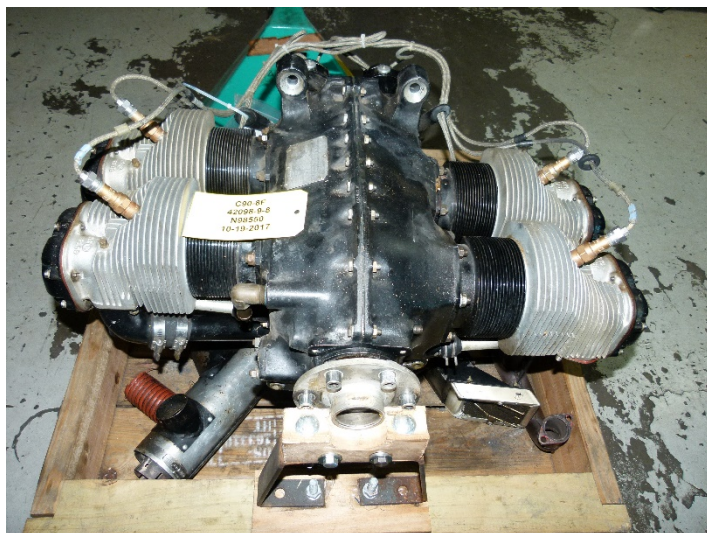
External examination of the engine did not reveal any anomalies. The engine was placed on an examination stand for disassembly.

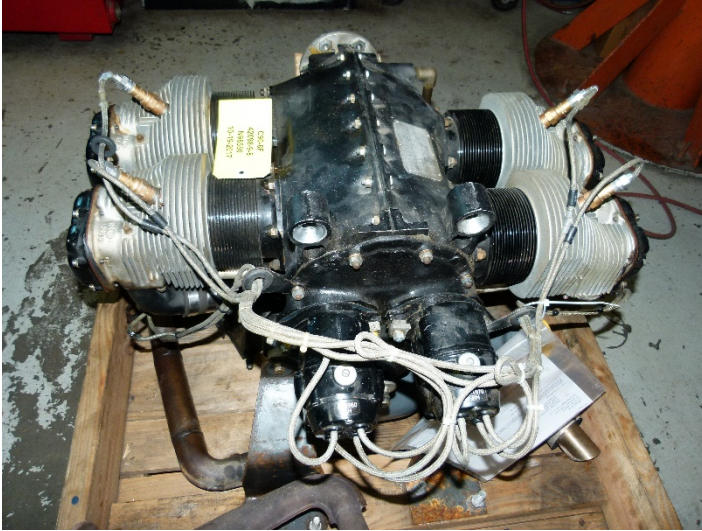
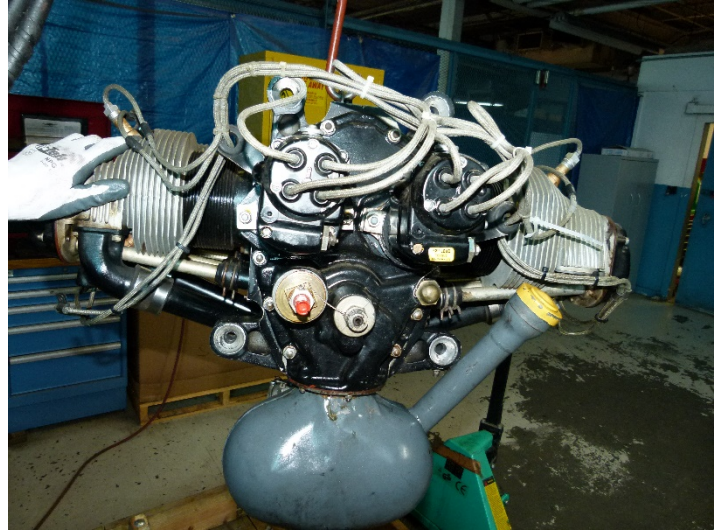
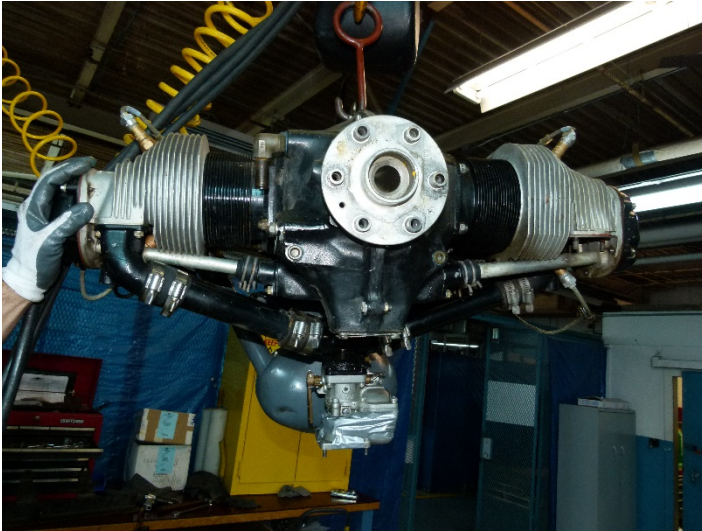
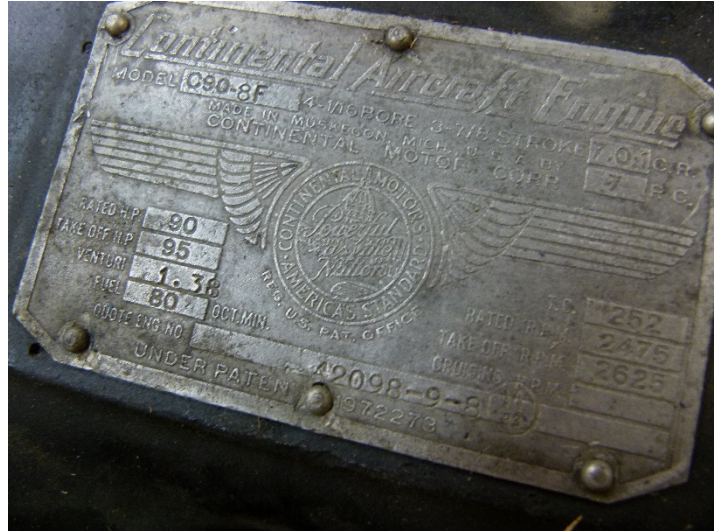
Disassembly of the engine revealed that the crankshaft gear was fractured and separated from the crankshaft. The four crankshaft gear screws that retain the gear to the crankshaft were fractured and the safety-wire remained intact and in place. Normally, the gear is piloted on the aft end of the crankshaft and aligned by a dowel pin, and the gear is retained by the four screws. However, the dowel was not present as the gear that was installed on the crankshaft did not have a dowel hole. The dowel hole was present on the crankshaft and it left a witness mark on the gear. The IPC and OM that were current at the time of the last overhaul and the last disassembly/repair specify a crankshaft and a gear that utilize a dowel pin (see OM and IPC excerpts attached at the end of this report). **NOTE:** The red arrows in the photos below indicate either the dowel pin hole on the crankshaft or the dowel pin hole witness mark on the gear.
