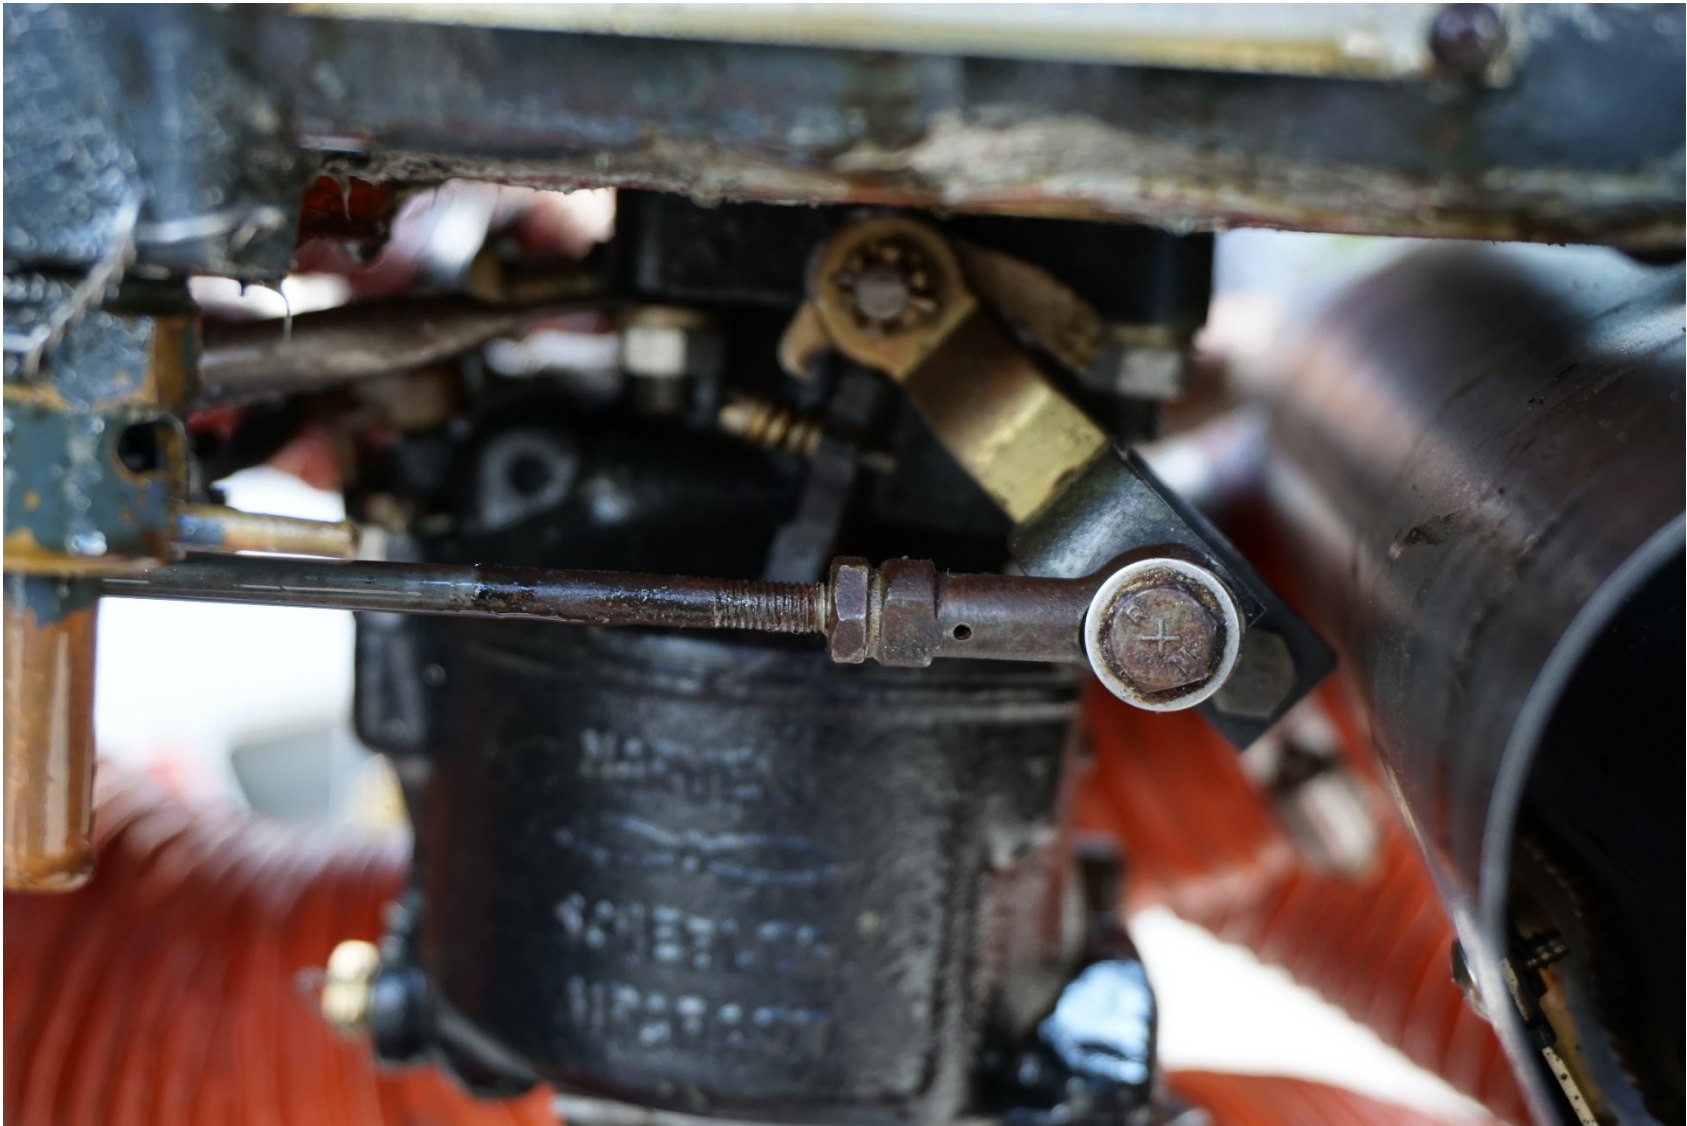
**Photo 2– Close up view of throttle linkage with restricted movement and resting on exhaust shroud (courtesy of FAA)**

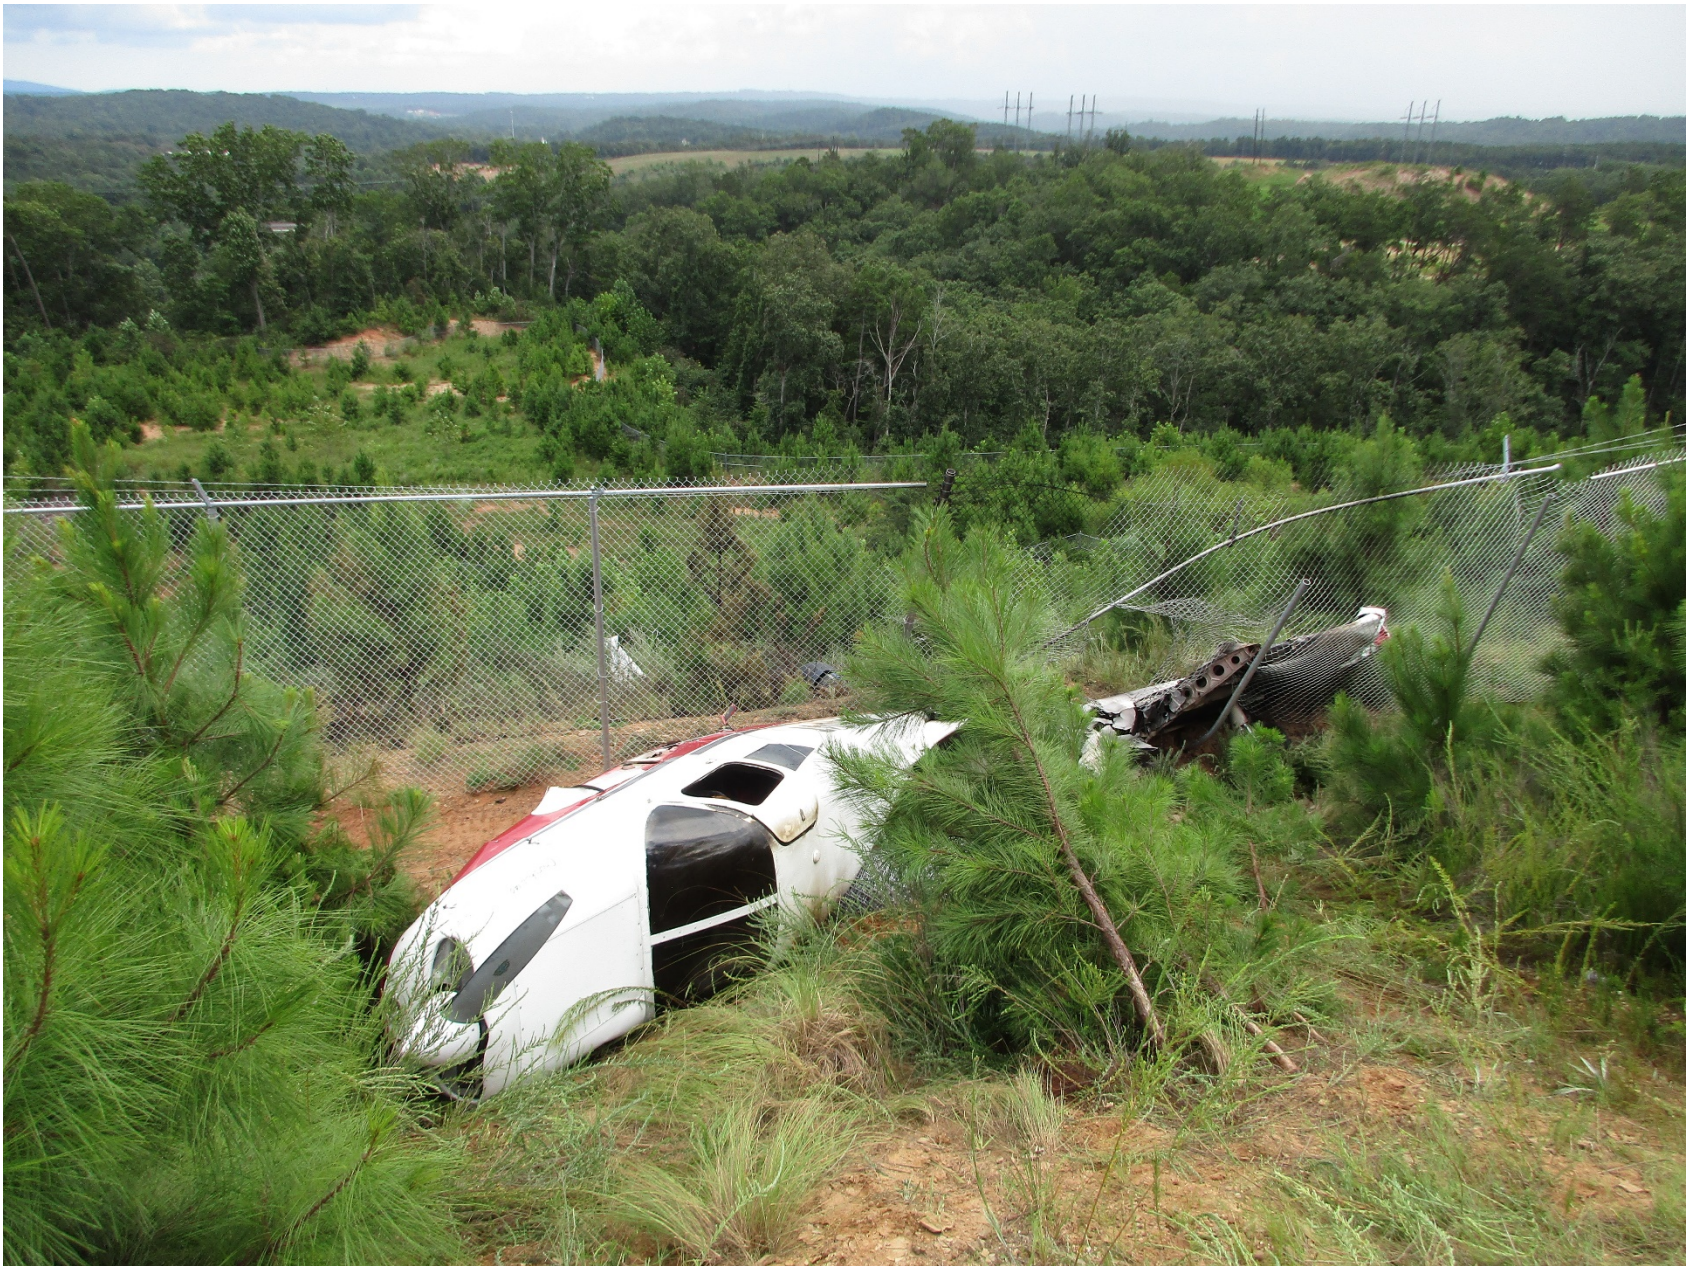
**Photo 3– View of fuselage off the end of runway with wings separated (courtesy of FAA)**
