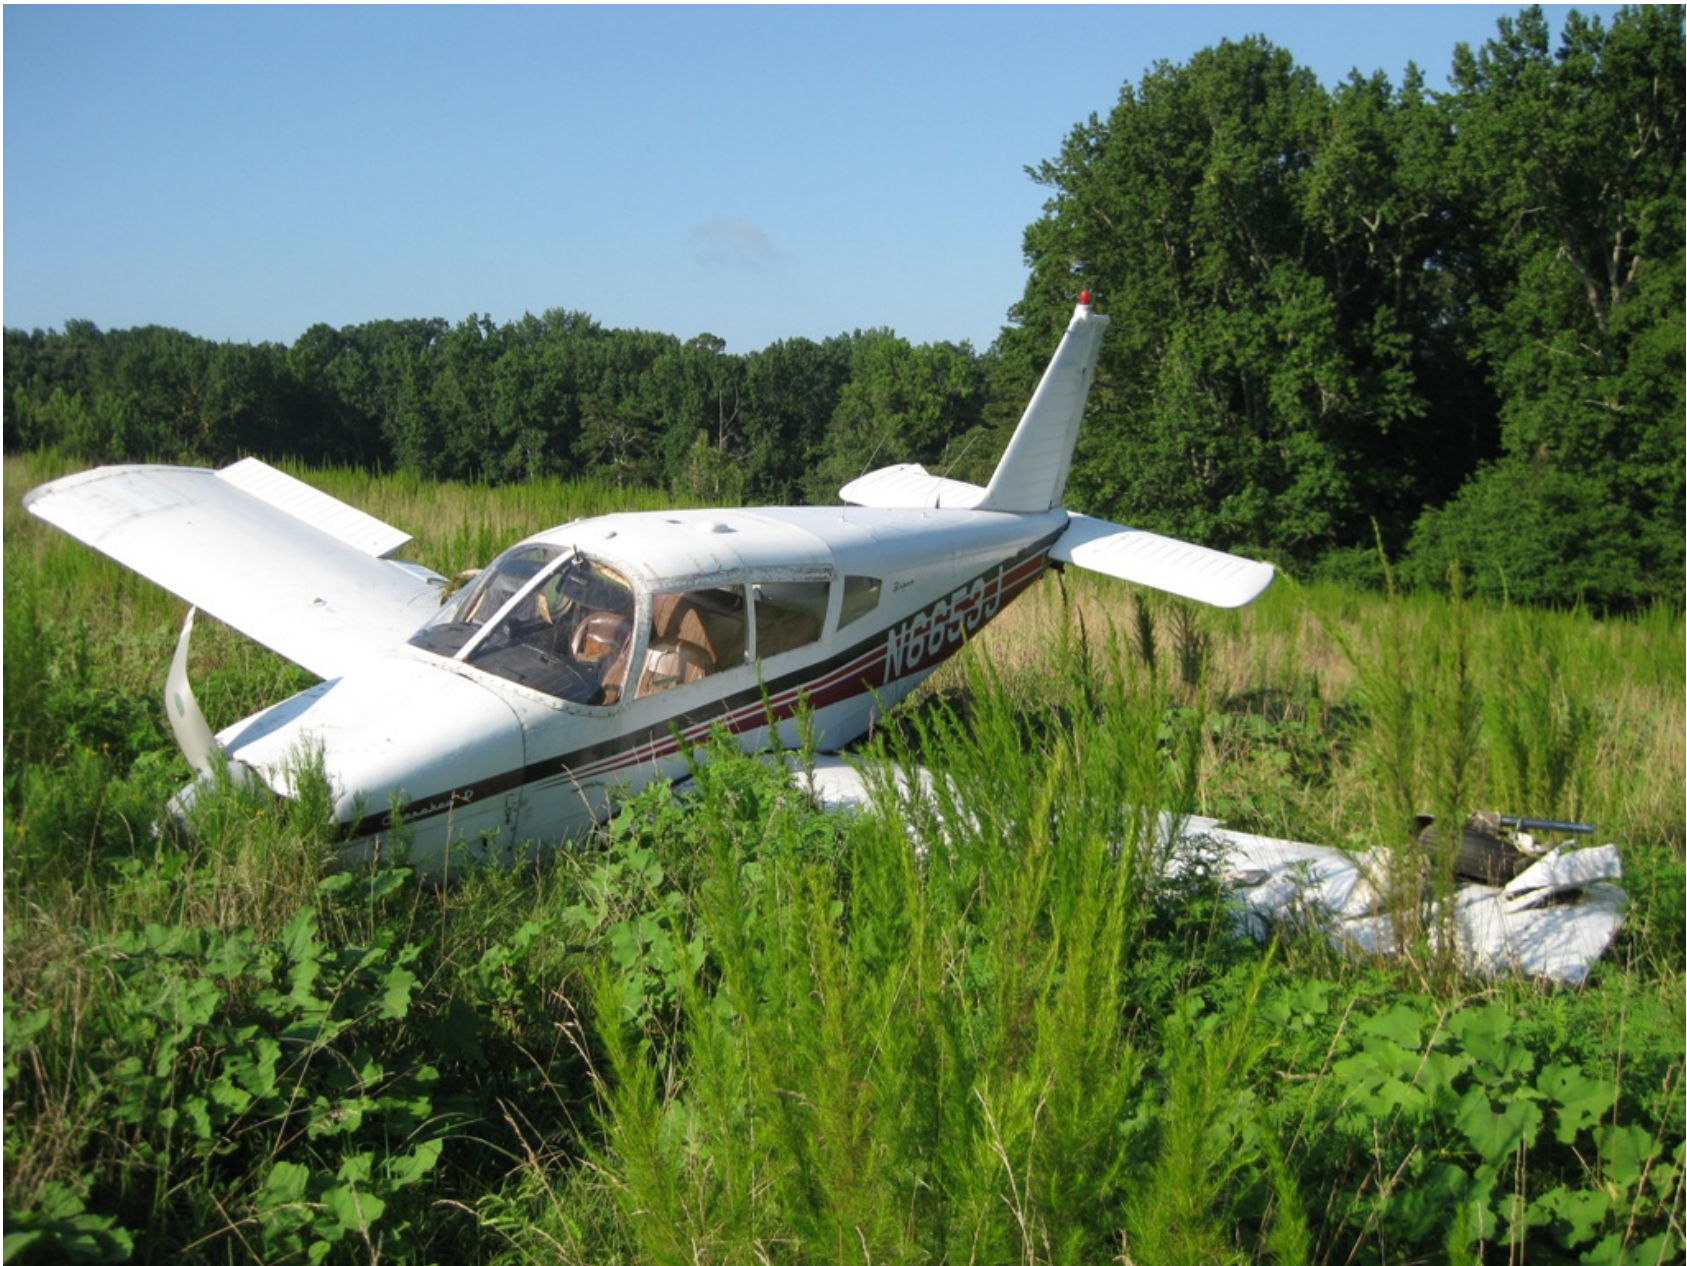
**Photo 1 – FAA Digital Photograph. View of the Airplane at the Accident Site**

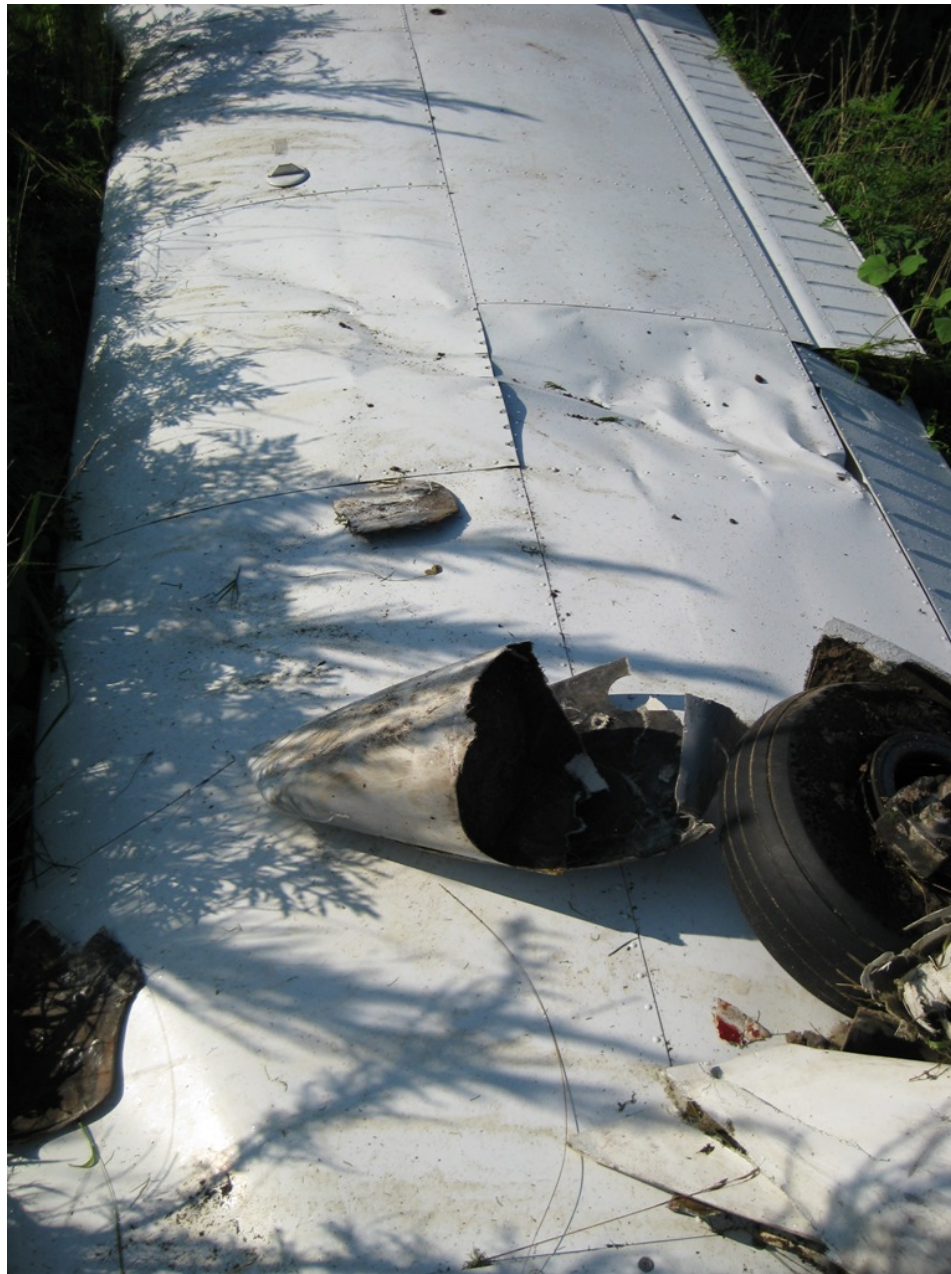
**Photo 2 – FAA Digital Photograph. View Depicting the Damage to the Left Wing**

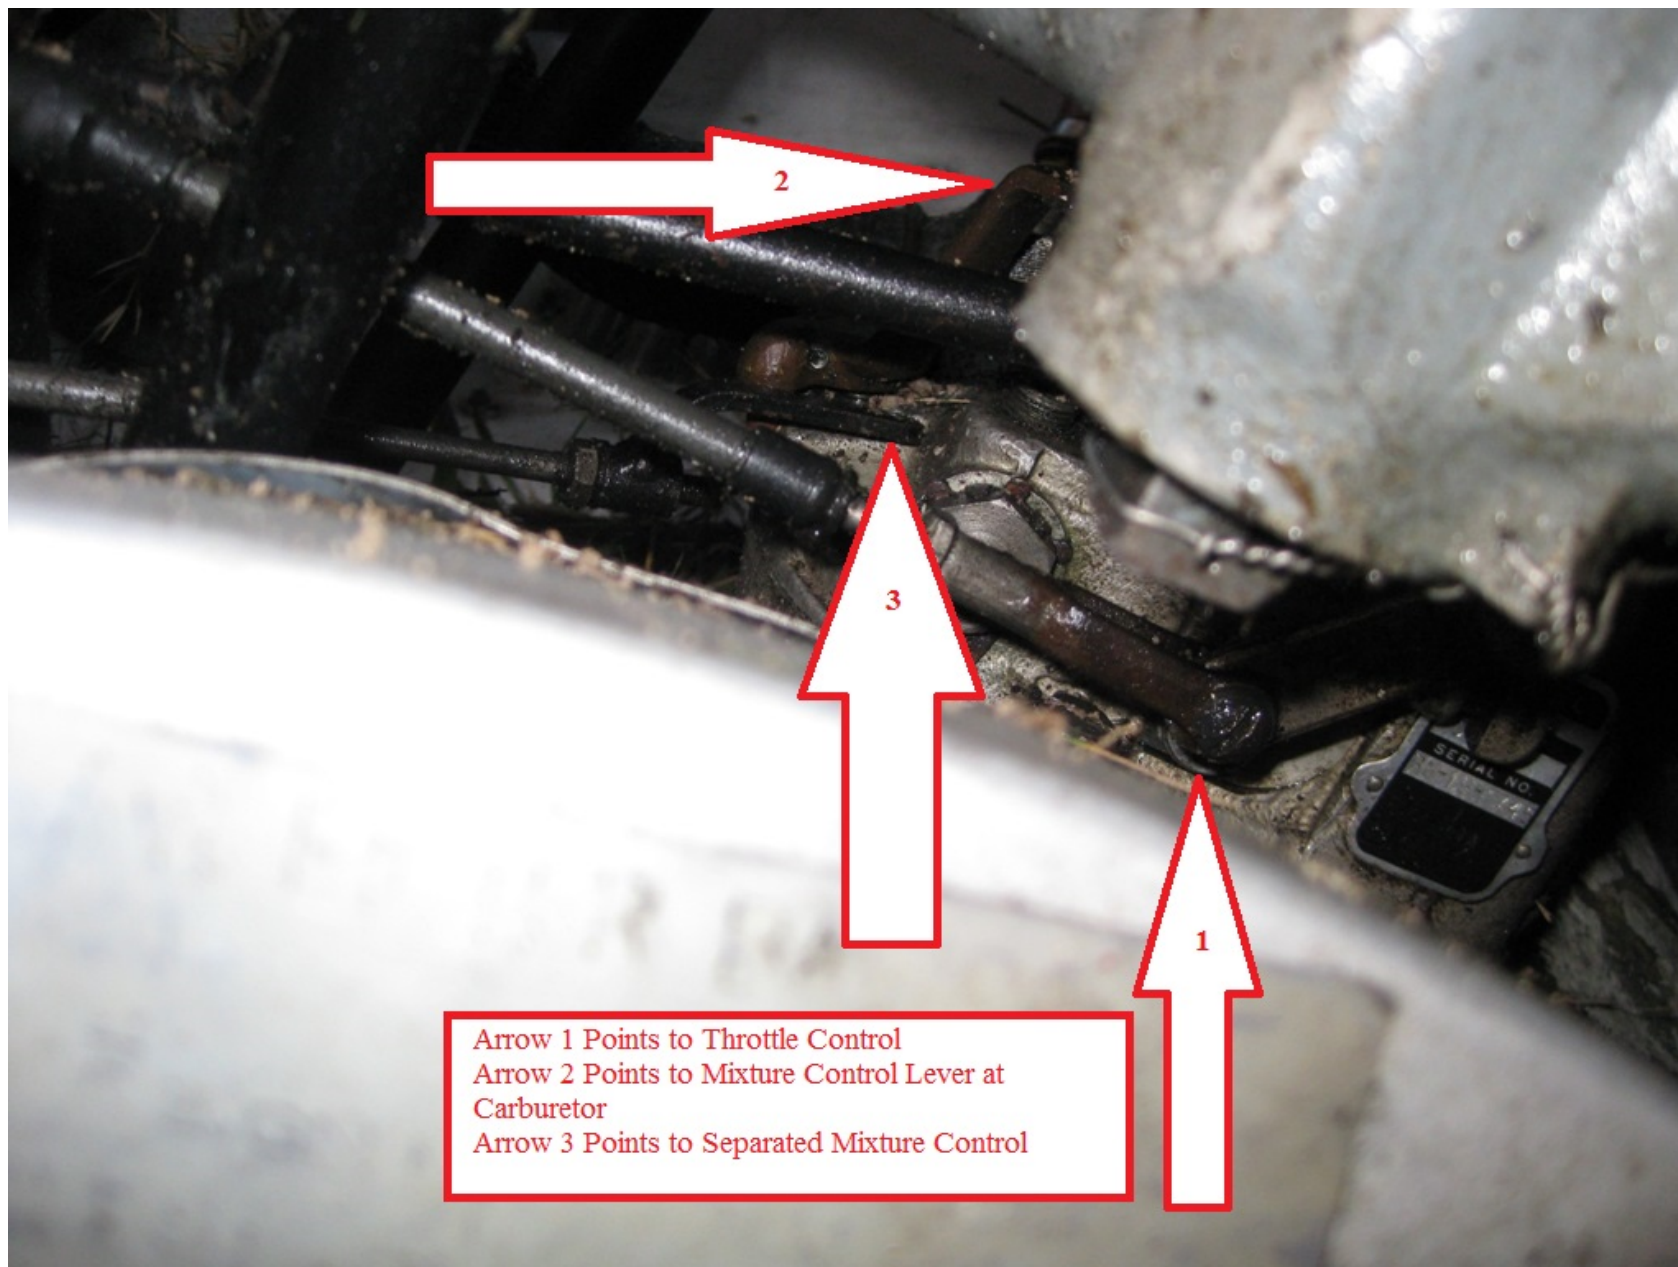
**Photo 3 – FAA Digital Photograph with Captions Added by NTSB. View Depicting the Connected Throttle Control and Separated Mixture Control at the Carburetor**
