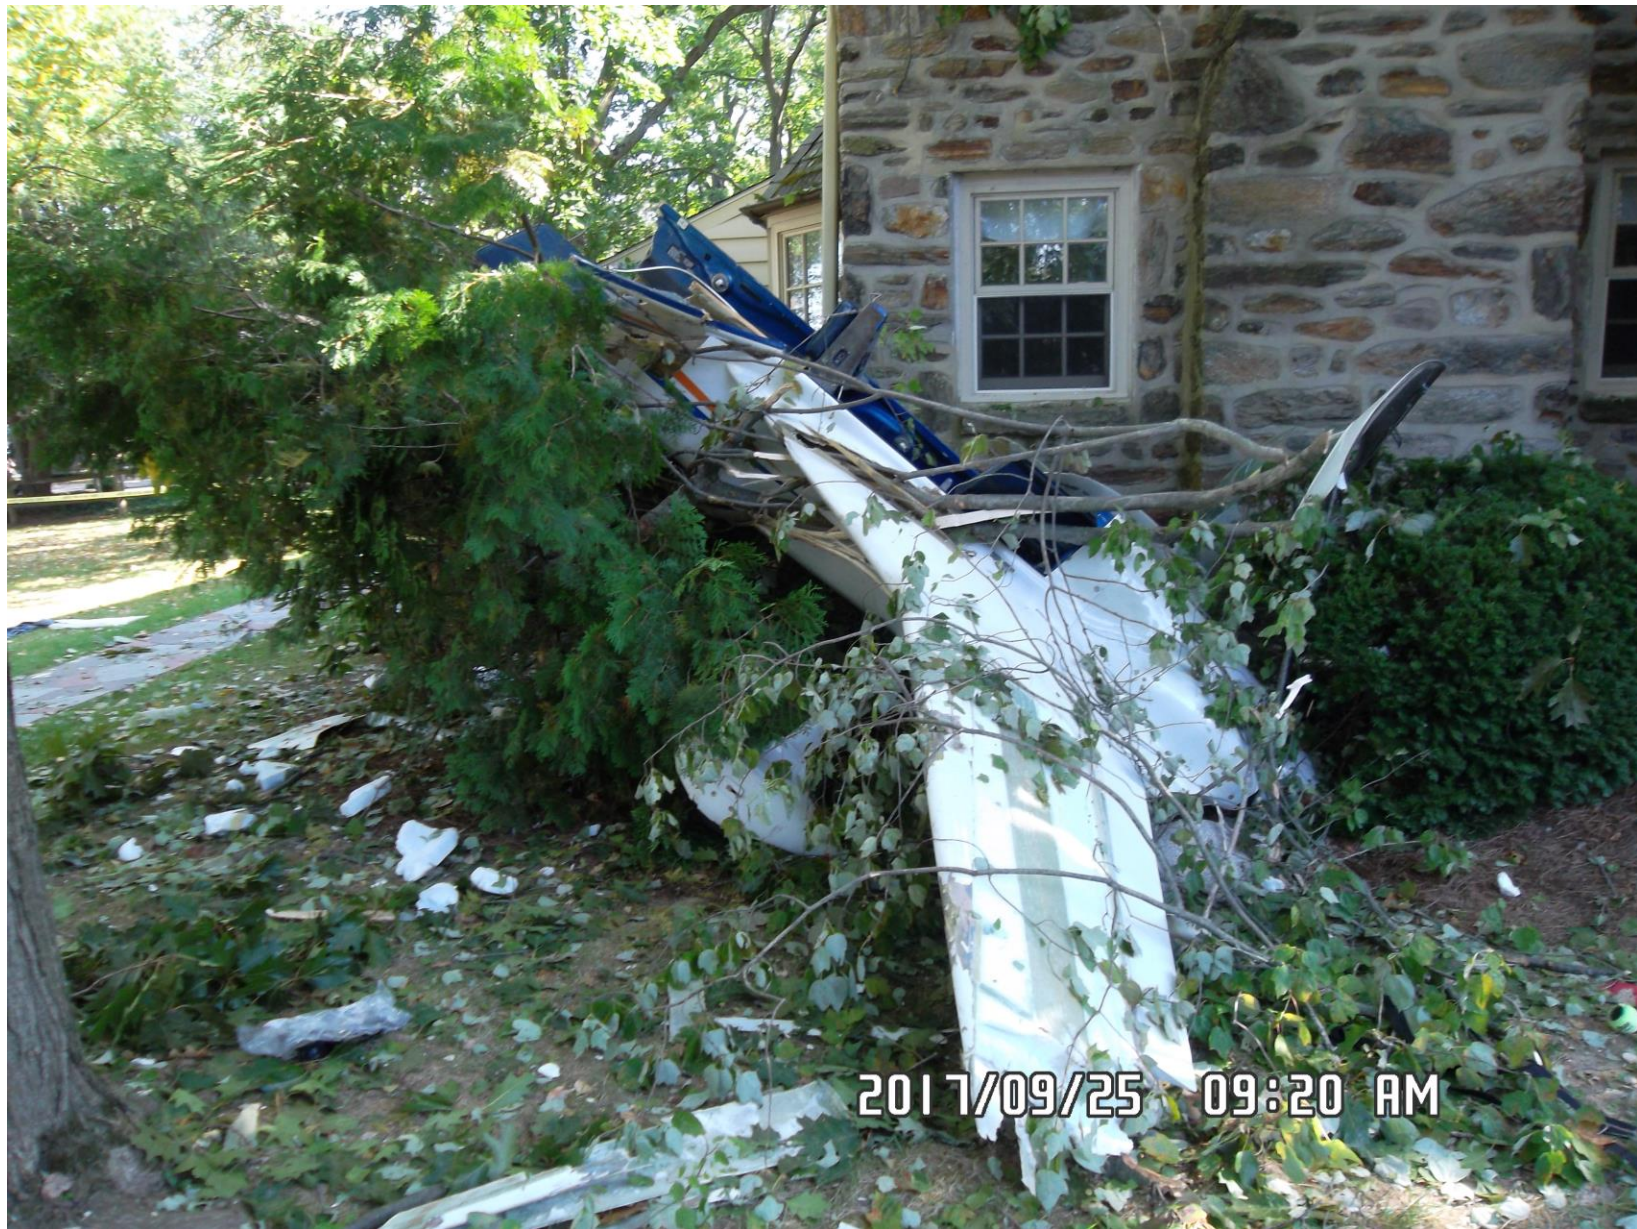
**Photo 1 – View of accident site.**

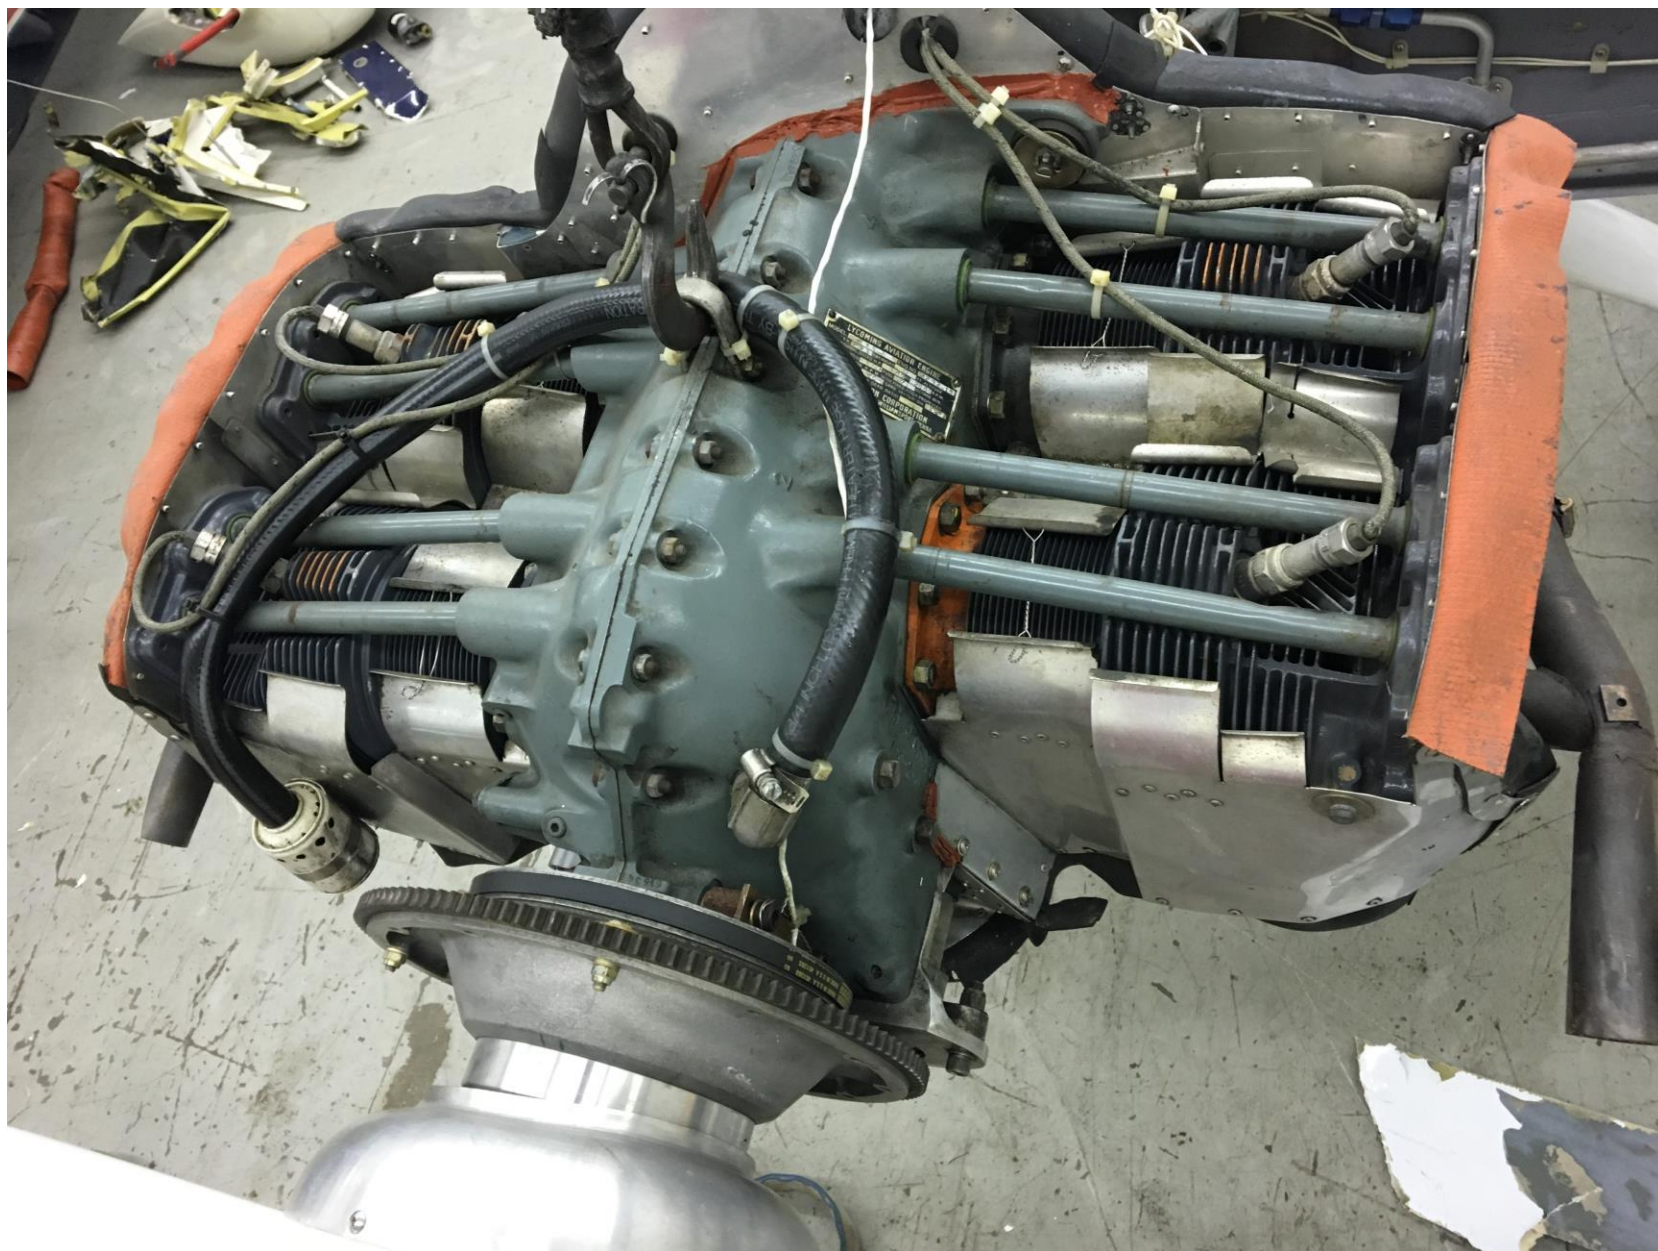
**Photo 2- View of Engine.**

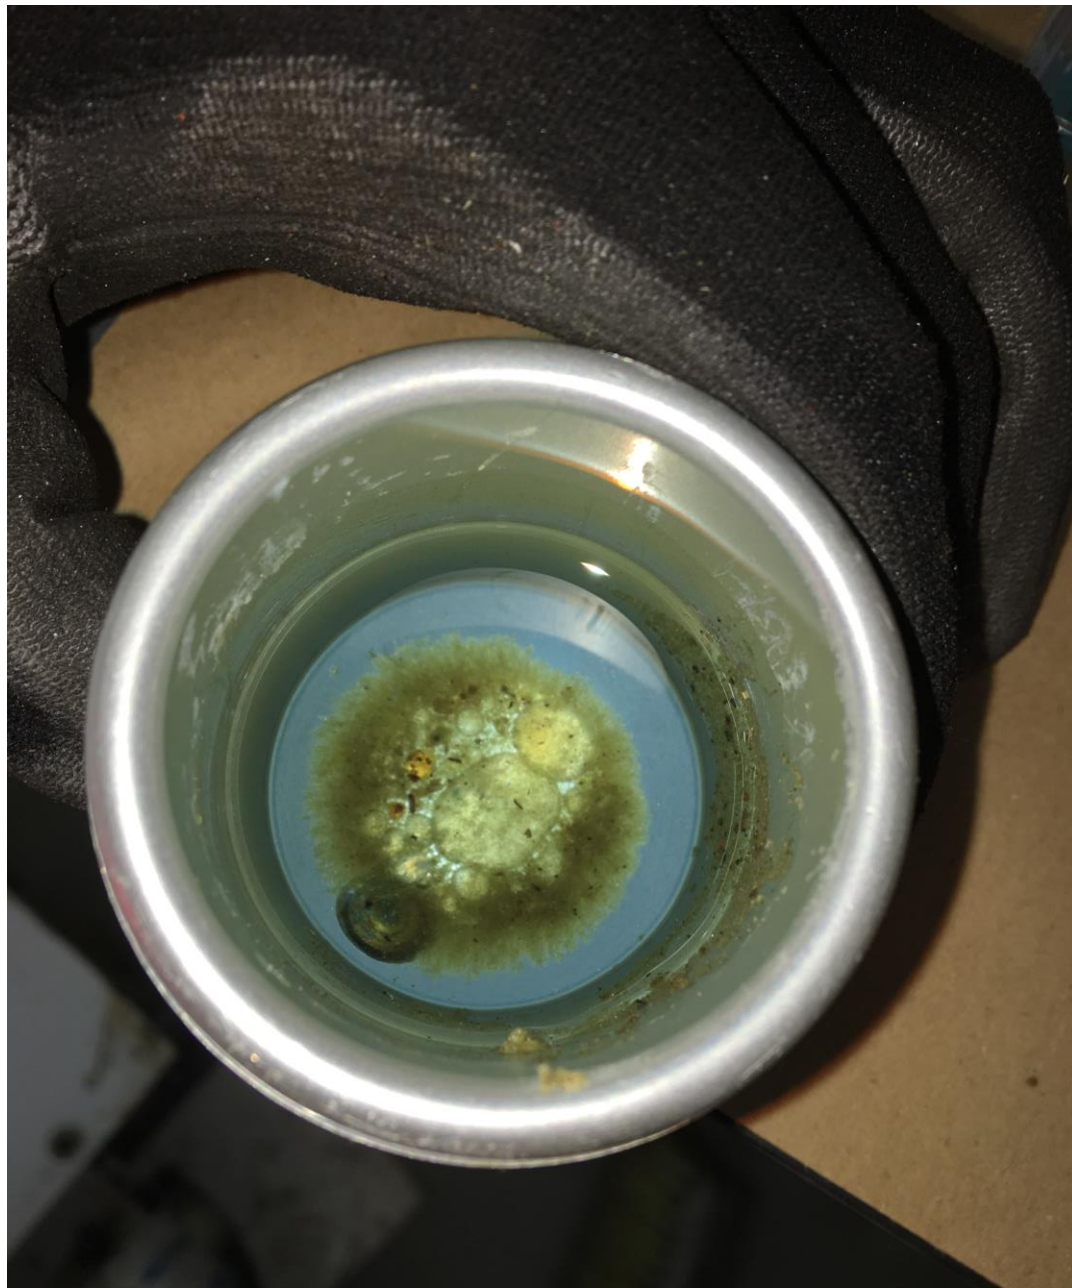
**Photo 3 – View of fluid in gascolator.**

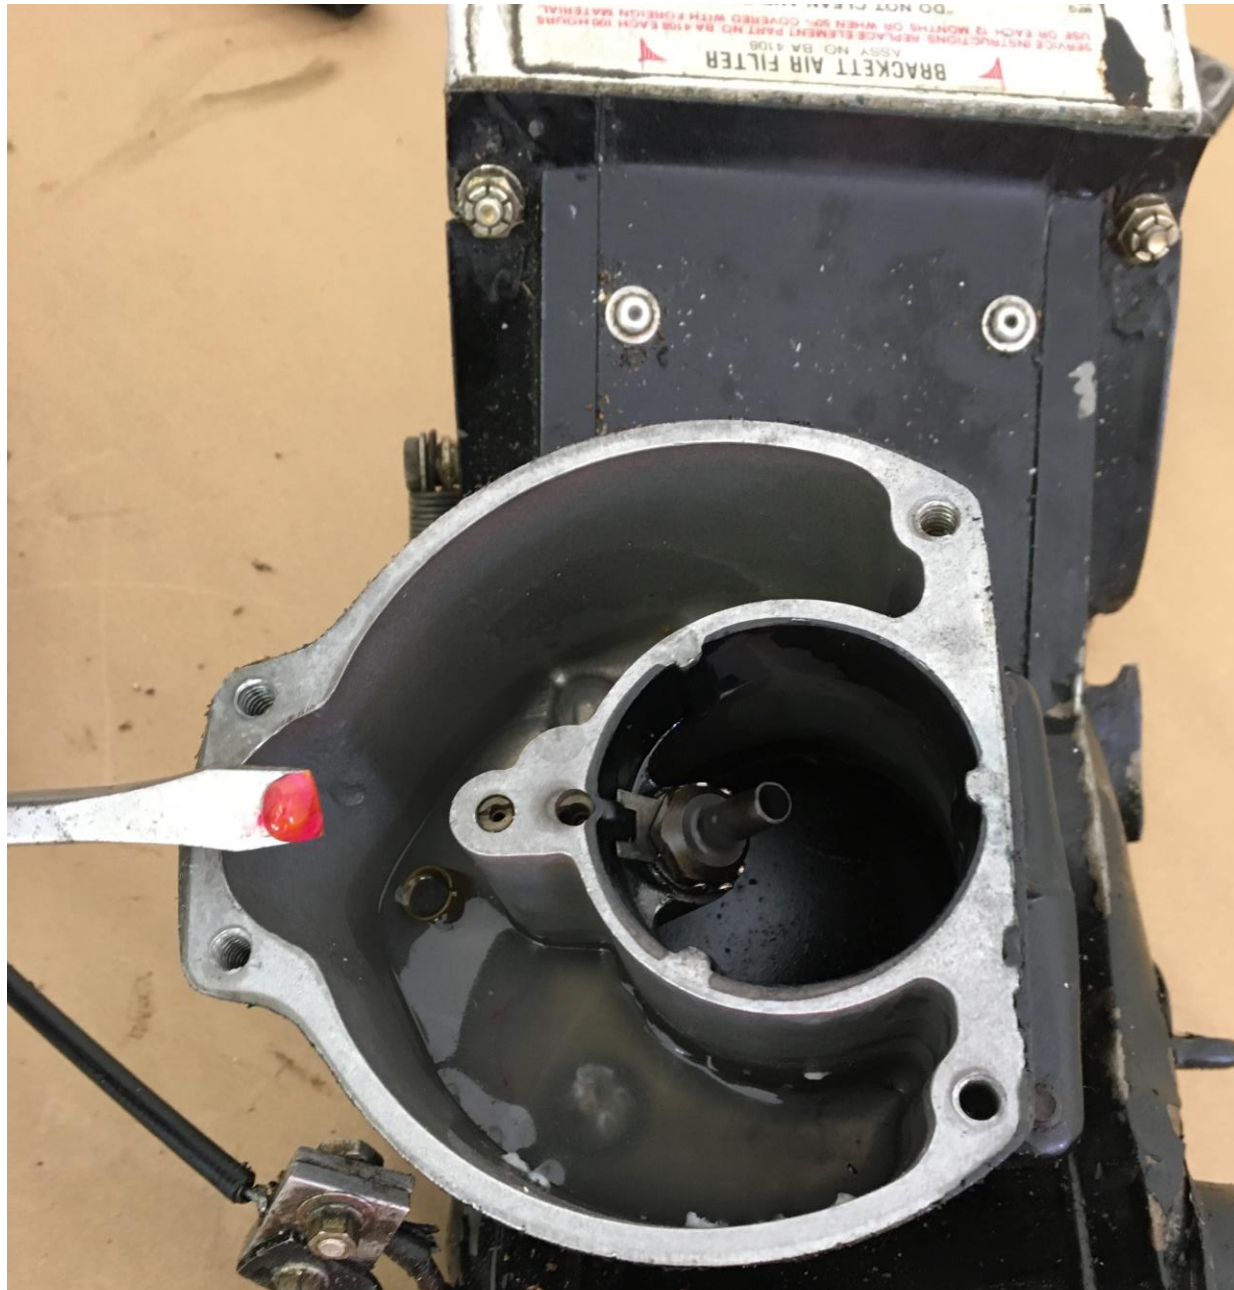
**Photo 4 – View of fluid in carburetor with water finding paste.**

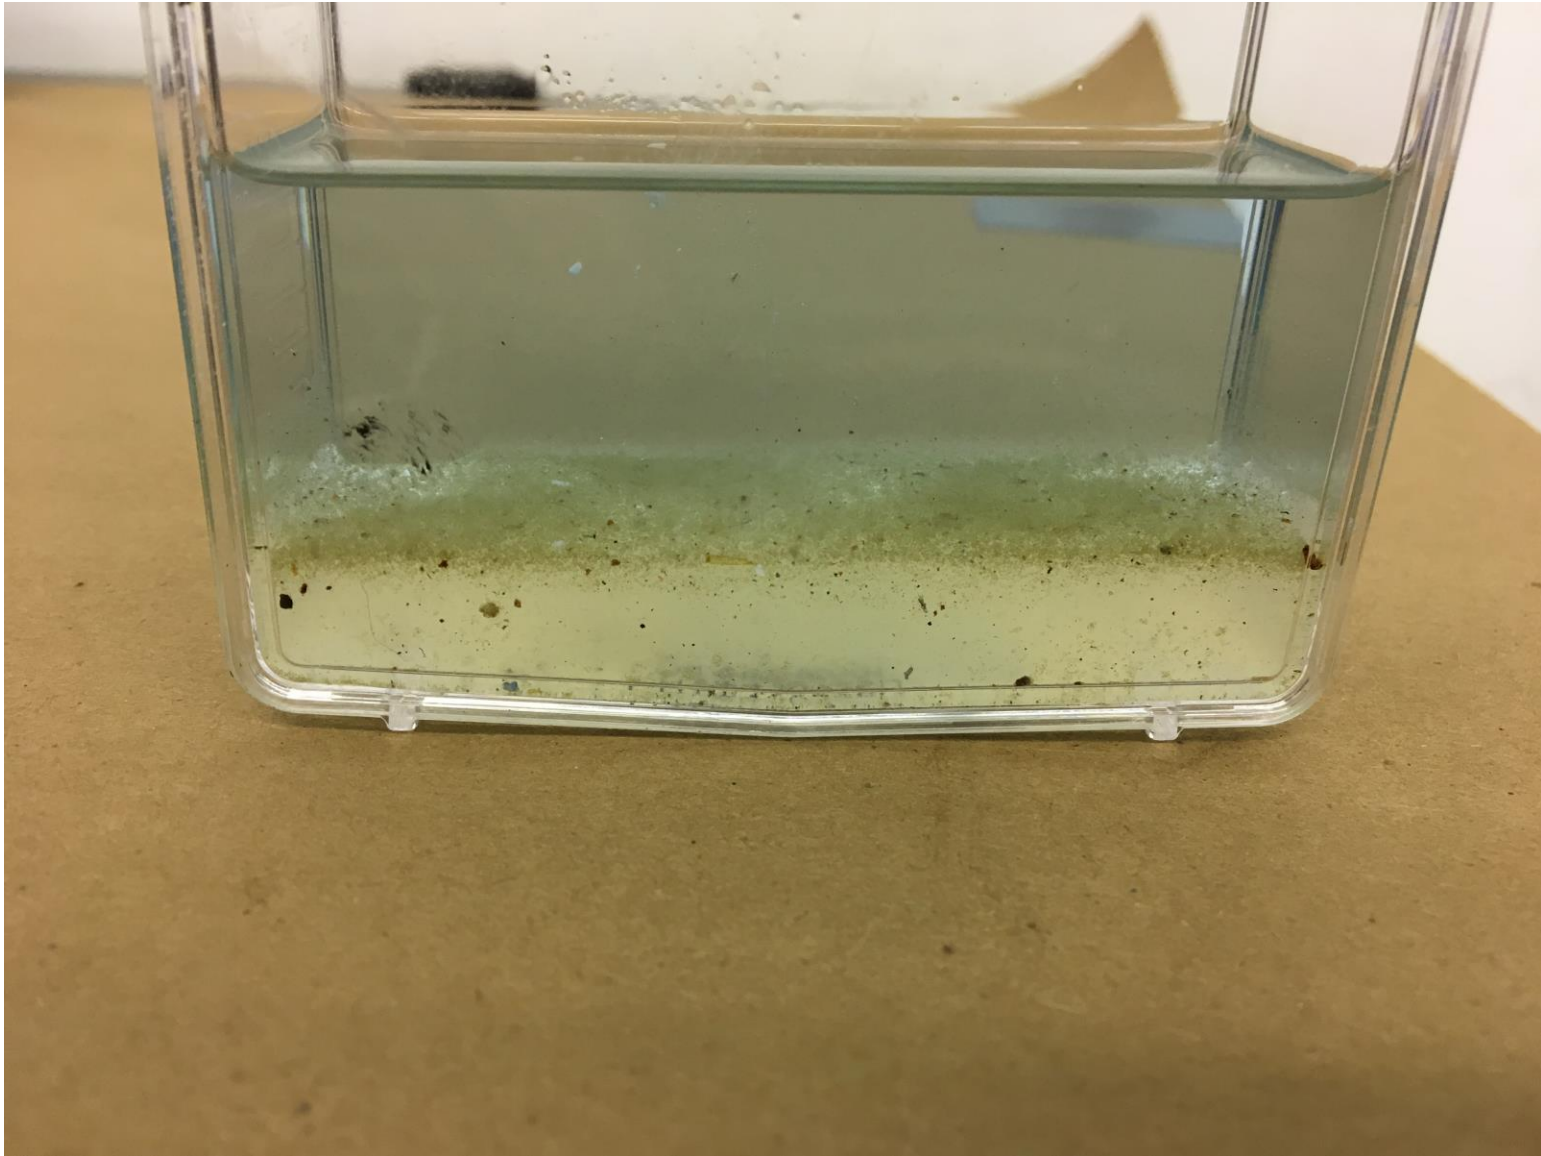
**Photo 5 – View of contaminated fuel extracted from fuel system.**

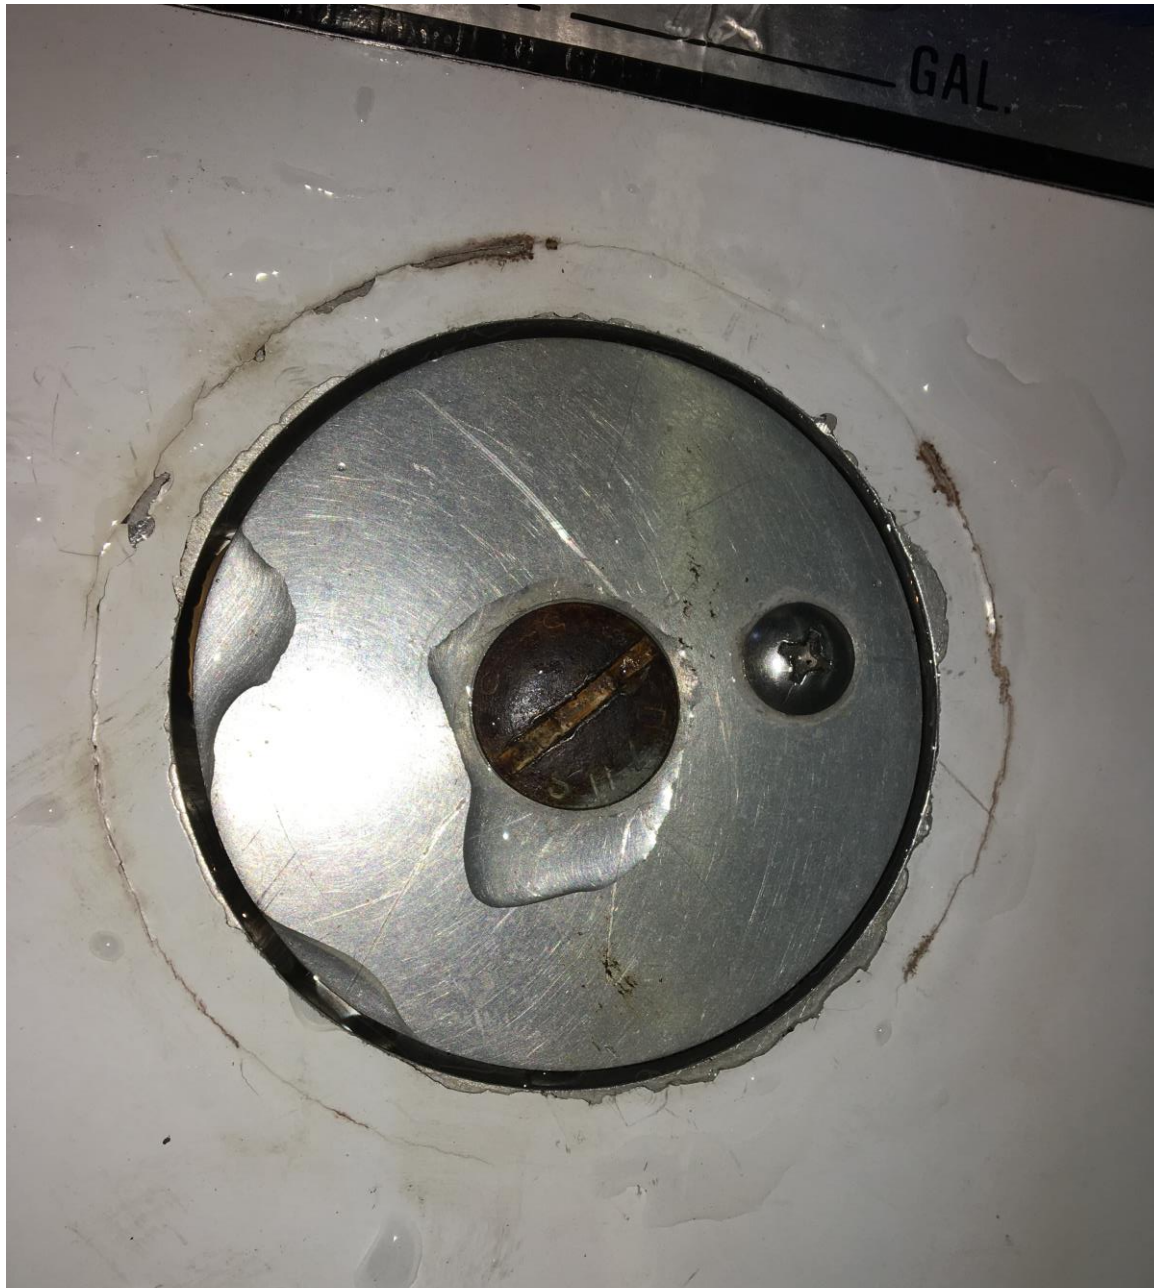
**Photo 6 – View of water on right fuel cap test.**
