**Photo 1 – Main Wreckage – Courtesy of FAA**

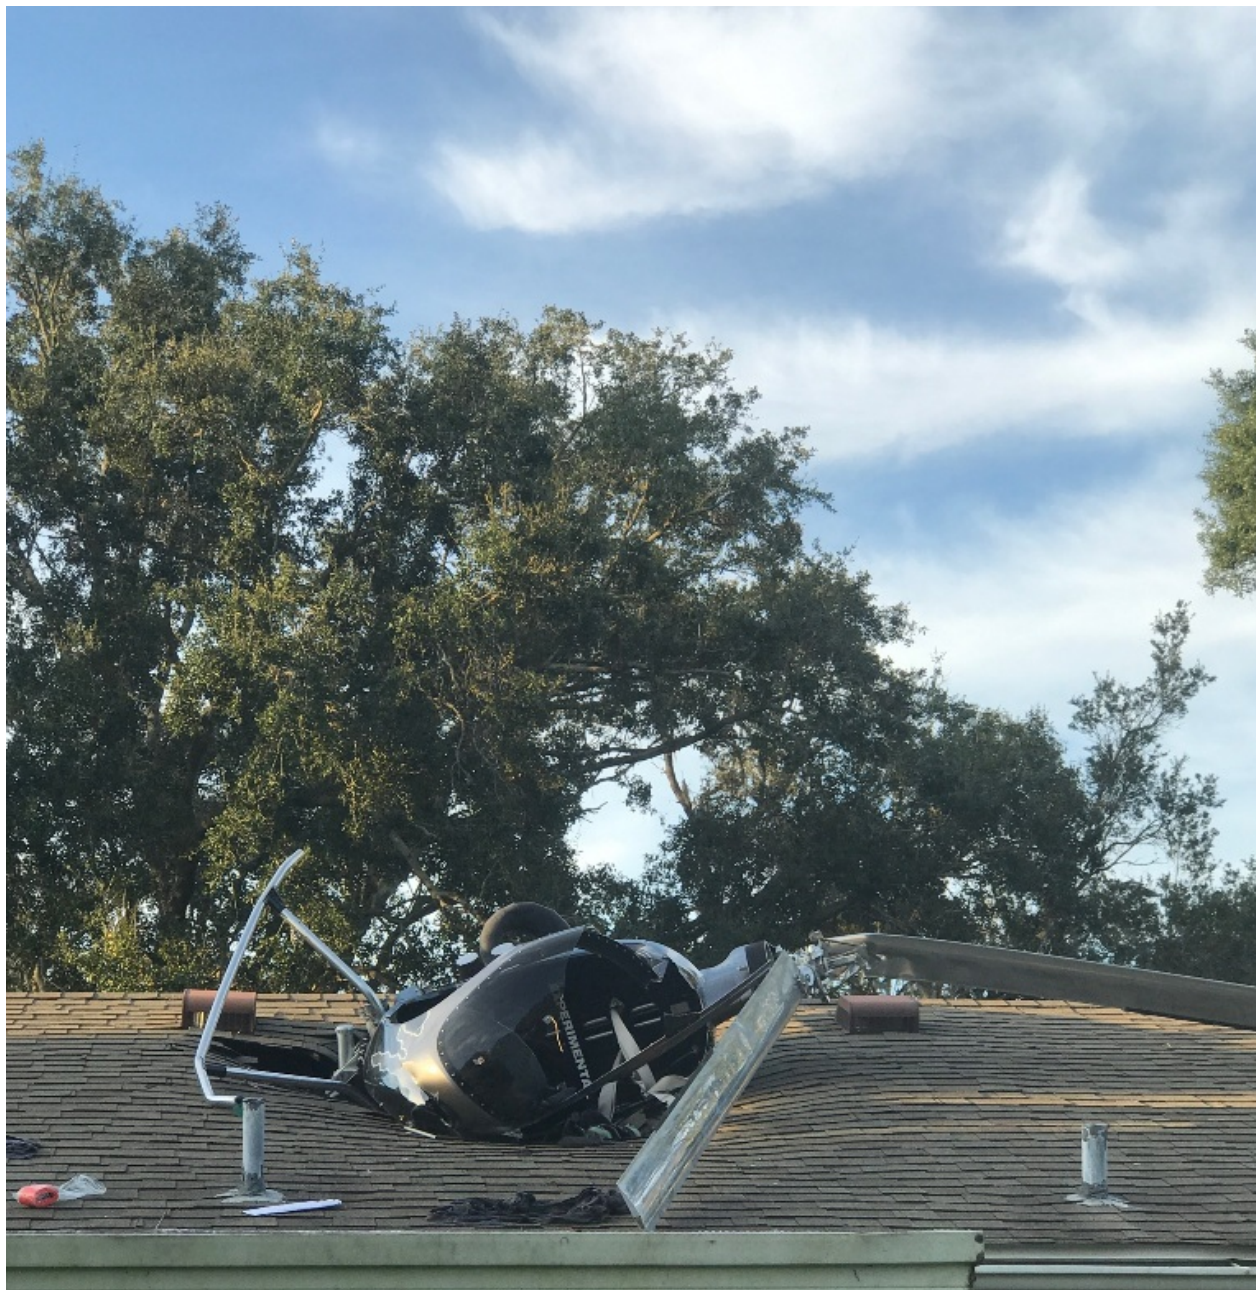
**Photo 2 – Front View of Main Wreckage – Courtesy of FAA**

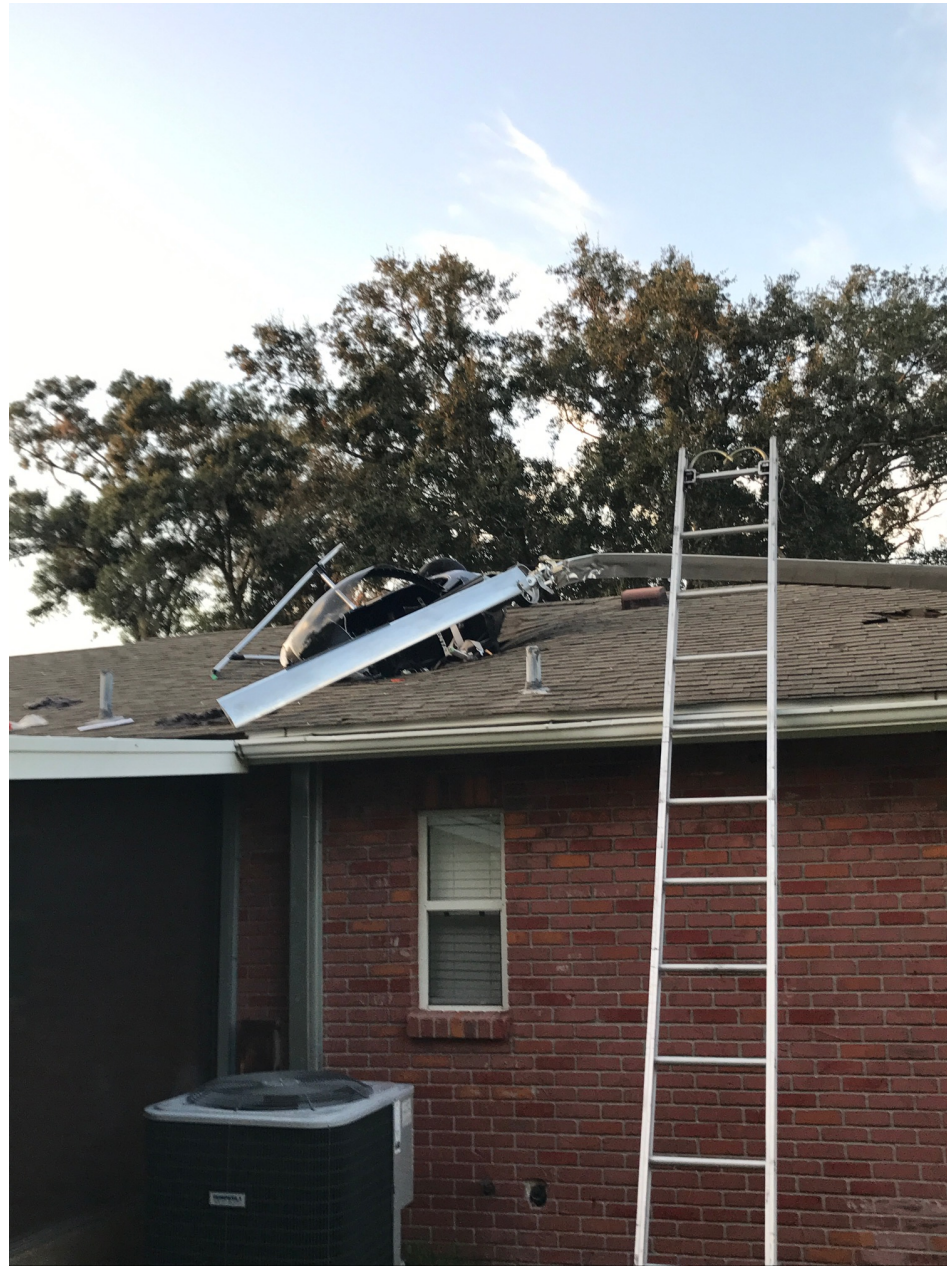
**Photo 3 – Left Side View of main Wreckage – Courtesy of FAA**

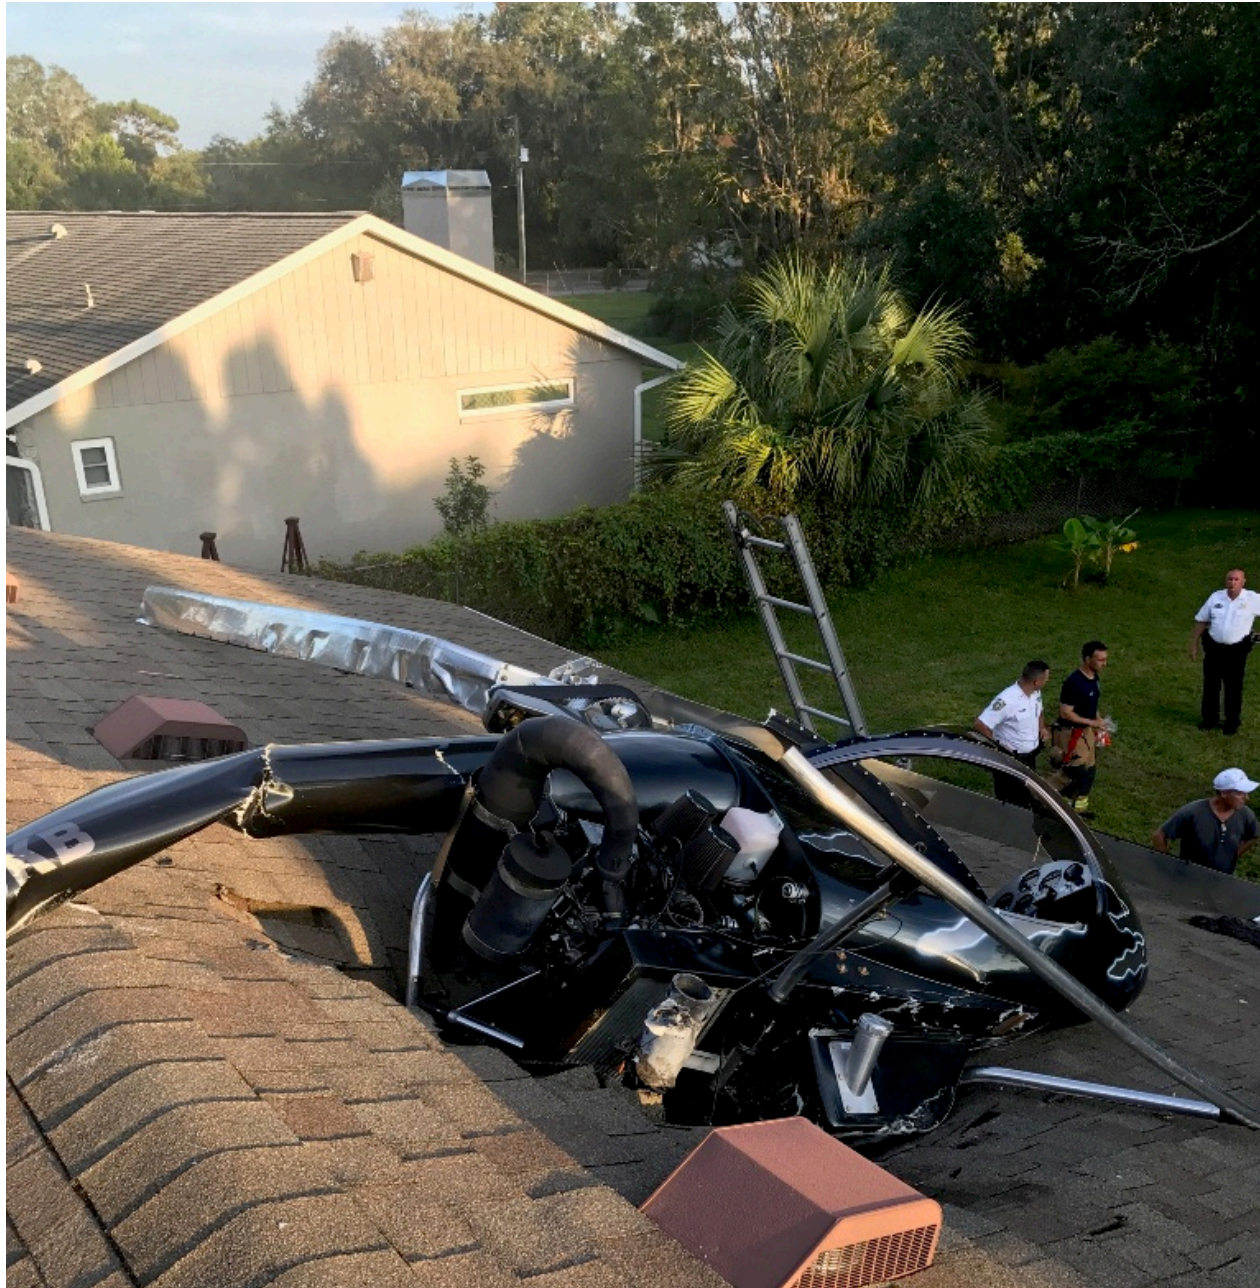
**Photo 4 – Right Side View of Main Wreckage – Courtesy of FAA**

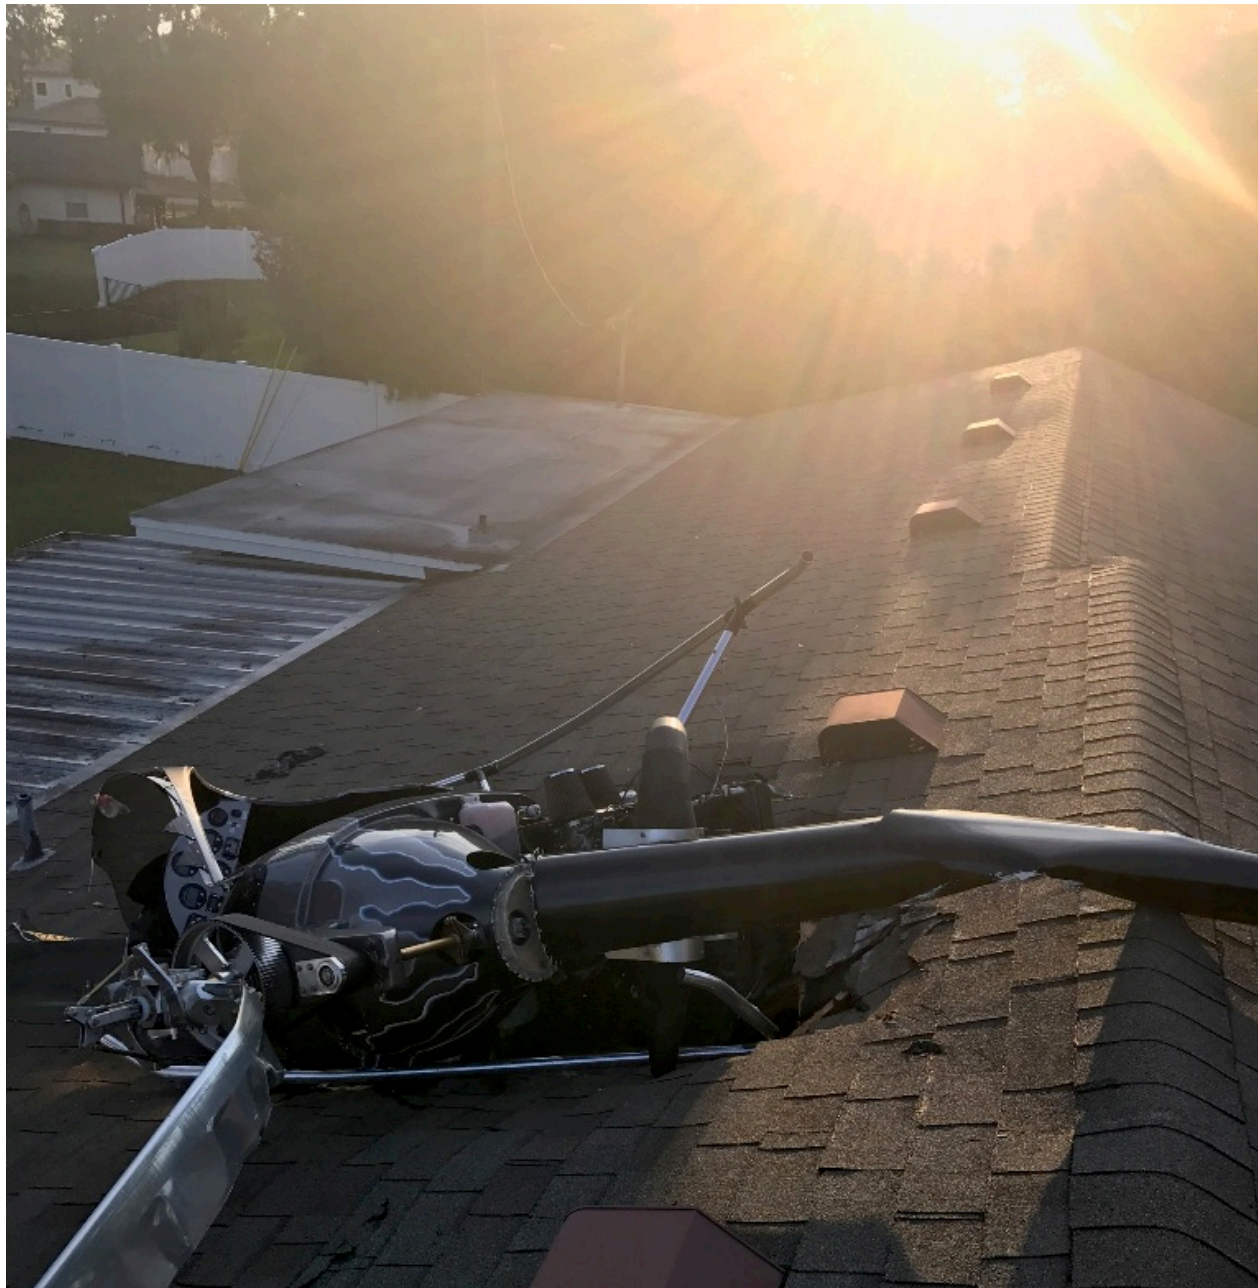
**Photo 5 – Rear View of Main Wreckage – Courtesy of FAA**

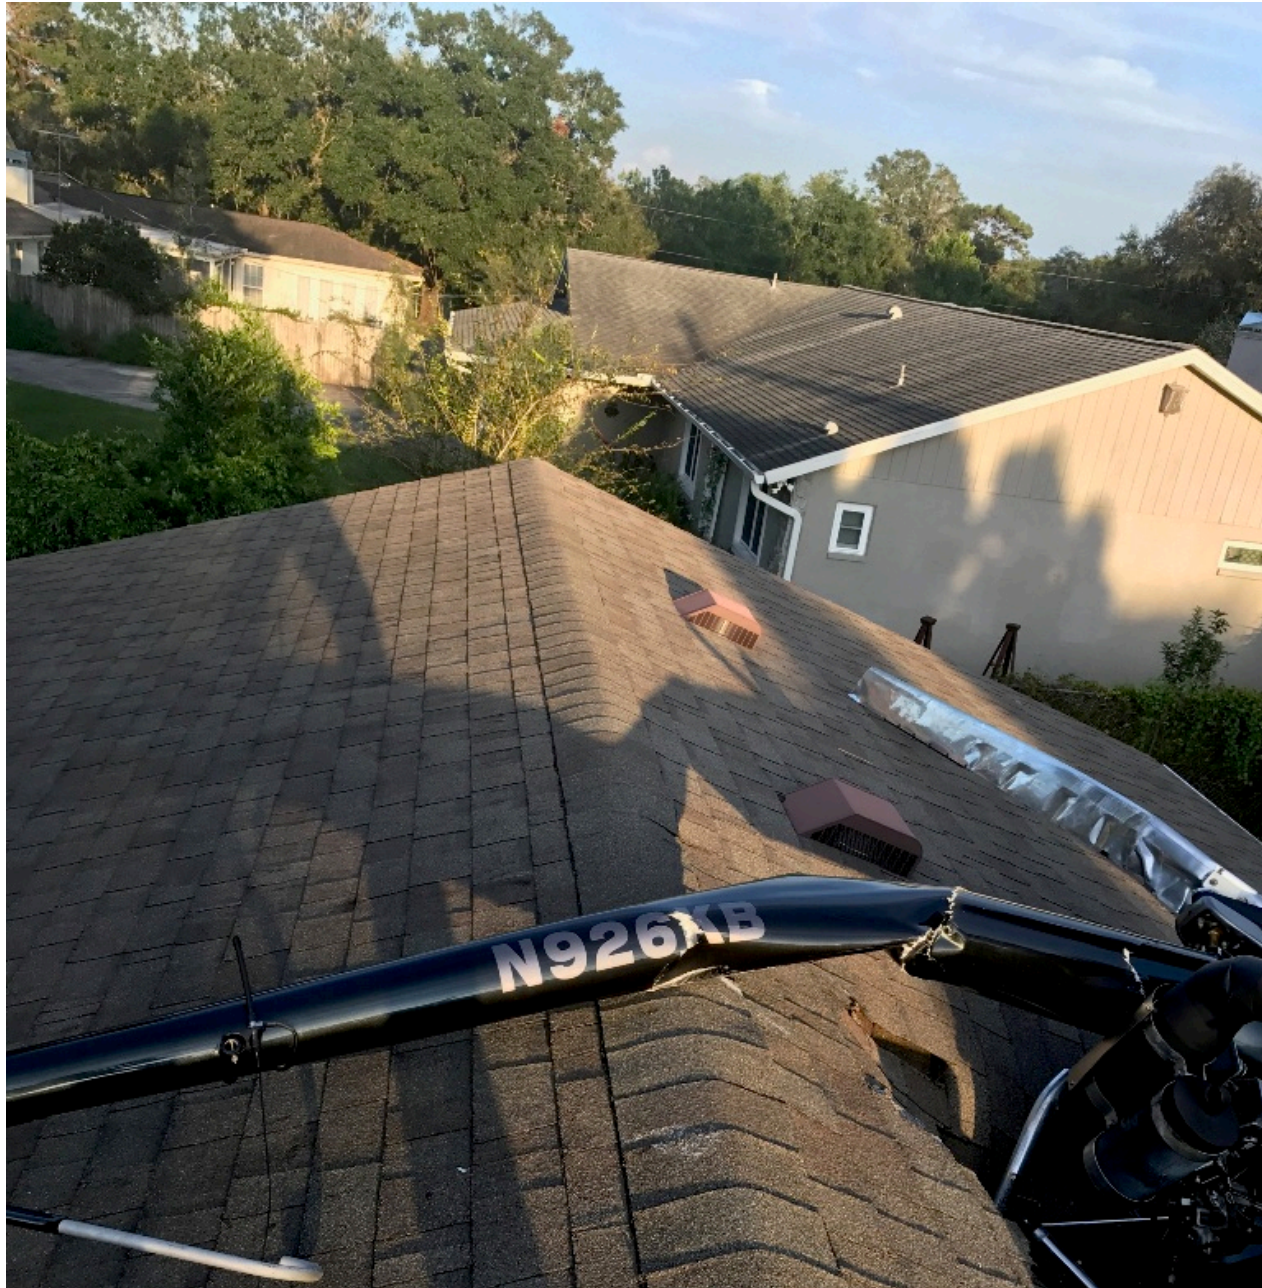
**Photo 6 – Tail Boom – Courtesy of FAA**

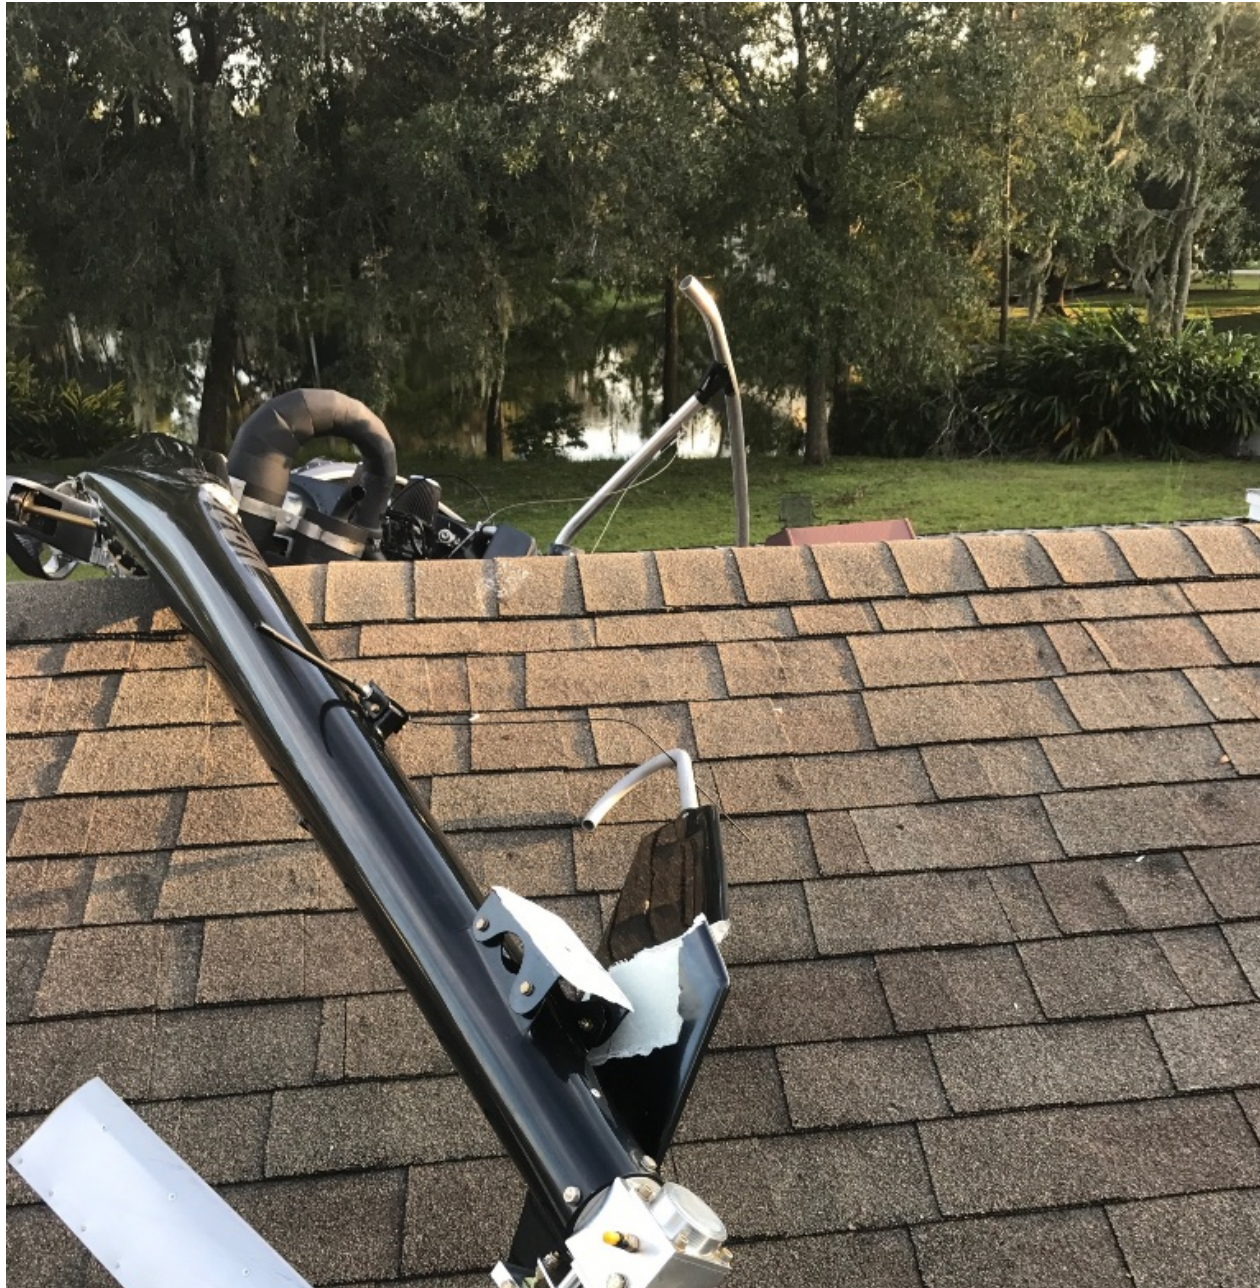
**Photo 7 – Tail Rotor – Courtesy of FAA**

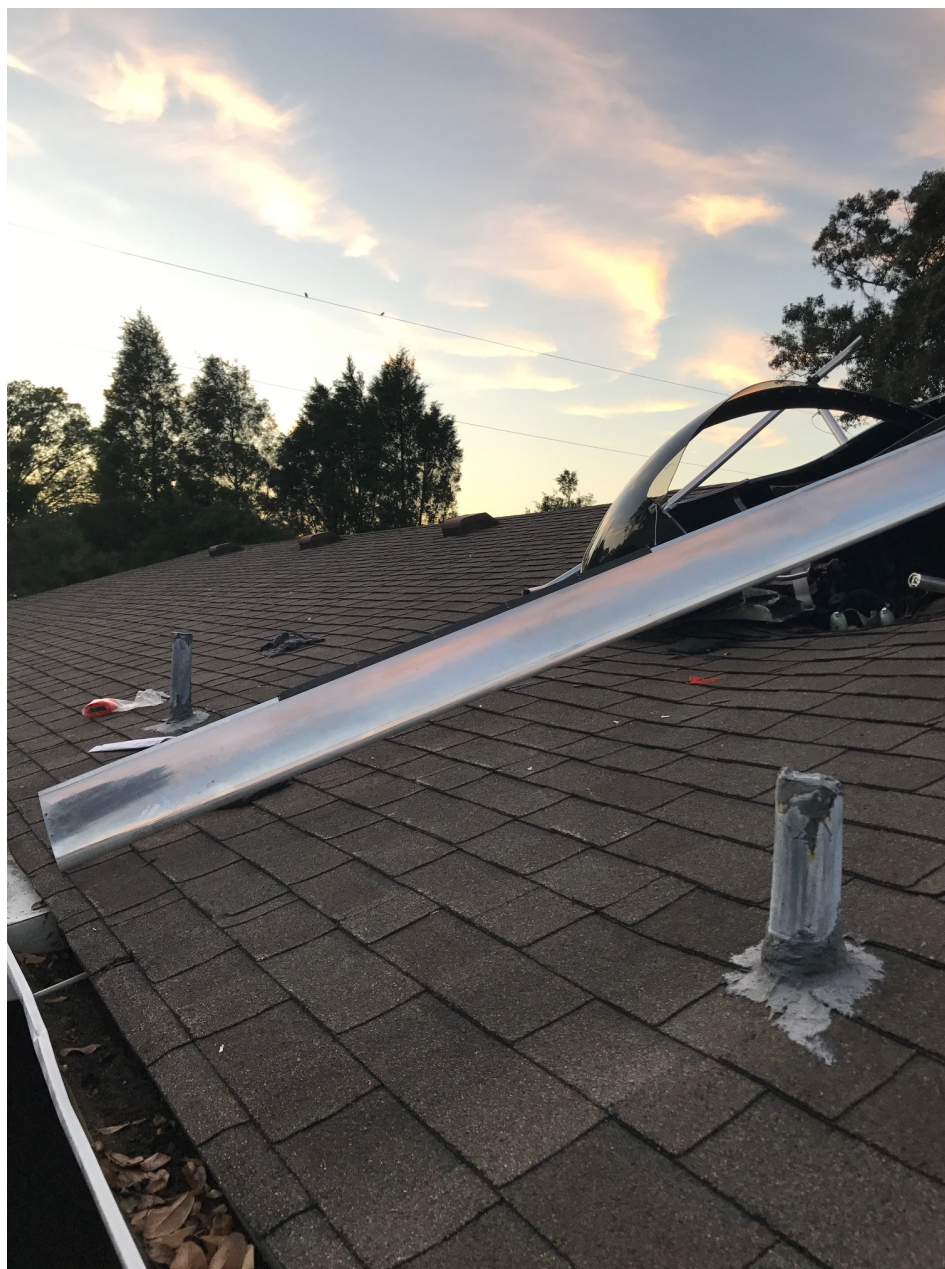
**Photo 8 –Main Rotor Blade Tip – Courtesy of FAA**

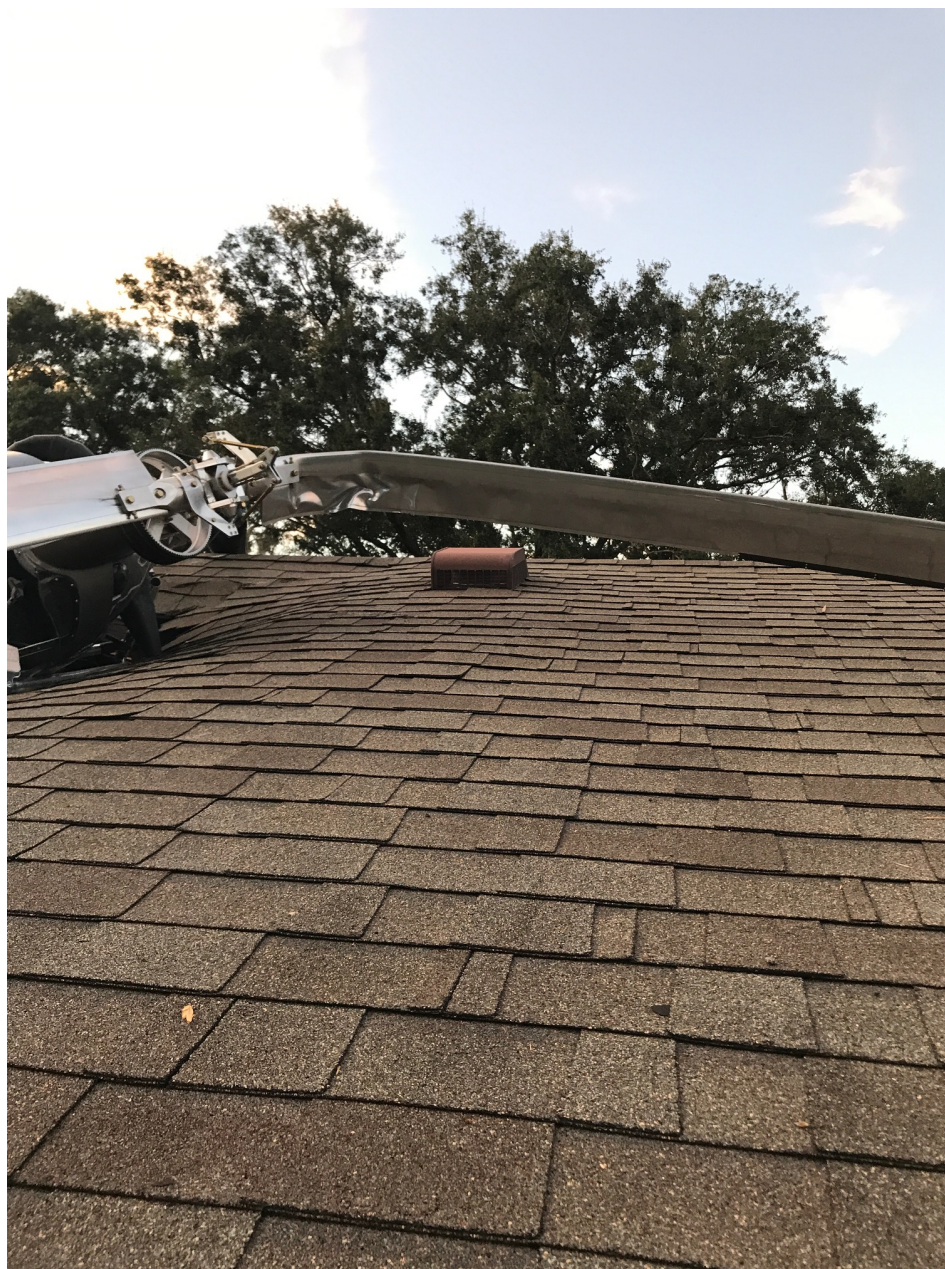
**Photo 9 – Main Rotor Head – Courtesy of FAA**

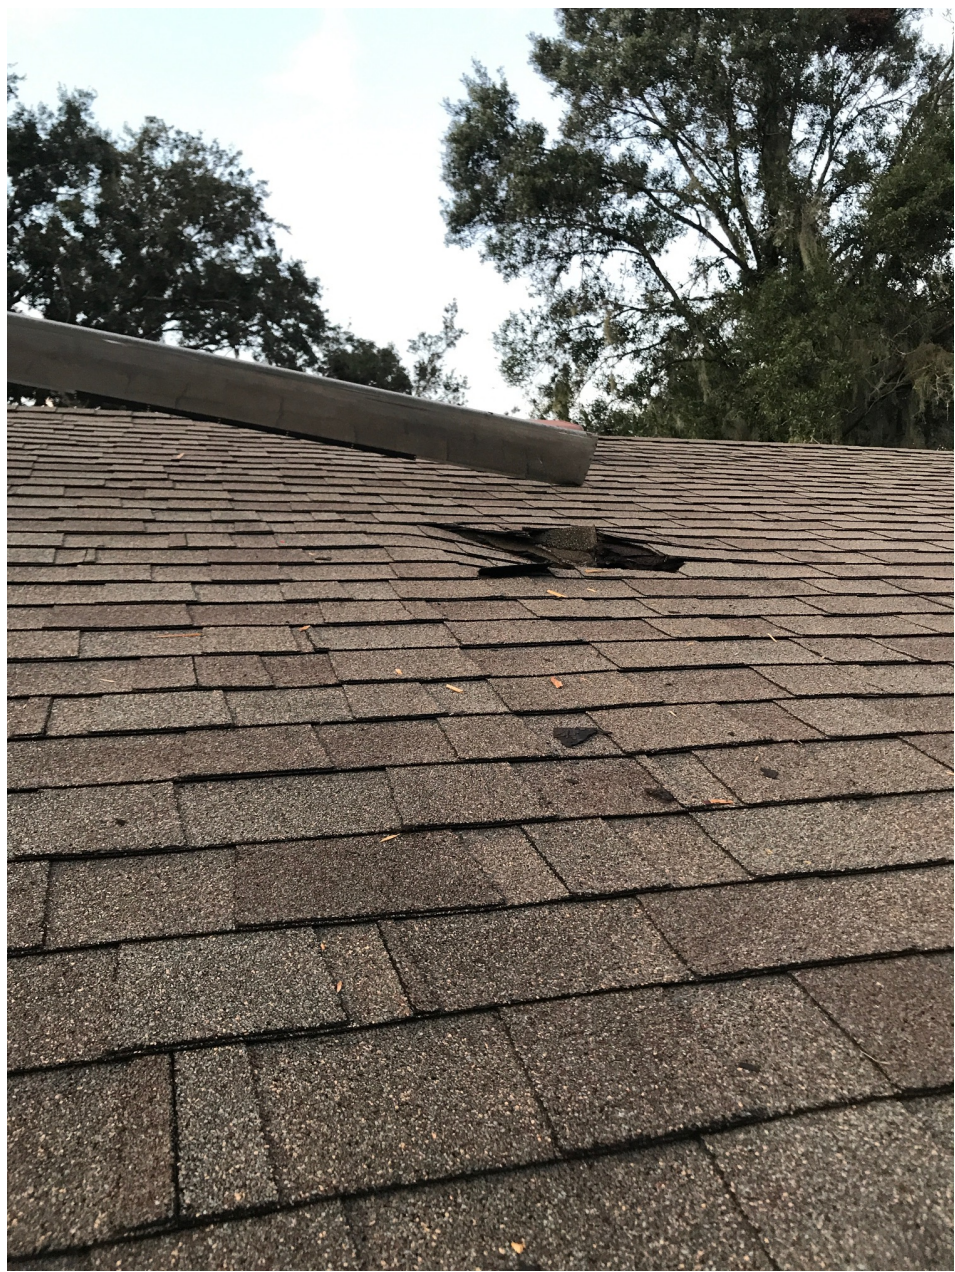
**Photo 10 – Other Main Rotor Blade Tip – Courtesy of FAA**

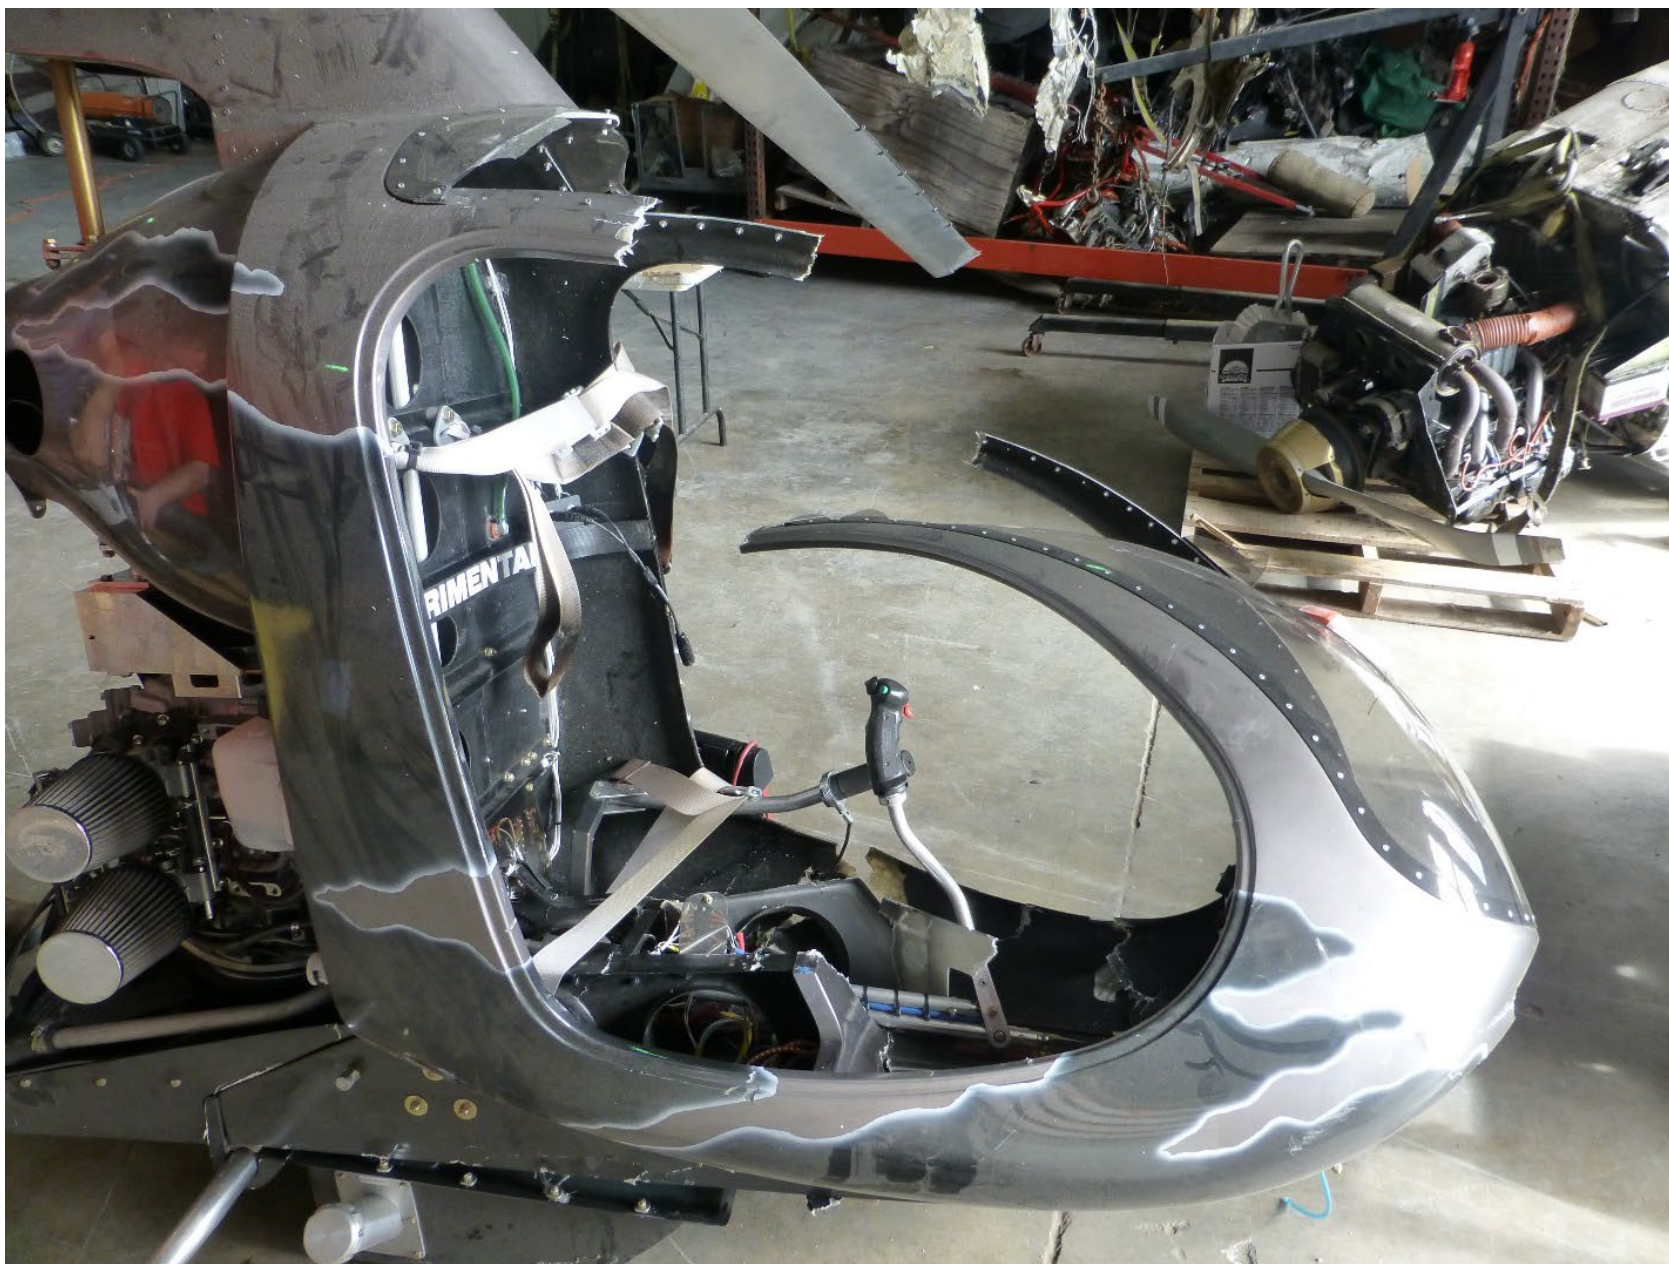
**Photo 11 – Cockpit and Engine**

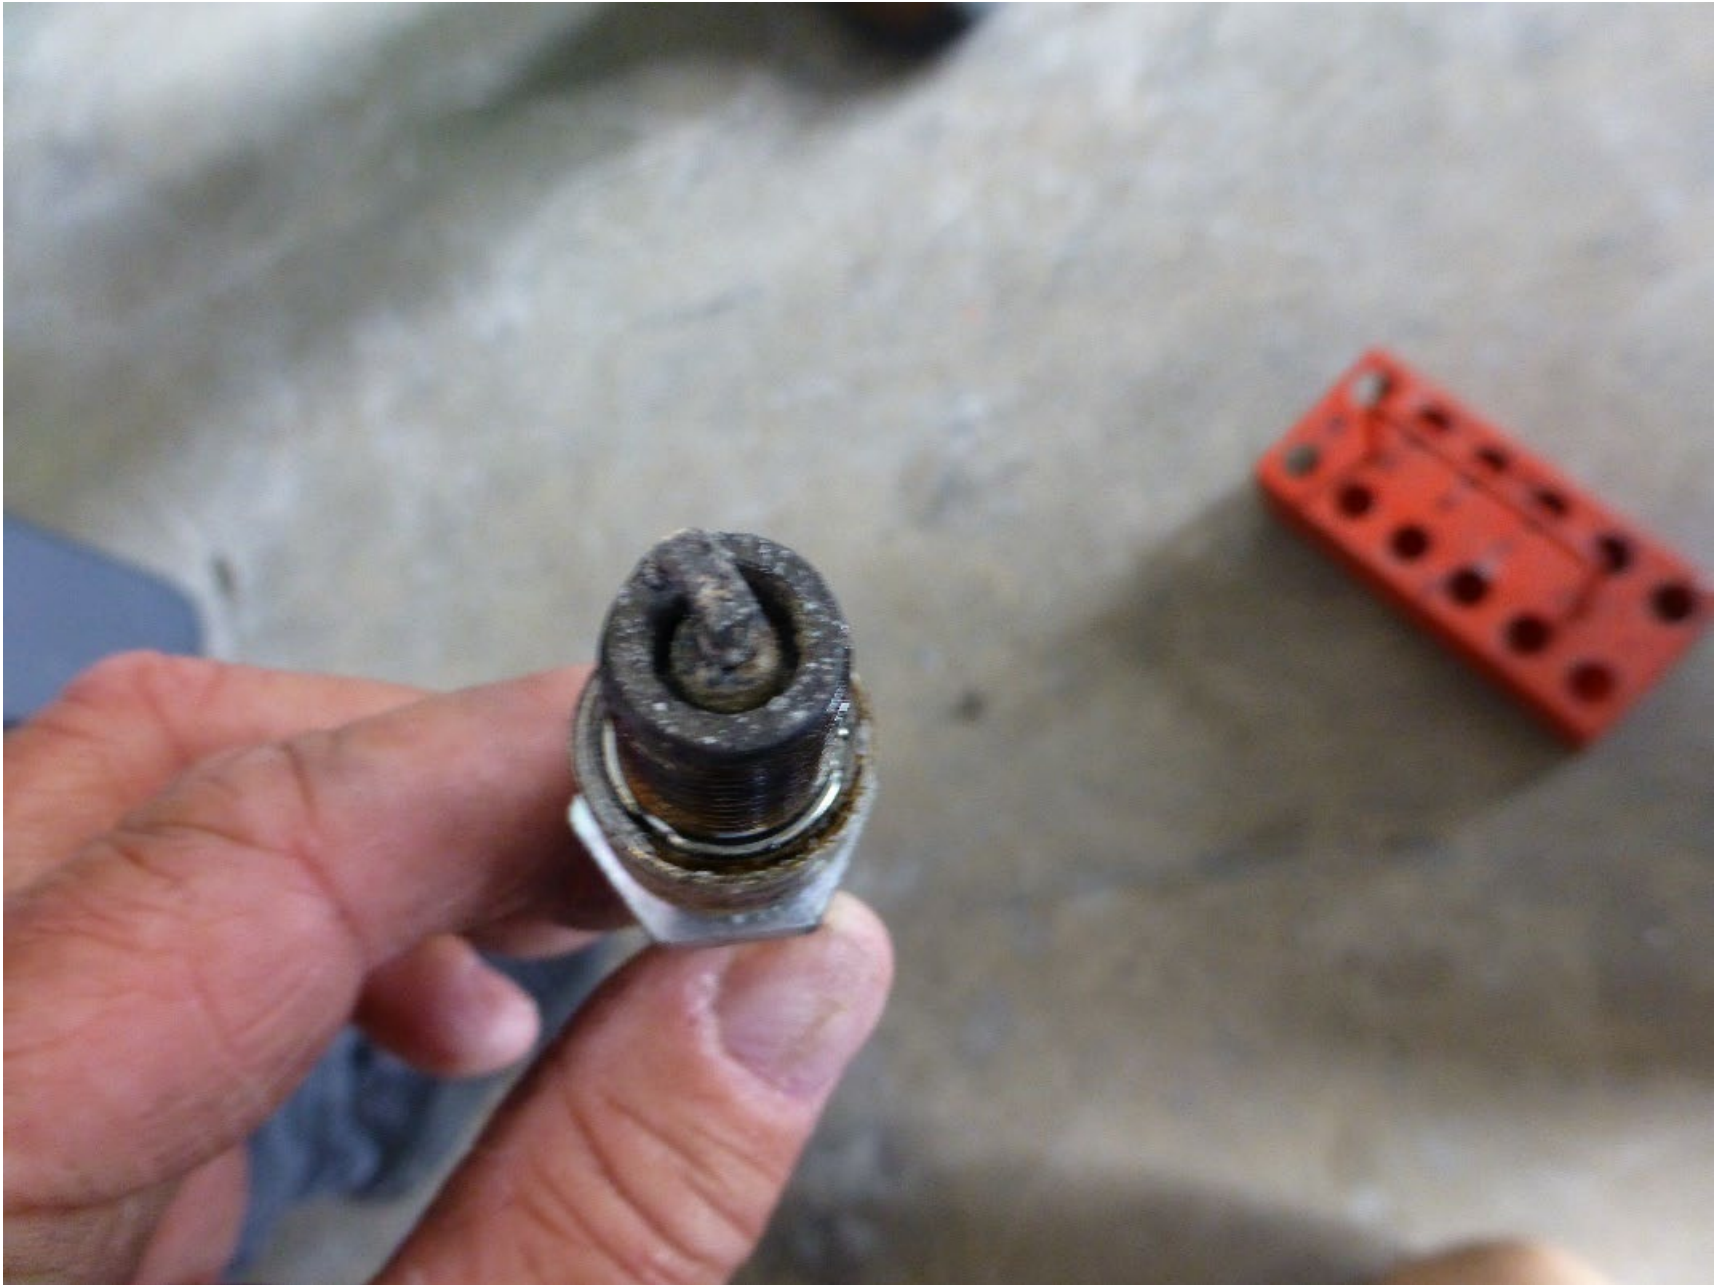
**Photo 13 – Spark Plug from No.1 Cylinder Displaying Spatter**

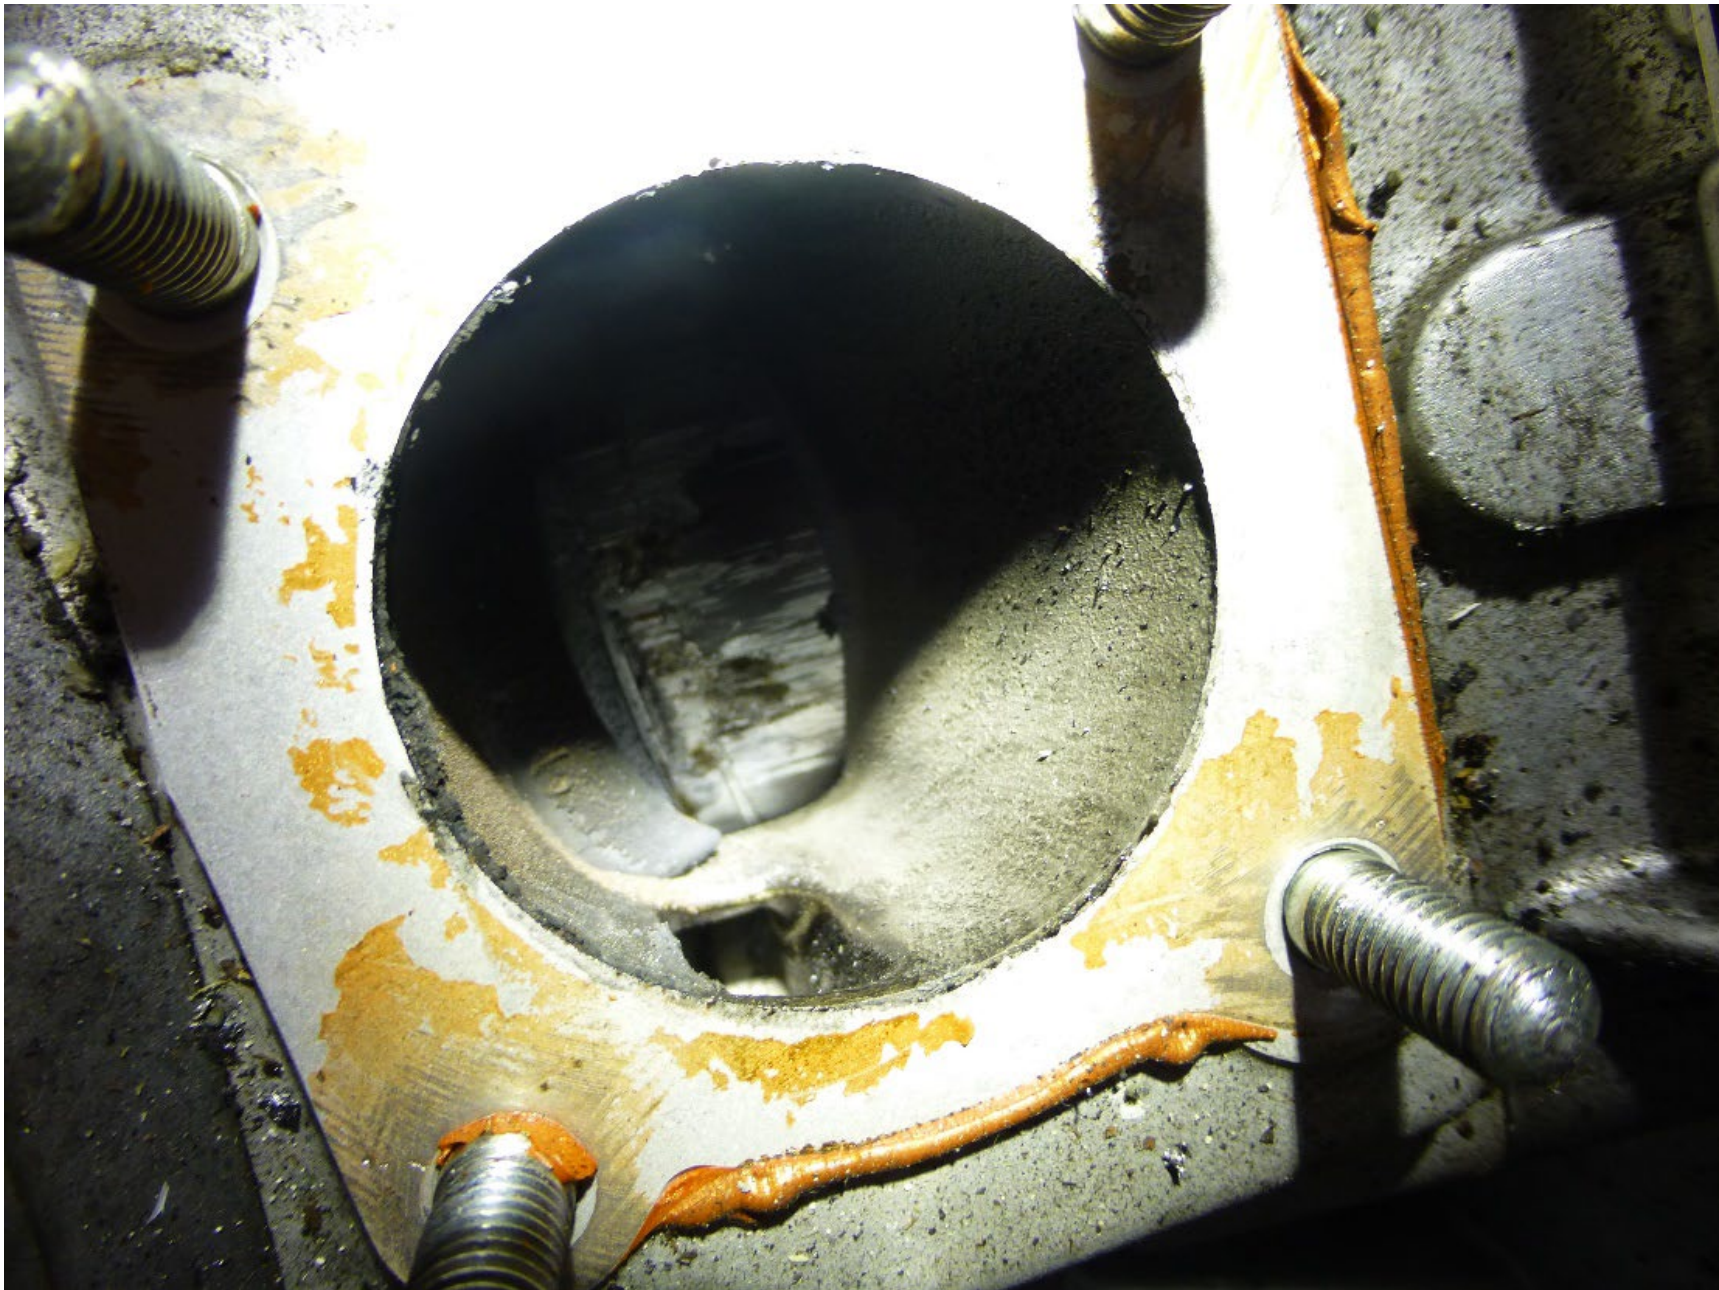
**Photo 15 – Scored Side of No.2 Piston**

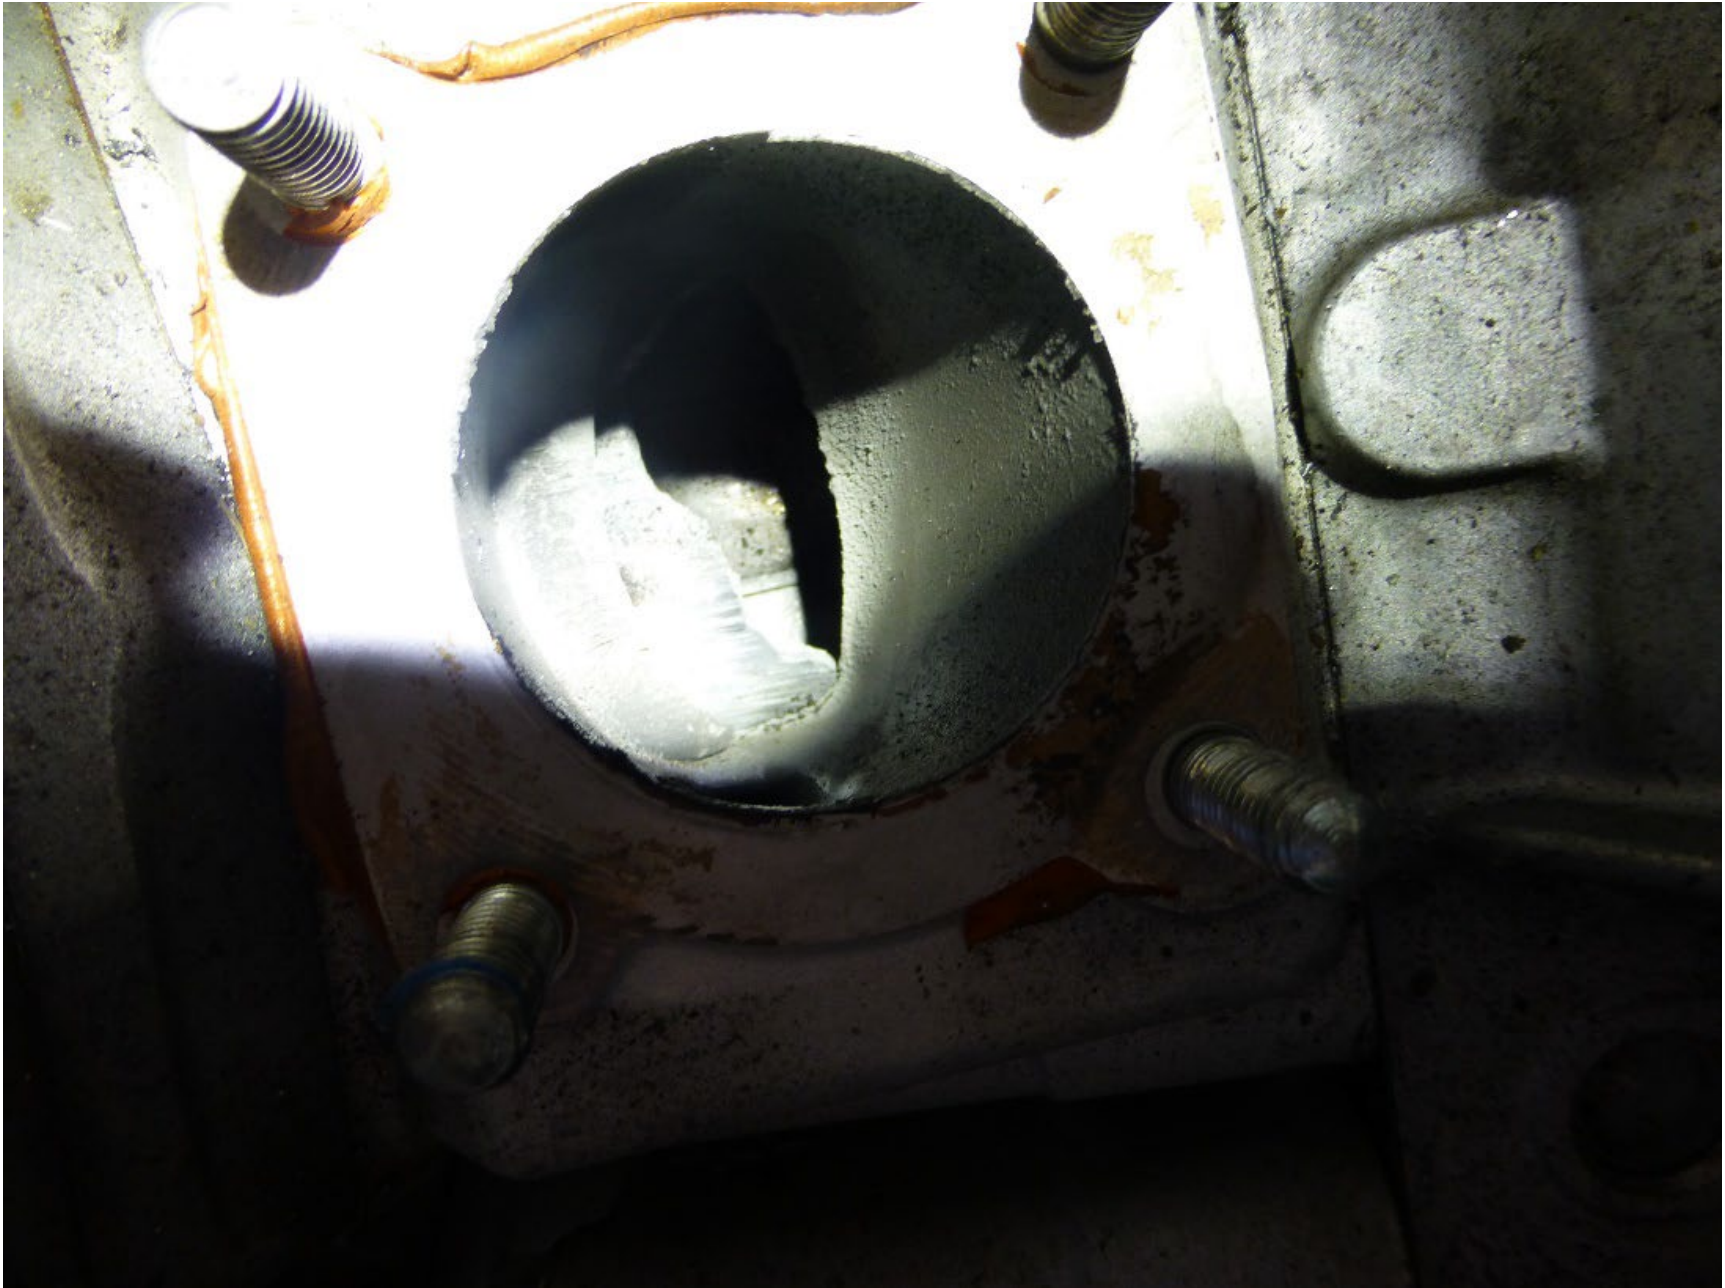
**Photo 16 – Scored and Fractured Side of No.1 Piston**
