**Photo 1 – Main Wreckage – Courtesy of FAA**

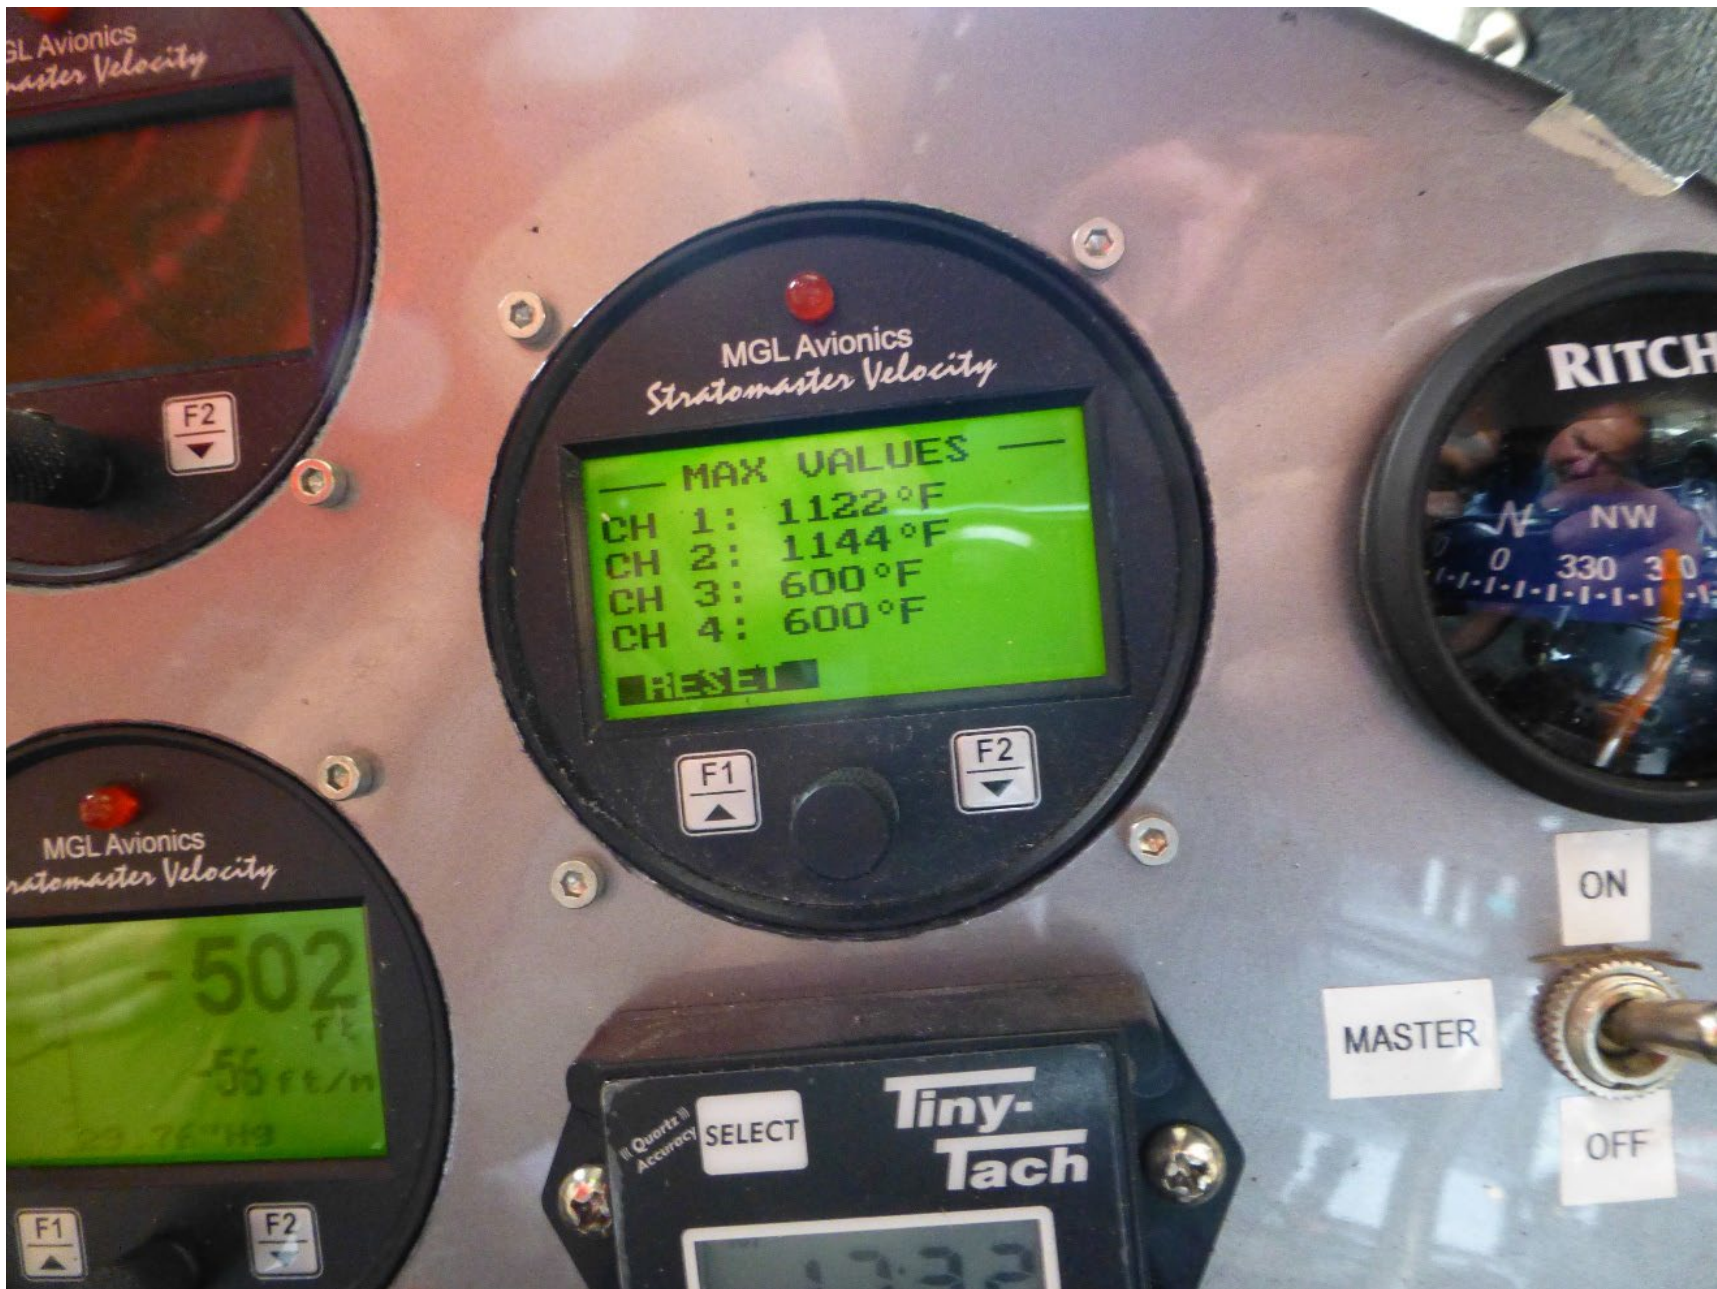
Photo 18 – Maximum Recorded Temperature Values
