# NATIONAL TRANSPORTATION SAFETY BOARD

## Image Recorder Parametric Data

### Specialist's Factual Report

Location: Front Royal, Virginia  
Date: October 7, 2017  
Aircraft: Piper PA-25-235  
Registration: N90866  
Operator: Skyline Soaring Club  
NTSB Number: ERA18FA006

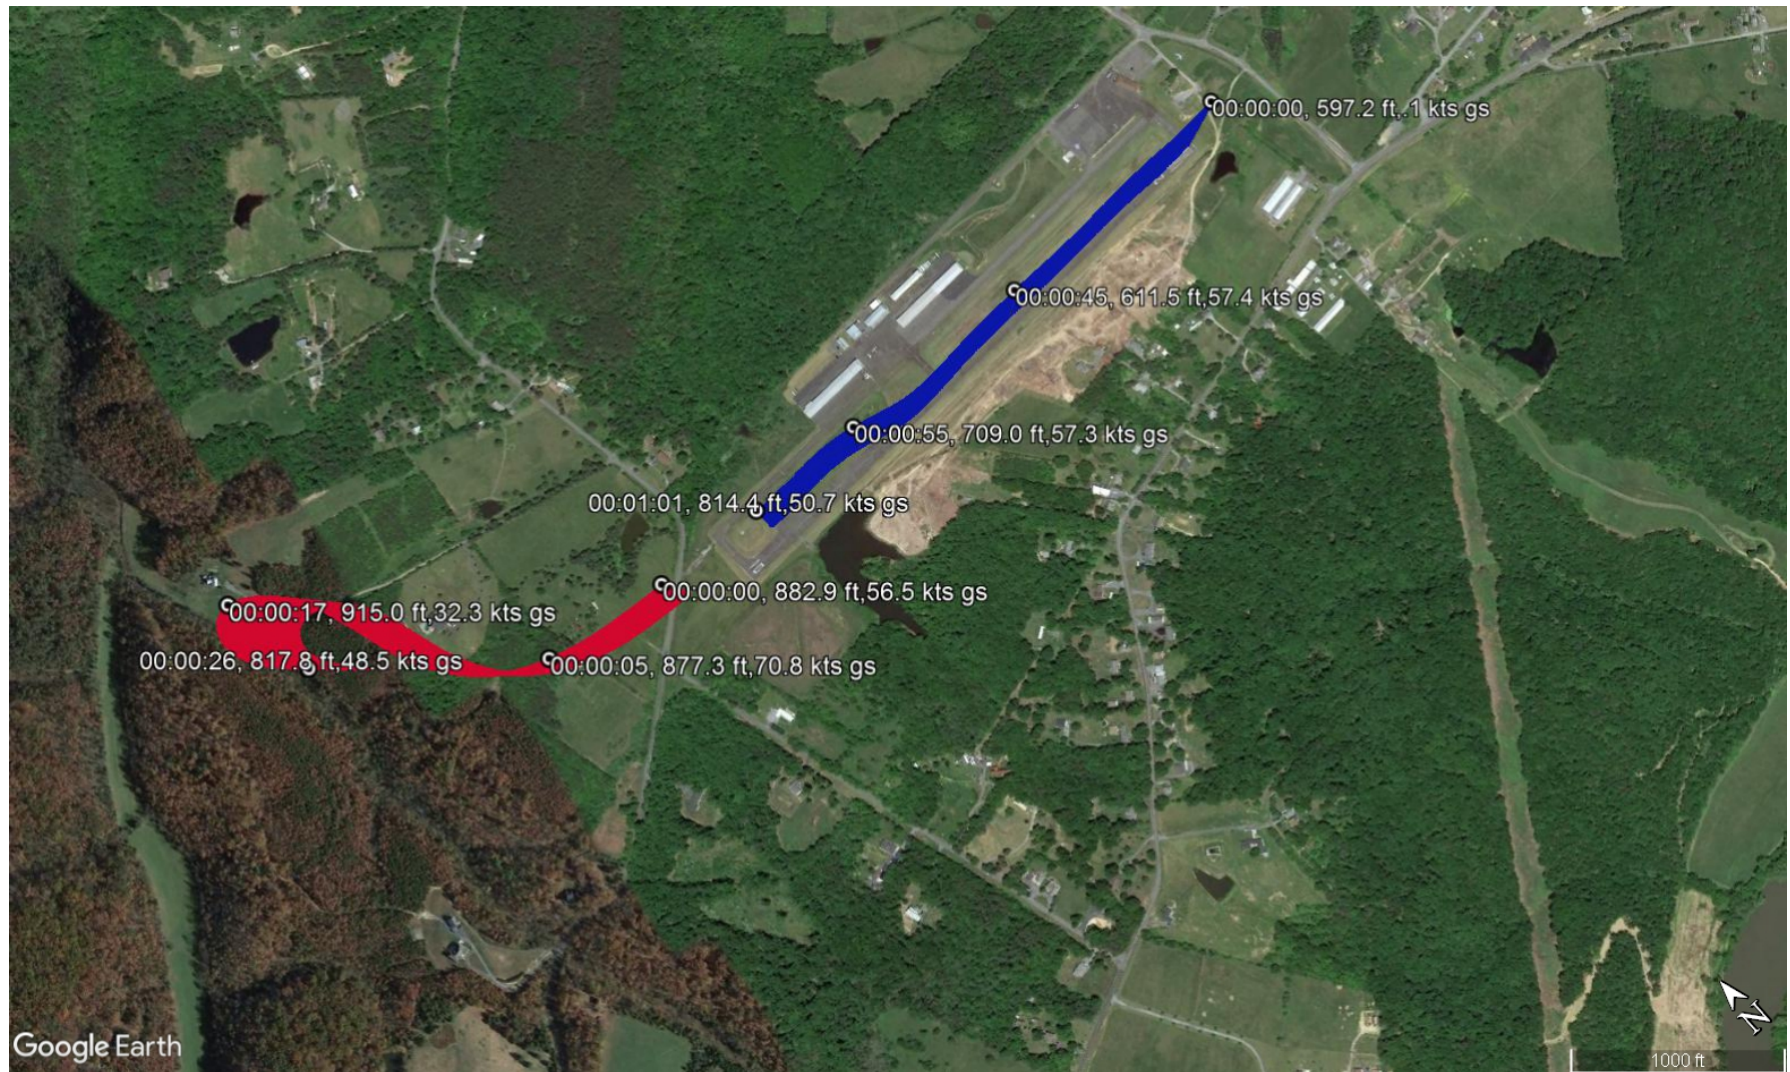
Figure 1 is a graphical overlay generated using Google Earth for the accident flight. The weather and lighting conditions in Google Earth are not necessarily the weather and lighting conditions present at the time of the recording.

GOPR0172's data starts on the east end of the airport and continues for 1 minute and 1 second, until approximately the west end of the runway.

There is a gap in the data of unknown duration, after GOPR0172 stopped recording until GOPR0173 began recording. The distance between the recordings is about 538 feet.

GOPR0173's data started west of the runway. After about 5 seconds of GOPR0173's recording, the glider began to track right. After about 17 seconds of GOPR0173's recording, the glider began to turn left and descend, back towards the Front Royal airport.

Figure 1. Google Earth overlay of recorded GPS data.

GOPR0173's recording continued beyond 26 seconds to the Front Royal airport; however, this data is not shown as it was not pertinent to this report.

Tabular data used to generate figure 1 are included as attachment 1. This attachment is provided in electronic comma-delimited (.CSV) format.
