## **NATIONAL TRANSPORTATION SAFETY BOARD**

### **Weather Study**

ERA18FA022

Location: Fountain Run, Kentucky  
Date: November 12, 2017  
Time: about 1410 central standard time (2010 UTC)<sup>1</sup>  
Airplane: Type: Piper PA 32-260; Registration: N3371W

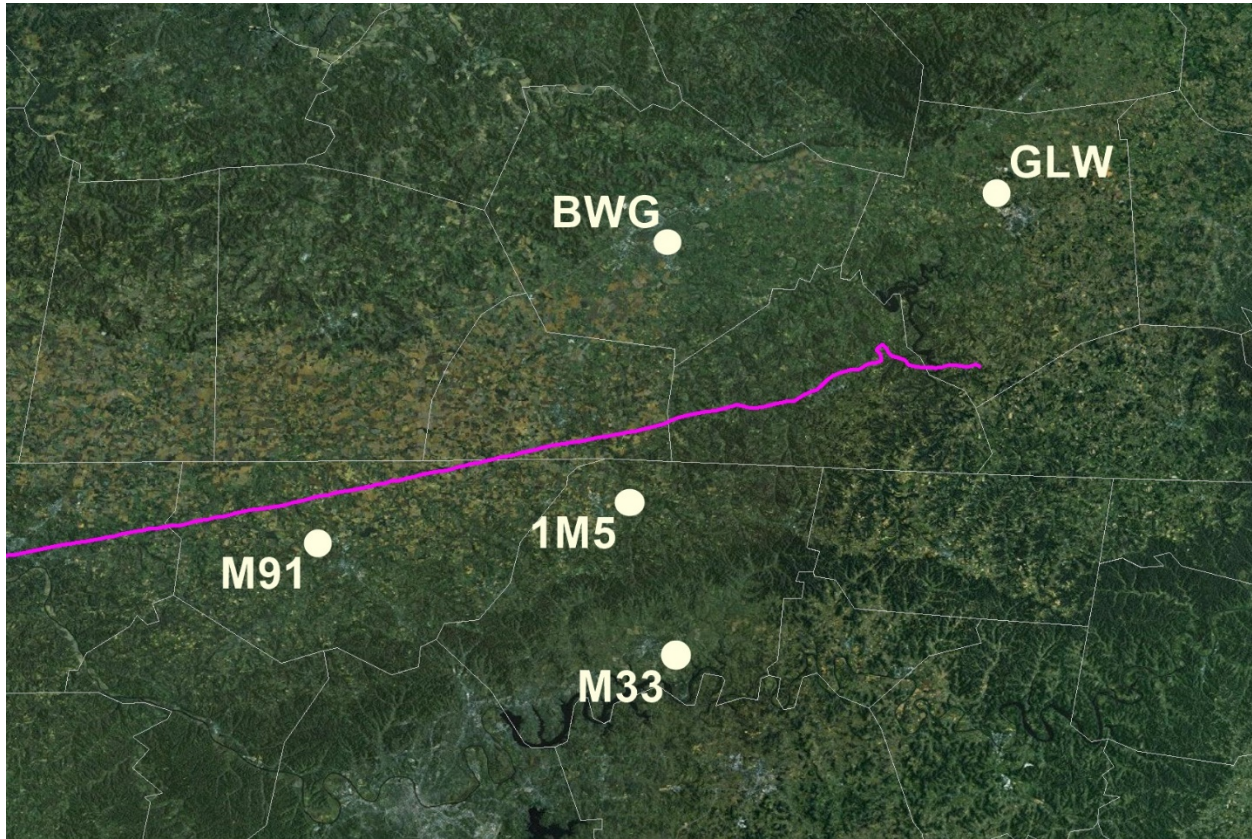
**Figure 2** – Map depicting locations of surface observing stations presented in this report, as well as the final portion of the accident aircraft’s flight path (pink line).
