# **Non-destructive testing of a memory module from GPSMAP 696, case ERA18FA030**

# Summary and Conclusions

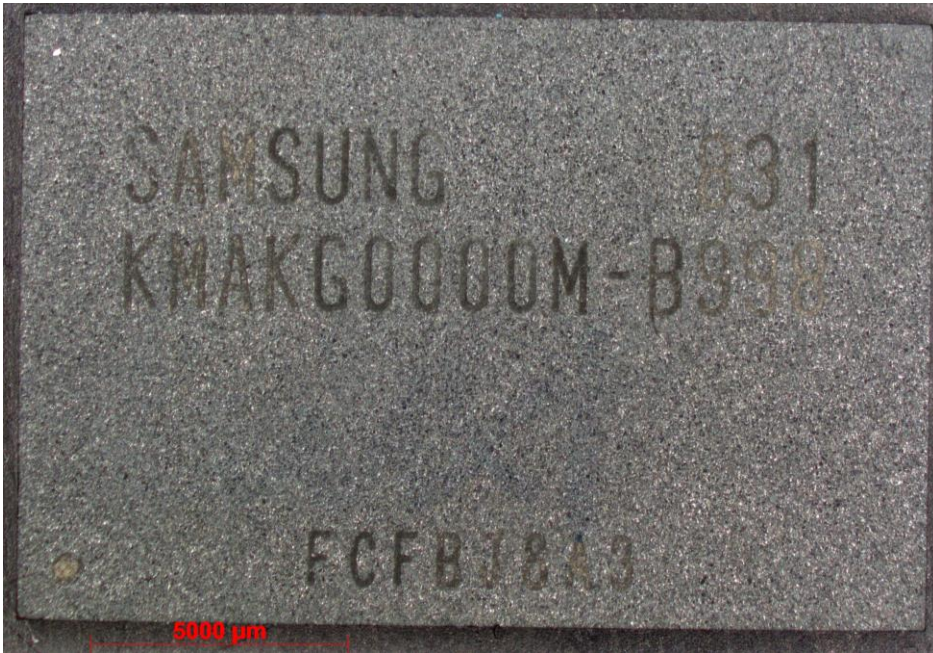
Front, mold side of the memory module

- A thorough visual inspection was done on the package from the mold as well as the laminated substrate side.
- No external damage was seen on any side.

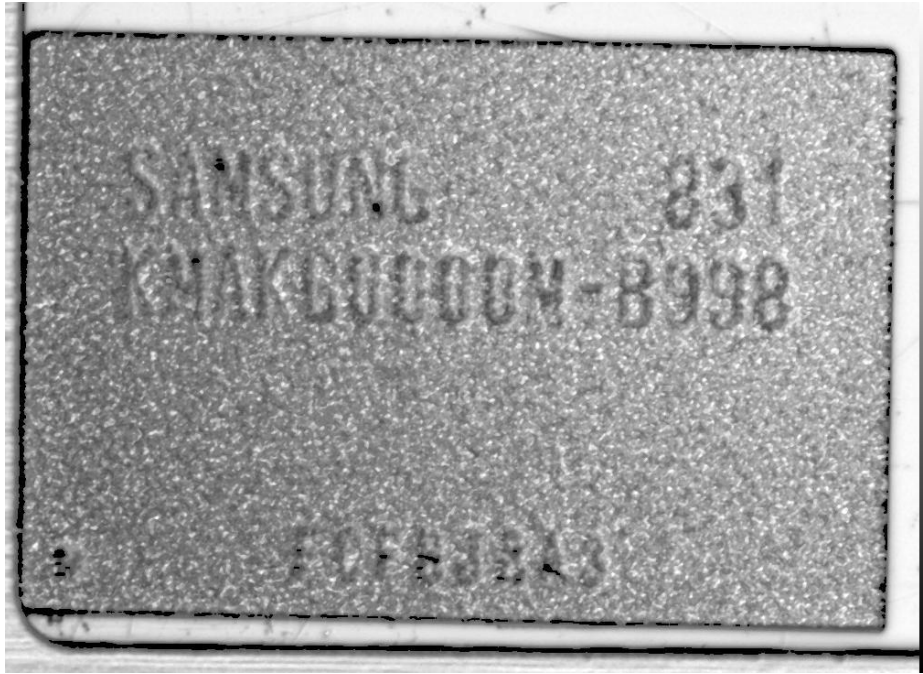
C-SAM image of the top surface of the package

No damage is seen on the package surface and within the mold compound. Small die looks OK.

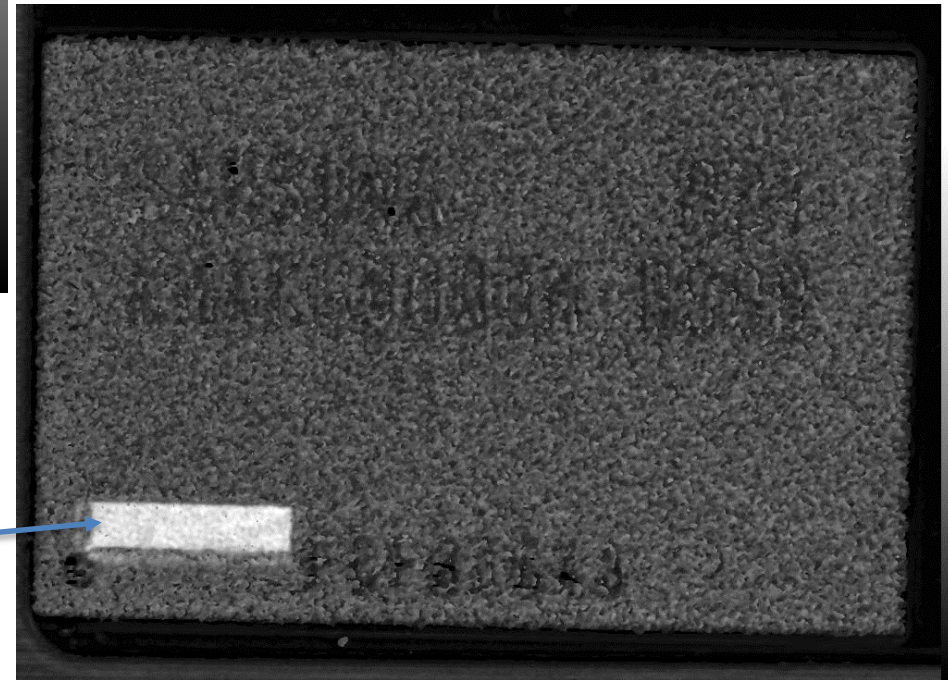
Small die with wire bonds on two edges

C-SAM image from within the mold compound.

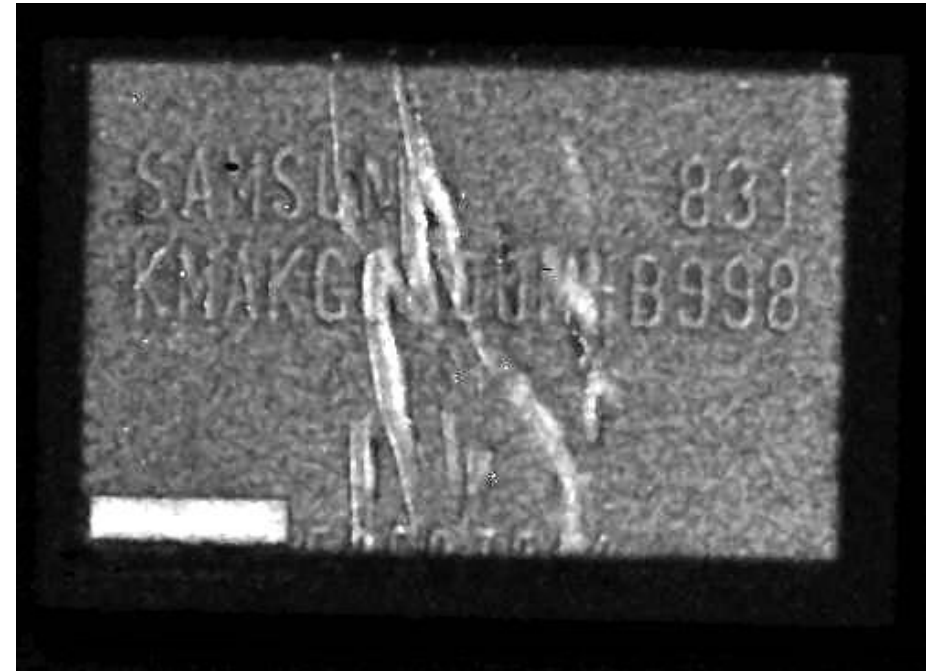
C-SAM image of the back side of the large die (it includes some echo interference from the top layers)

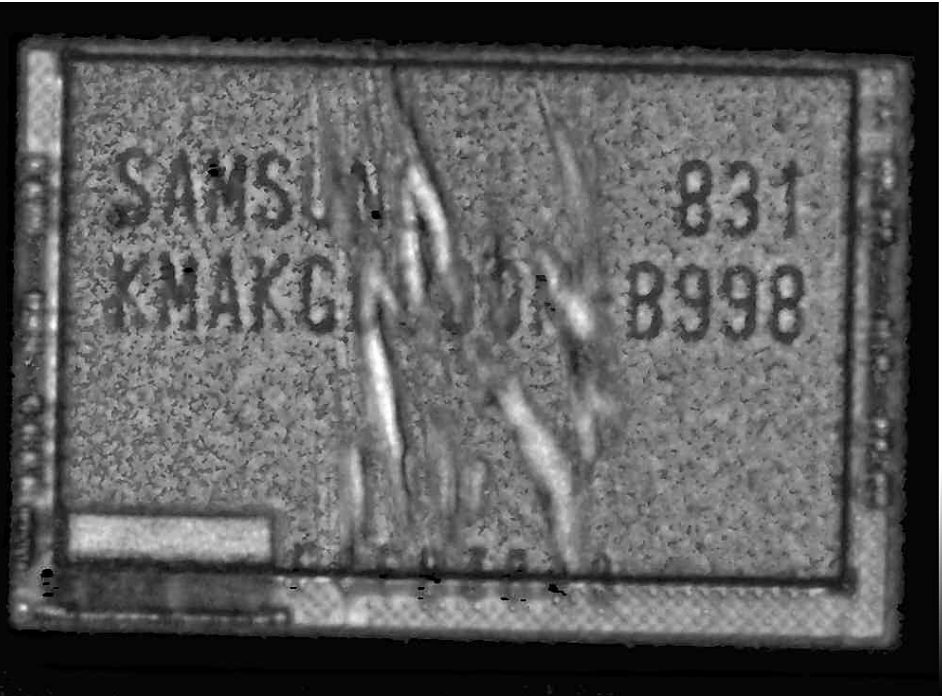
C-SAM image showing the laminated substrate. No cracks are seen in the substrate.
