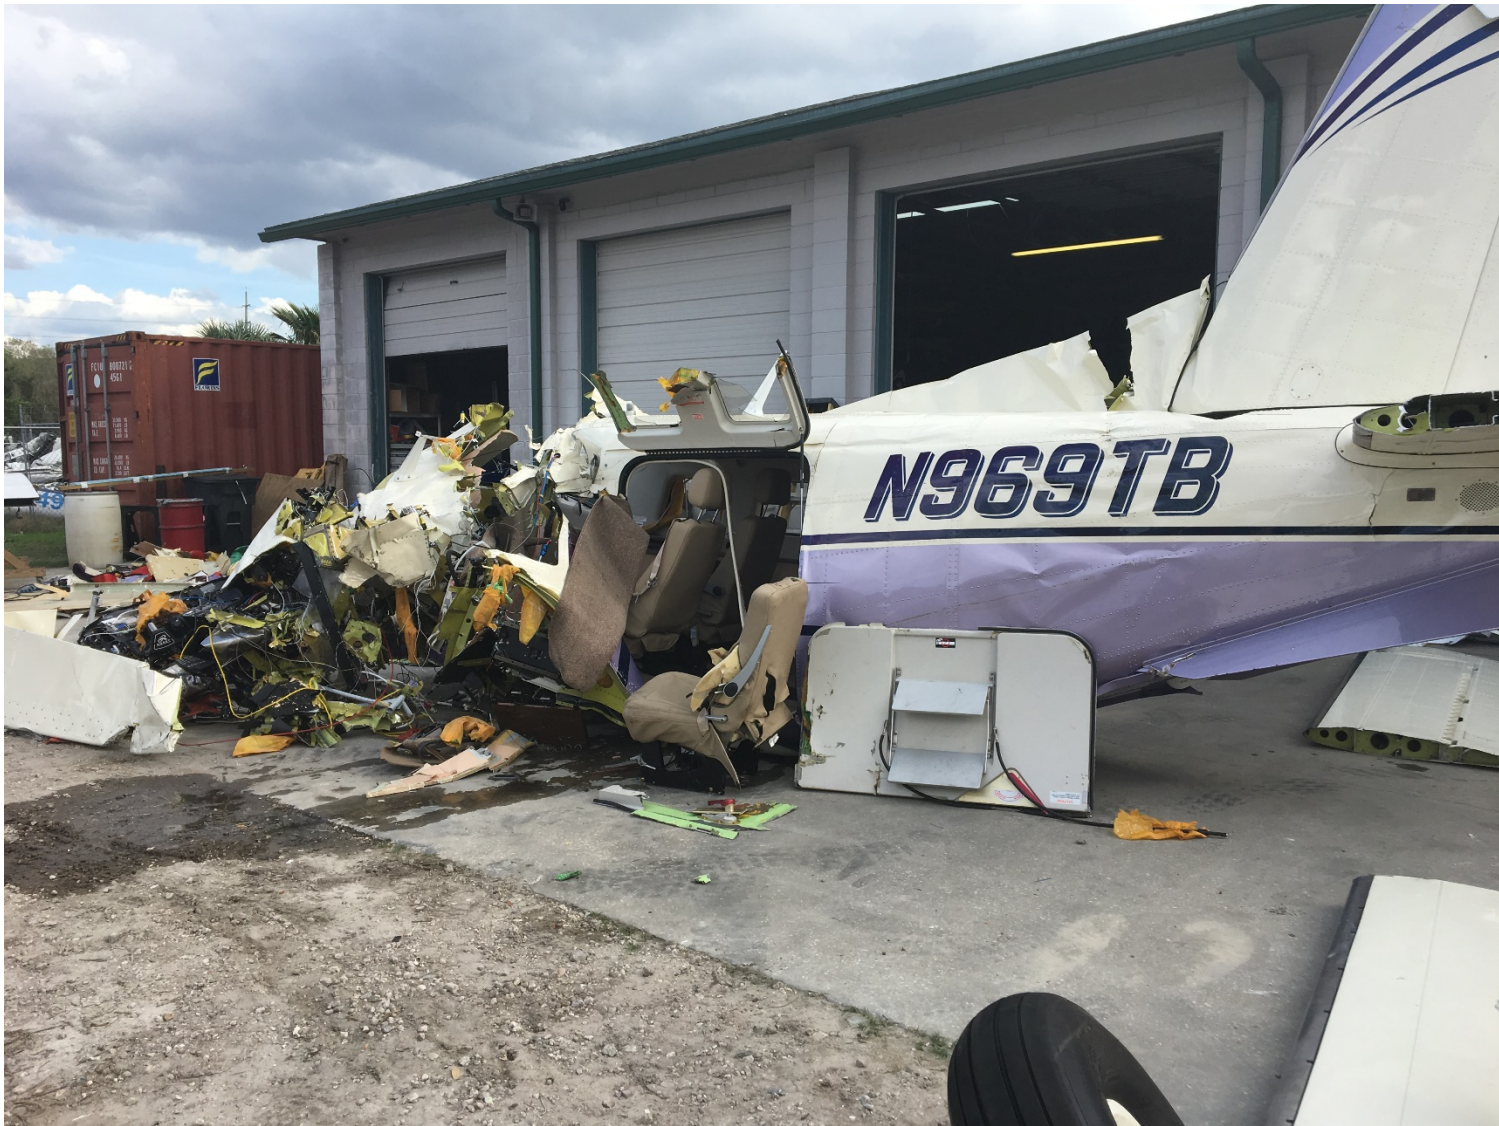
**Photo 1 – Left side of fuselage**

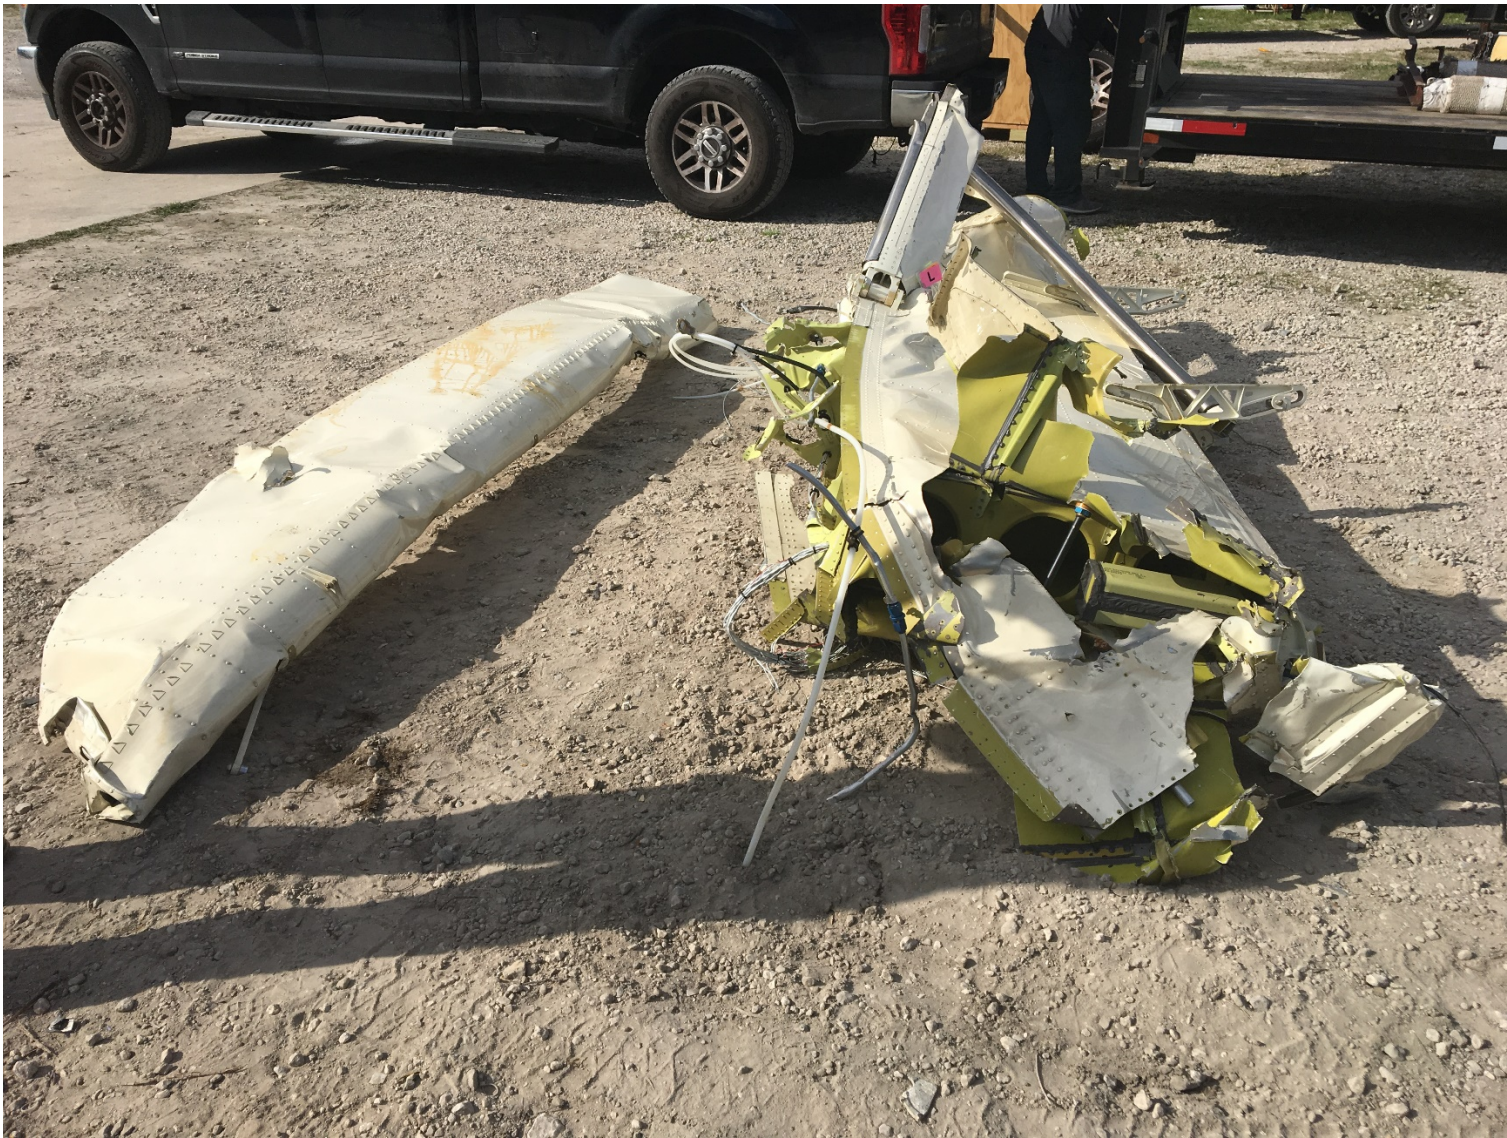
**Photo 2 – Left Wing and Left Flap**

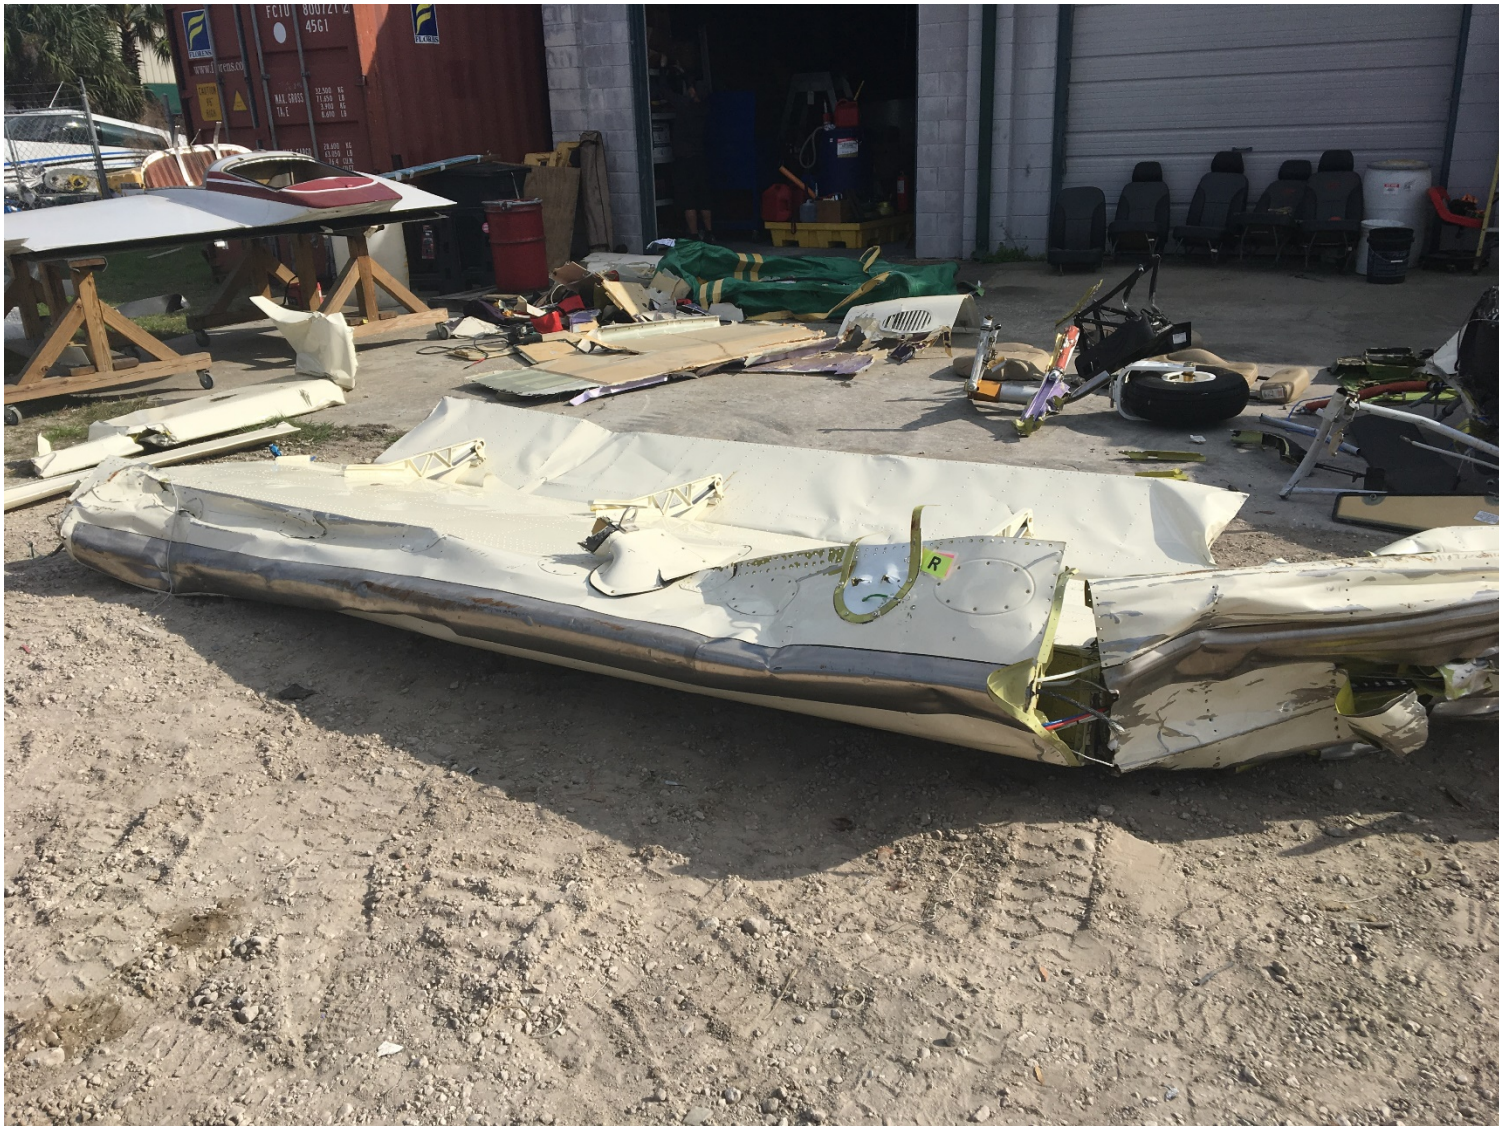
**Photo 3 – Right Wing**

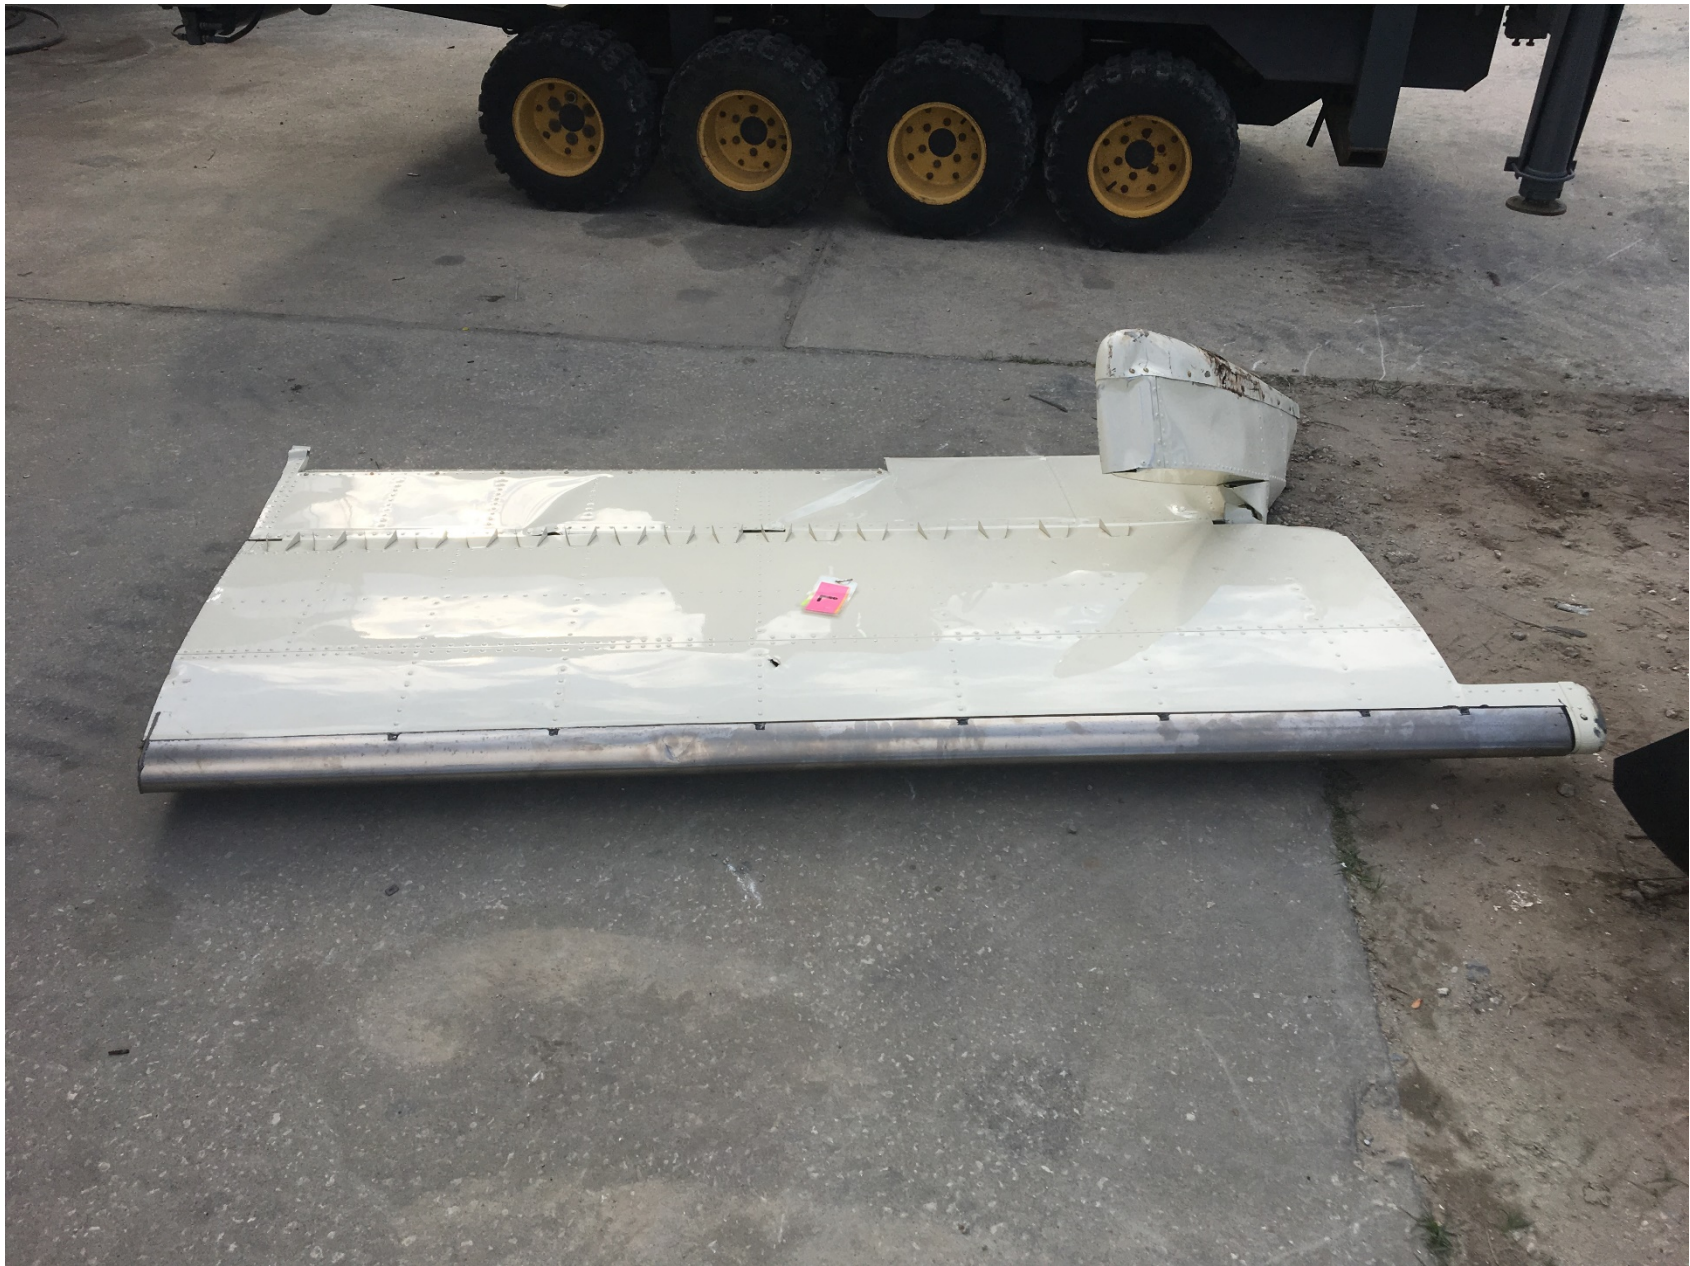
**Photo 4 – Left Elevator (cut by recovery personnel)**

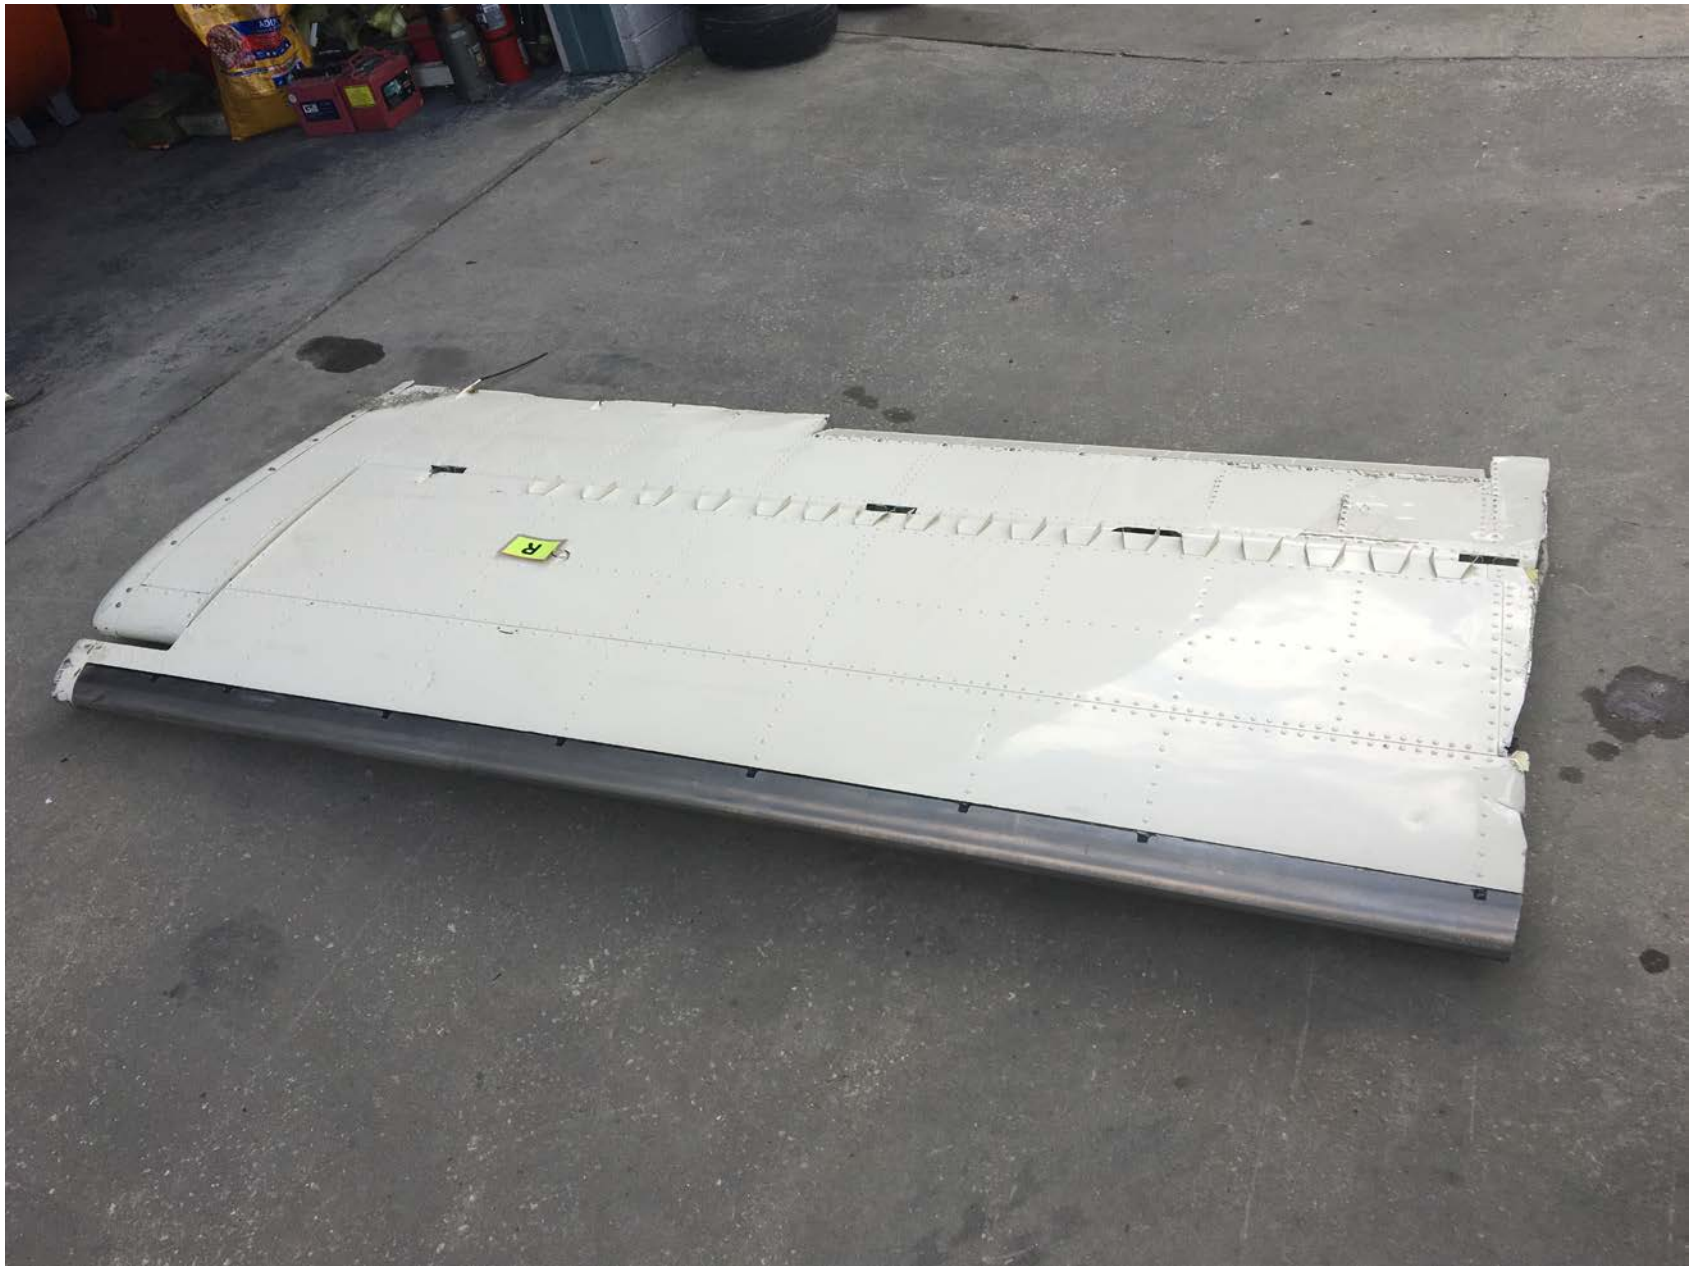
**Photo 5 – Right Elevator (cut by recovery personnel)**

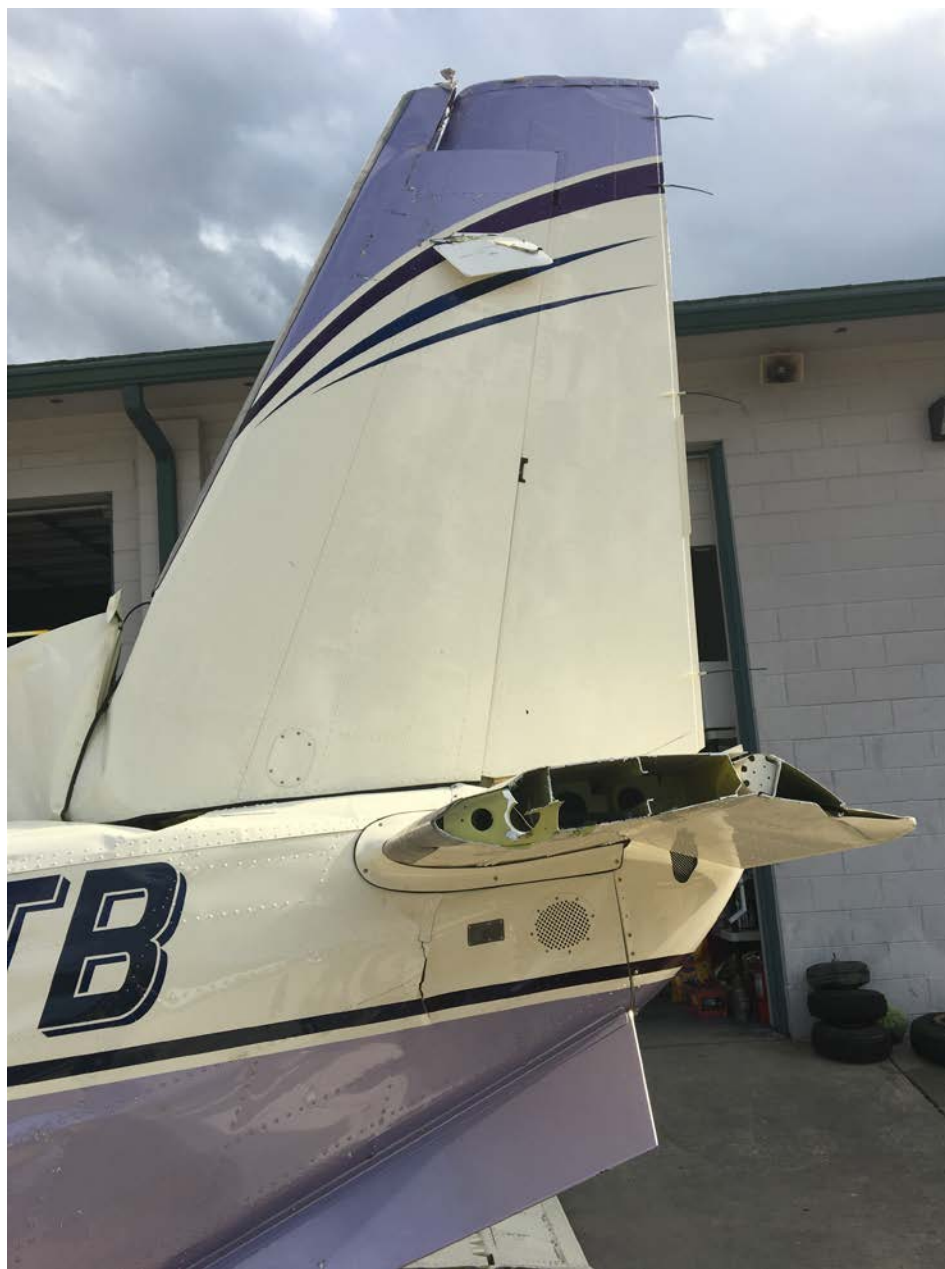
**Photo 6 – Vertical Stabilizer and Rudder**

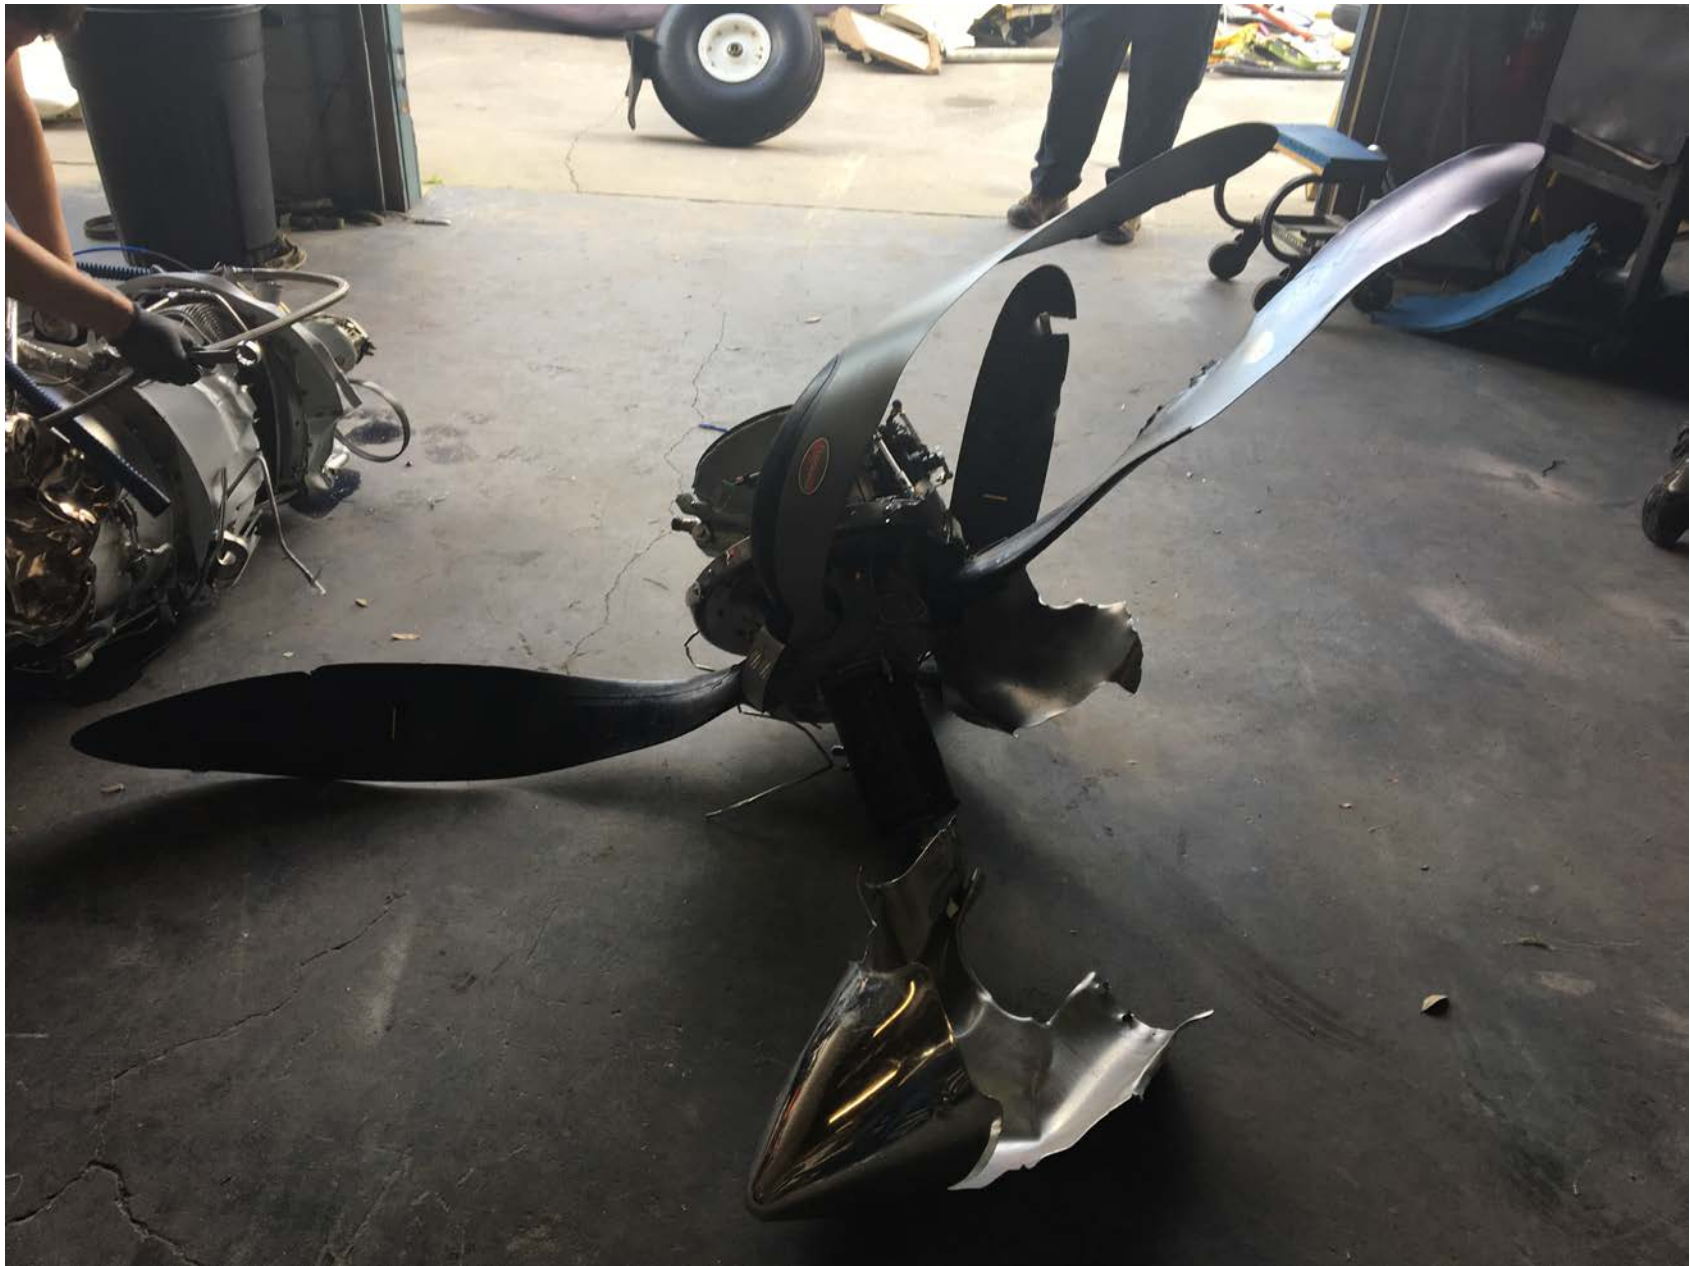
**Photo 7 – Propeller and Spinner**

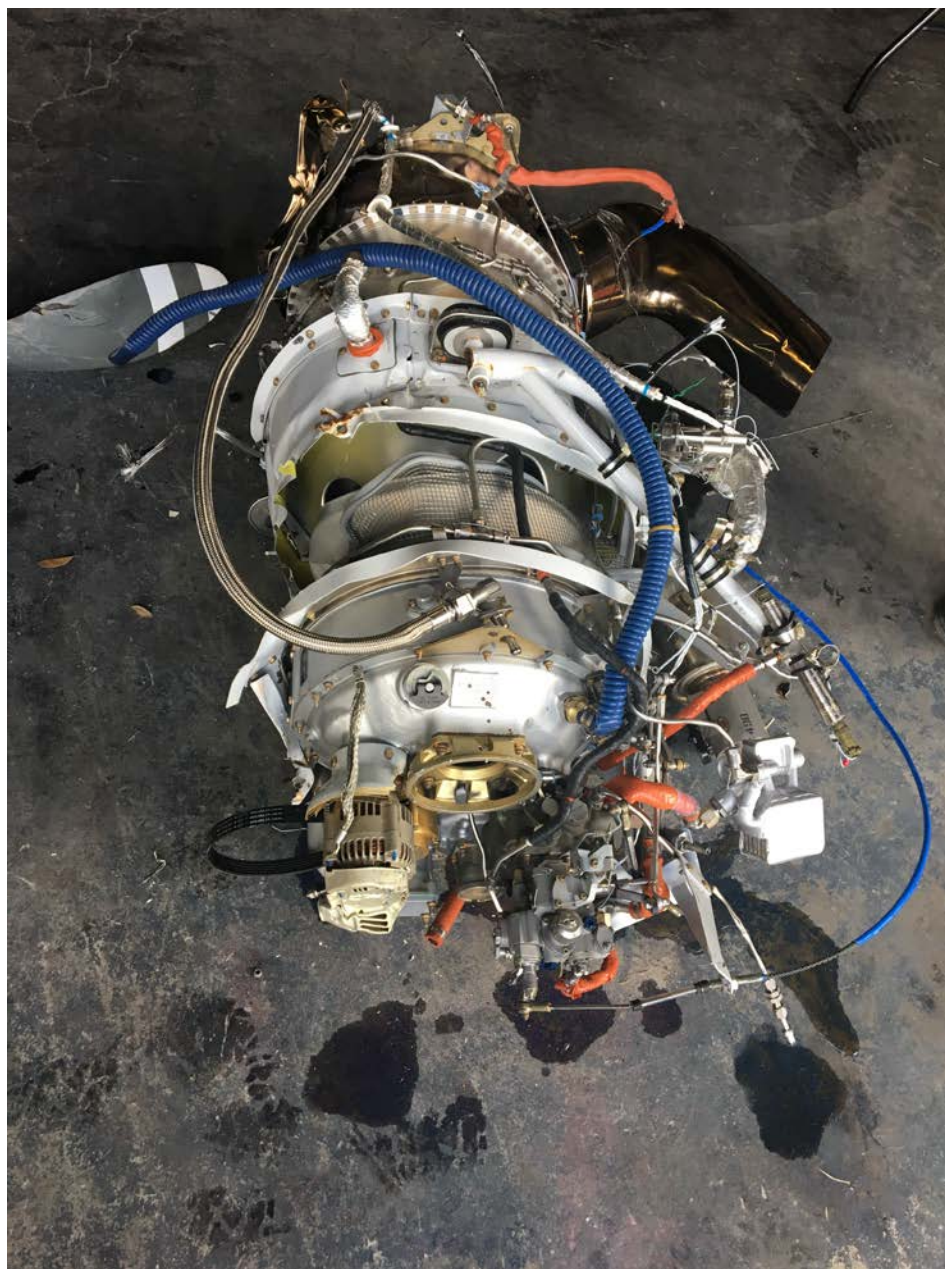
**Photo 8 – Aft View of Engine**

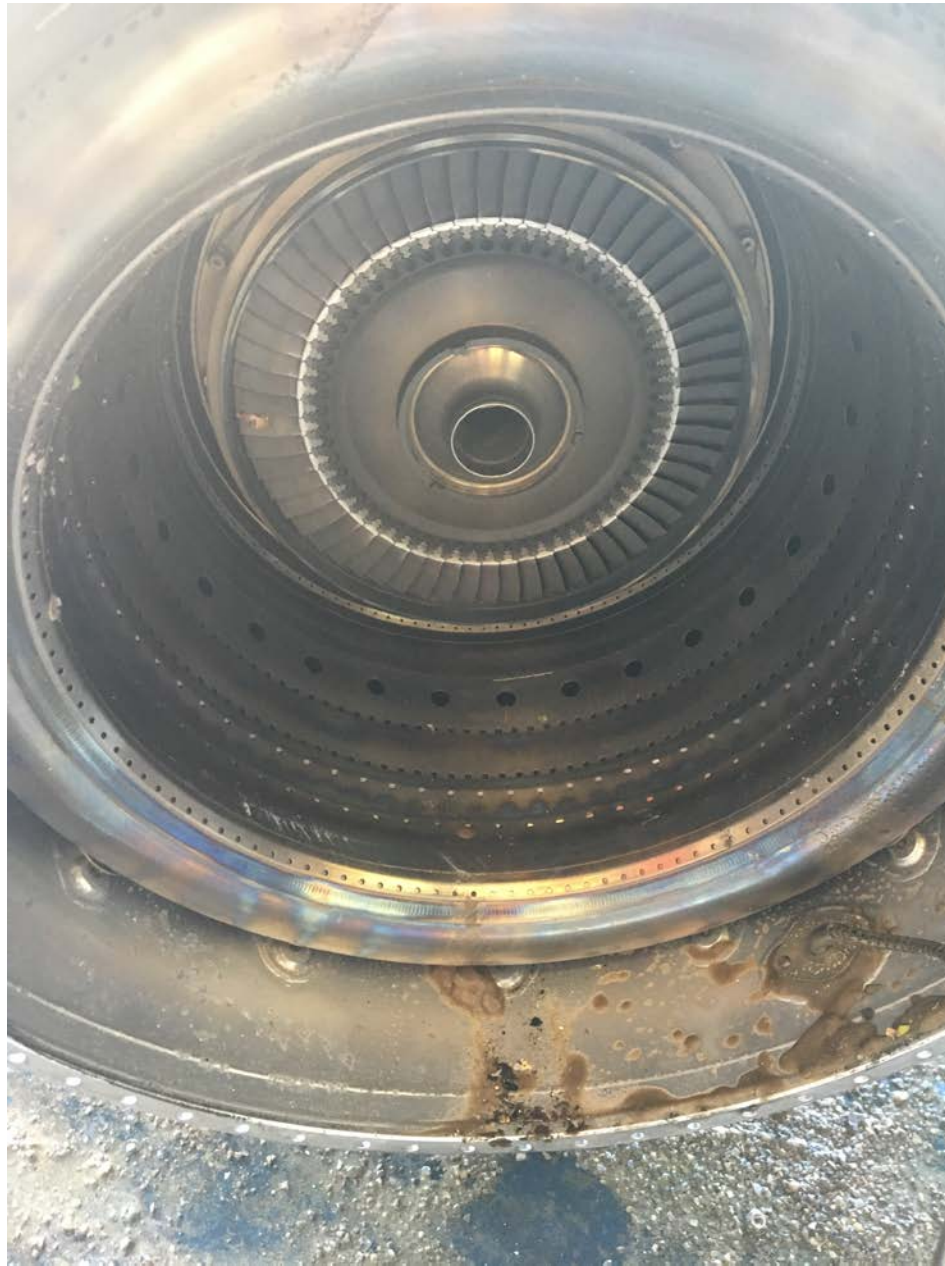
**Photo 9 – View of debris in engine and rotational scoring on fir trees.**

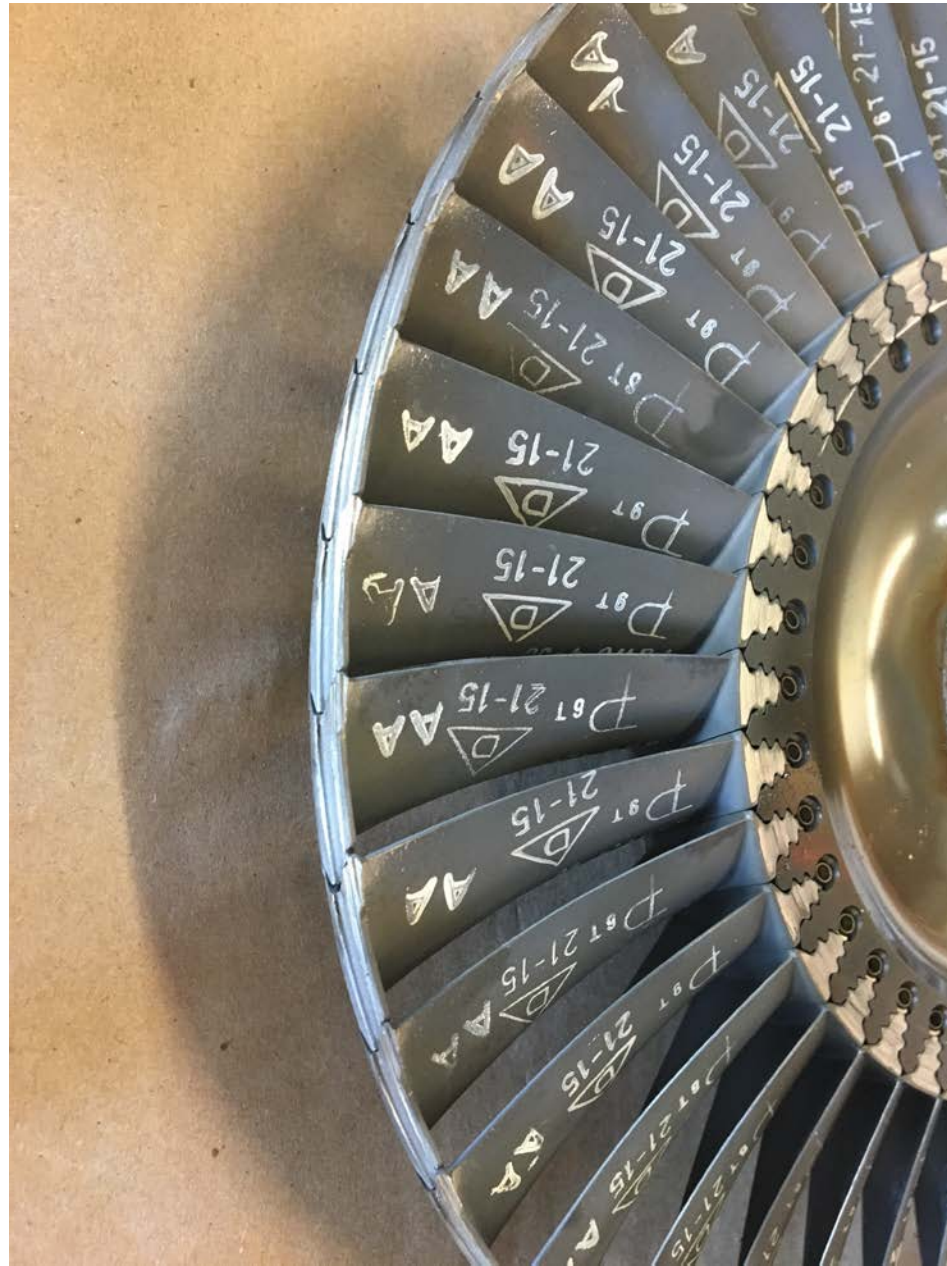
**Photo 10 – View of rotational scoring on power turbine blades.**

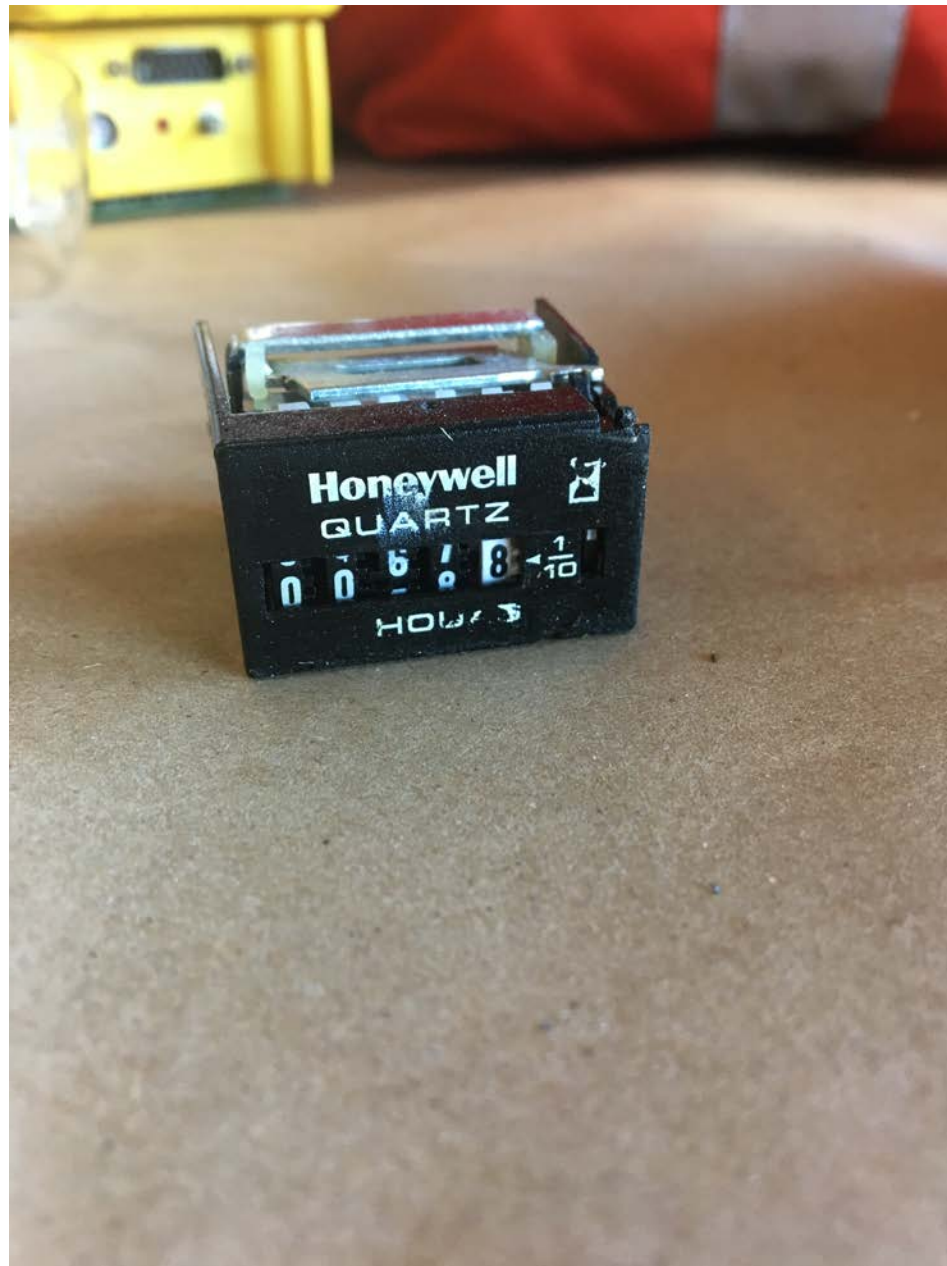
Photo 11 – Hobbs Meter
