# NATIONAL TRANSPORTATION SAFETY BOARD

## Global Positioning System Device

### Specialist's Factual Report

Location: Crozet, Virginia  
Date: April 15, 2018  
Aircraft: Cessna 525  
Registration: N525P  
Operator: Private  
NTSB Number: ERA18FA127

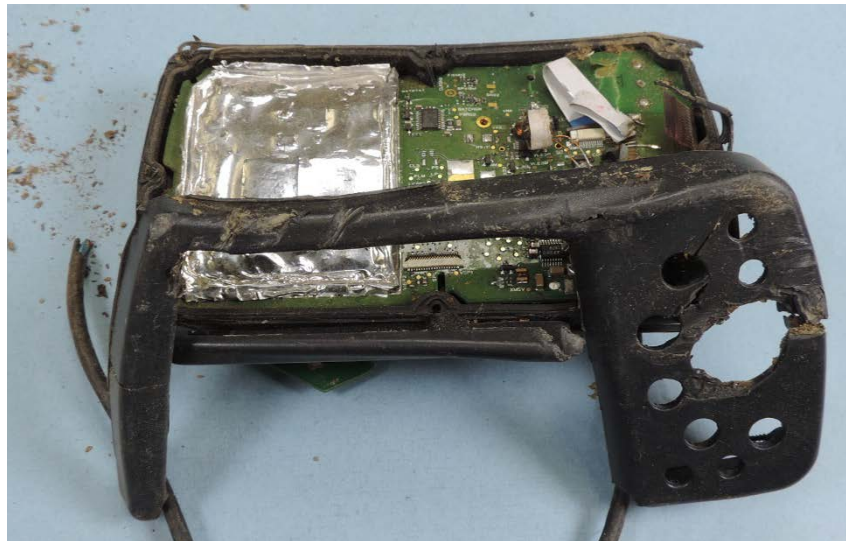
**Figure 1.** Front of damaged GPSMap 496, as received.

Figures 1 and 2 show damage sustained during the accident. Due to the damage, the device was not able to be connected to a computer for a normal download. The device's memory chip was removed and imaged (Figure 3).

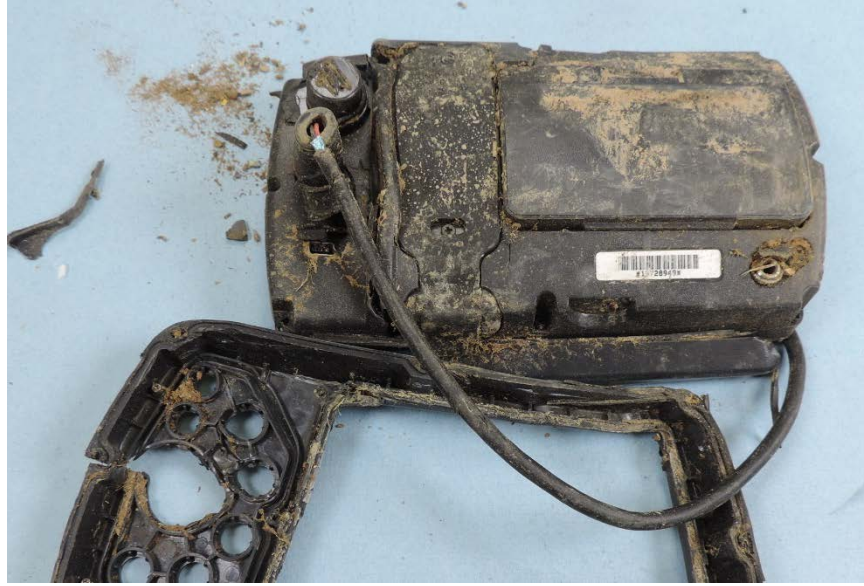
**Figure 2.** Rear of GPSMap 496, as received.

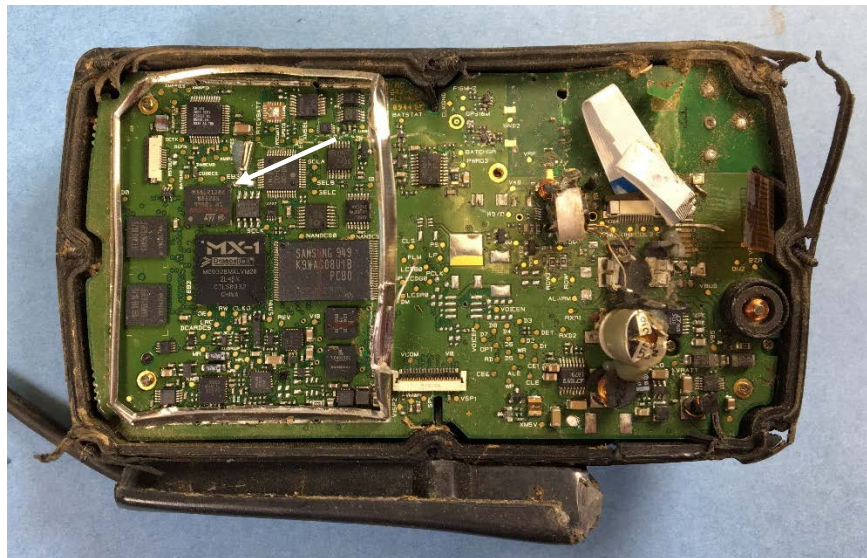
**Figure 3.** GPS memory chip indicated by white arrow.
