## **NATIONAL TRANSPORTATION SAFETY BOARD**

### **Weather Study**

ERA18FA150

Location: Chesapeake, Virginia  
Date: May 22, 2018  
Time: 0728 eastern daylight time  
1128 Coordinated Universal Time (UTC)  
Airplane: Piper PA-28-140 Cherokee; registration: N6177W

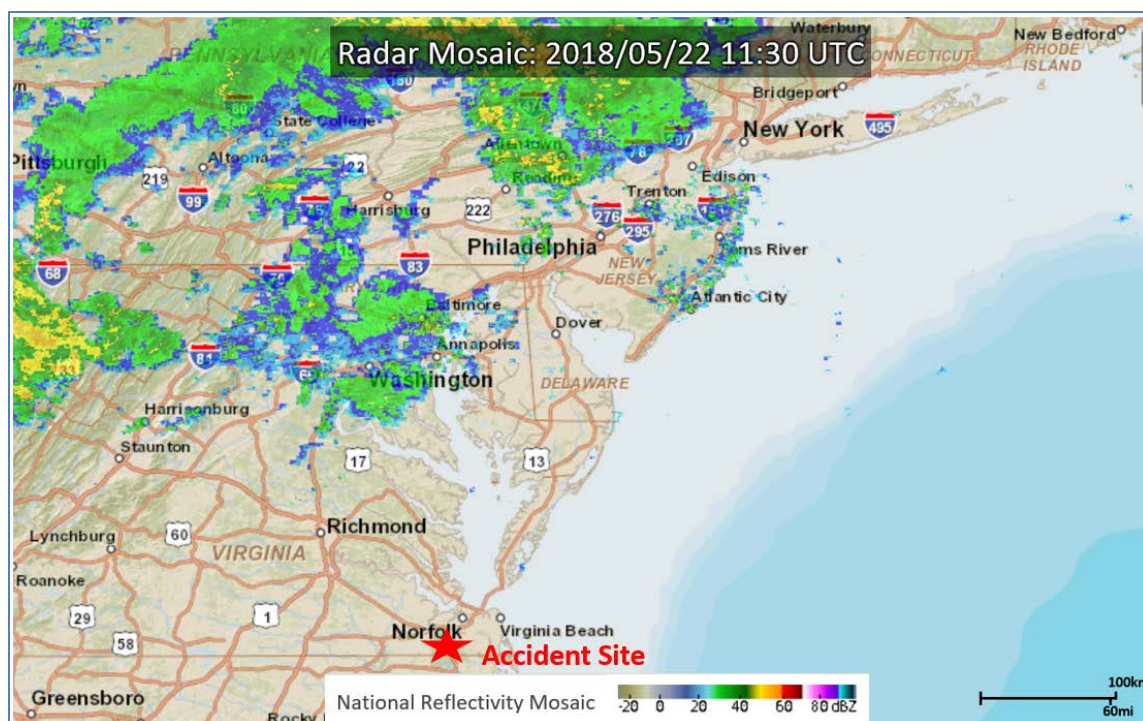
Figure 3 – NWS National Composite Radar Mosaic for 0730 EDT over the region

The NWS National Composite Radar Mosaic over the mid-Atlantic region for 0730 EDT is included in figure 3, with the approximate accident site marked by the star. The image depicted several areas of light to moderate radar reflectivity associated with rain over Virginia, the District of Columbia, Maryland, Pennsylvania, and New Jersey, with no significant echoes in the Chesapeake, Virginia, area.
