**NATIONAL TRANSPORTATION SAFETY BOARD**  
Vehicle Recorder Division  
Washington, D.C. 20594

## **Electronic Devices**

### **Specialist's Factual Report by Sean Payne**

Location: Swainsboro, Georgia  
Date: August 24, 2018  
Aircraft: Cessna 182A  
Registration: N4785D  
Operator: Tjp@Jax Inc  
NTSB Number: ERA18FA231

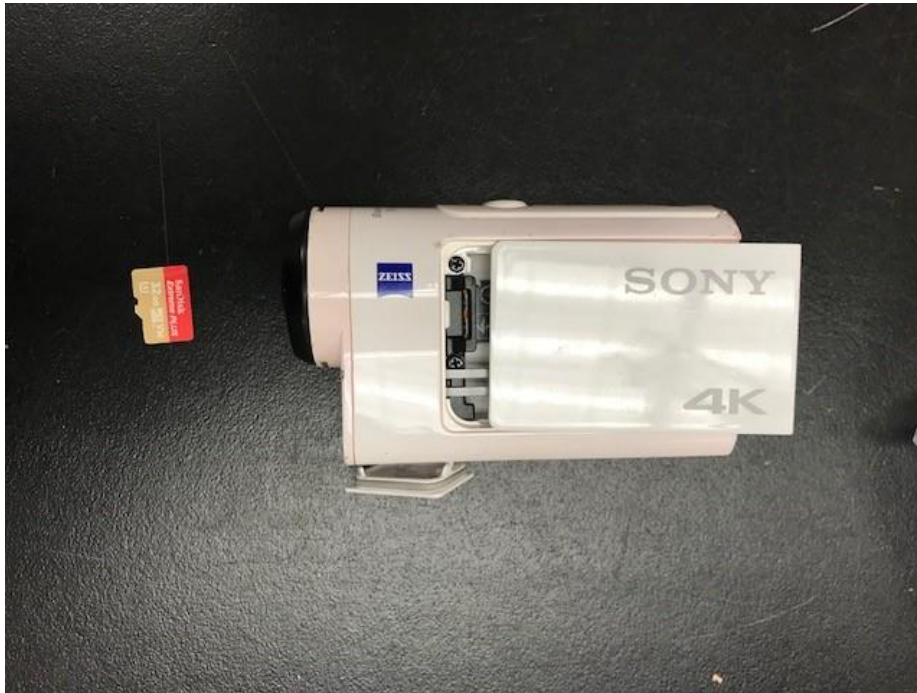
Upon arrival at the Vehicle Recorder Division, an exterior examination revealed the unit had sustained light impact damage. The camera's associated microSD memory card was found seated in the device. Figure 1 shows the device's condition.

Figure 1. The recovered Sony FDR-X3000 and associated microSD card
