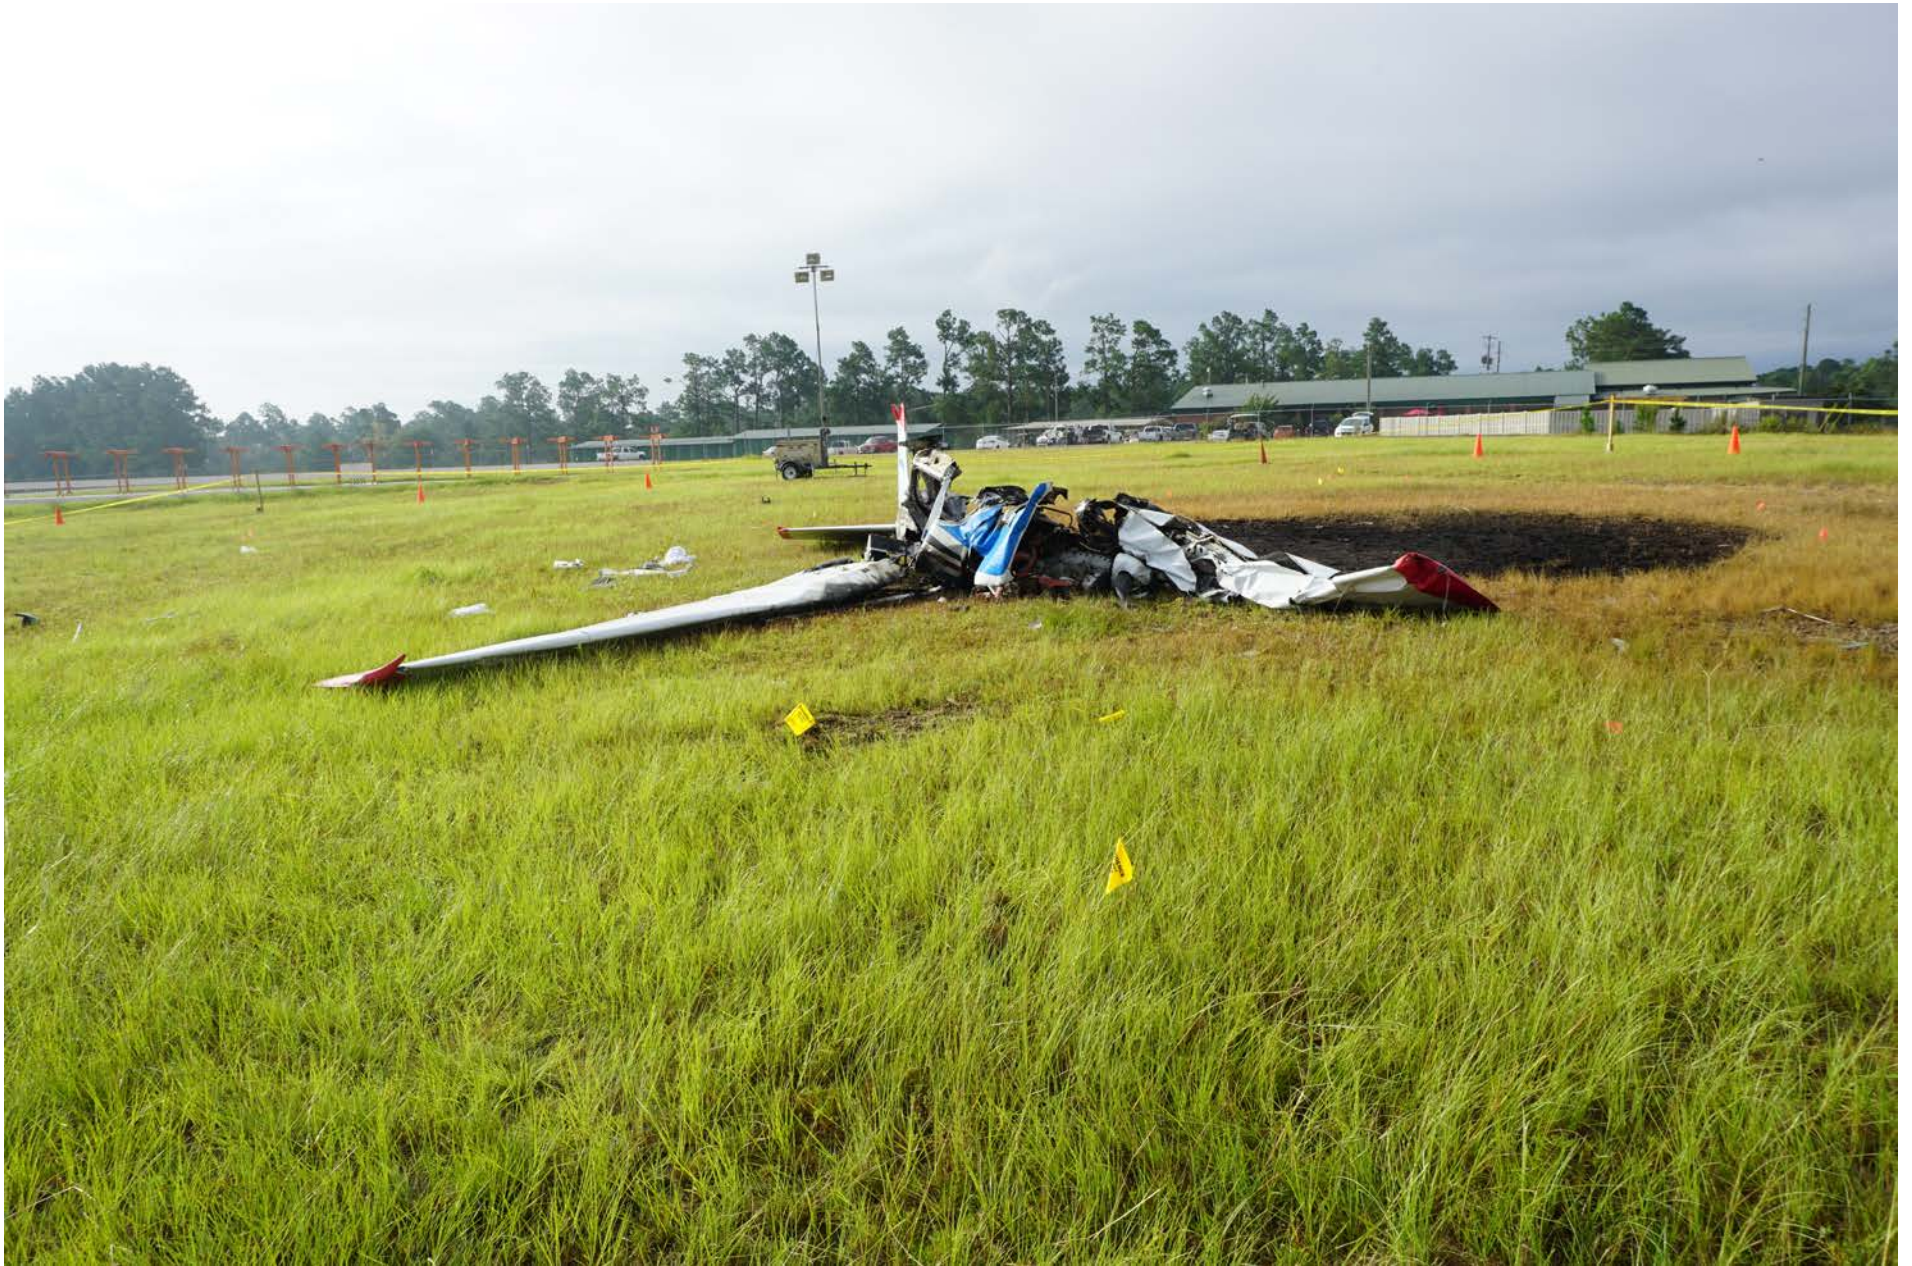
**Photo 1 – Forward view of airplane wreckage showing fuselage post-crash fire damage**

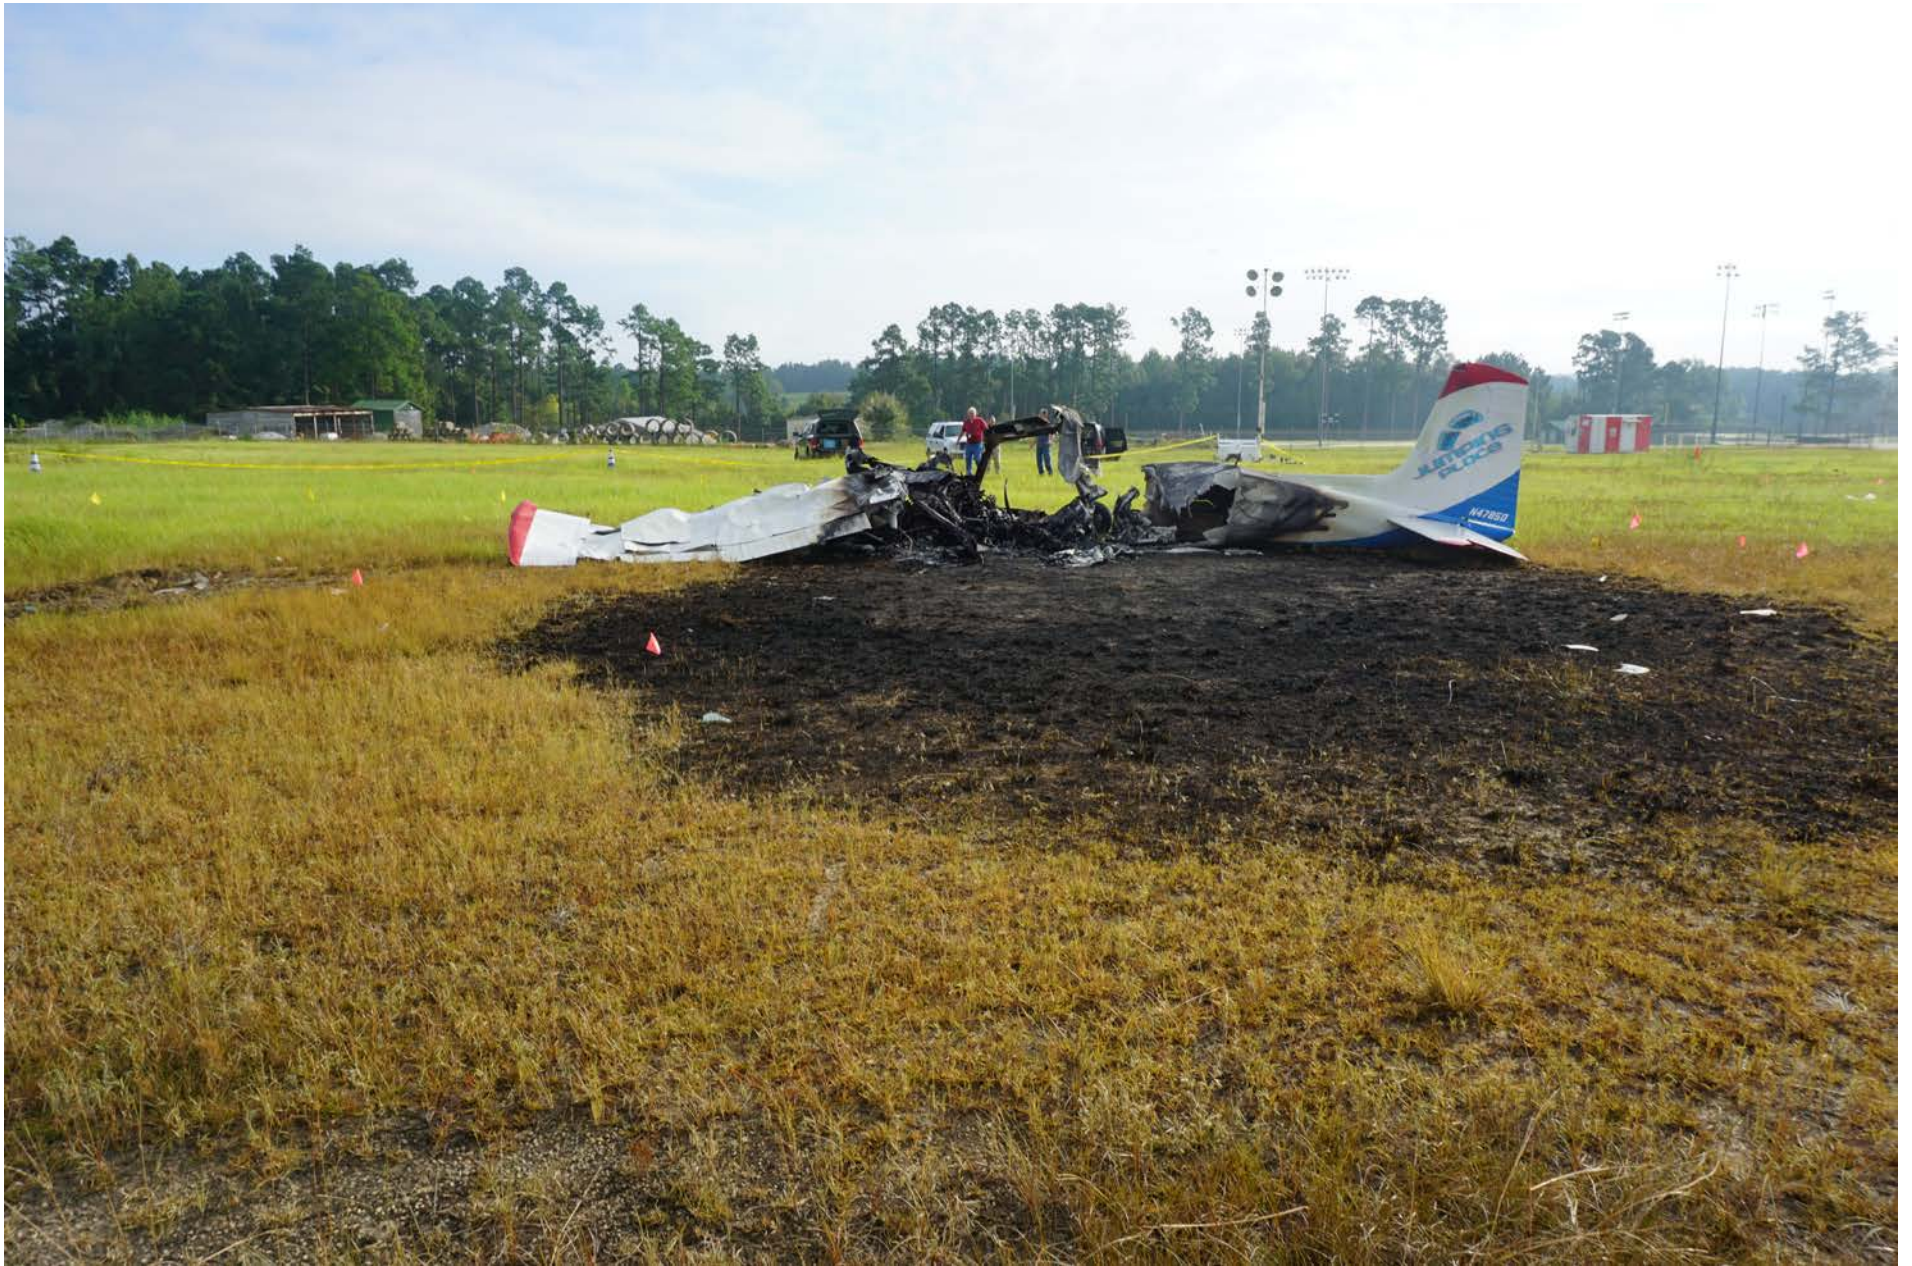
**Photo 2 – Left side view of wreckage**

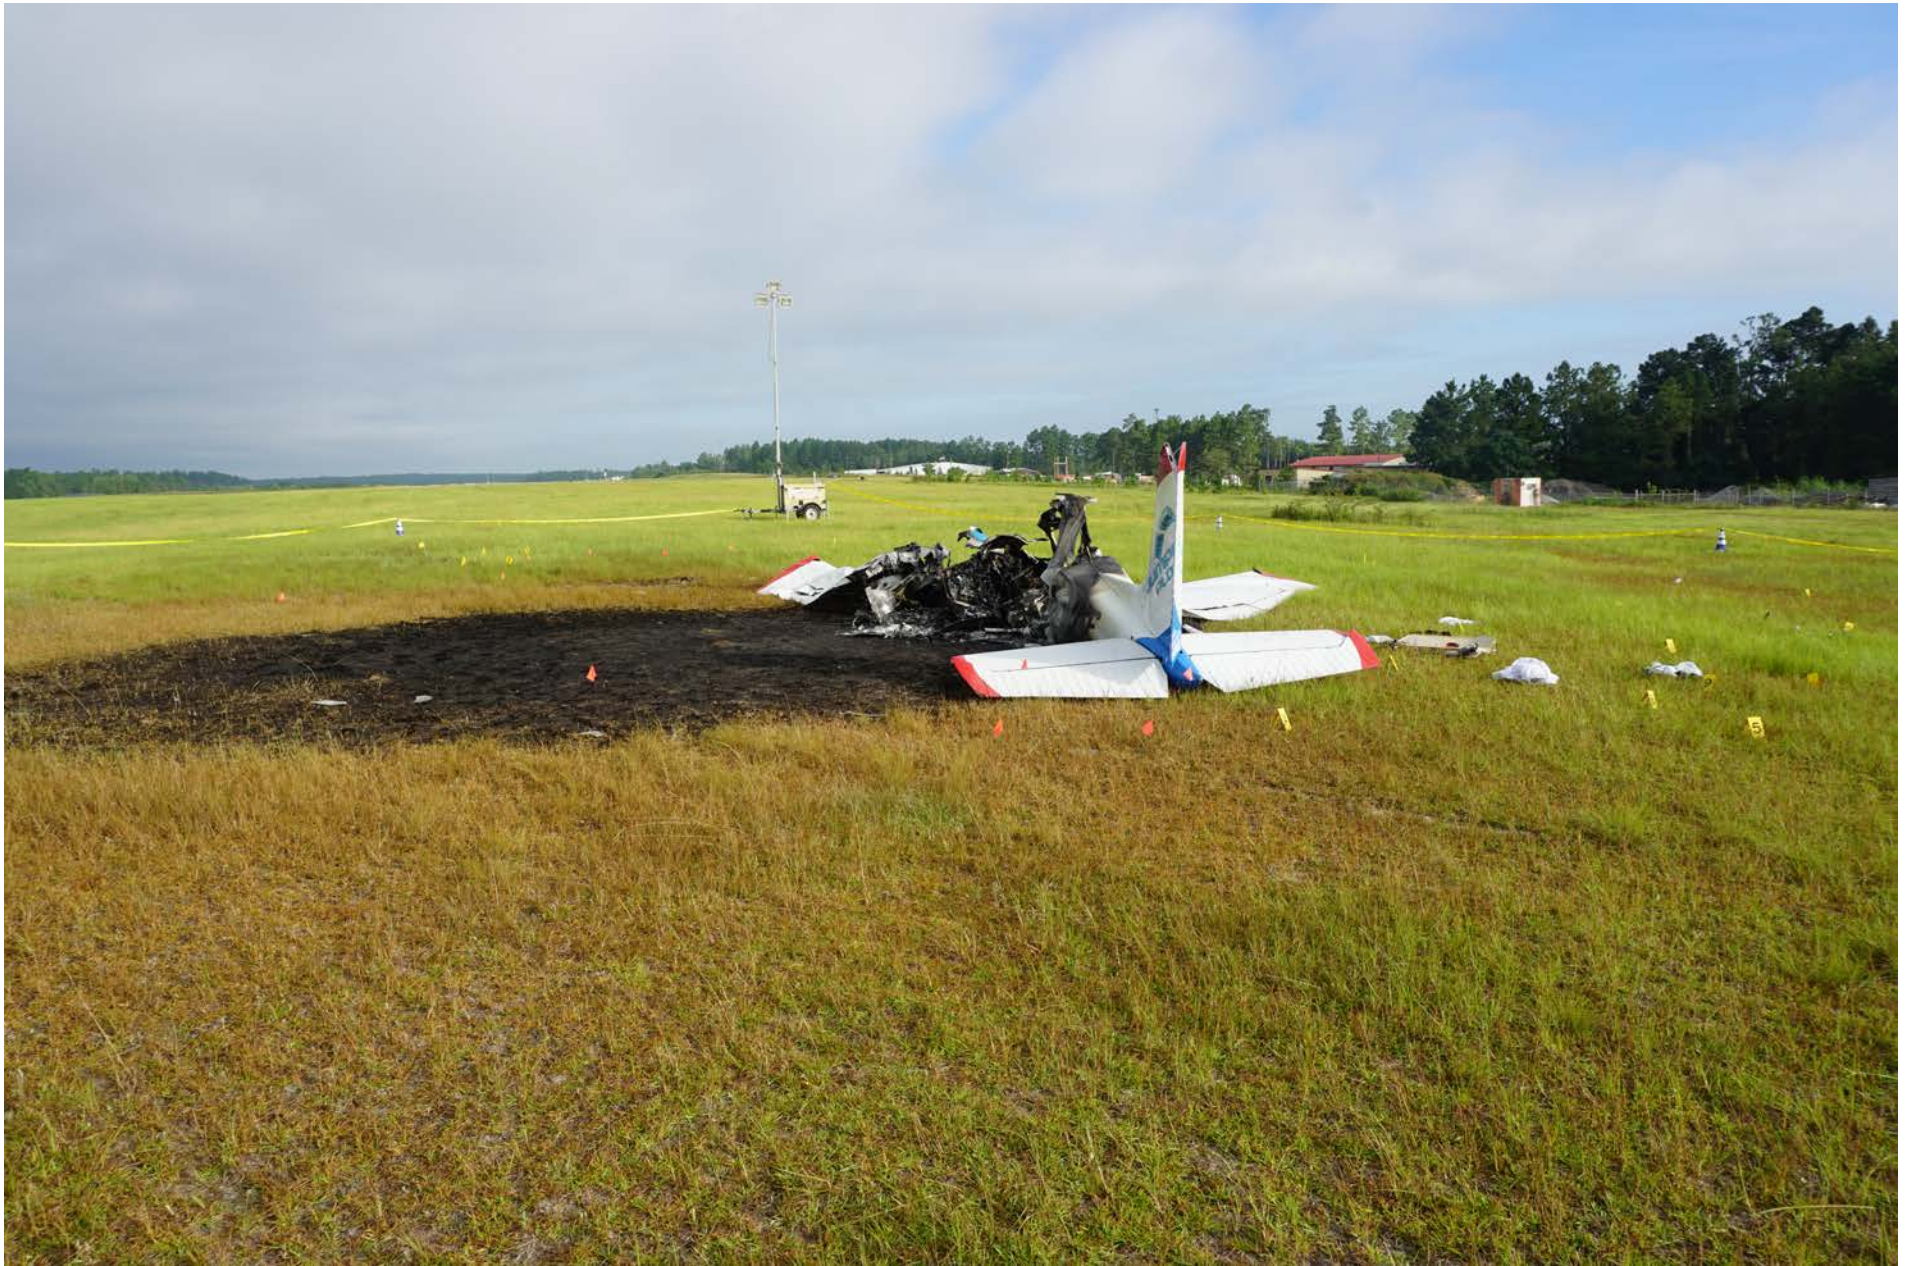
**Photo 3 – Aft view of wreckage**

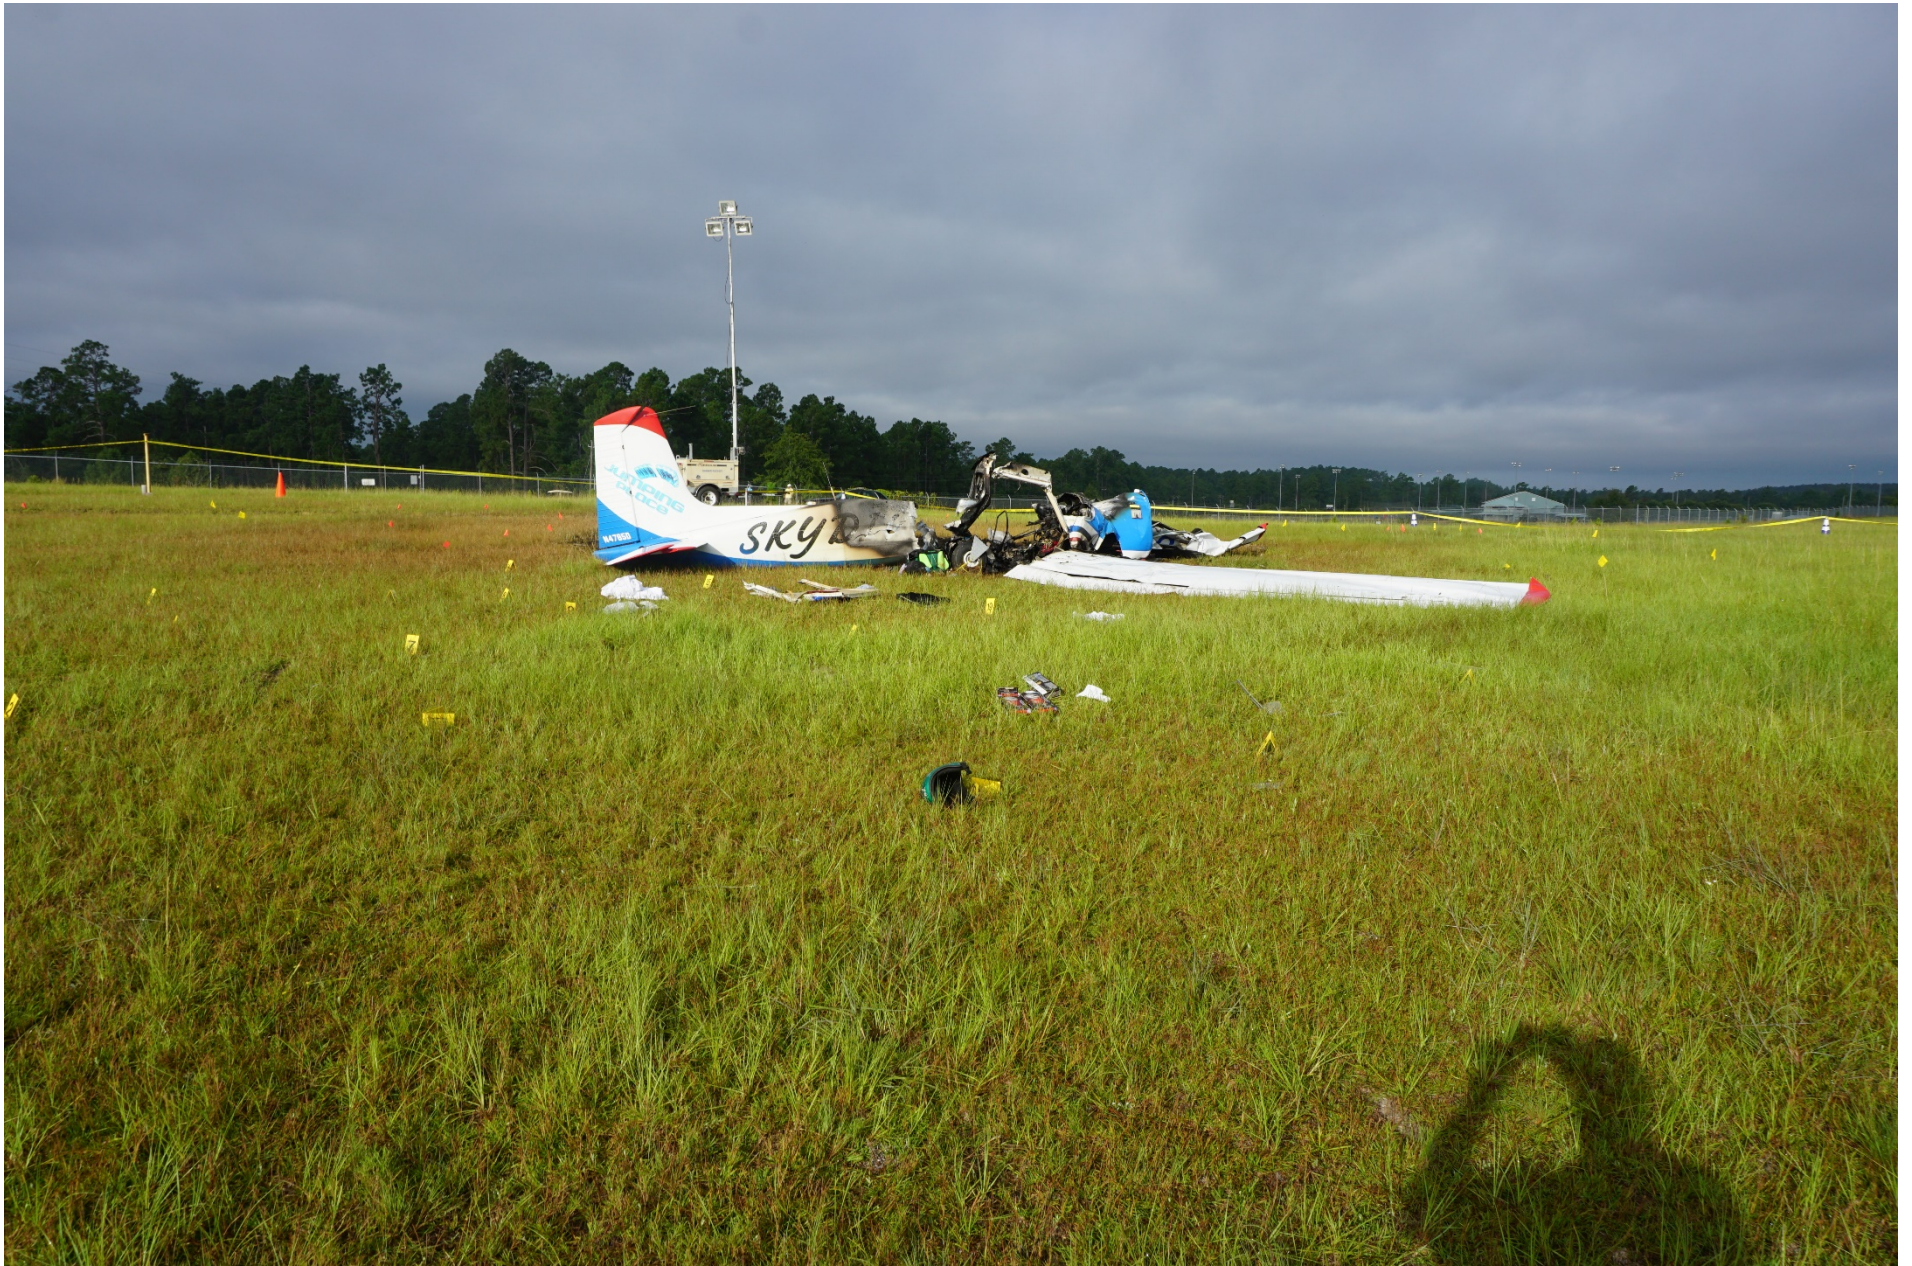
**Photo 4 – Right side view of wreckage**

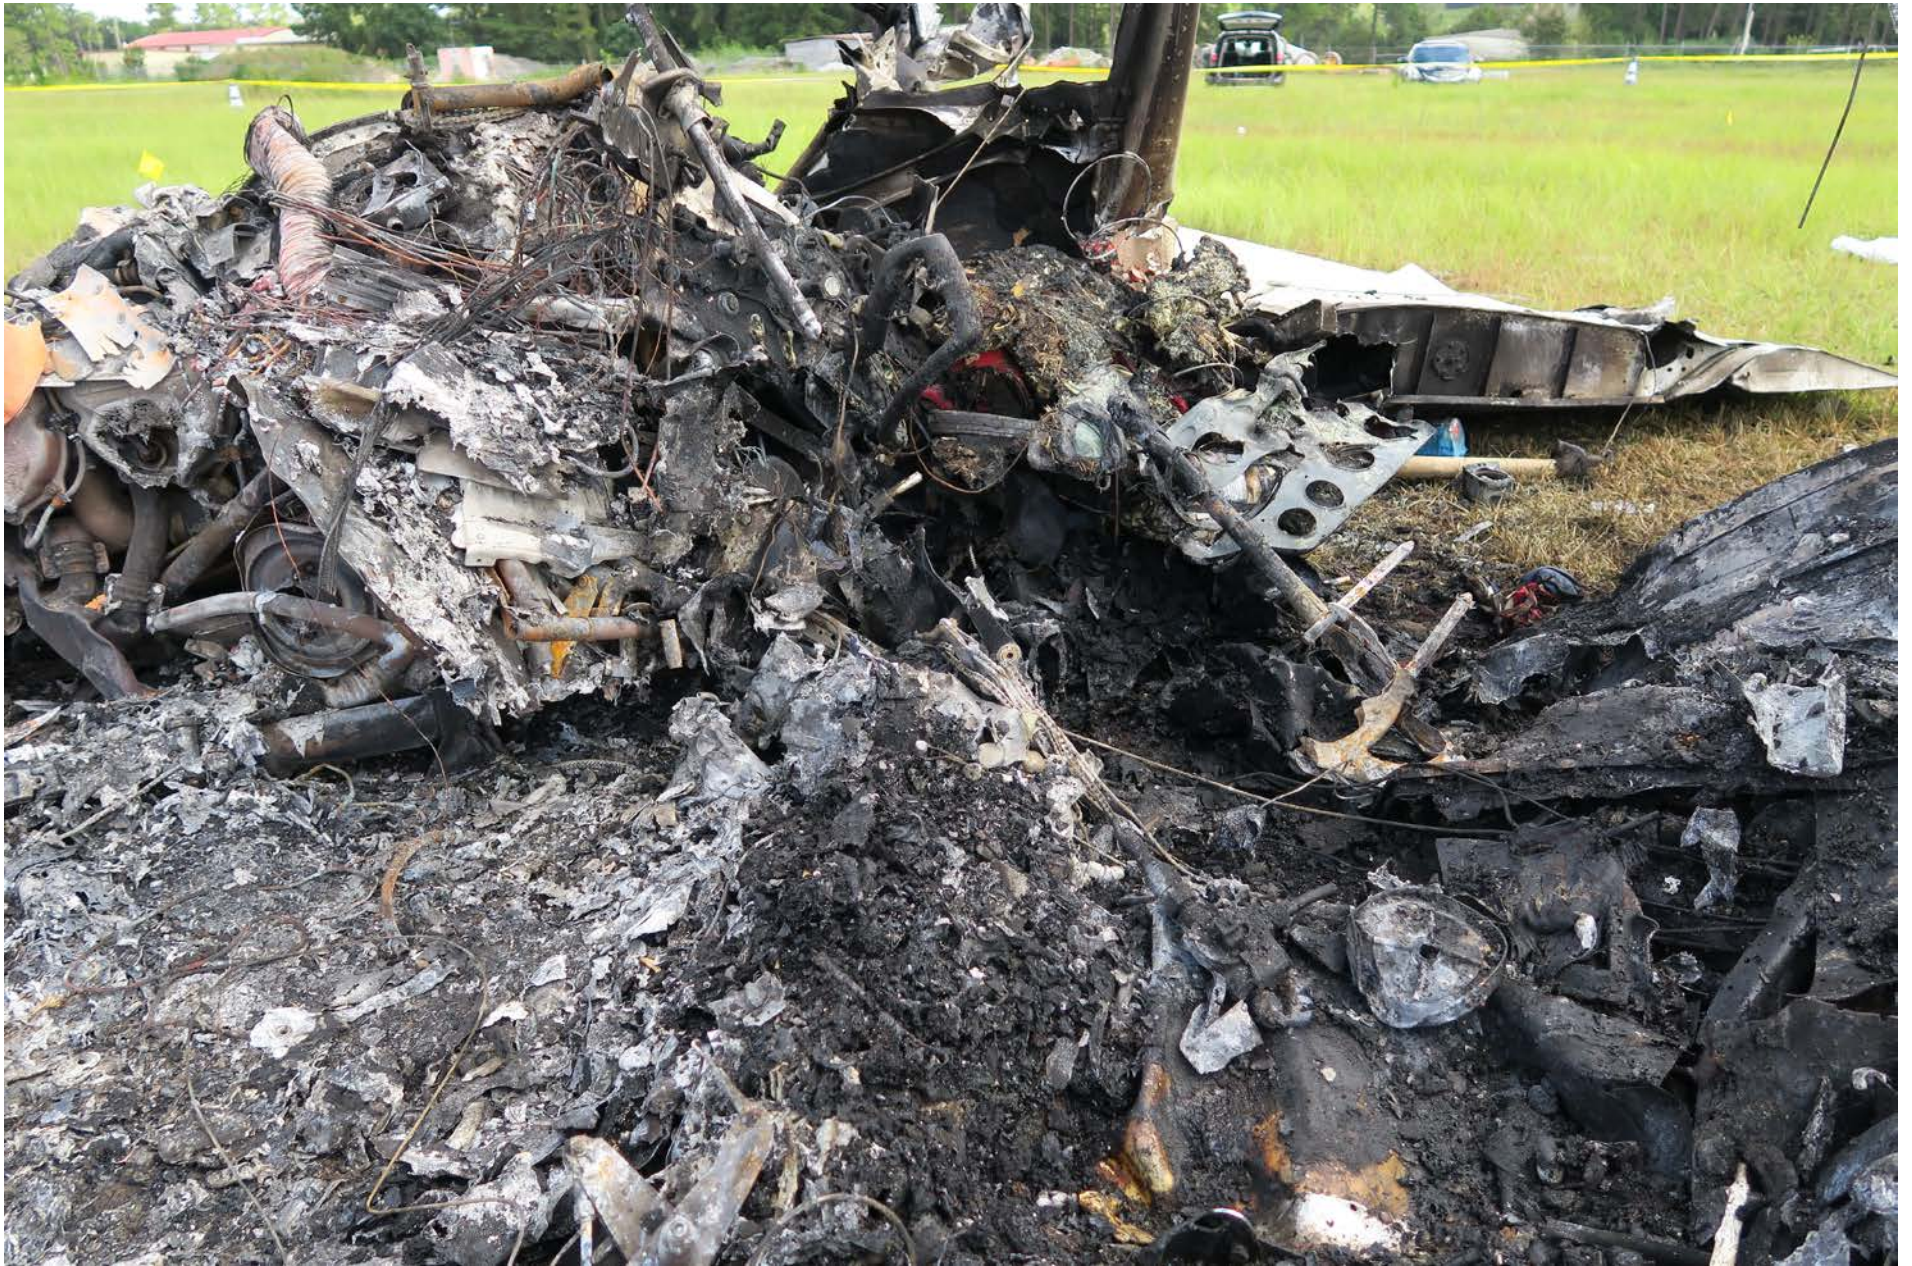
**Photo 5 – View of cockpit and cabin section**

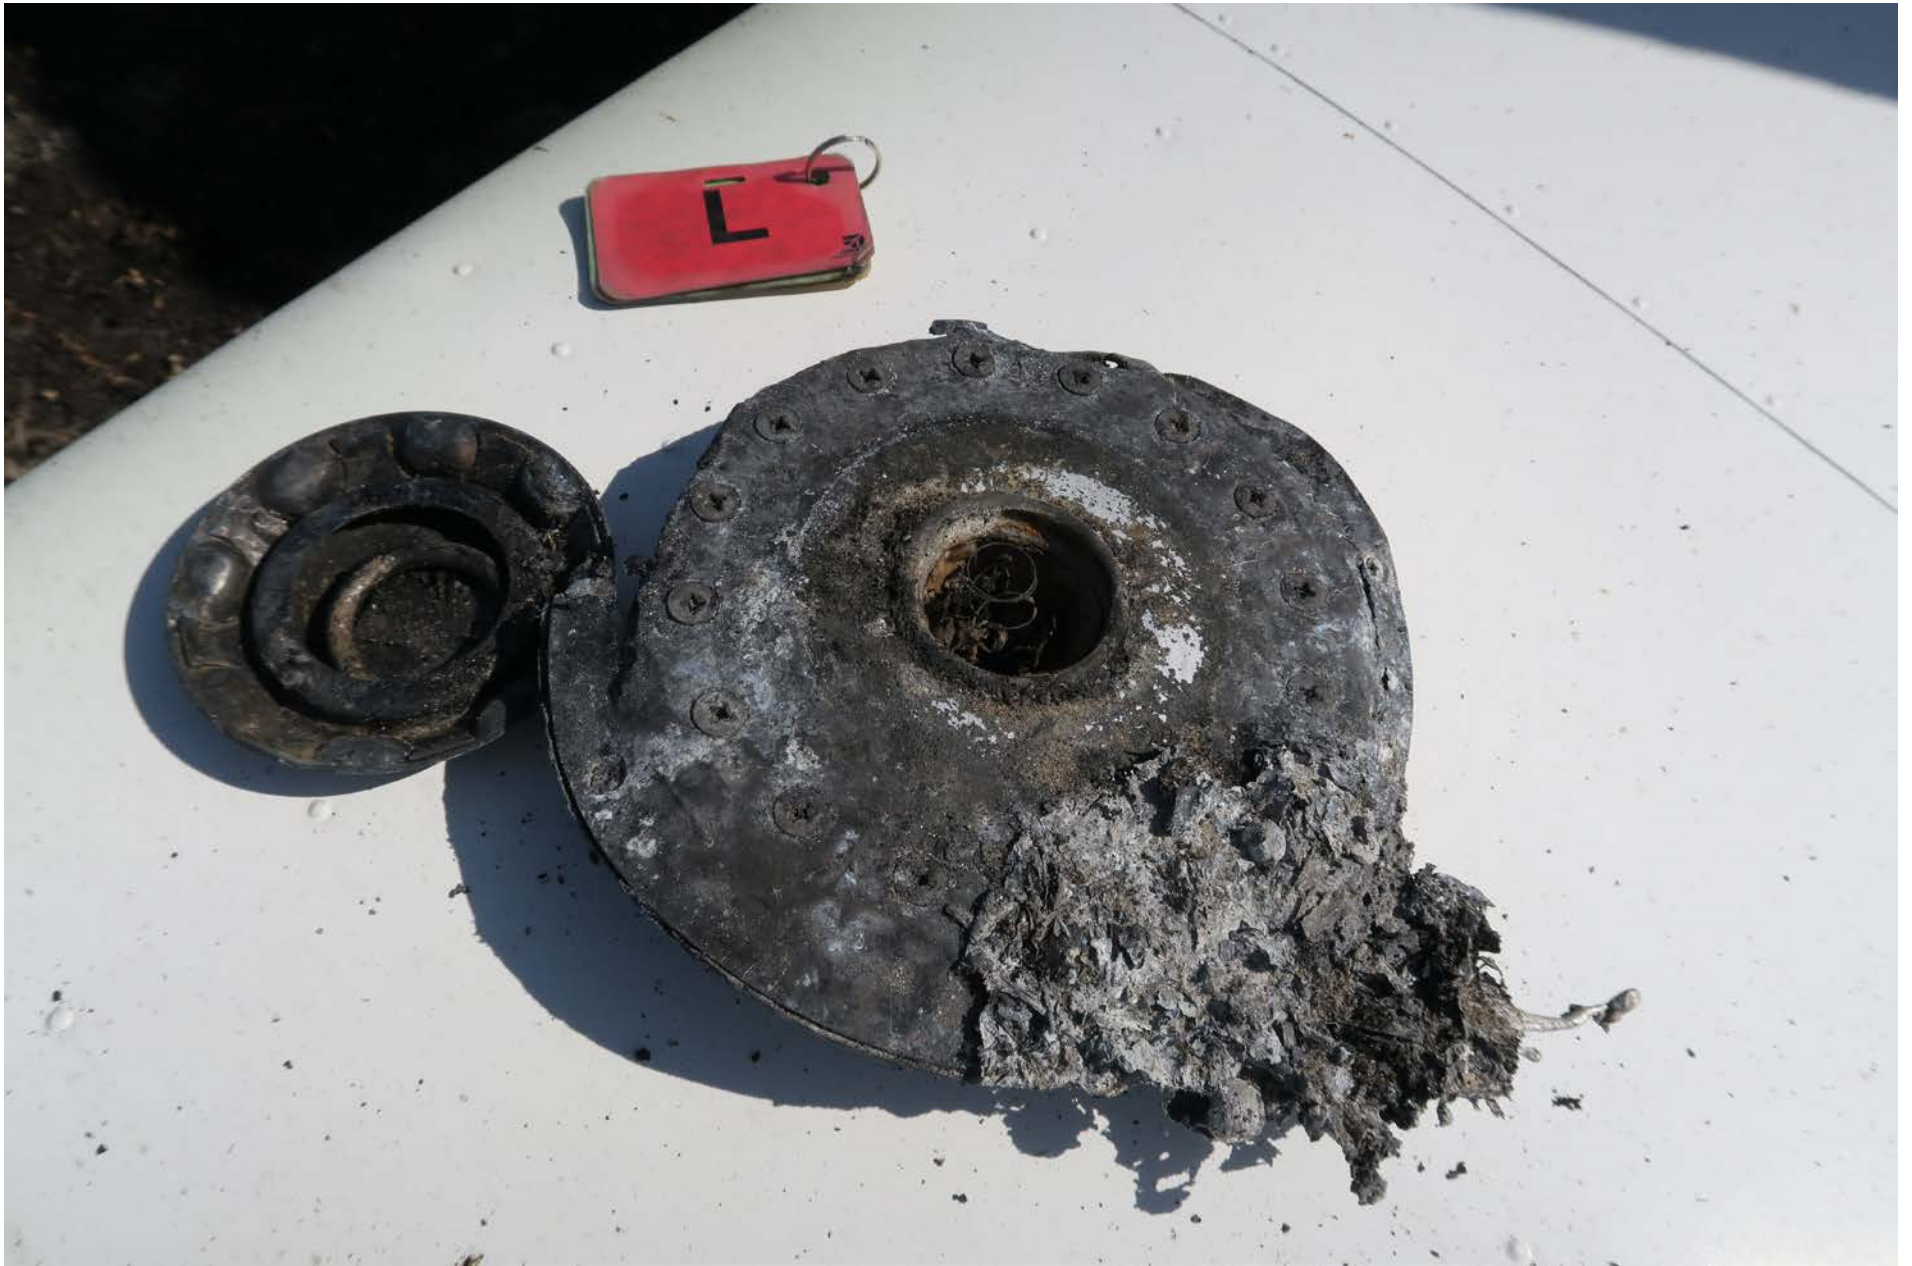
**Photo 6 – View of fire damaged left wing vented fuel cap and fuel port (top view)**

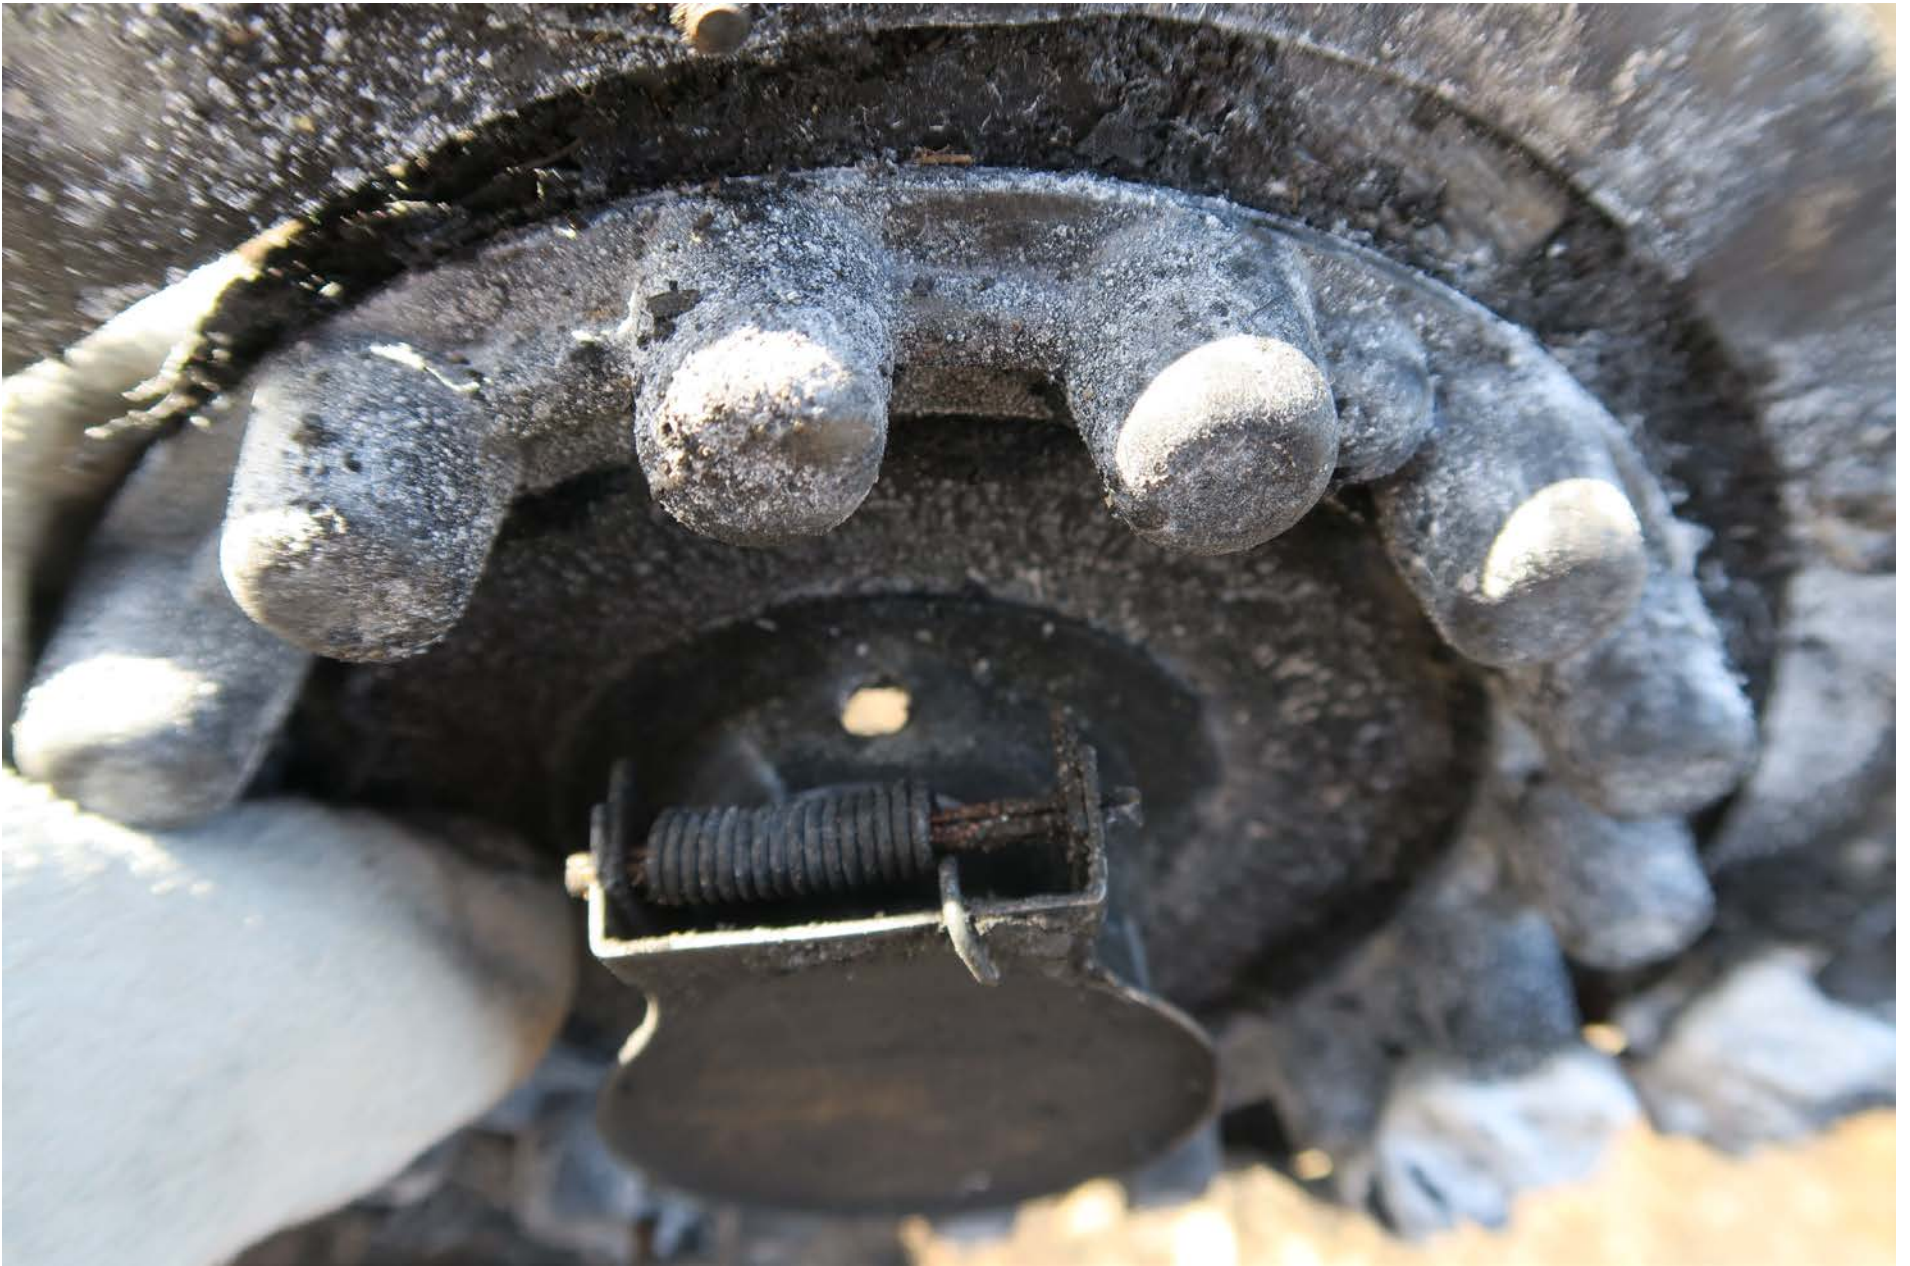
**Photo 7 – Bottom view of left side fuel port showing vent hole**

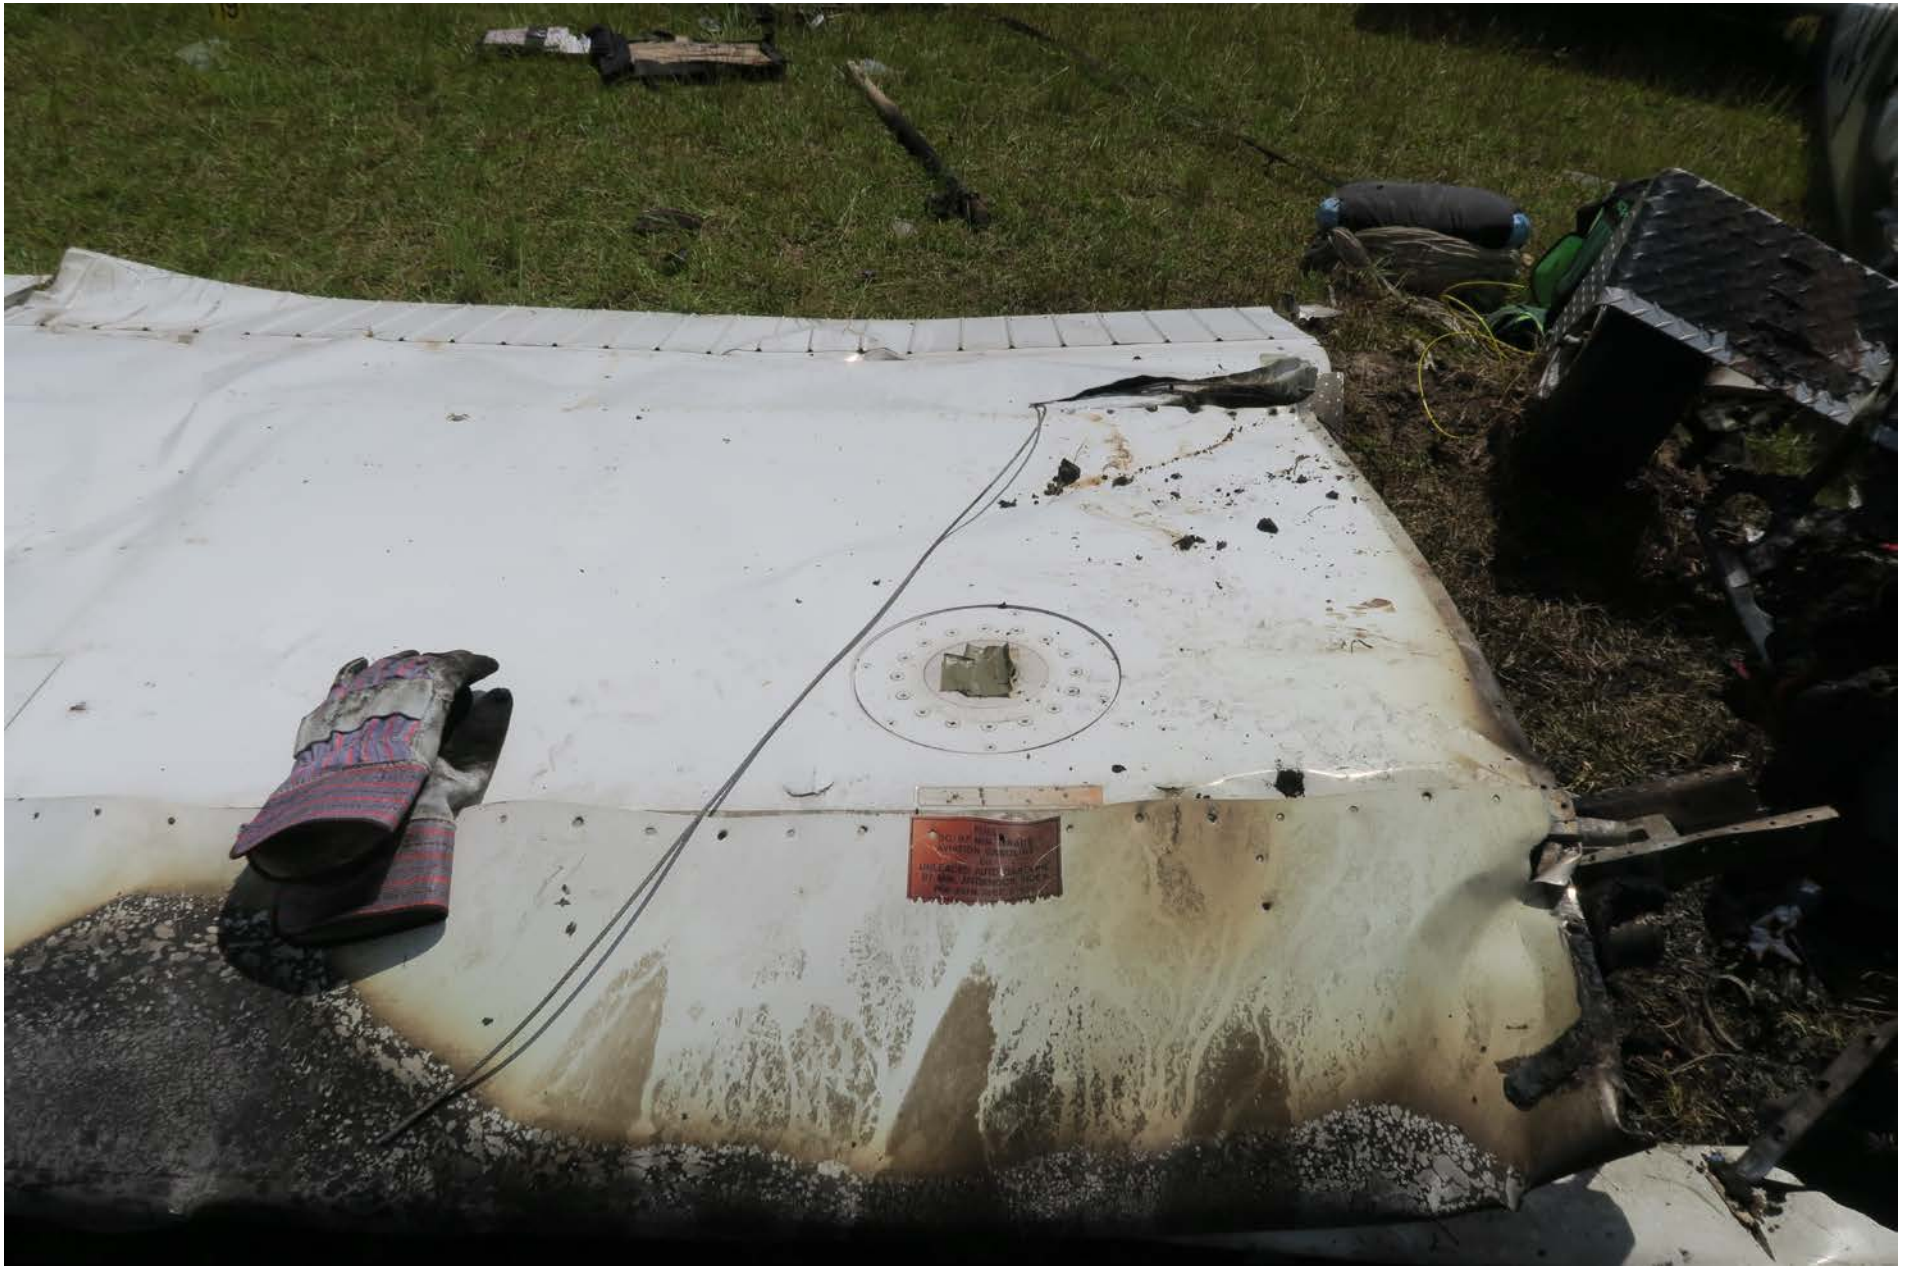
**Photo 8 – View of right wing showing tape over right fuel port filler**

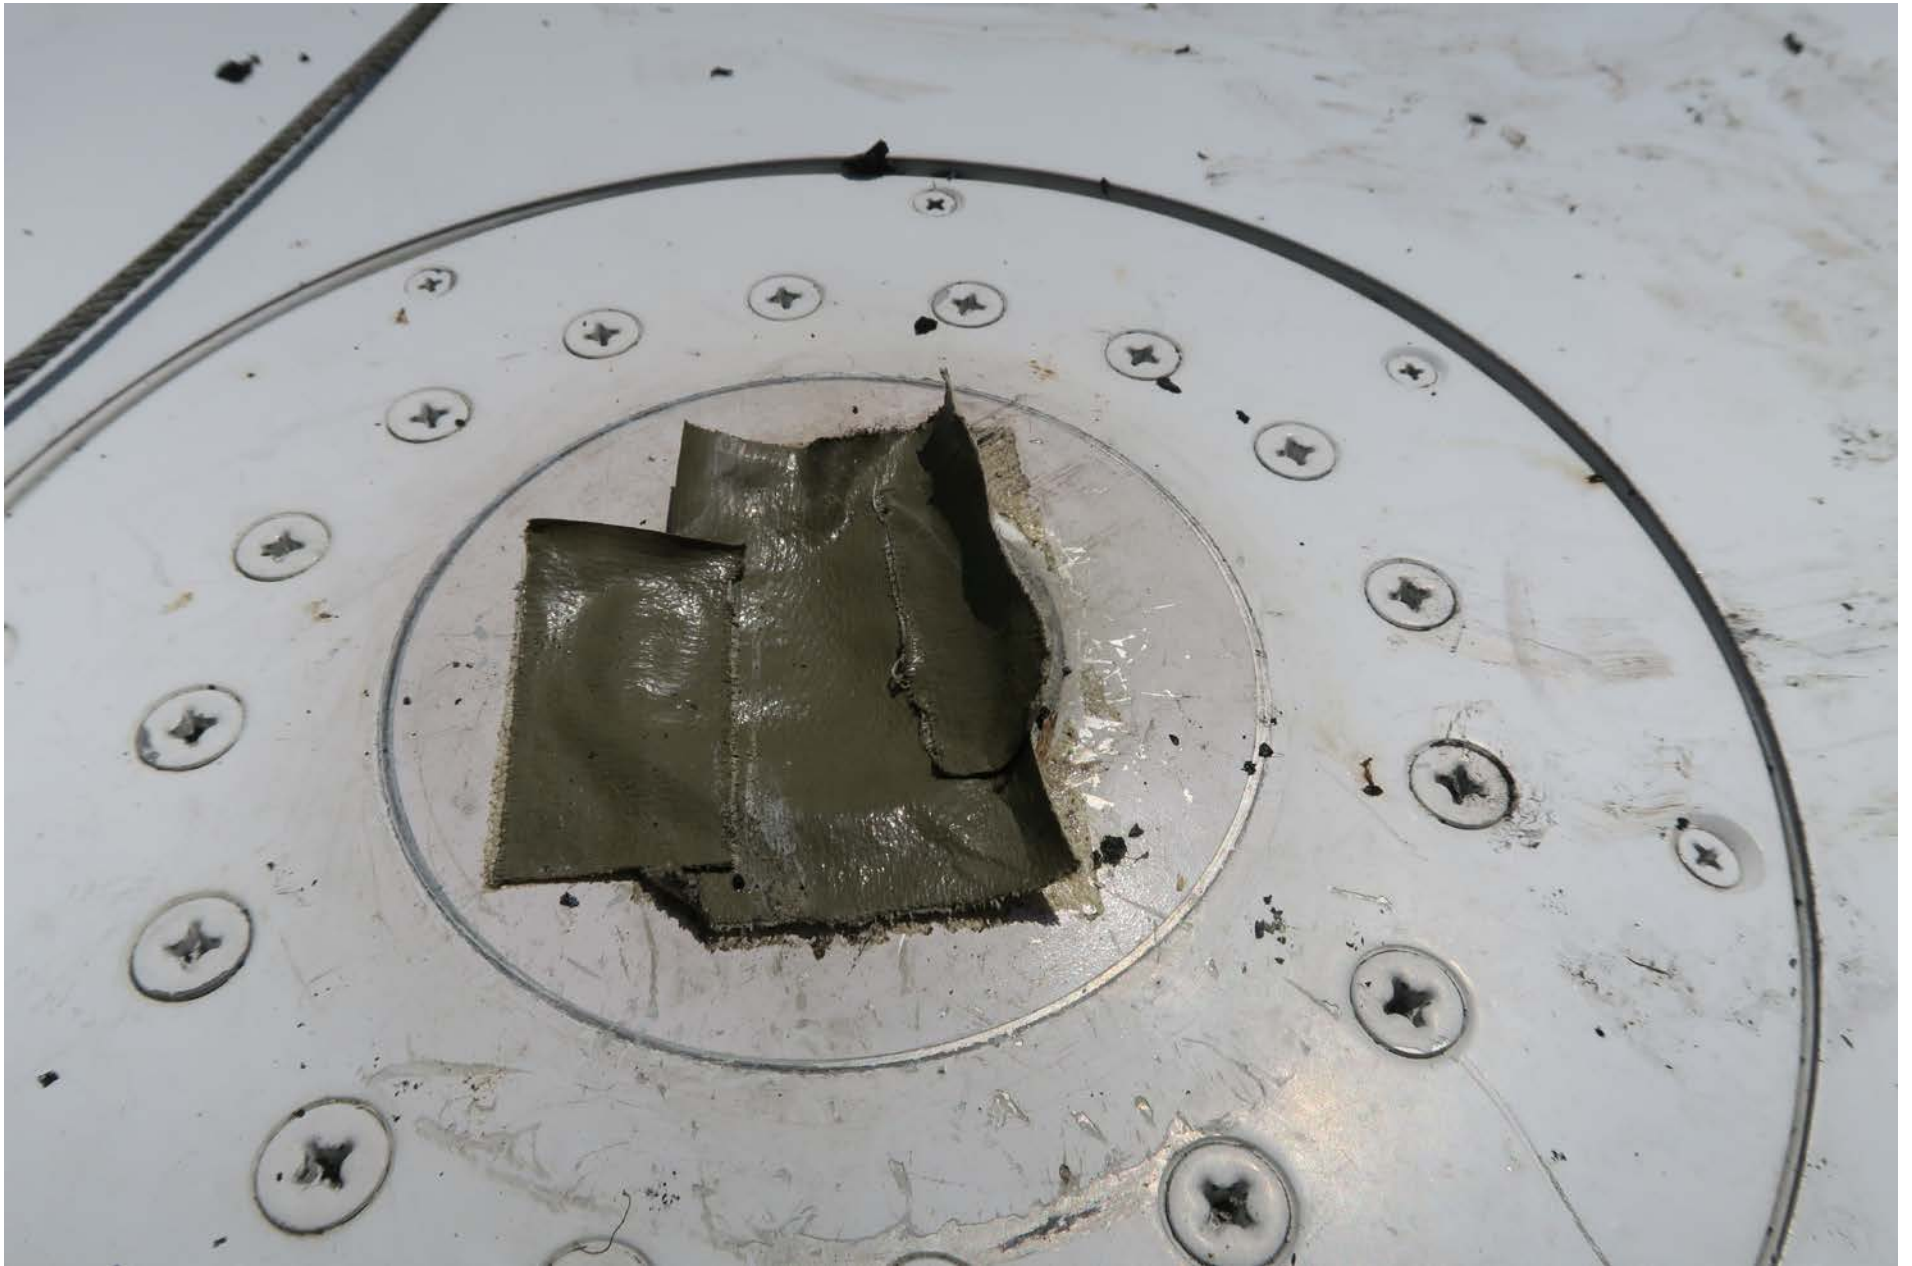
**Photo 9 – Close up view of tape over right fuel port filler showing some heat damage**
