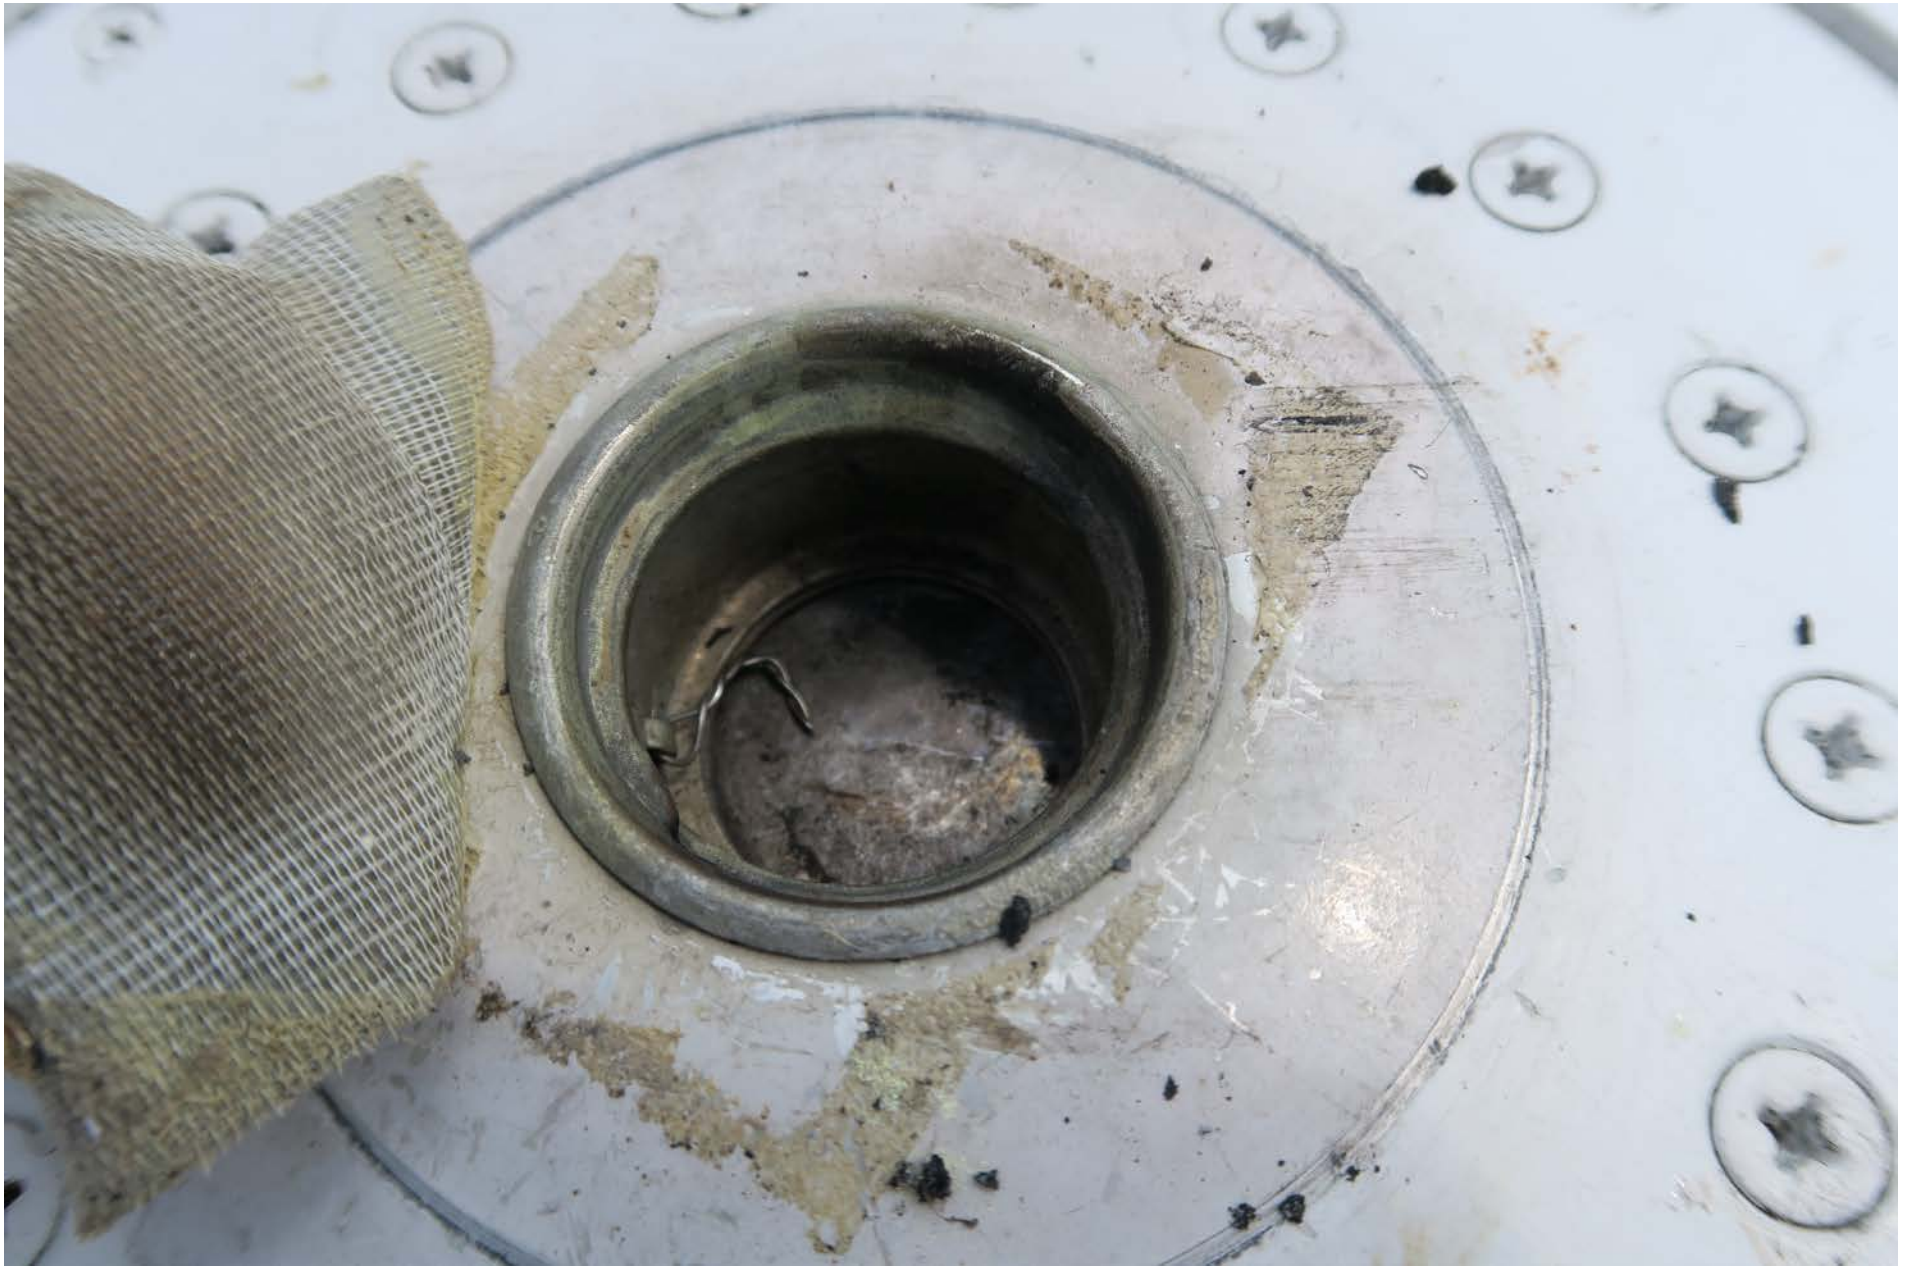
**Photo 10 – View of right fuel port filler with tape peeled back for inspection, showing broken safety wire**

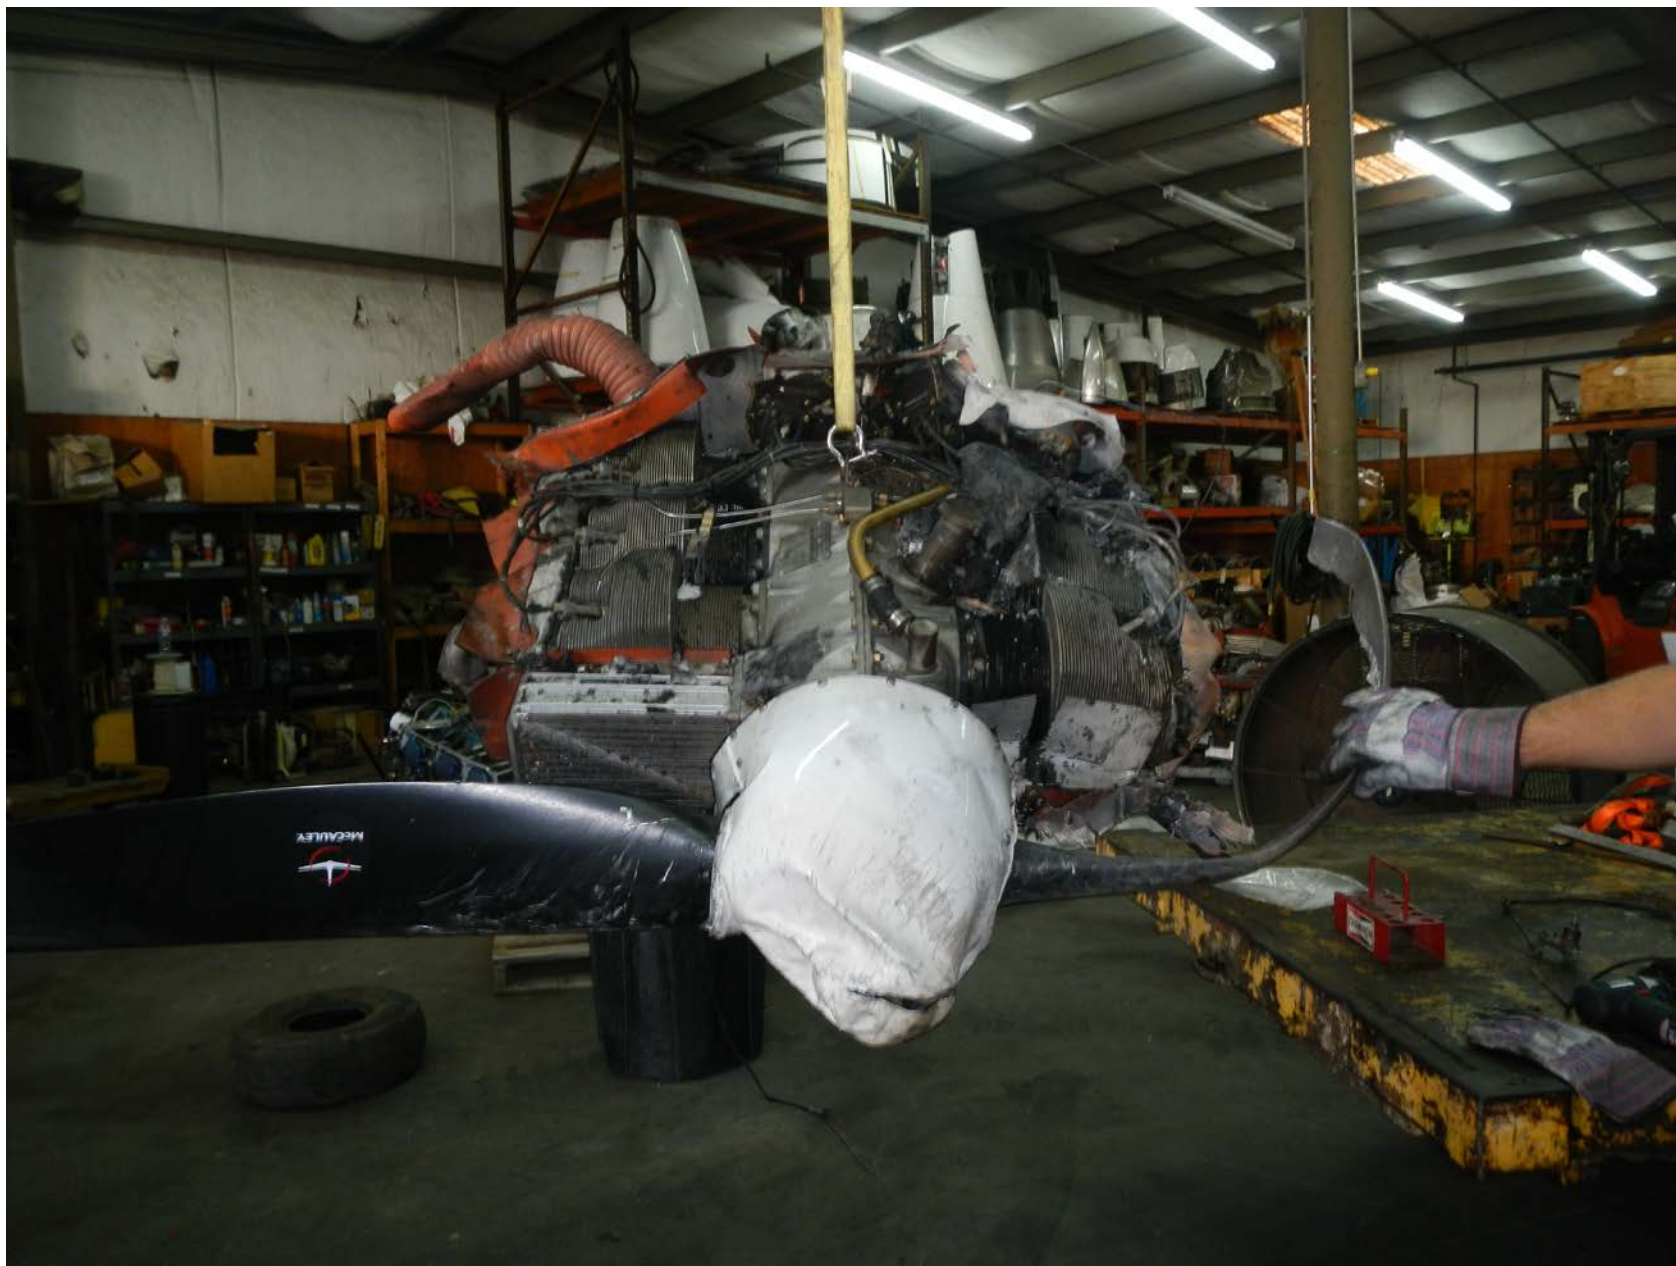
**Photo 11 – View of front of engine and propeller showing impact damage**

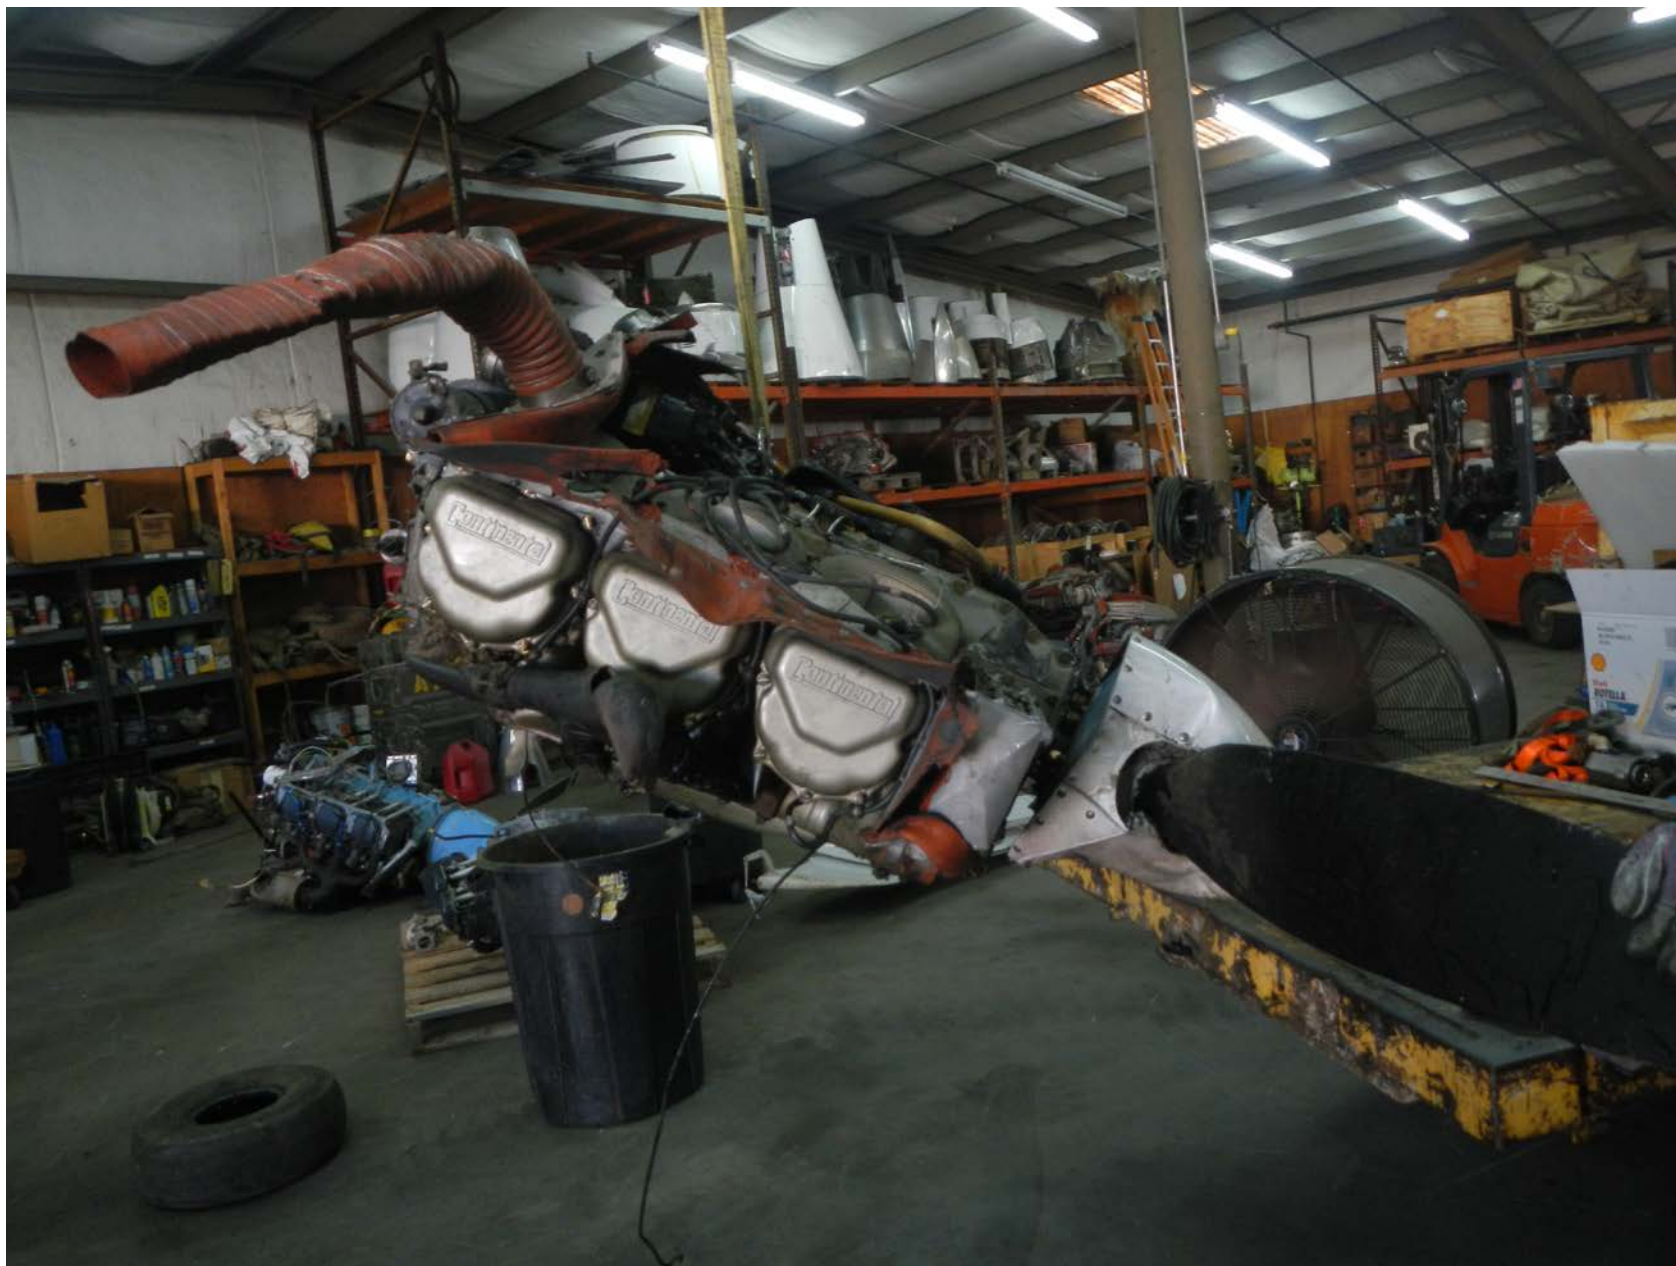
**Photo 12 – View of right side of engine showing impact damage**

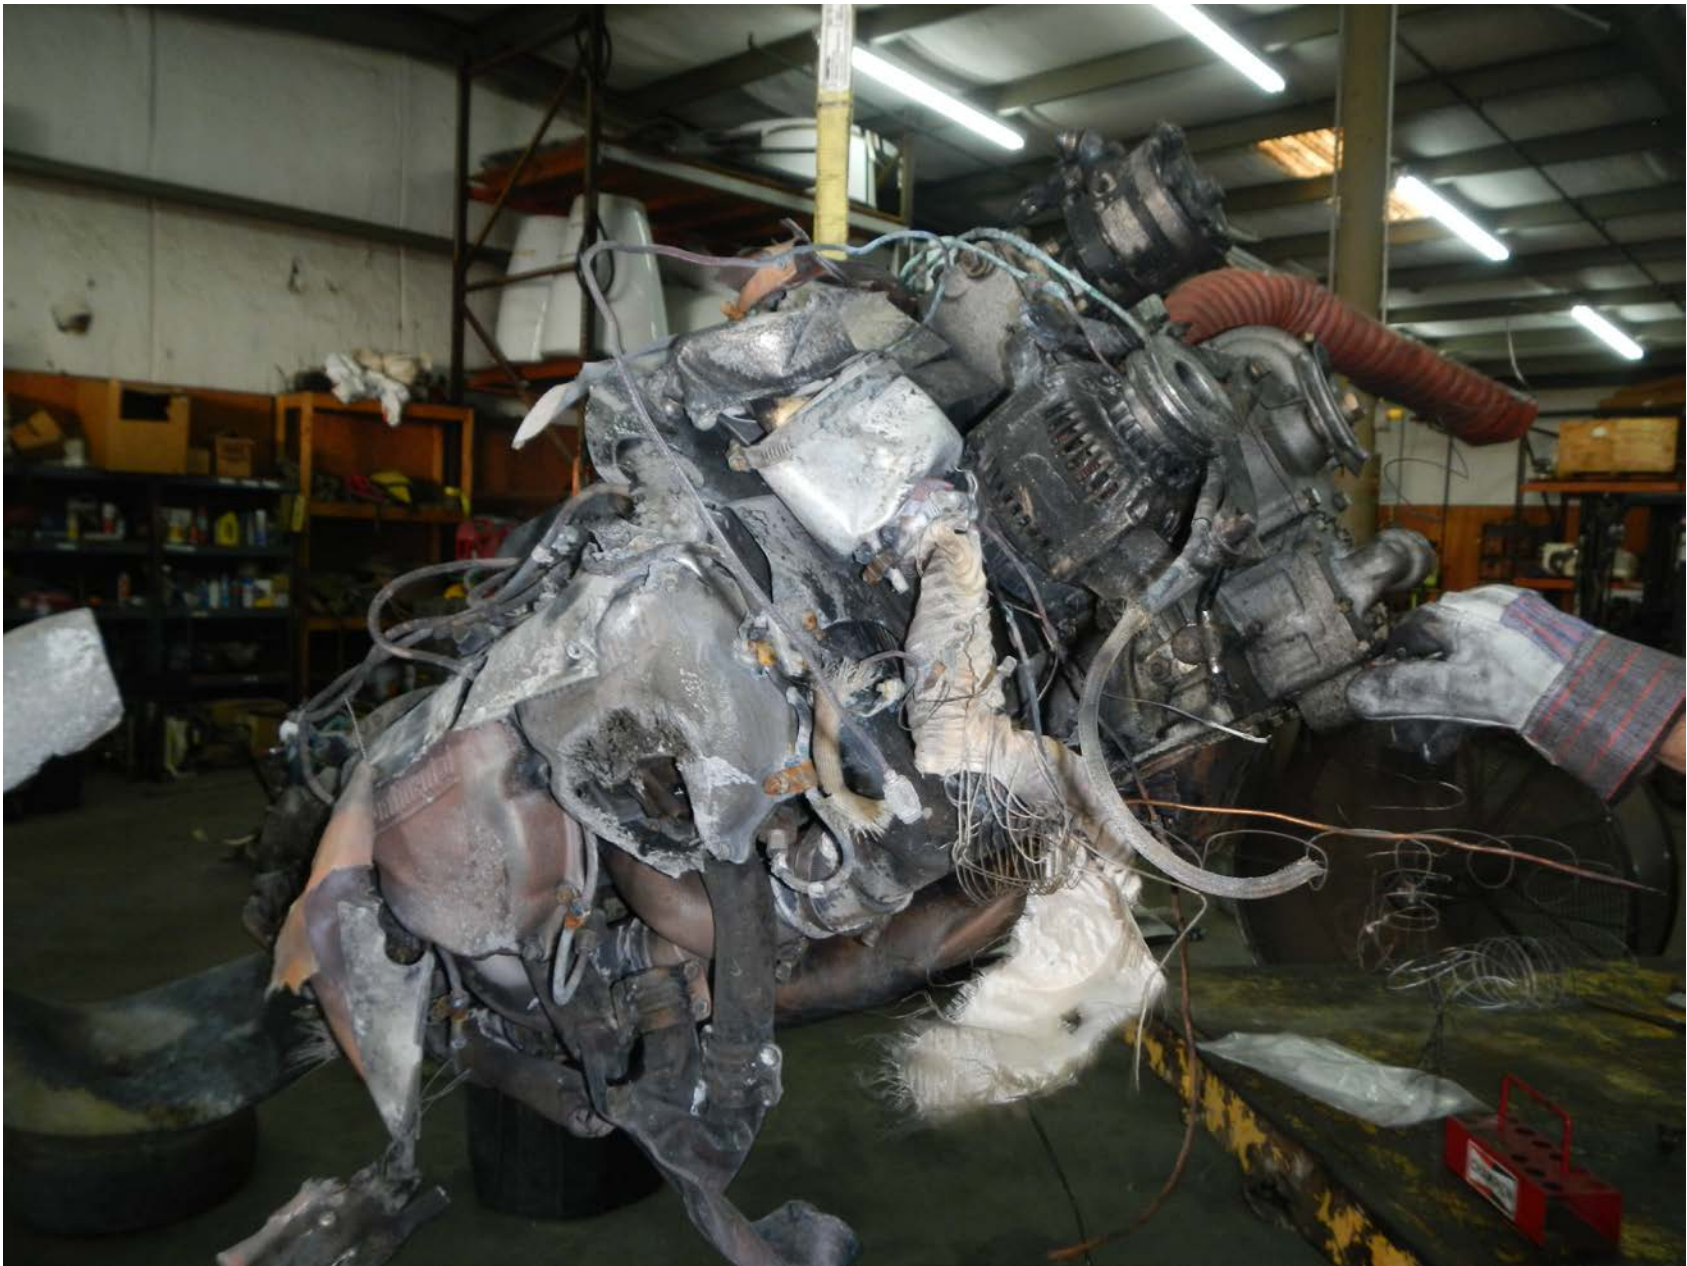
**Photo 13 – View of left side engine showing impact and fire damage**

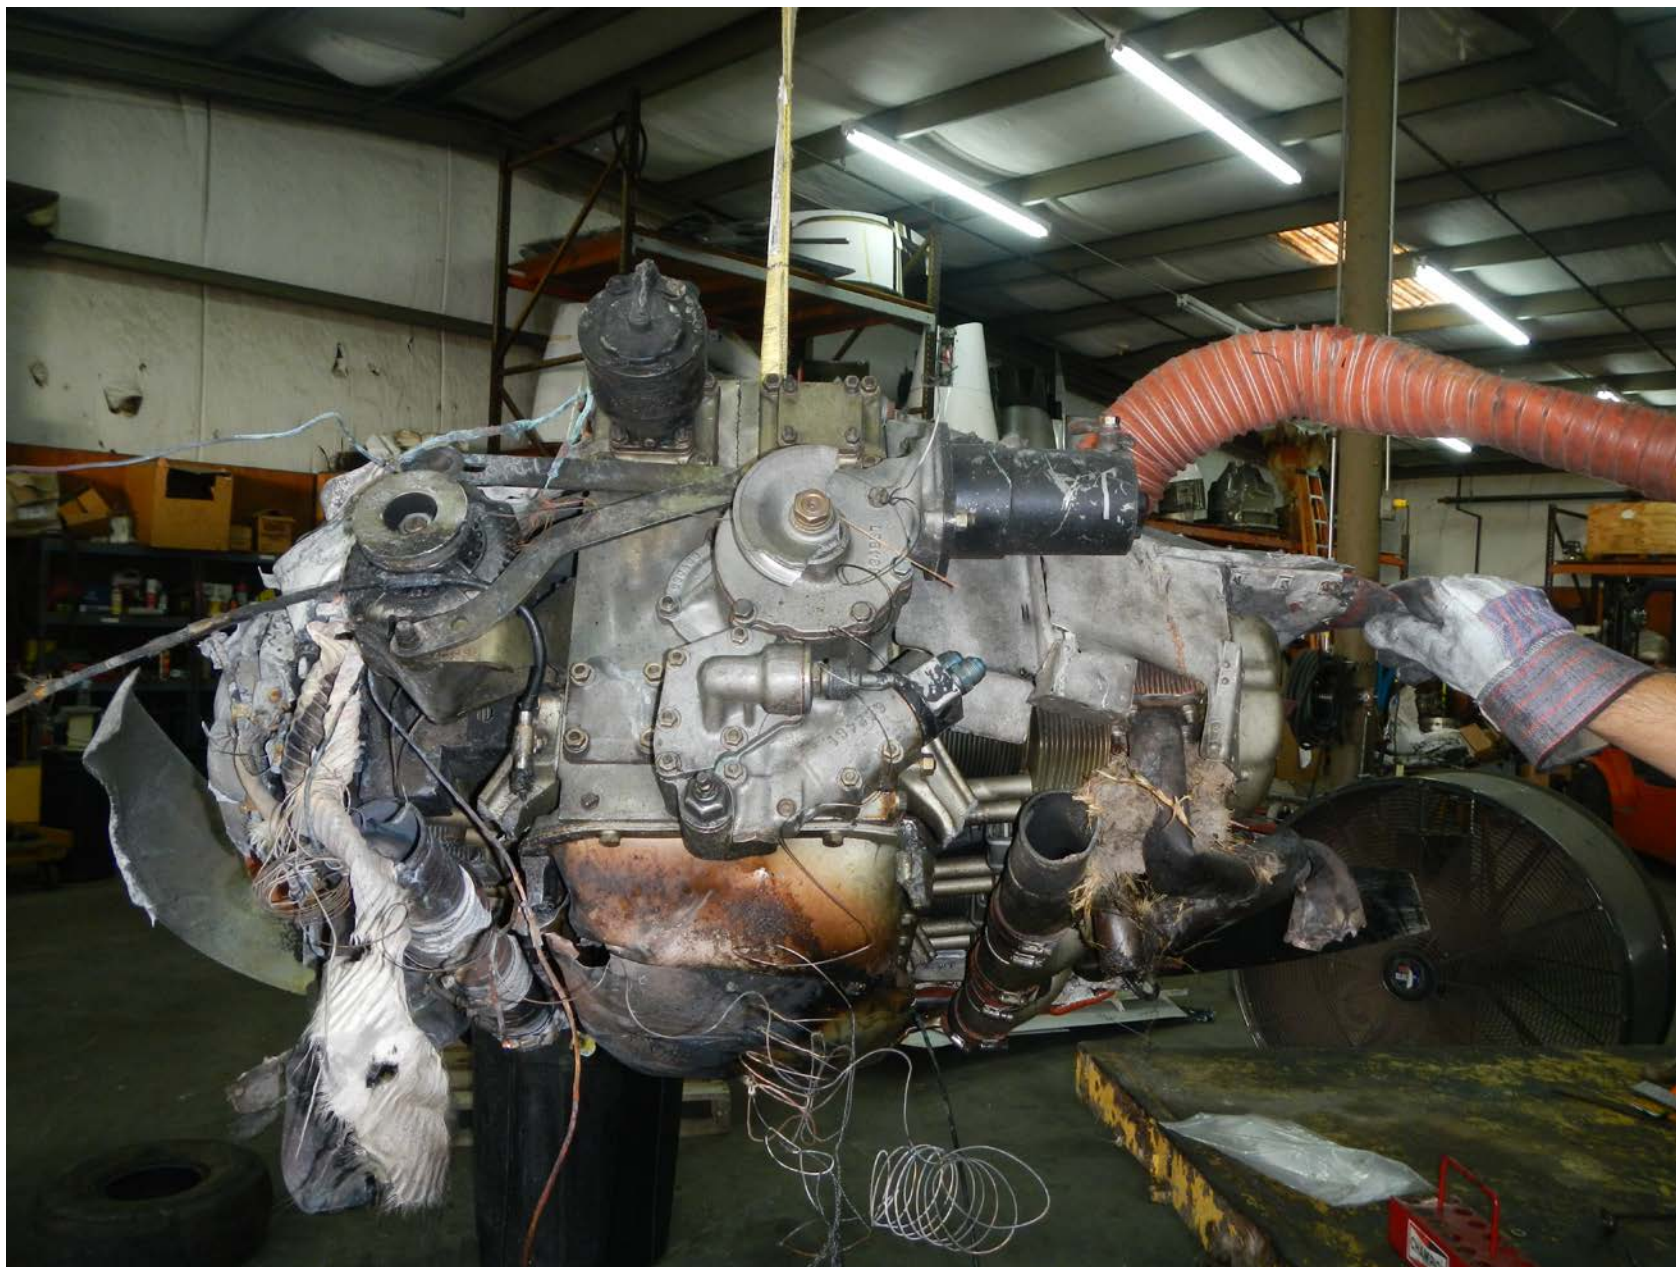
**Photo 14 – View of accessory section showing impact and fire damage**
