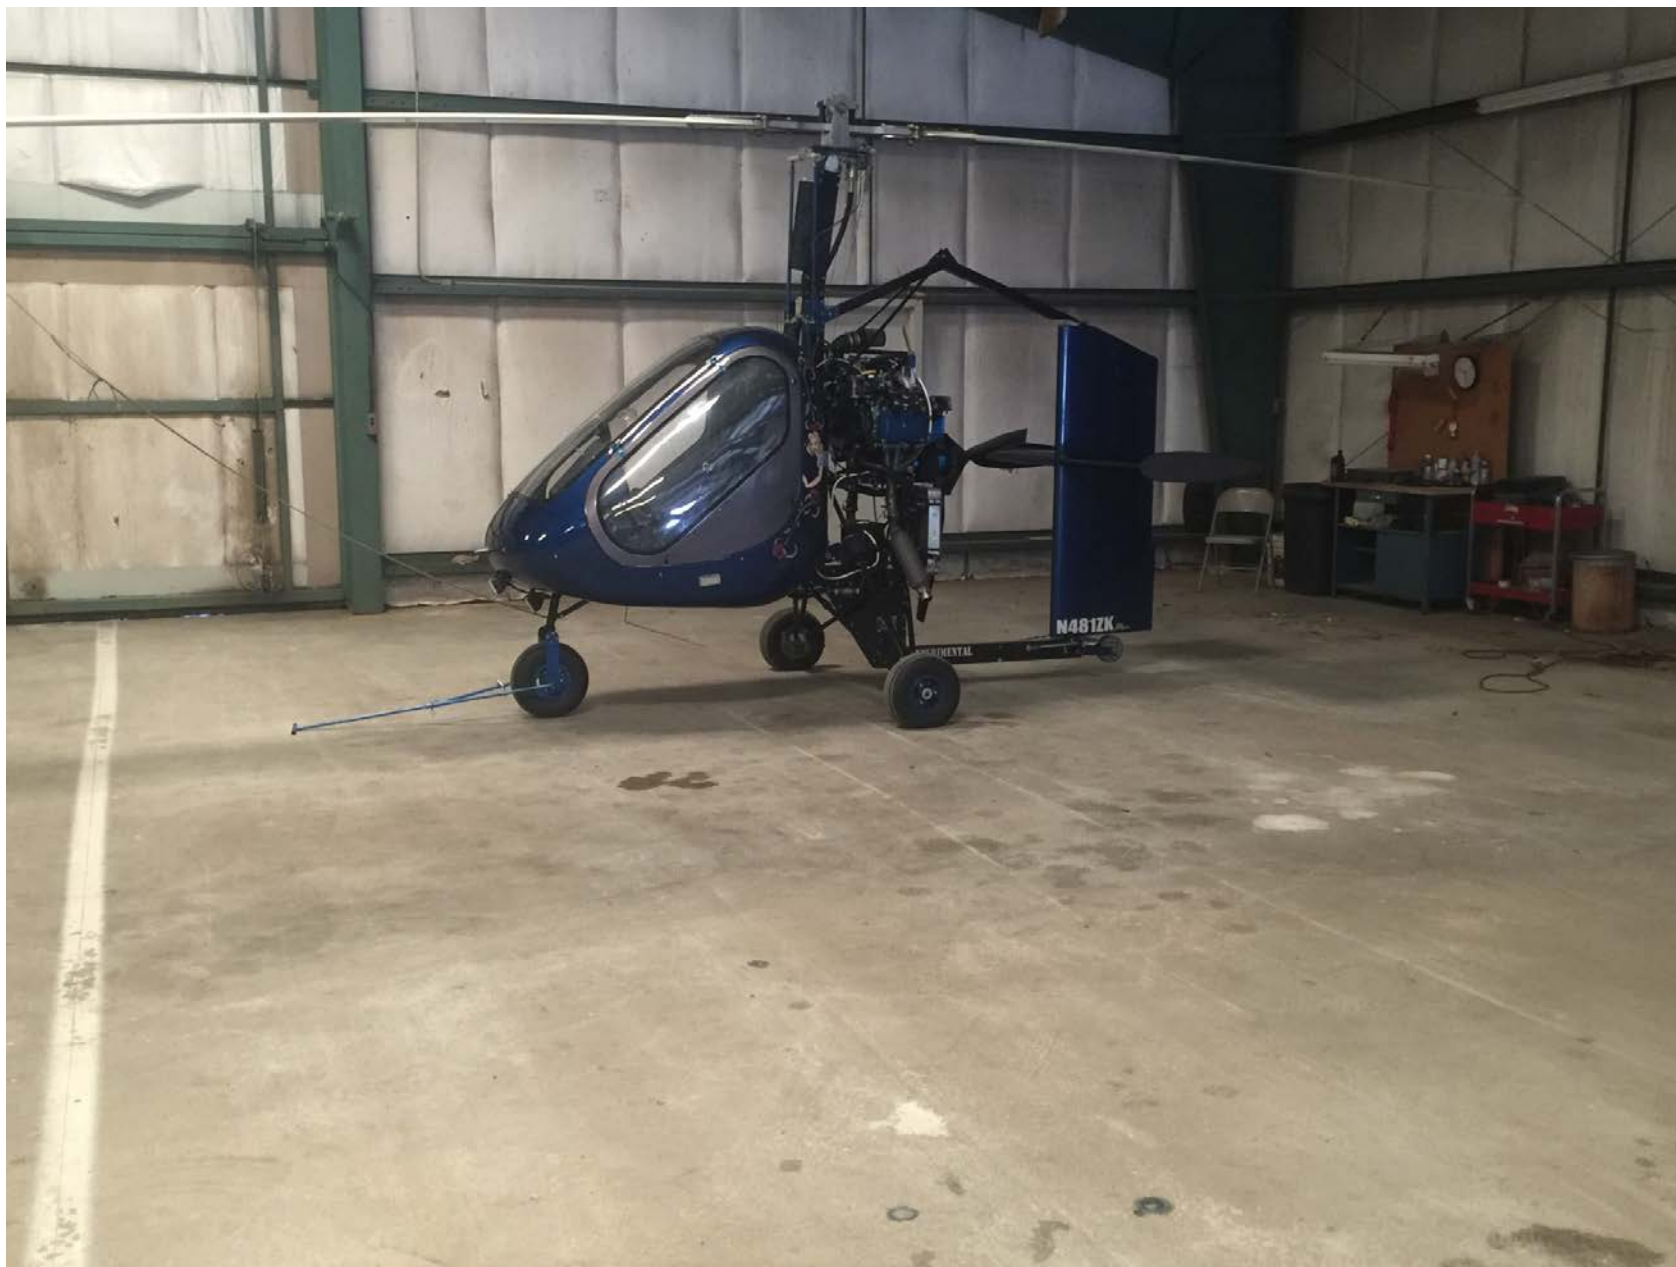
**Photo 1 – Left Side View Photo of the Accident Gyroplane Taken Unknown Date.**

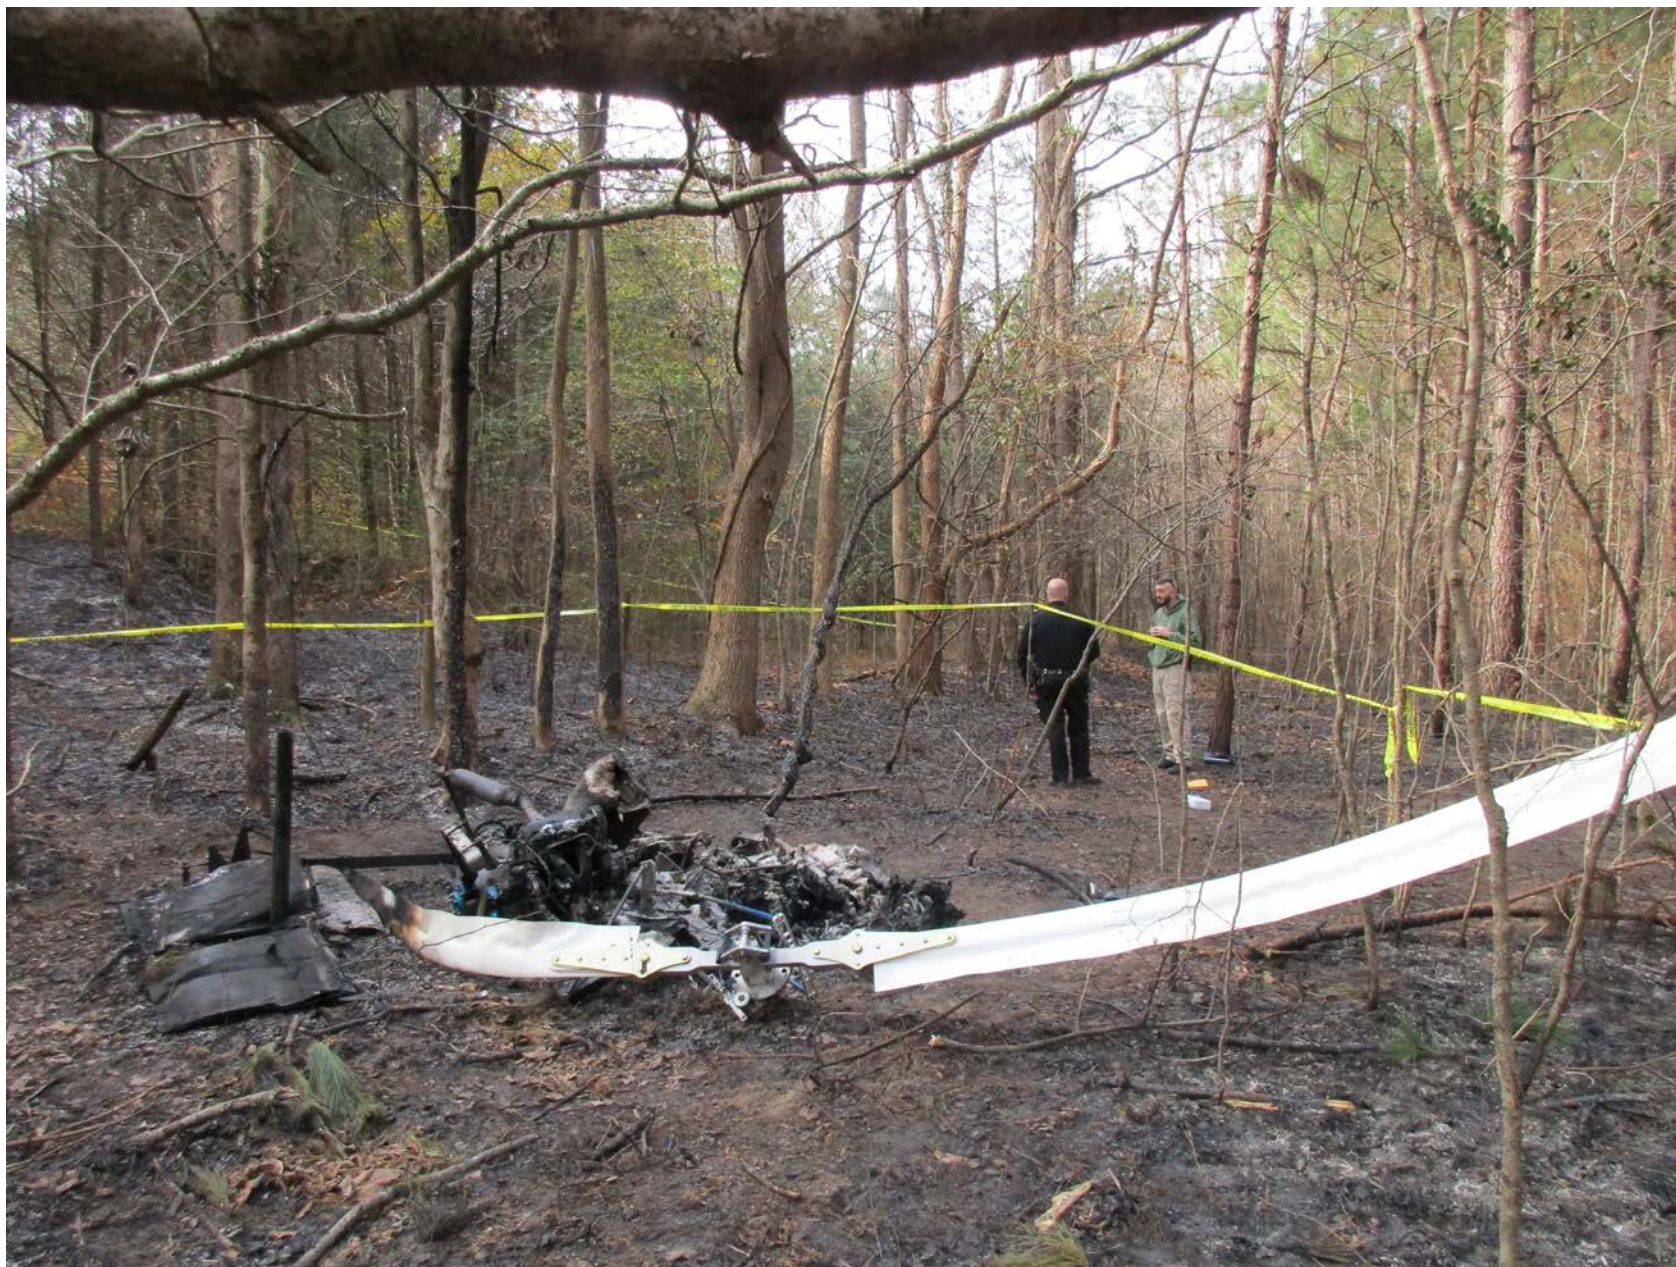
**Photo 2 – FAA Digital Photograph. View of the Gyroplane and Surrounding Area. Note the extensive Fire Damage.**

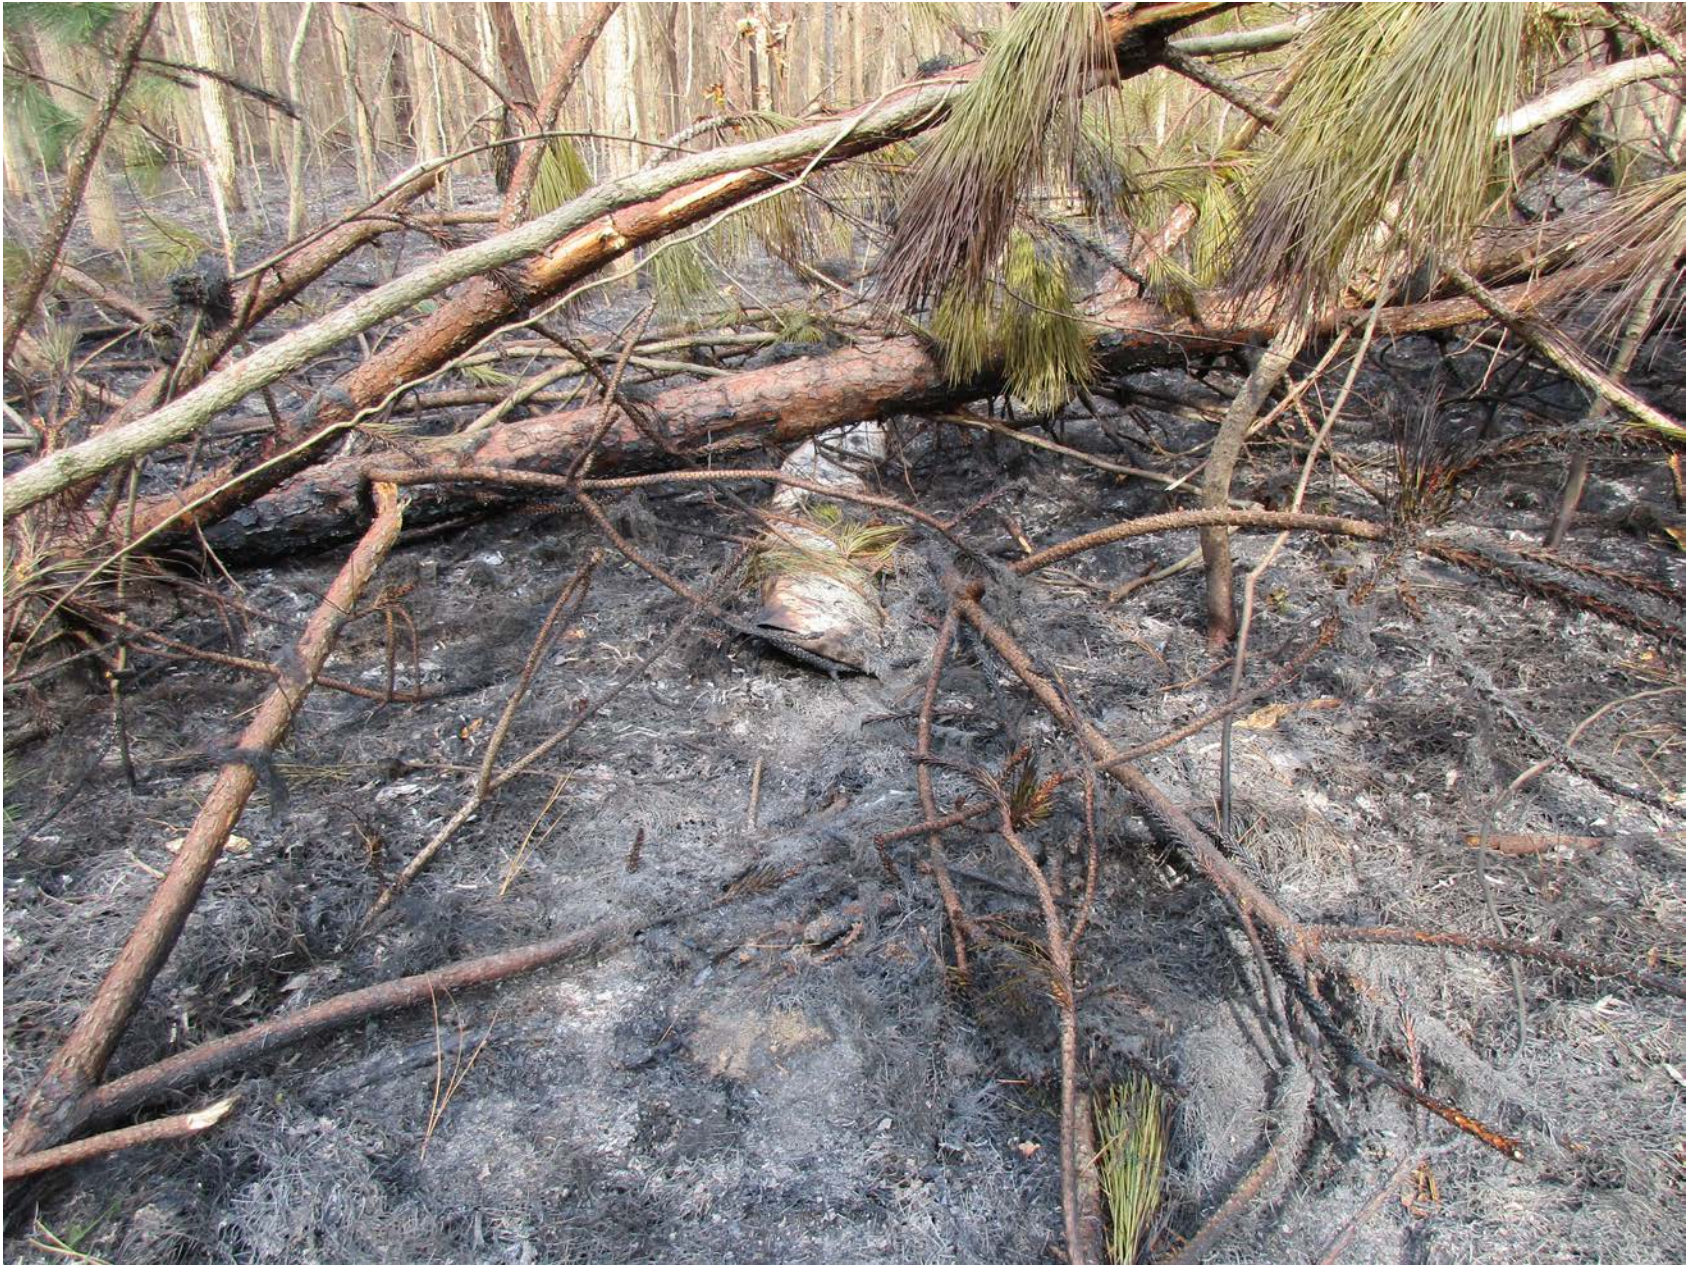
**Photo 3 – FAA Digital Photograph. View of the Separated main rotor blade piece under Cut tree, Located about 10 ft from Wreckage**

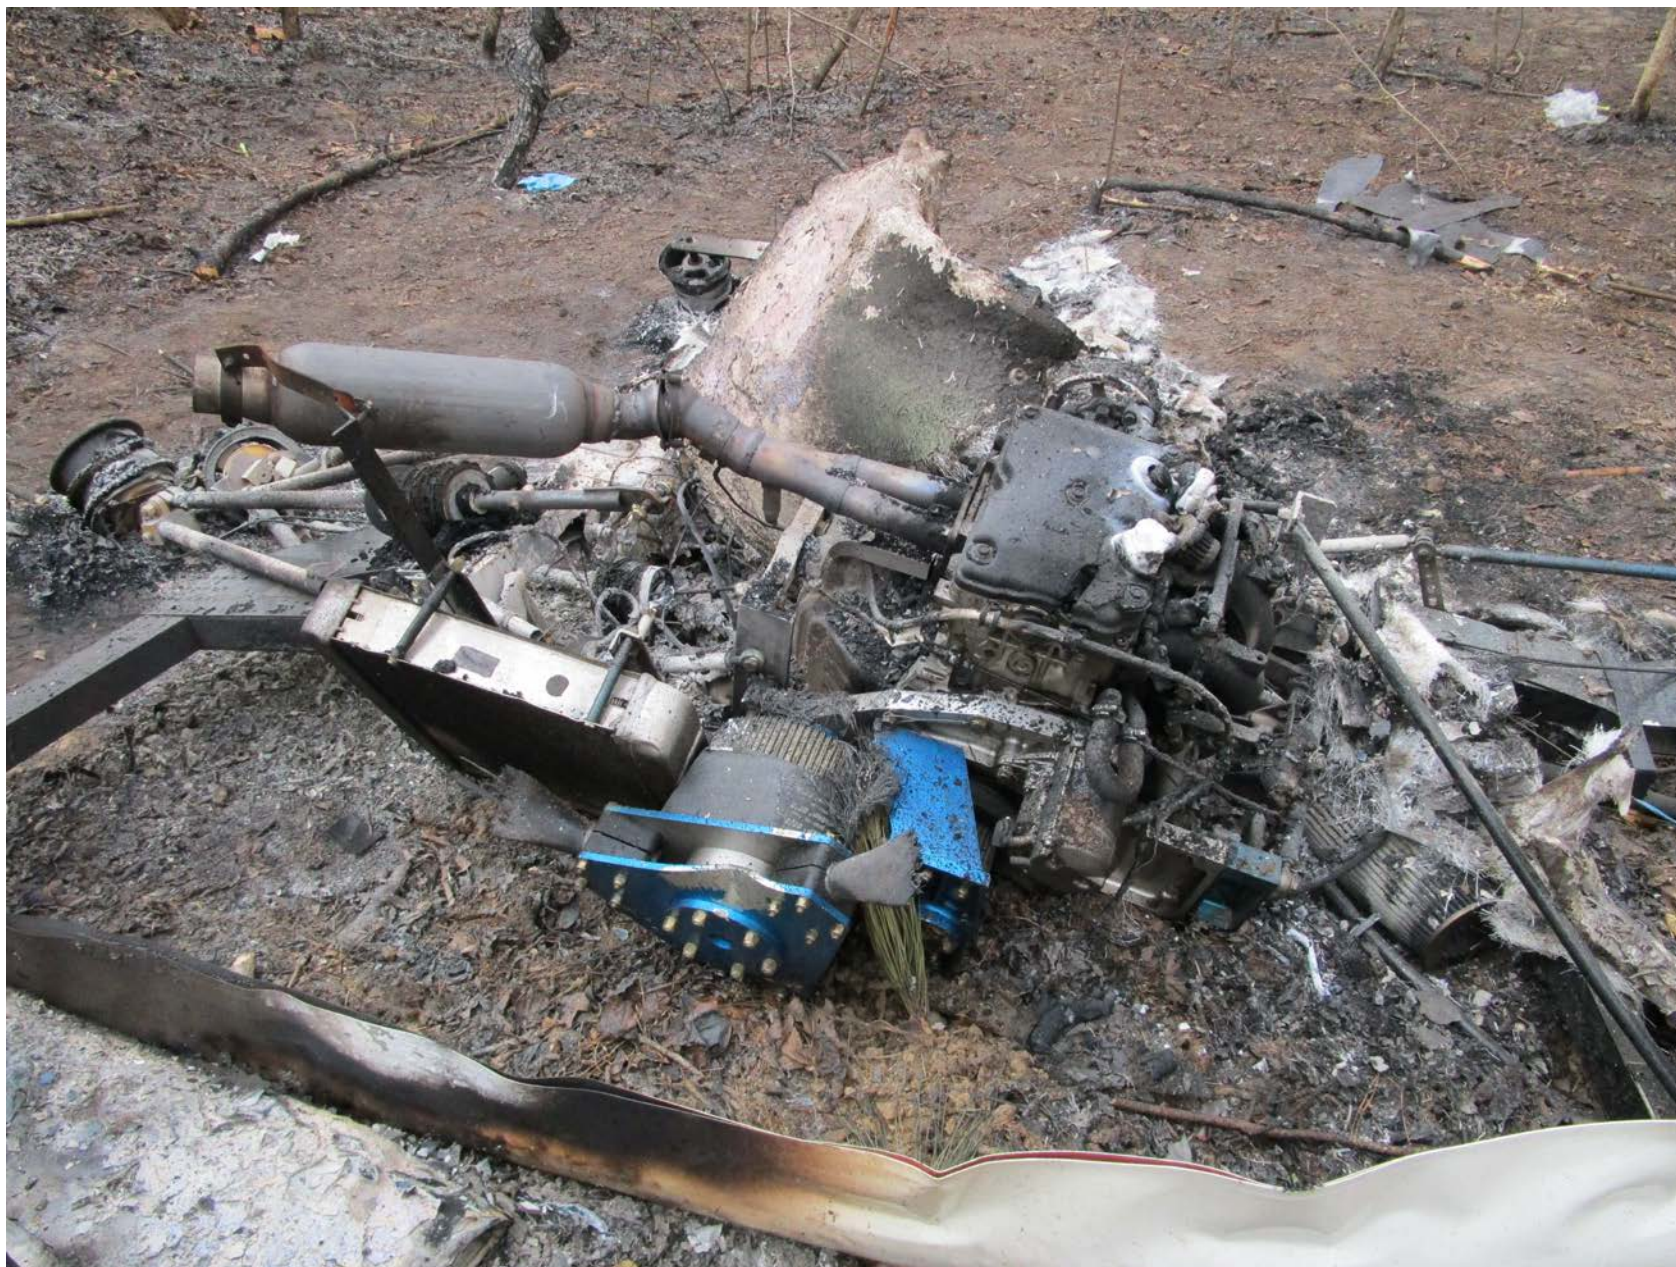
**Photo 4 – FAA Digital Photograph. View of the Heat Damaged Engine Assembly, Propeller Hub, 2 shattered Propeller Blades, and Section of Main Rotor Blade.**

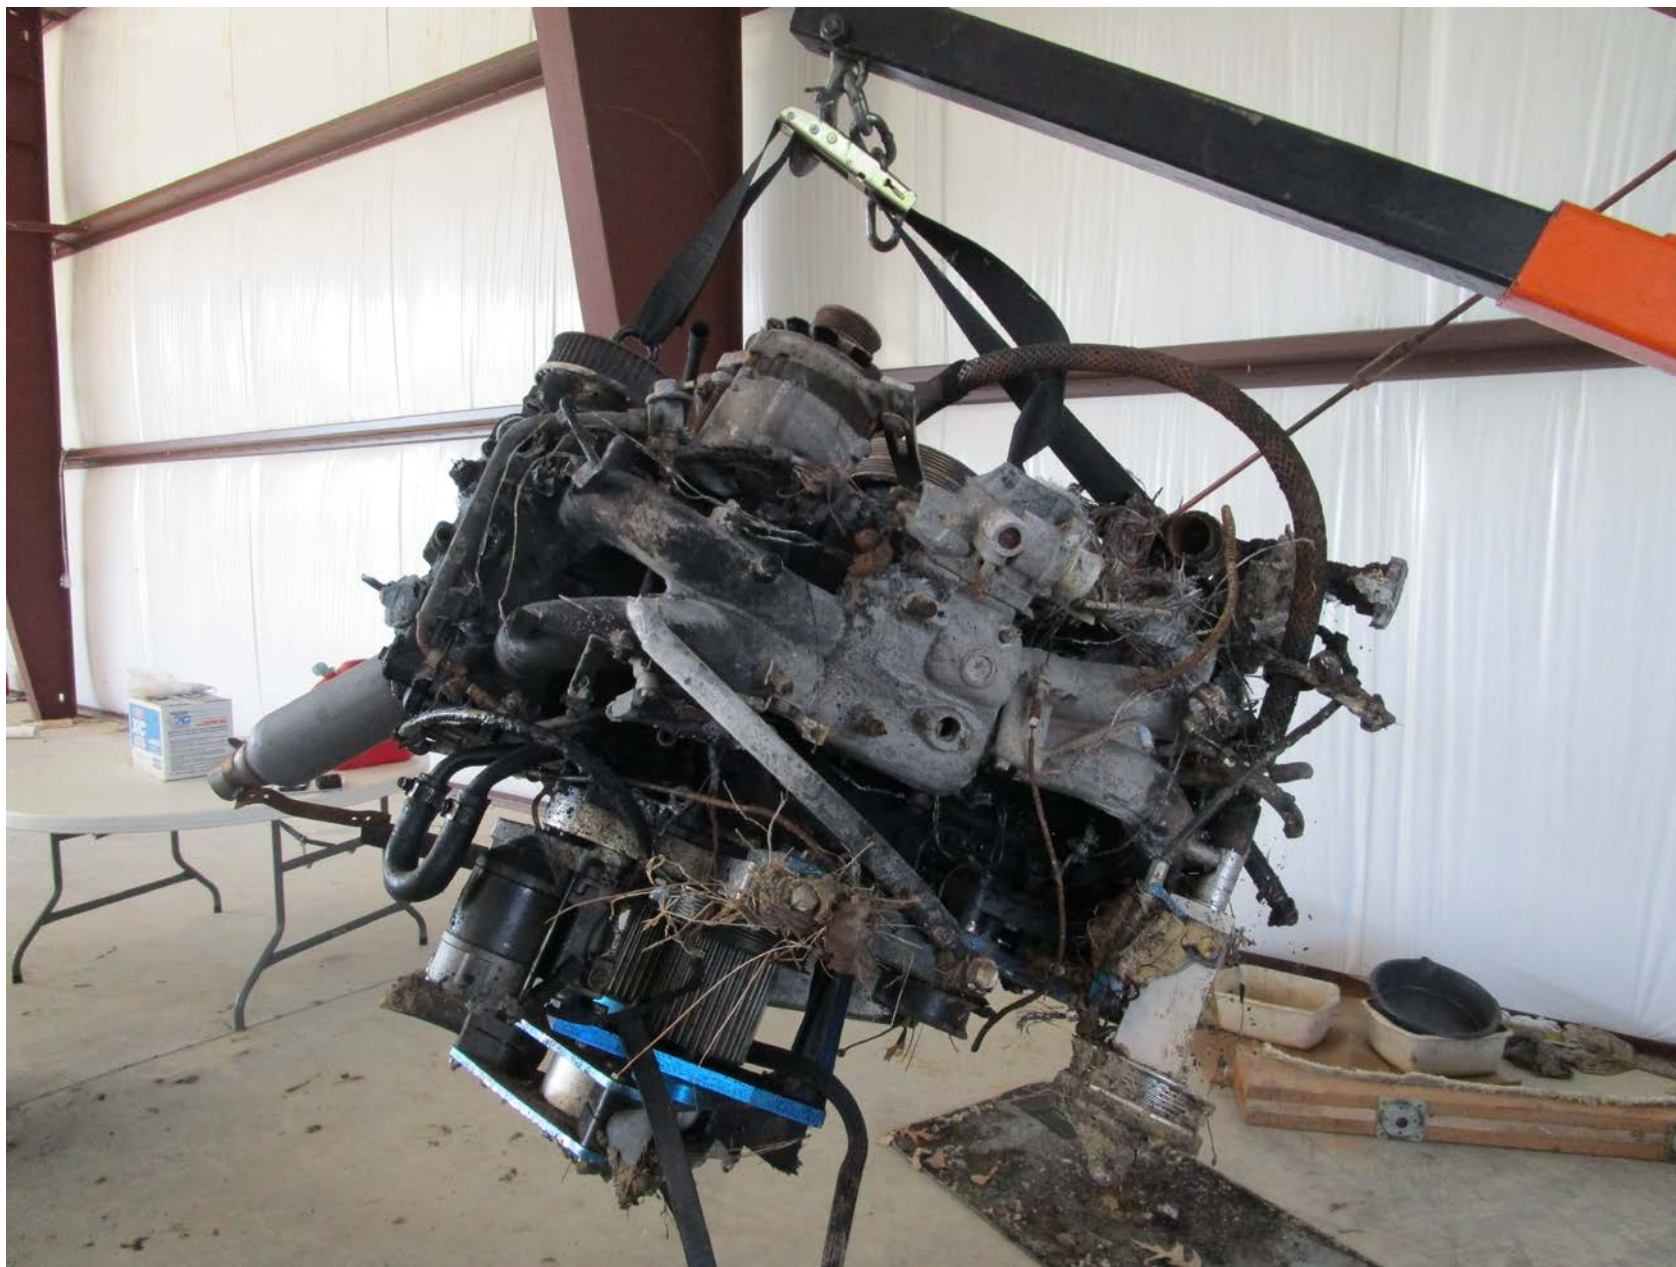
**Photo 5 – FAA Digital Photograph. View of the Engine Assembly During Engine Examination.**
