## **NATIONAL TRANSPORTATION SAFETY BOARD**

### **Weather Study**

# **METEOROLOGY**

ERA18LA119

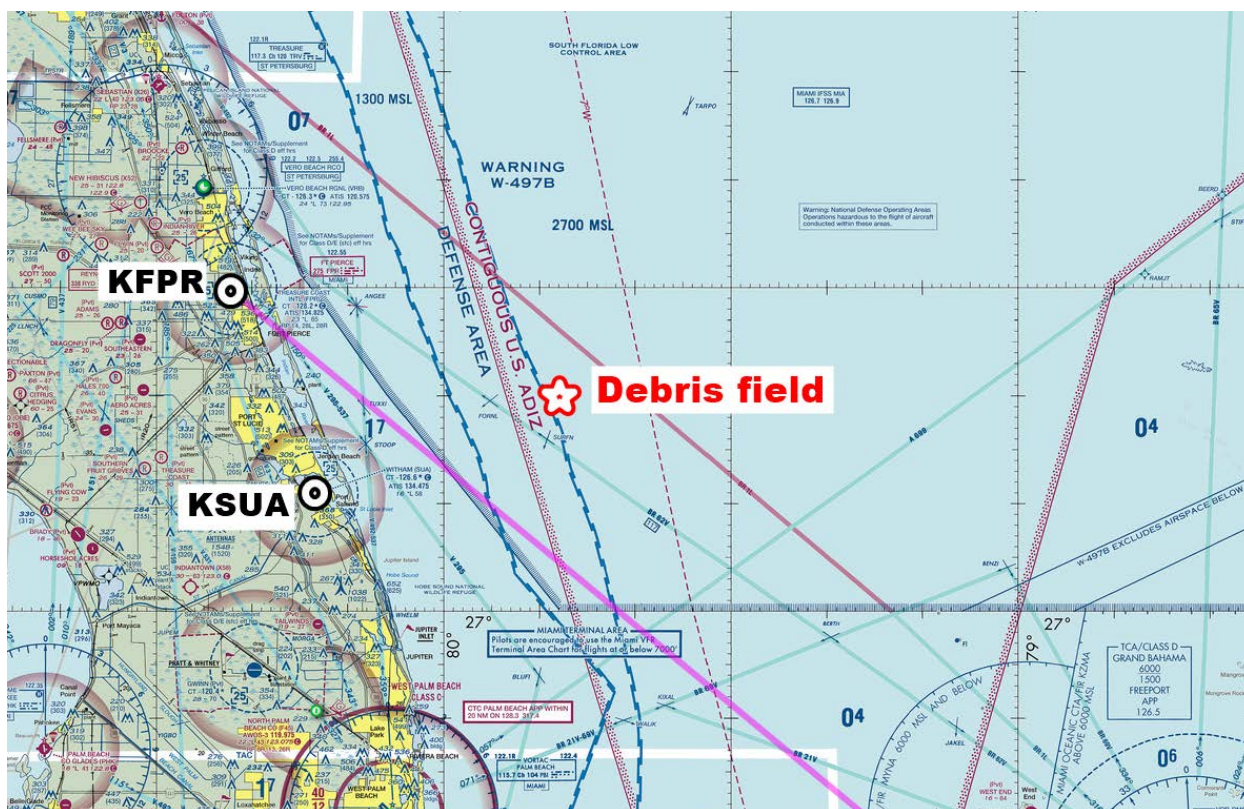
The area surrounding the accident site was documented using official Meteorological Aerodrome Reports (METARs) and Specials (SPECIs). Figure 8 is a sectional chart with the accident site and the closest weather reporting locations to the accident site marked.

**Figure 8 – Sectional chart of accident area with the location of the debris field, the closest surface observation sites, and the direct route of flight from departure to intended destination (pink line)**
