## **NATIONAL TRANSPORTATION SAFETY BOARD**

### **Group Chairman's Factual Report**

# **METEOROLOGY**

ERA18LA157

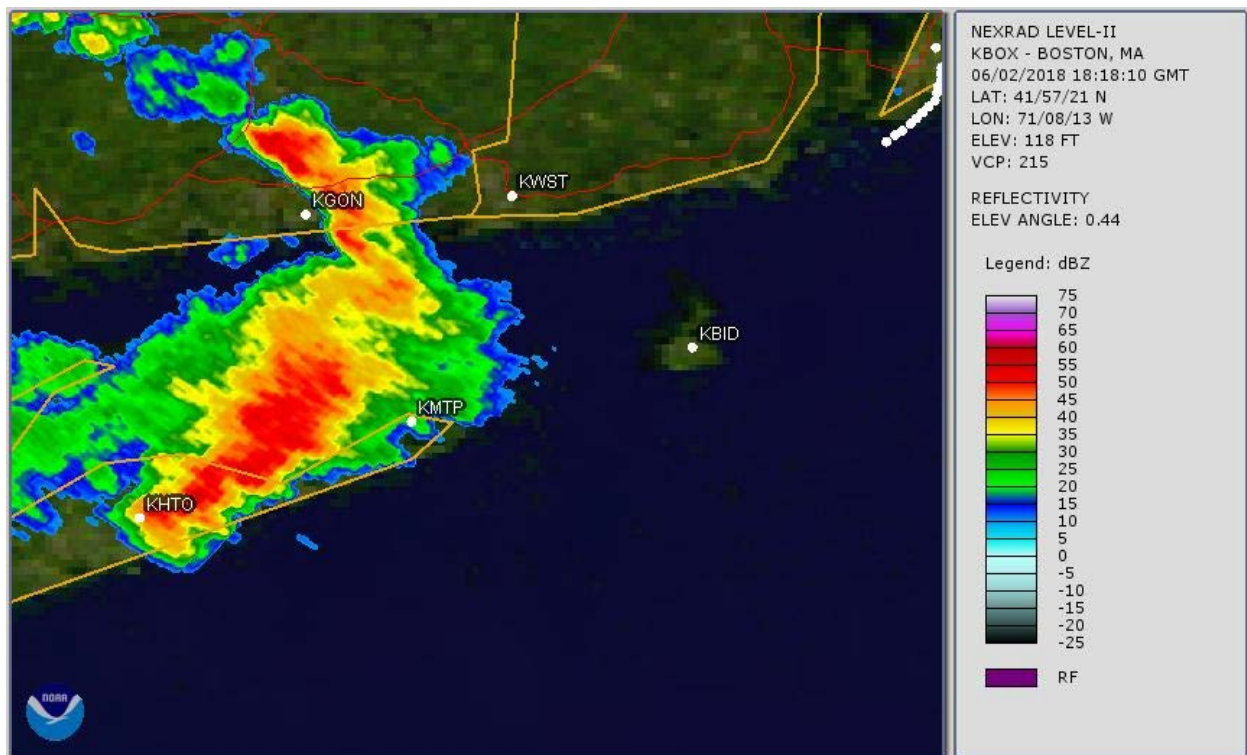
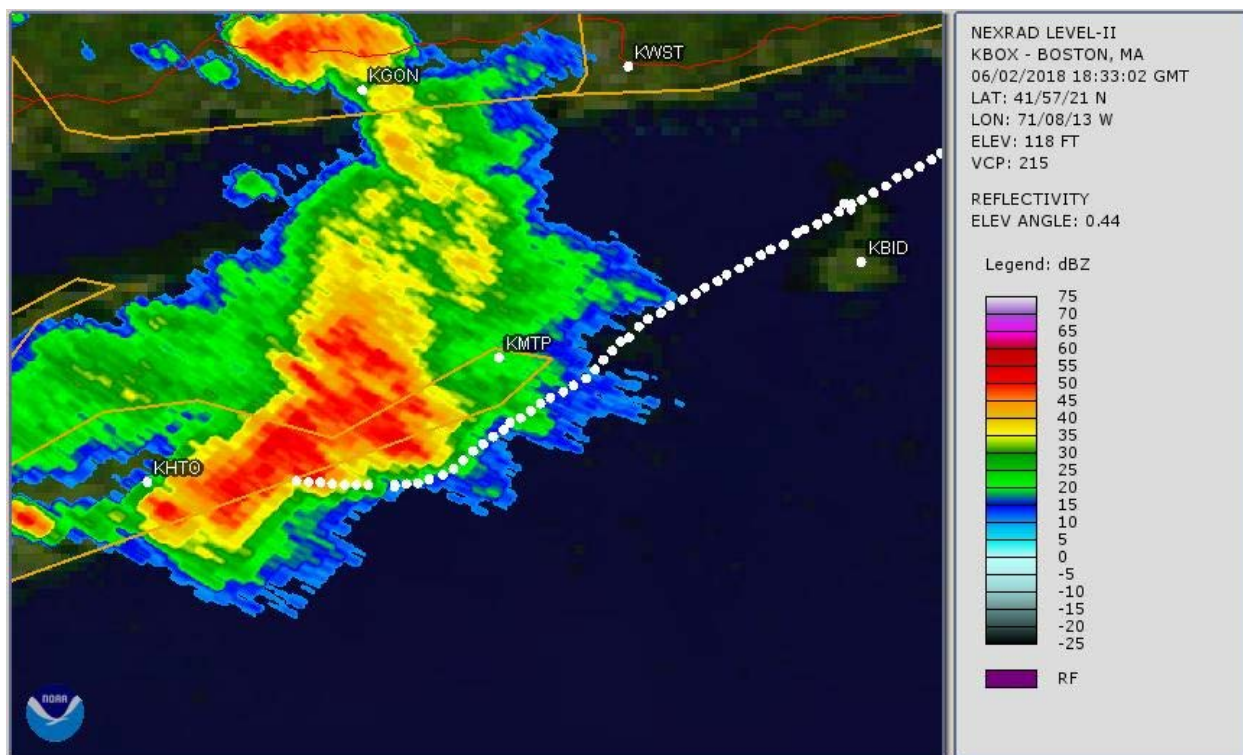
The KBOX WSR-88D 0.44° base reflectivity image for 1418, 1422, 1428, 1433, and 1438 EDT as figures 18 through 22. Echoes less than 10.0 dBZ have been removed from the images. The FAA flight track data obtained from the NTSB ATC Specialist for the period of the radar scan has also been added. The radar images depict a large multicellular cluster of thunderstorms about 30 miles long and 20 miles wide moving southward at around 10 knots. The accident airplanes flight track is observed approaching the area from the west and southwest, and then enters under the leading edge of the echoes with a maximum of 53.0 dBZ “extreme” intensity echo along the track where echo tops near 48,000 ft. The extreme intensity echoes over 50.0 dBZ extended between the accident site and KHTO by 1438 EDT.

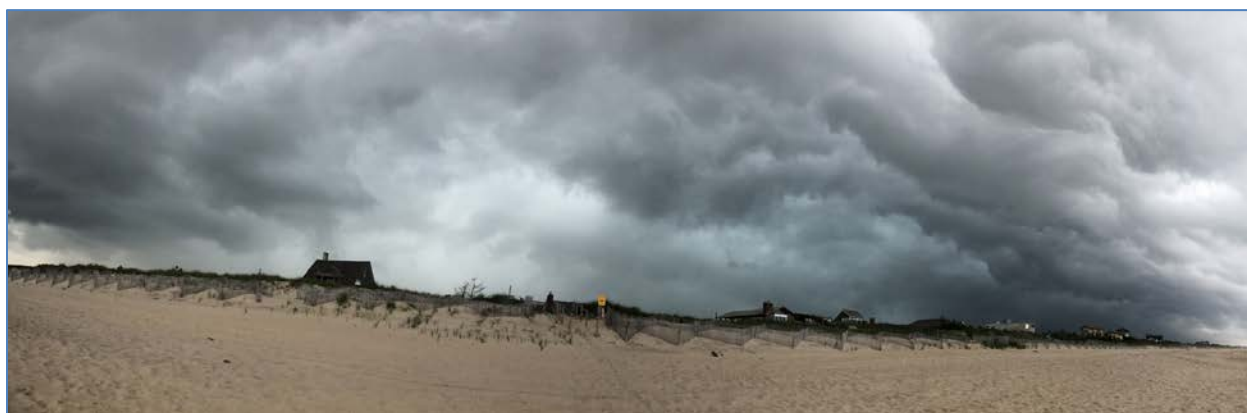
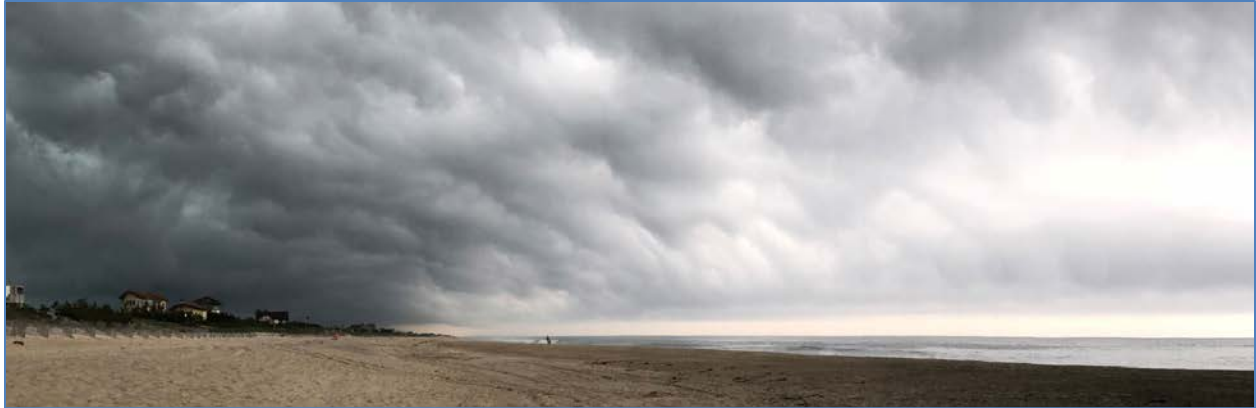
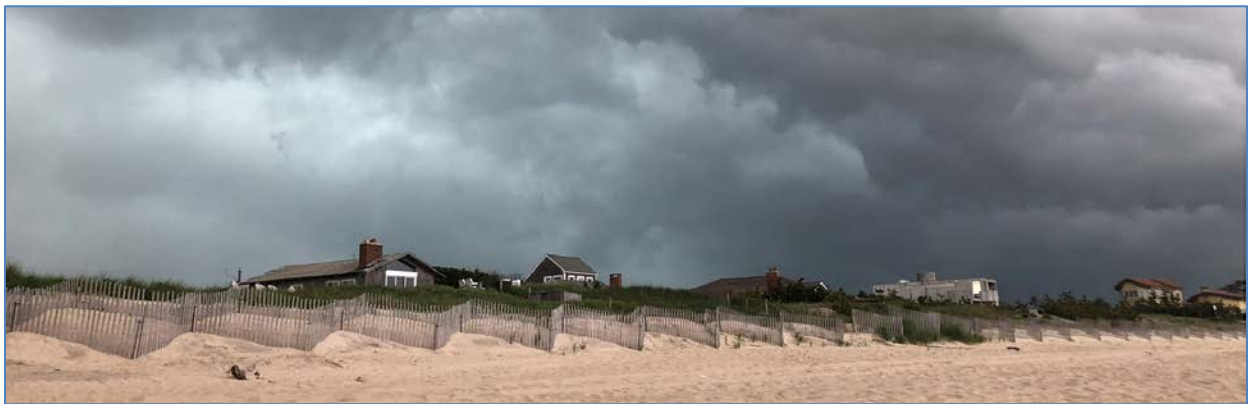
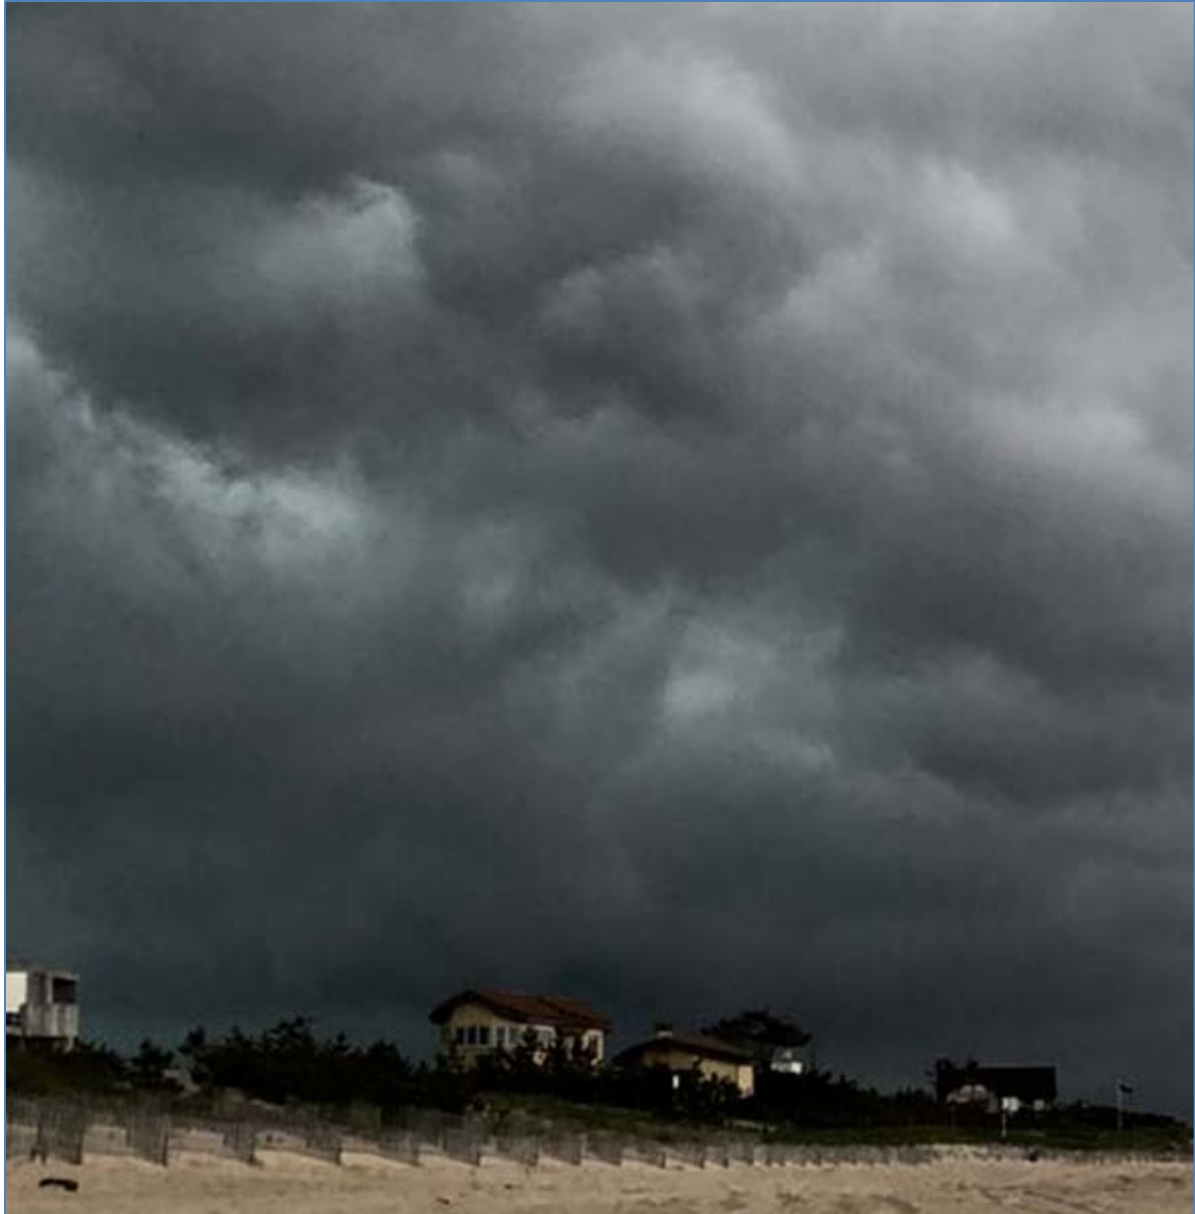
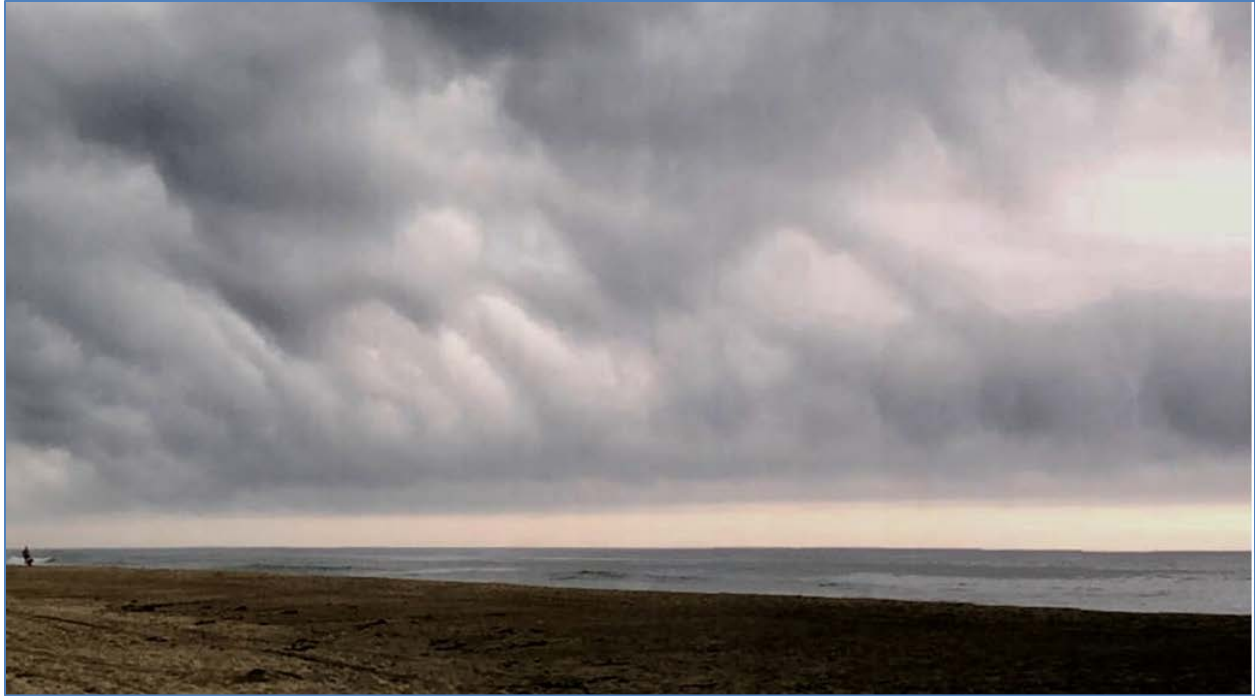
The attached photographs (figures 40 through 44) were taken by the witness at 1421 EDT on June 2, 2018 who was on the beach approximately one block east of Atlantic Avenue in Amagansett, as he was heading home due to the approaching storm clouds. The witness stated that when he arrived home around 1530 EDT, he went to check the local NWS weather radar at Upton, NY, to see what was happening and across the top of the radar display it indicated “down for maintenance”. A short time later he received an alert on his phone that a plane had gone down in the area, just off of Indian Wells Beach a short distance away.

**Figure 40 - Witness photograph of storm clouds approaching Amagansett looking north**

**Figure 41 - Witness photograph of storm clouds looking up the coast to the east-northeast**

**Figure 42 - Witness photograph again looking north**

**Figure 43 - Witness photograph looking North at Indian Wells Beach**

**Figure 44 - Witness photograph looking south to southeast on Indian Wells Beach**
