## **NATIONAL TRANSPORTATION SAFETY BOARD**

### **Weather Study**

ERA18LA164

Location: Daytona Beach, Florida  
Date: June 9, 2018  
Time: 1500 eastern daylight time  
1900 Coordinated Universal Time (UTC)  
Aircraft: Piper PA-44-180, Registration: N21161

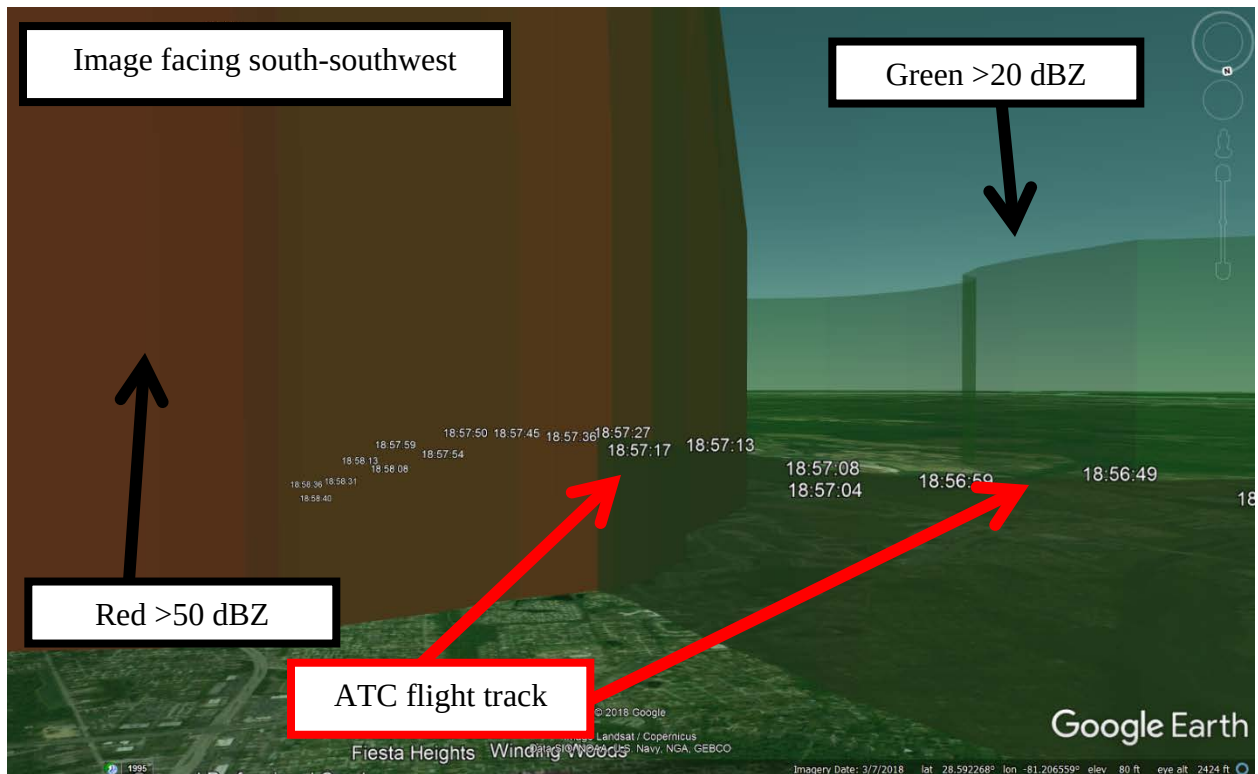
**Figure 20 – 3-dimensional KMLB WSR-88D base reflectivity from the scan initiated at 1457 EDT and the ATC Flight Track (gray dots) with the image facing south-southwest**

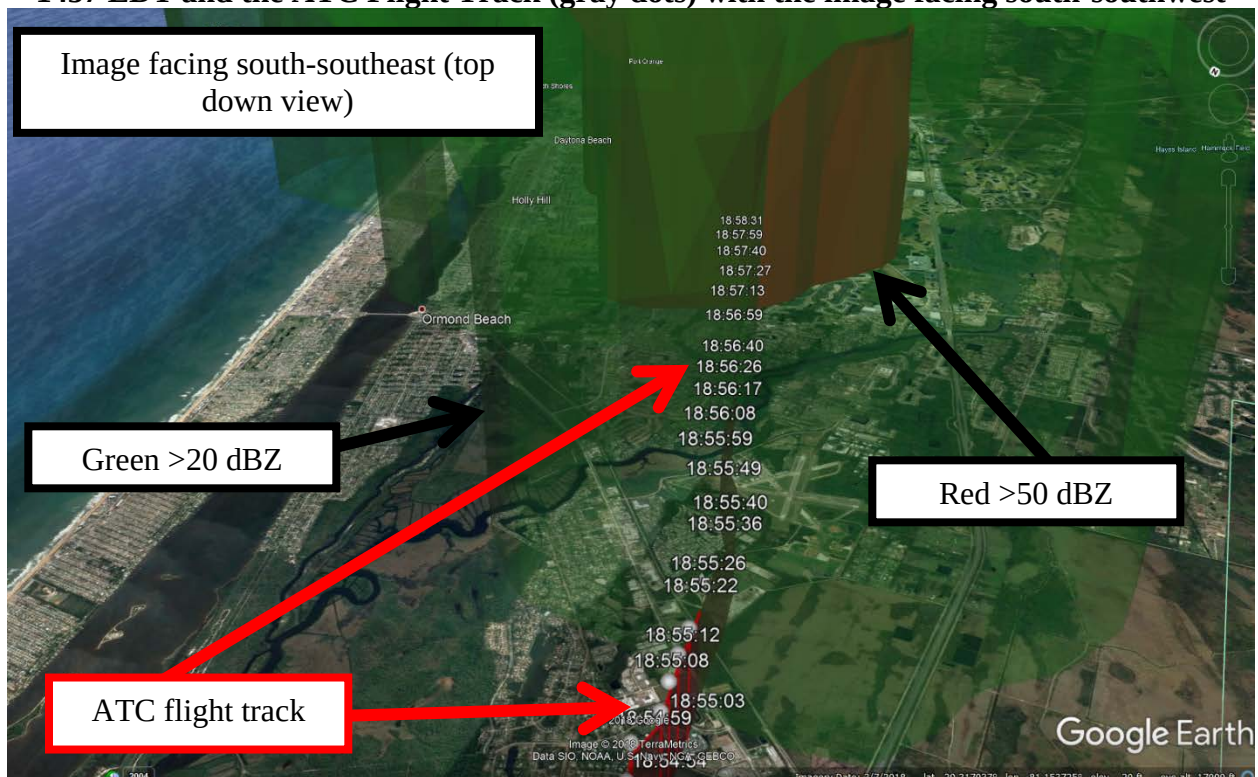
**Figure 21 – 3-dimensional KMLB WSR-88D base reflectivity from the scan initiated at 1457 EDT and the ATC Flight Track (gray dots) with the image facing south-southeast**
