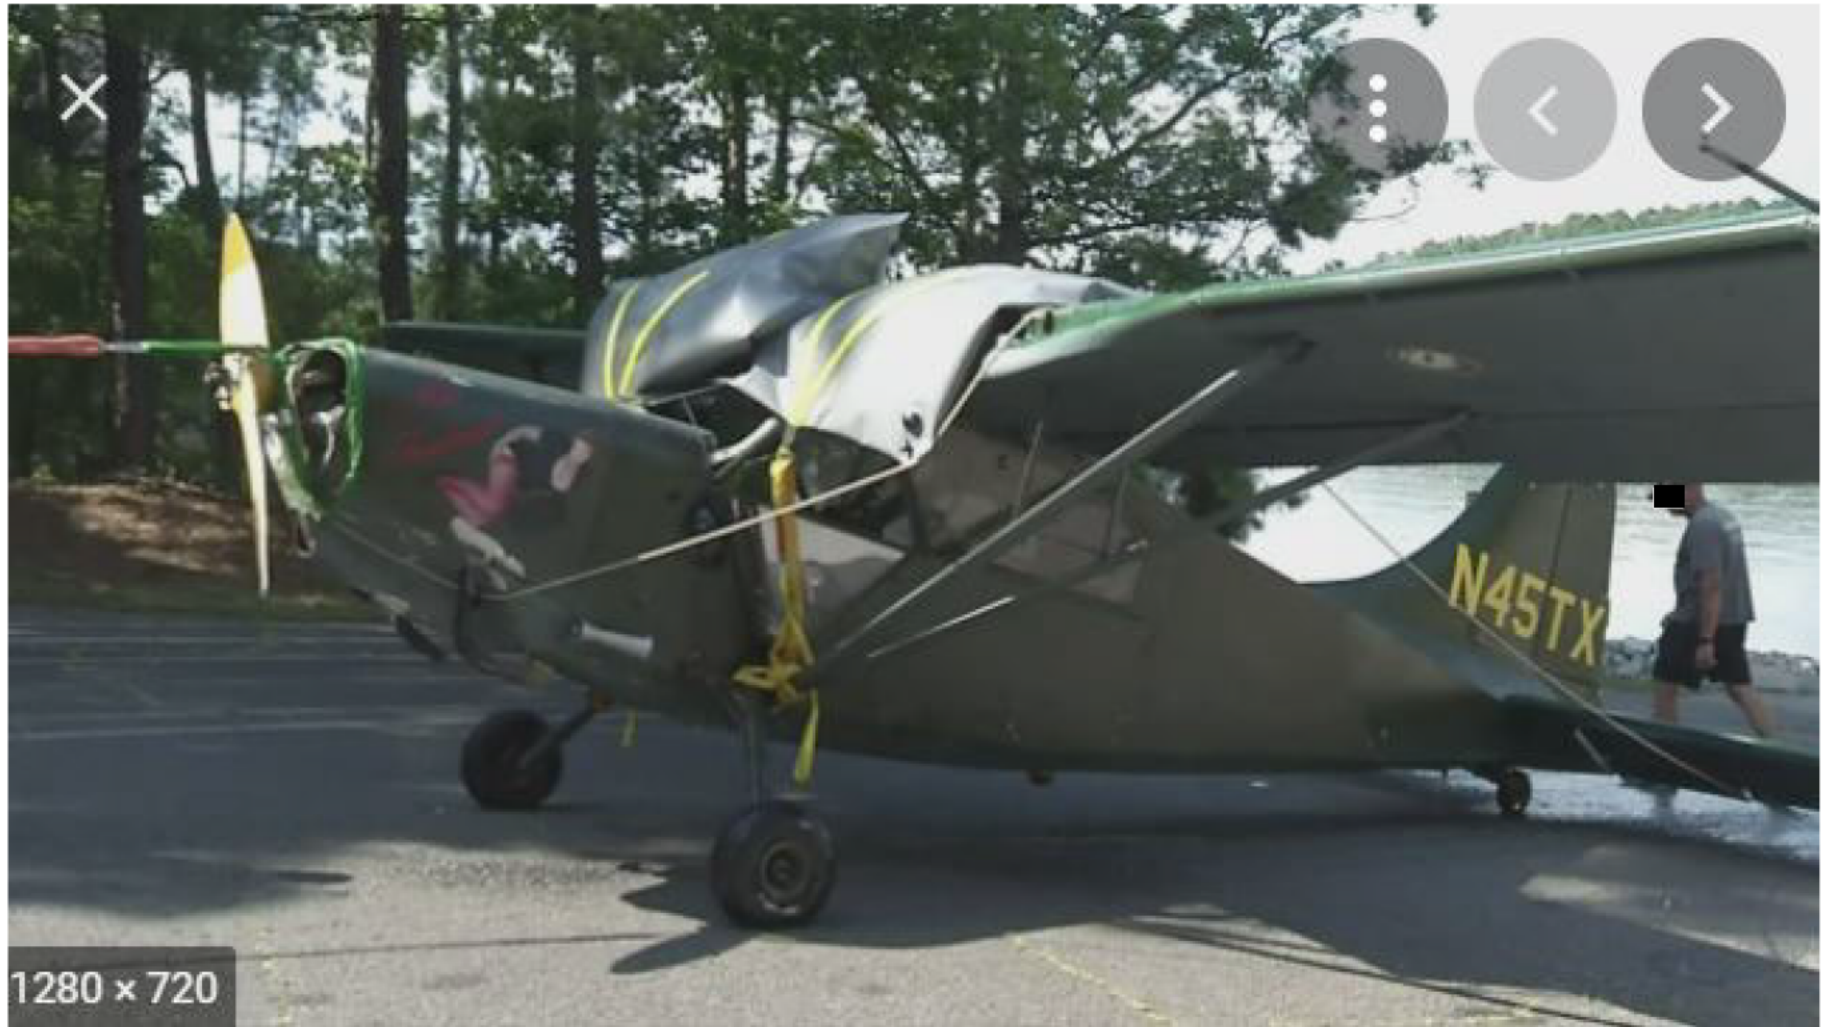
**Photo 1 – View of airplane after recovery from lake. (Courtesy of WJBF News)**

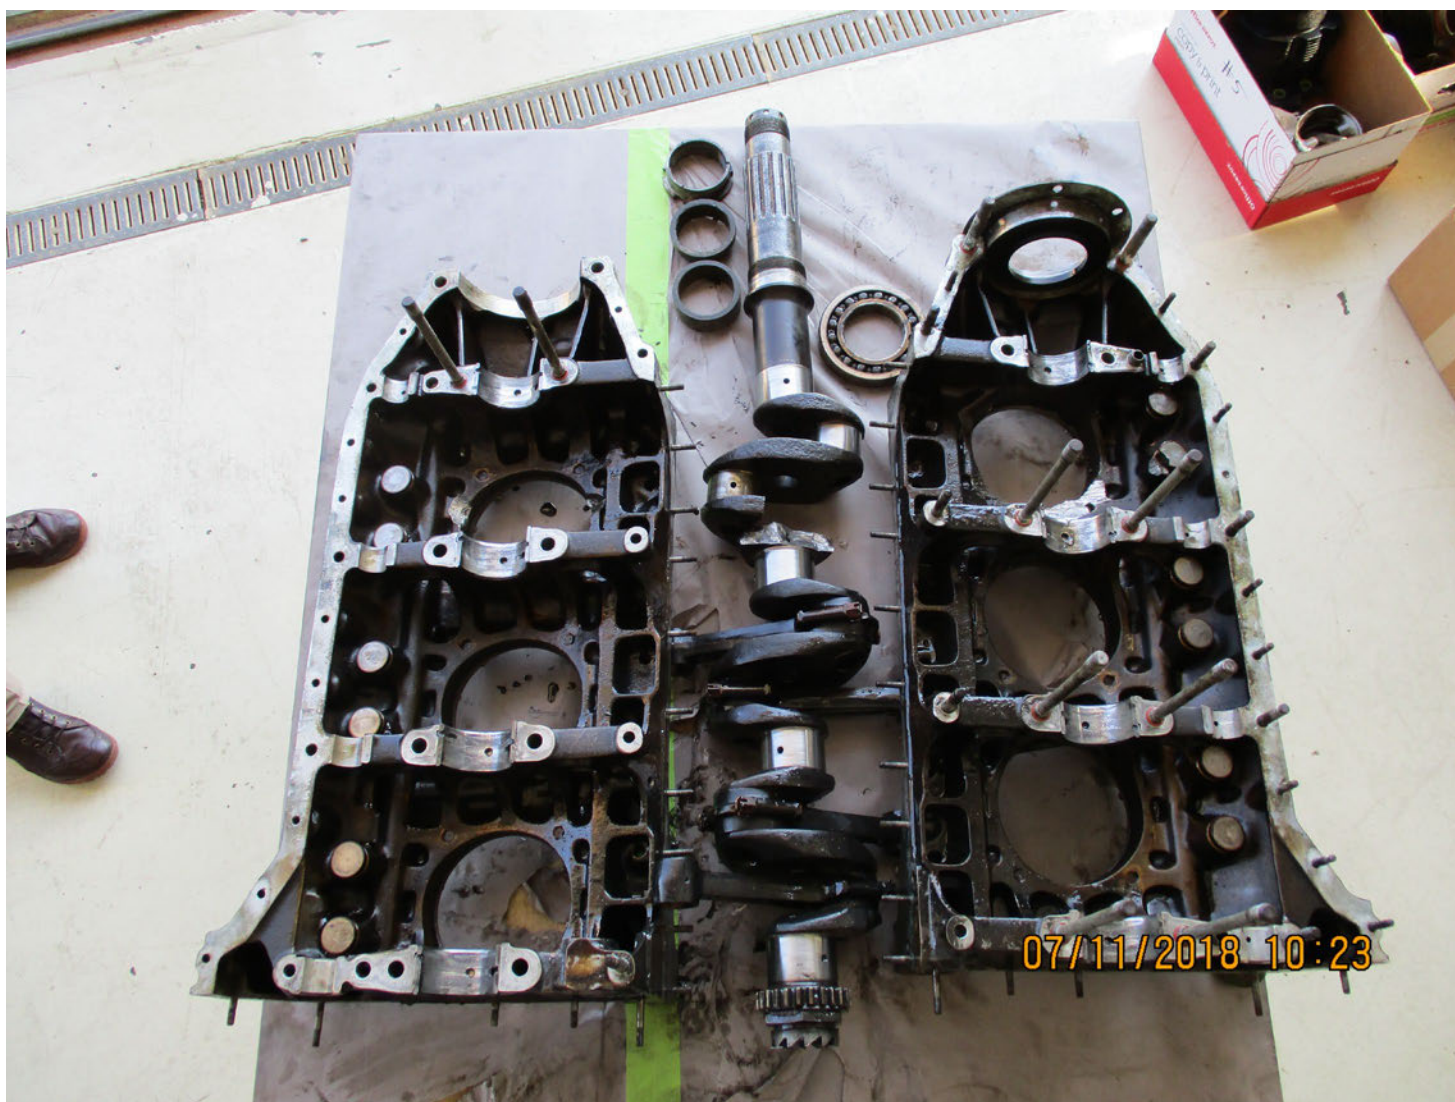
**Photo 2 – View of open engine crankcase. Note fractured crankshaft. (Courtesy of FAA)**

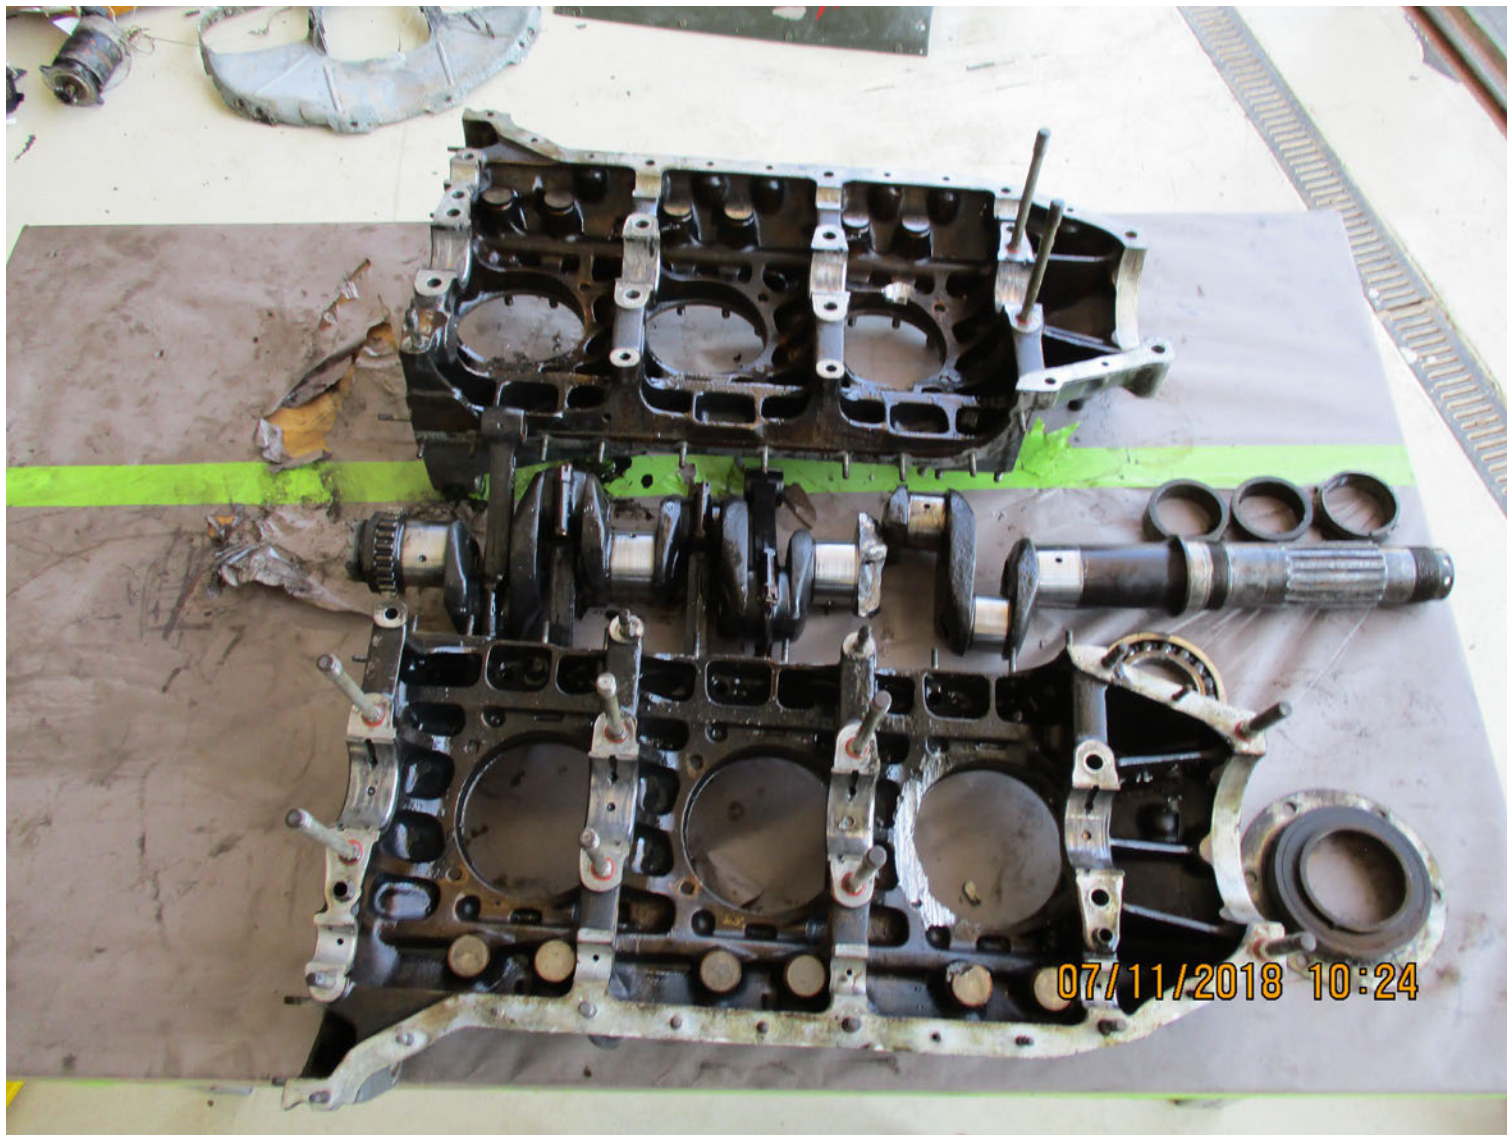
**Photo 3 – Horizontal view of engine crankcase and fractured crankshaft. (Courtesy of FAA)**
