**Photo 1 – FAA Digital Photograph. Right Forward Quartering View of the Resting Position of the Airplane.**

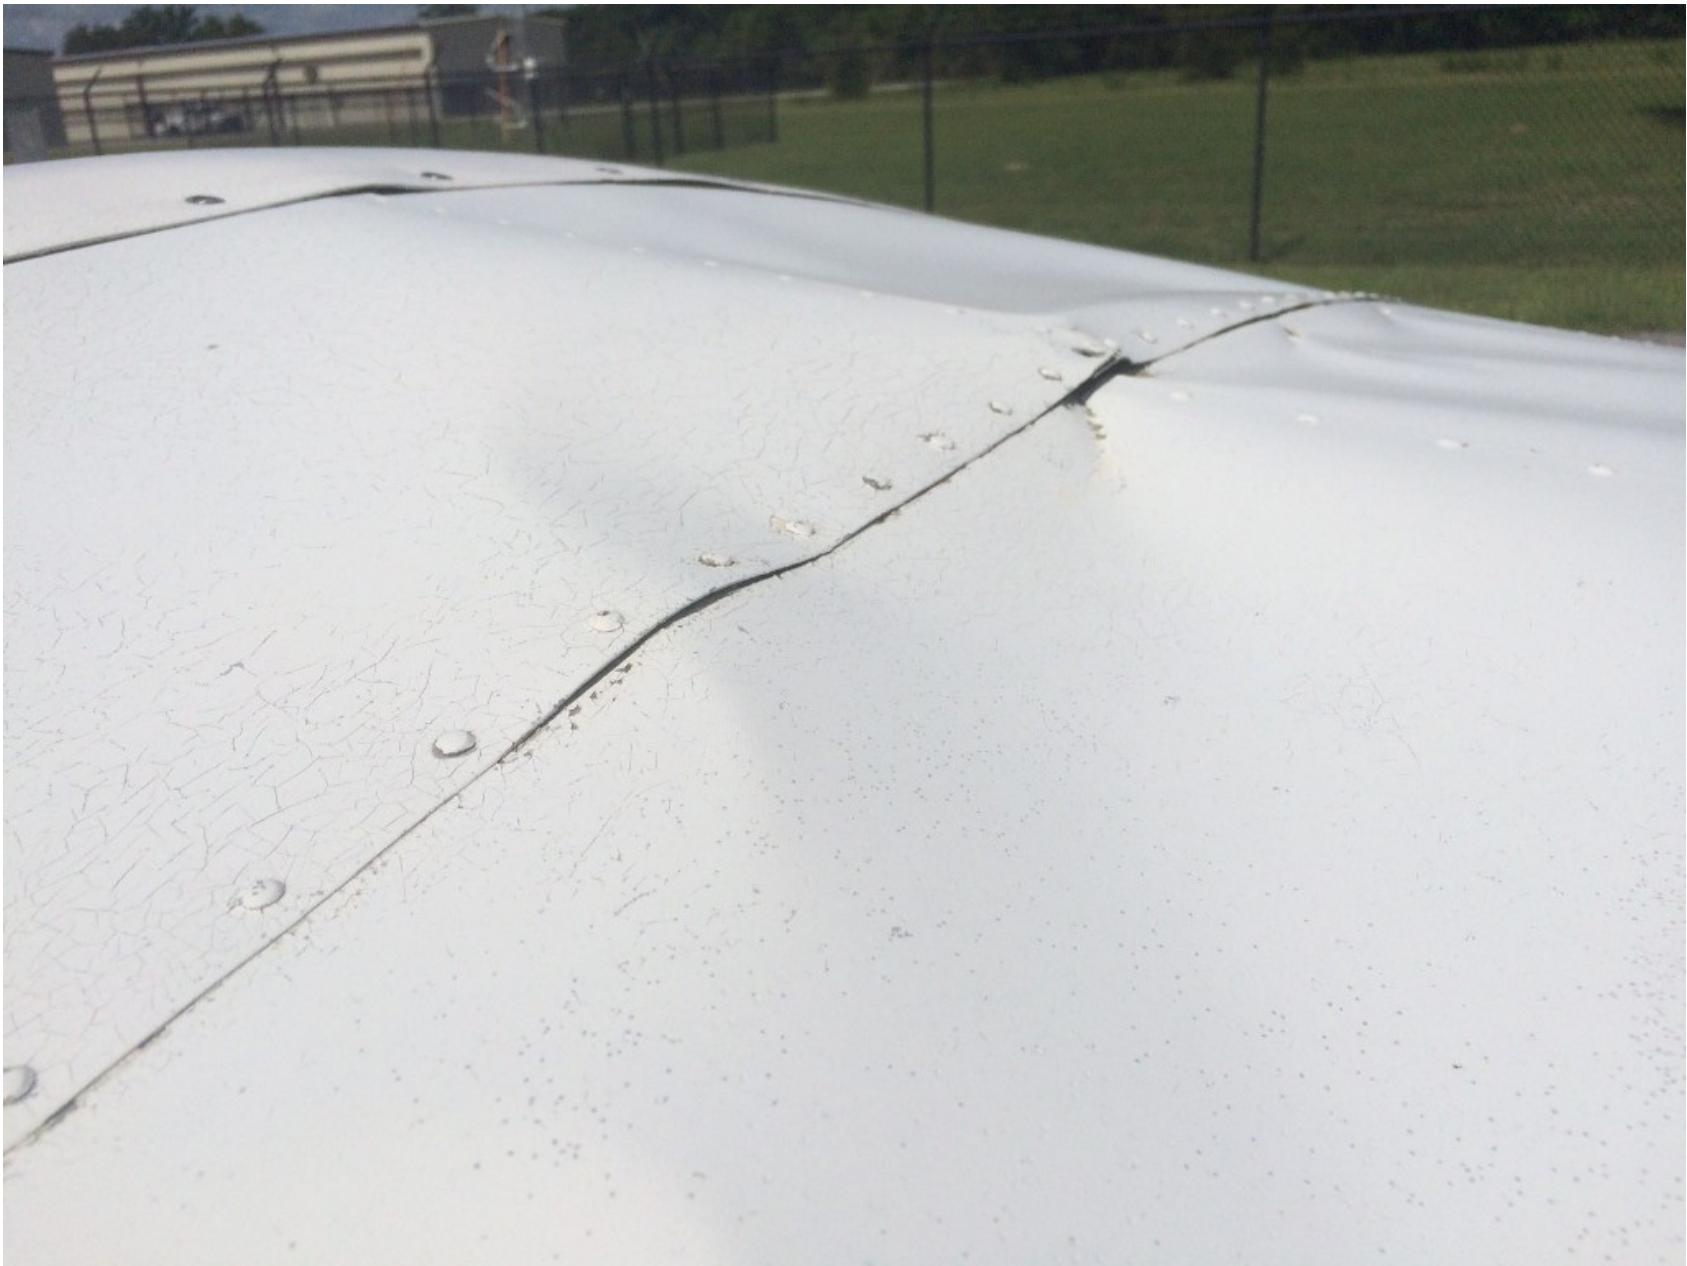
**Photo 2 - FAA Digital Photograph. View Depicting the Damage to the Outer Section of the Right Wing.**

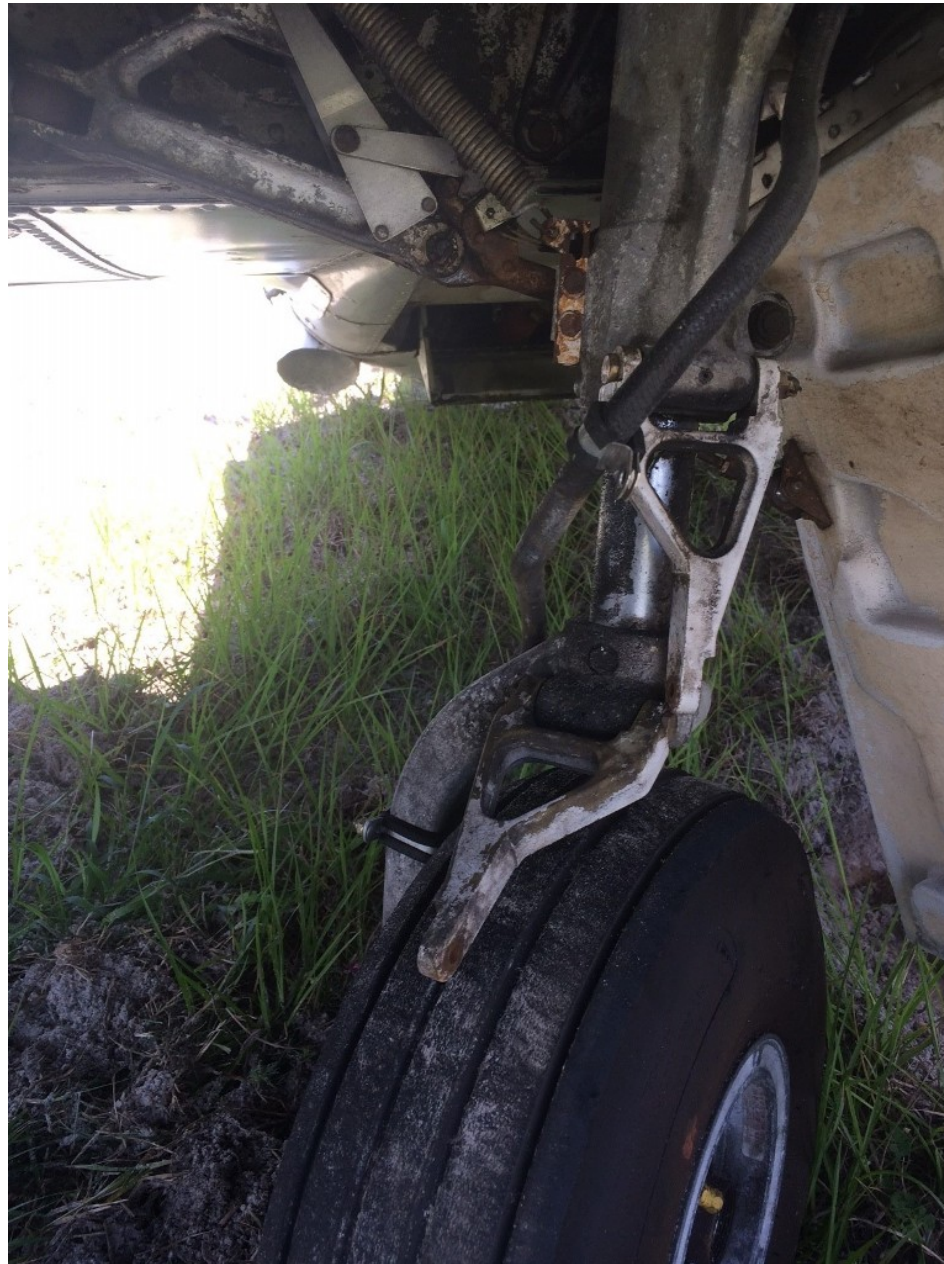
**Photo 3 - FAA Digital Photograph. View Depicting the Separated Upper and Lower Undamaged Torque Links of the Right Main Landing Gear**
