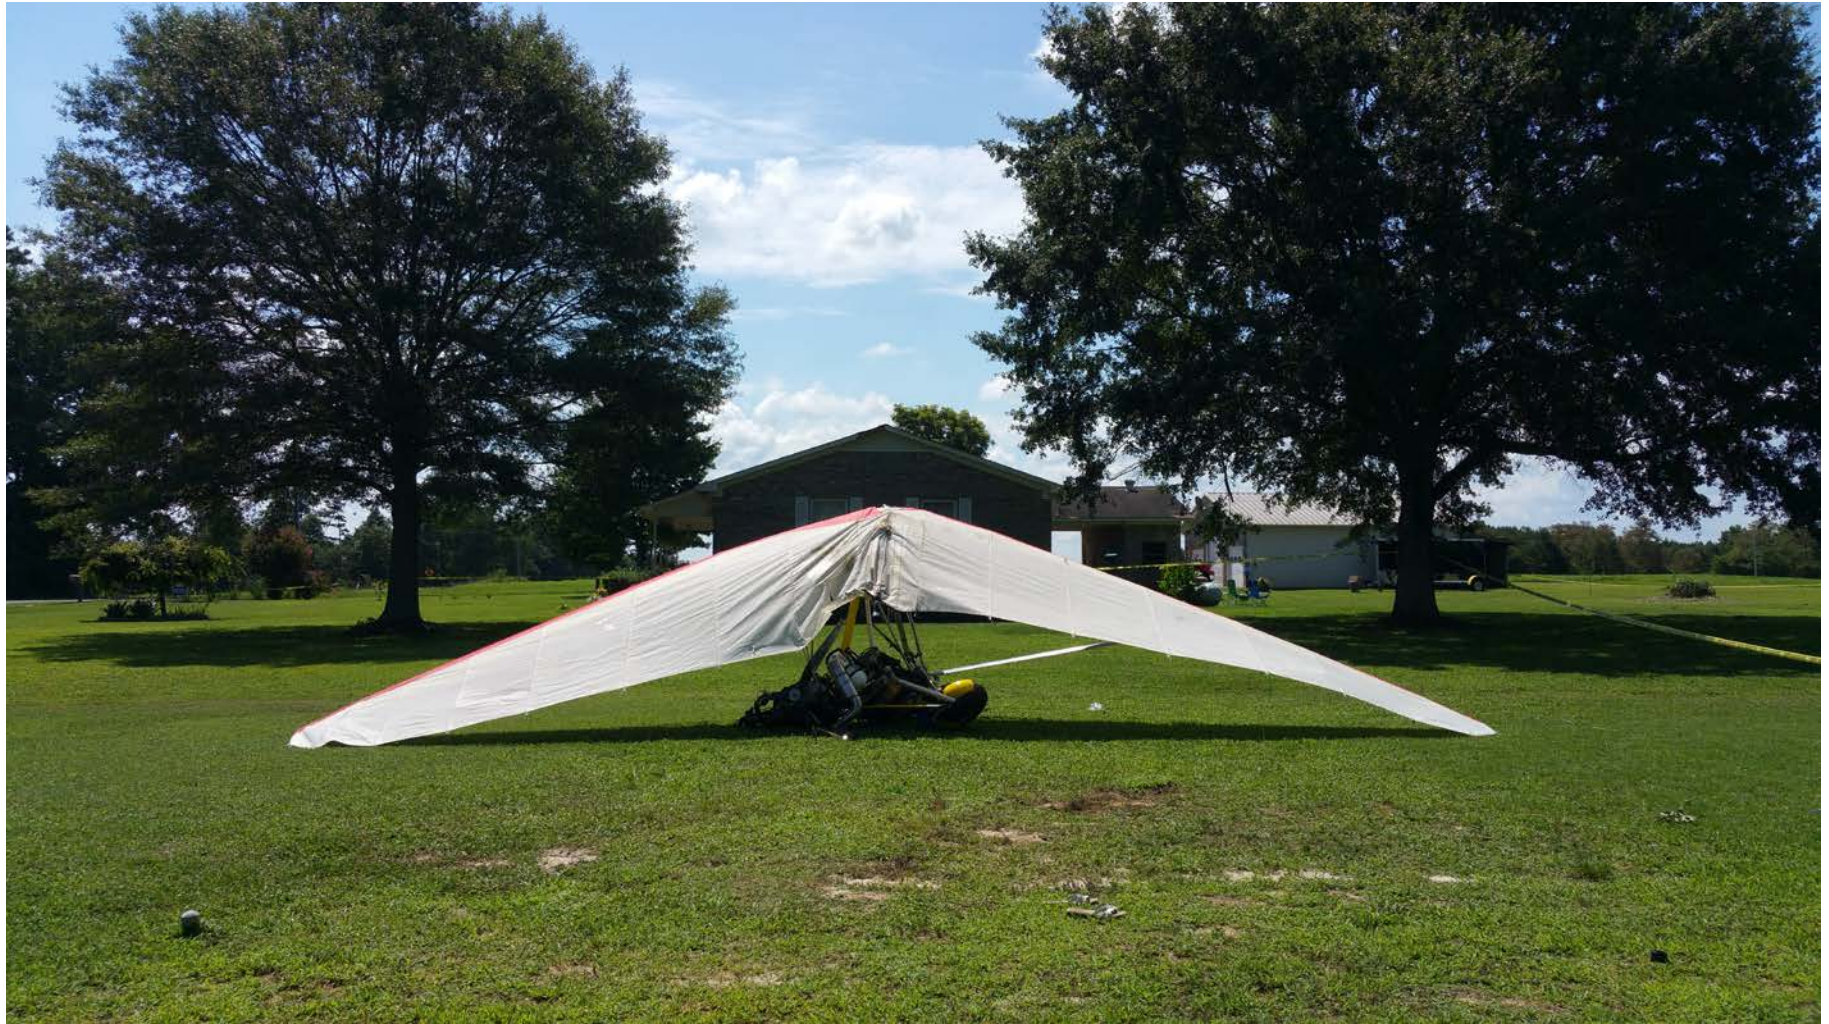
**Photo 1 – Photograph of wreckage and accident site. (Courtesy of FAA)**

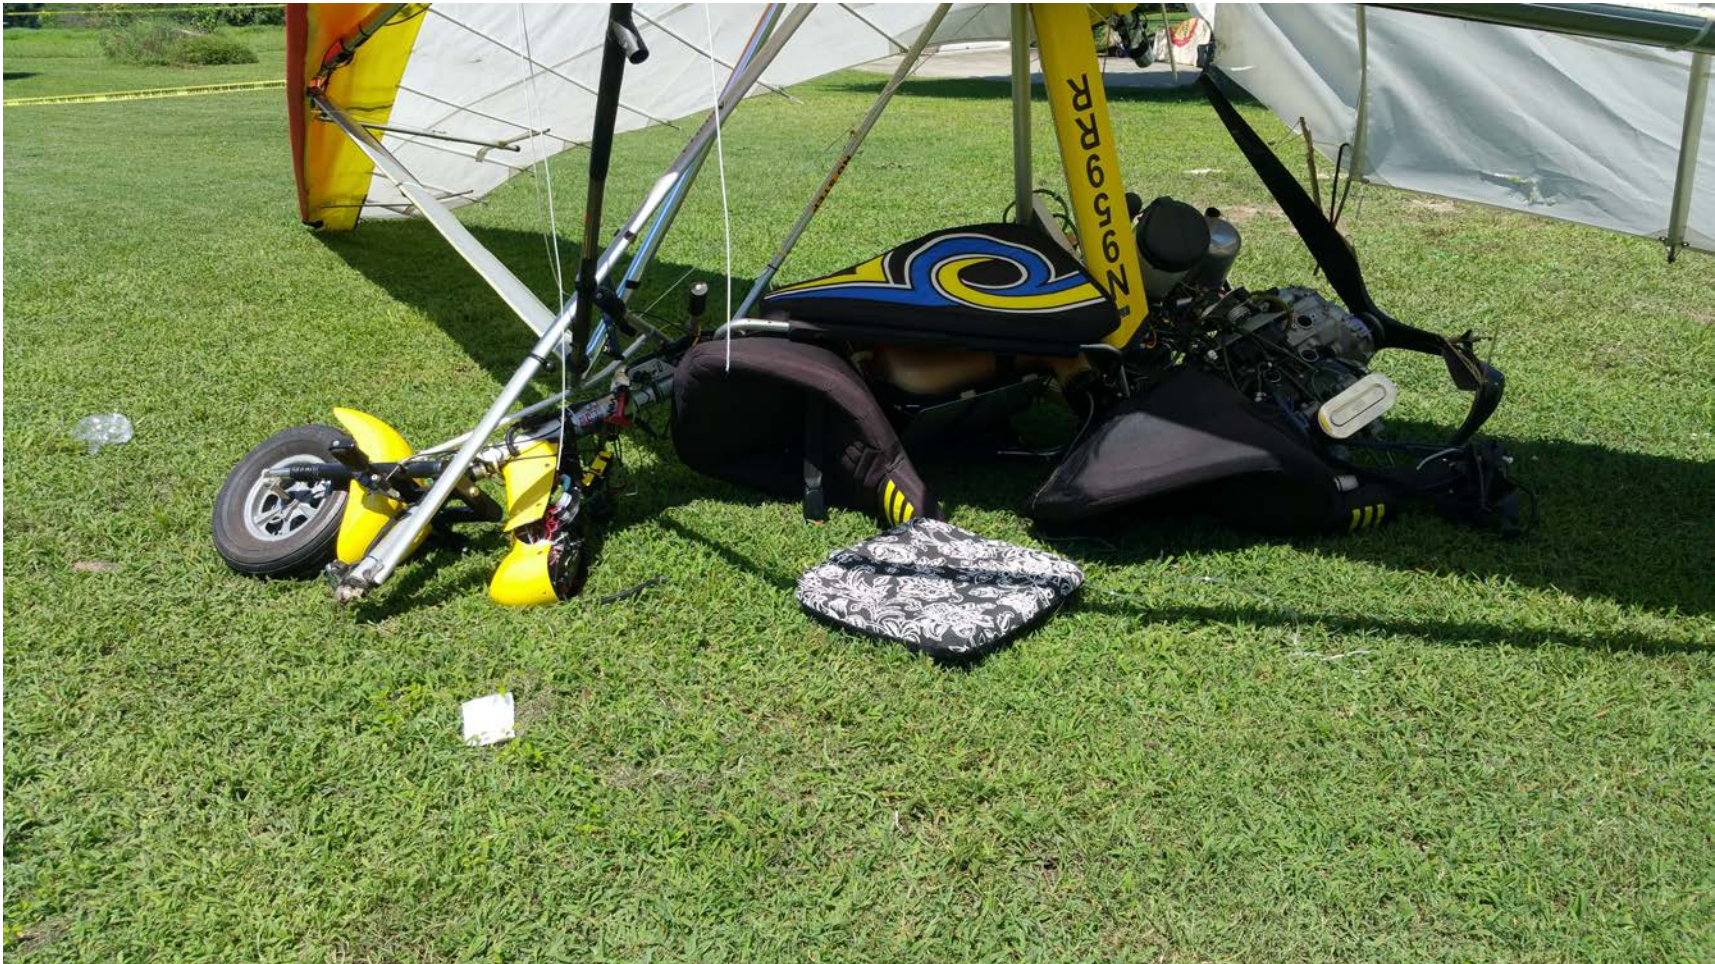
**Photo 2 – Photograph of wreckage showing cockpit seat resting on its left side. (Courtesy of FAA)**

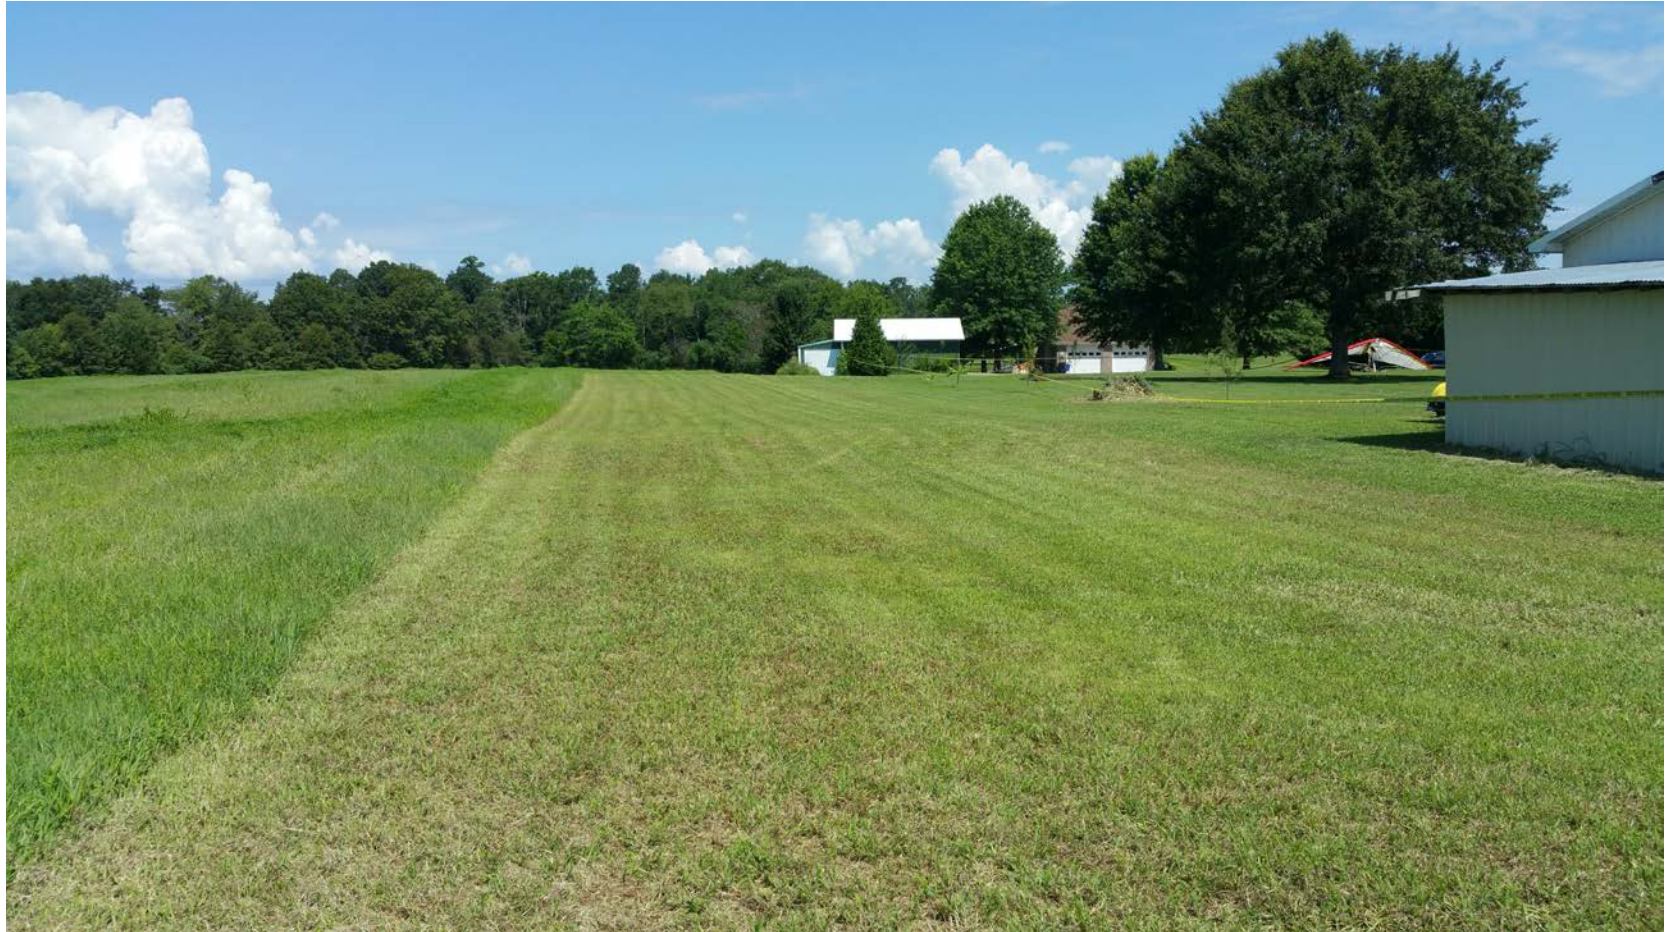
**Photo 3 – Photograph of runway looking northwest. Note large tree and wreckage in background. (Courtesy of FAA)**

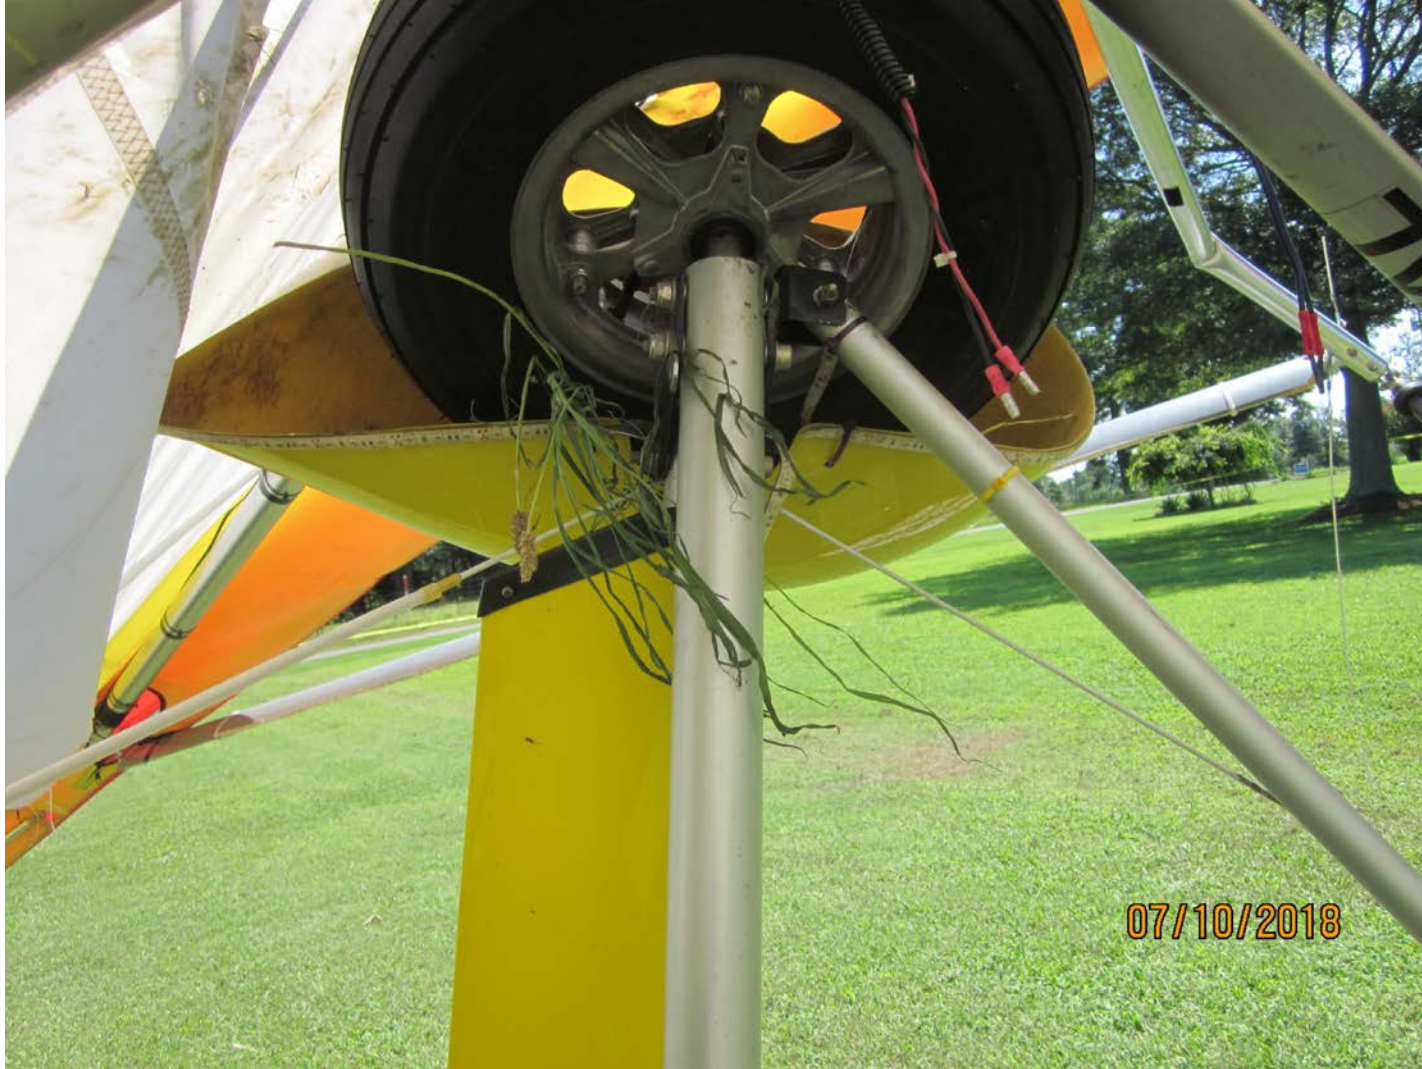
**Photo 4 – Grass wrapped around landing gear. (Courtesy of FAA)**

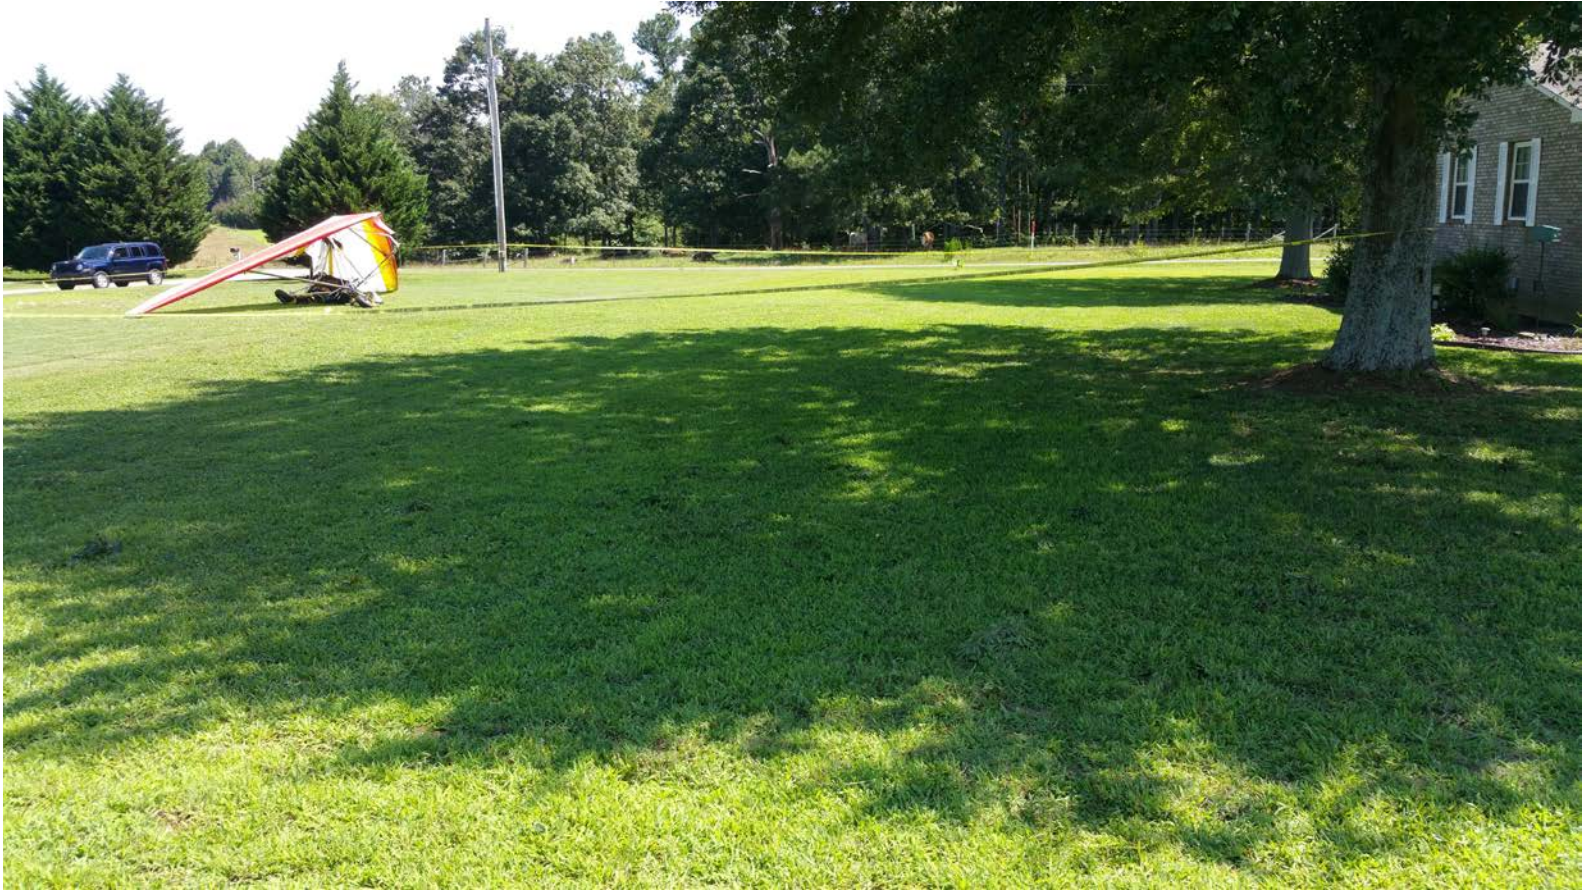
**Photo 5 – Tree with broken branches on ground near accident site. (Courtesy of FAA)**

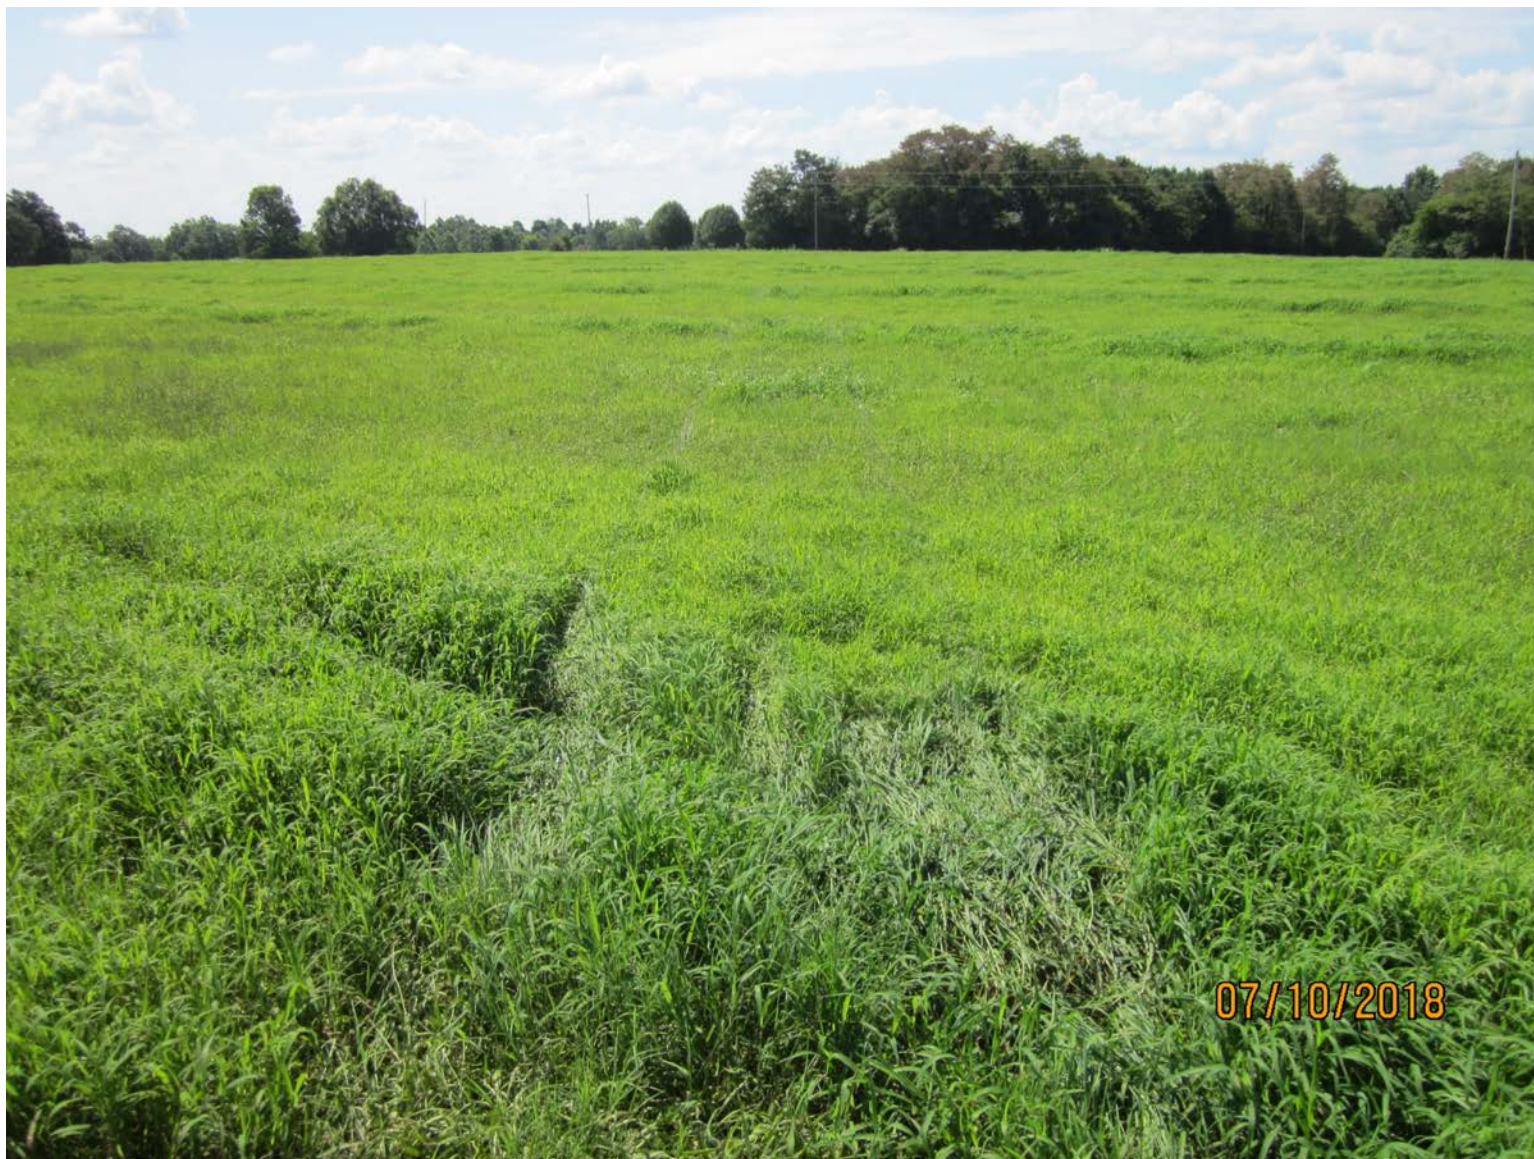
**Photo 6 – Landing gear wheel tracks in grass bordering runway looking southeast. Grass is the same type that was found wrapped around landing gear. (Courtesy of FAA)**
