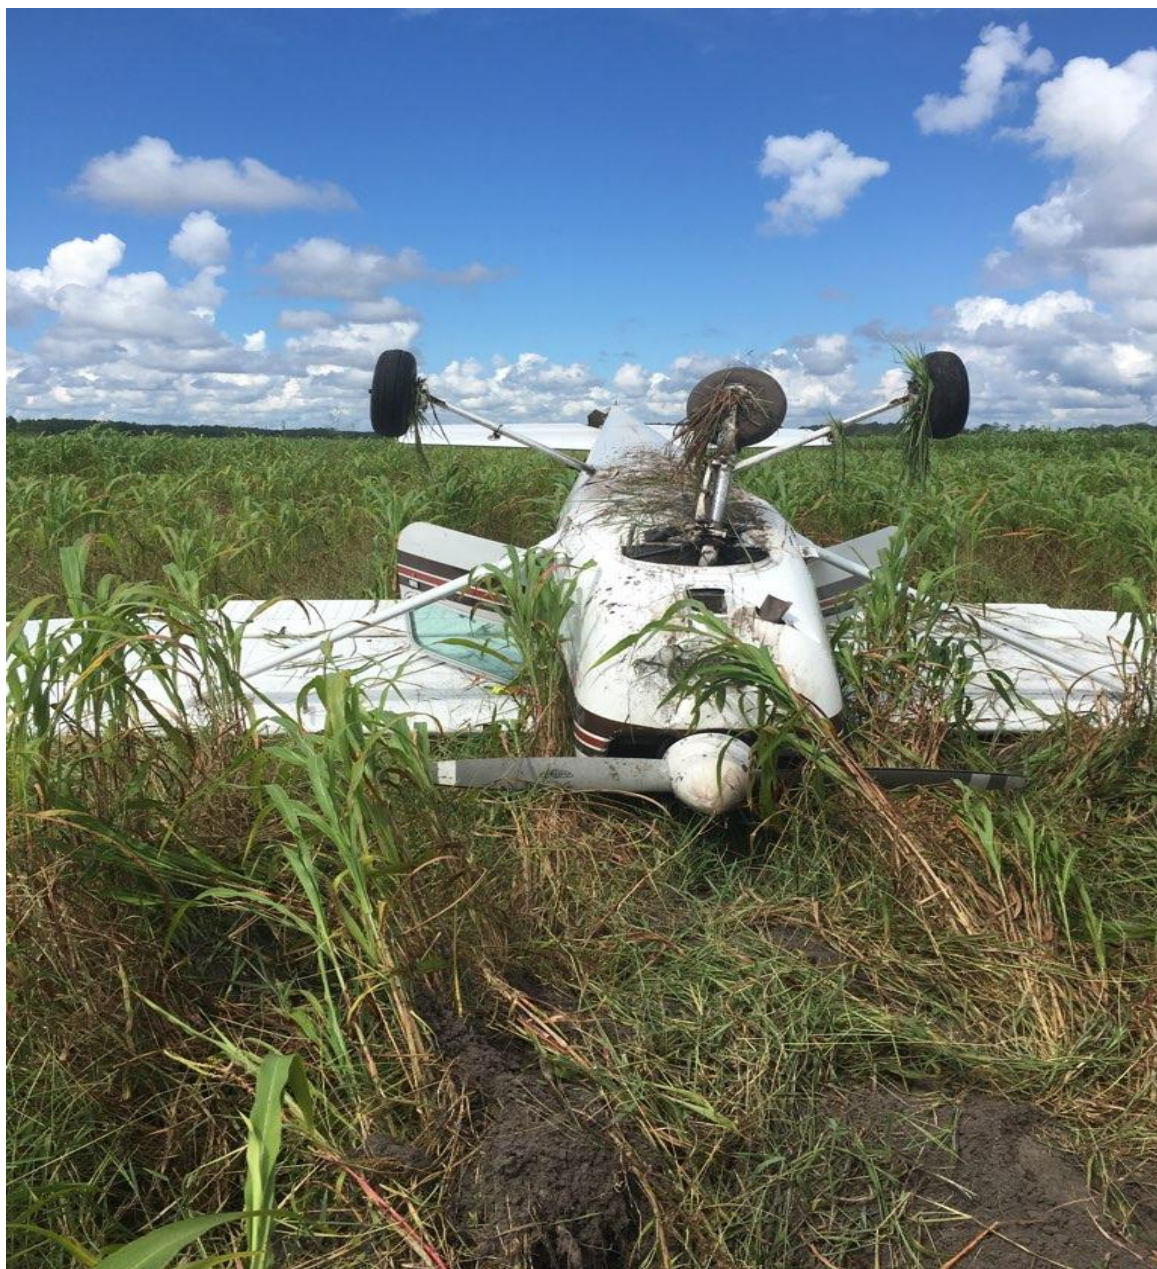
**Photo 1 – Main wreckage, front inverted view. (FAA)**

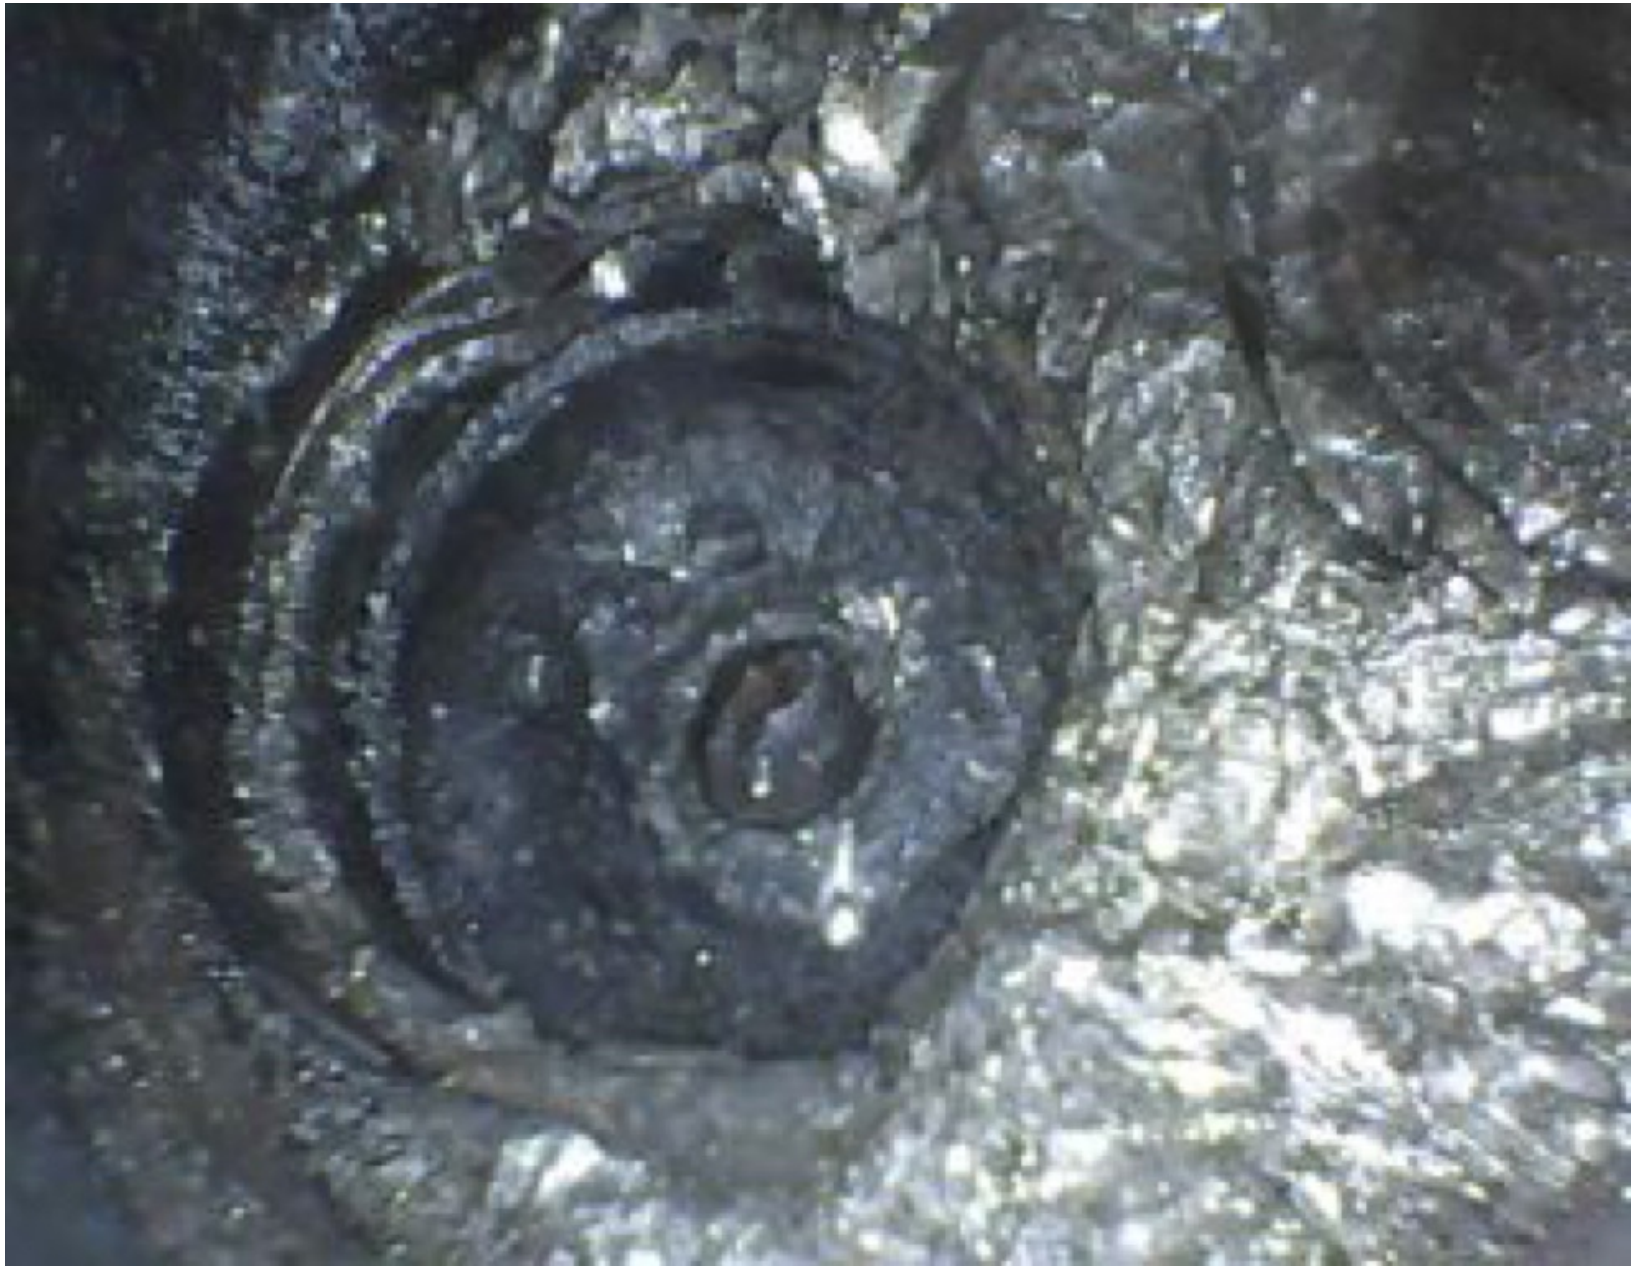
**Photo 2 - #4-cylinder, fractured exhaust valve**

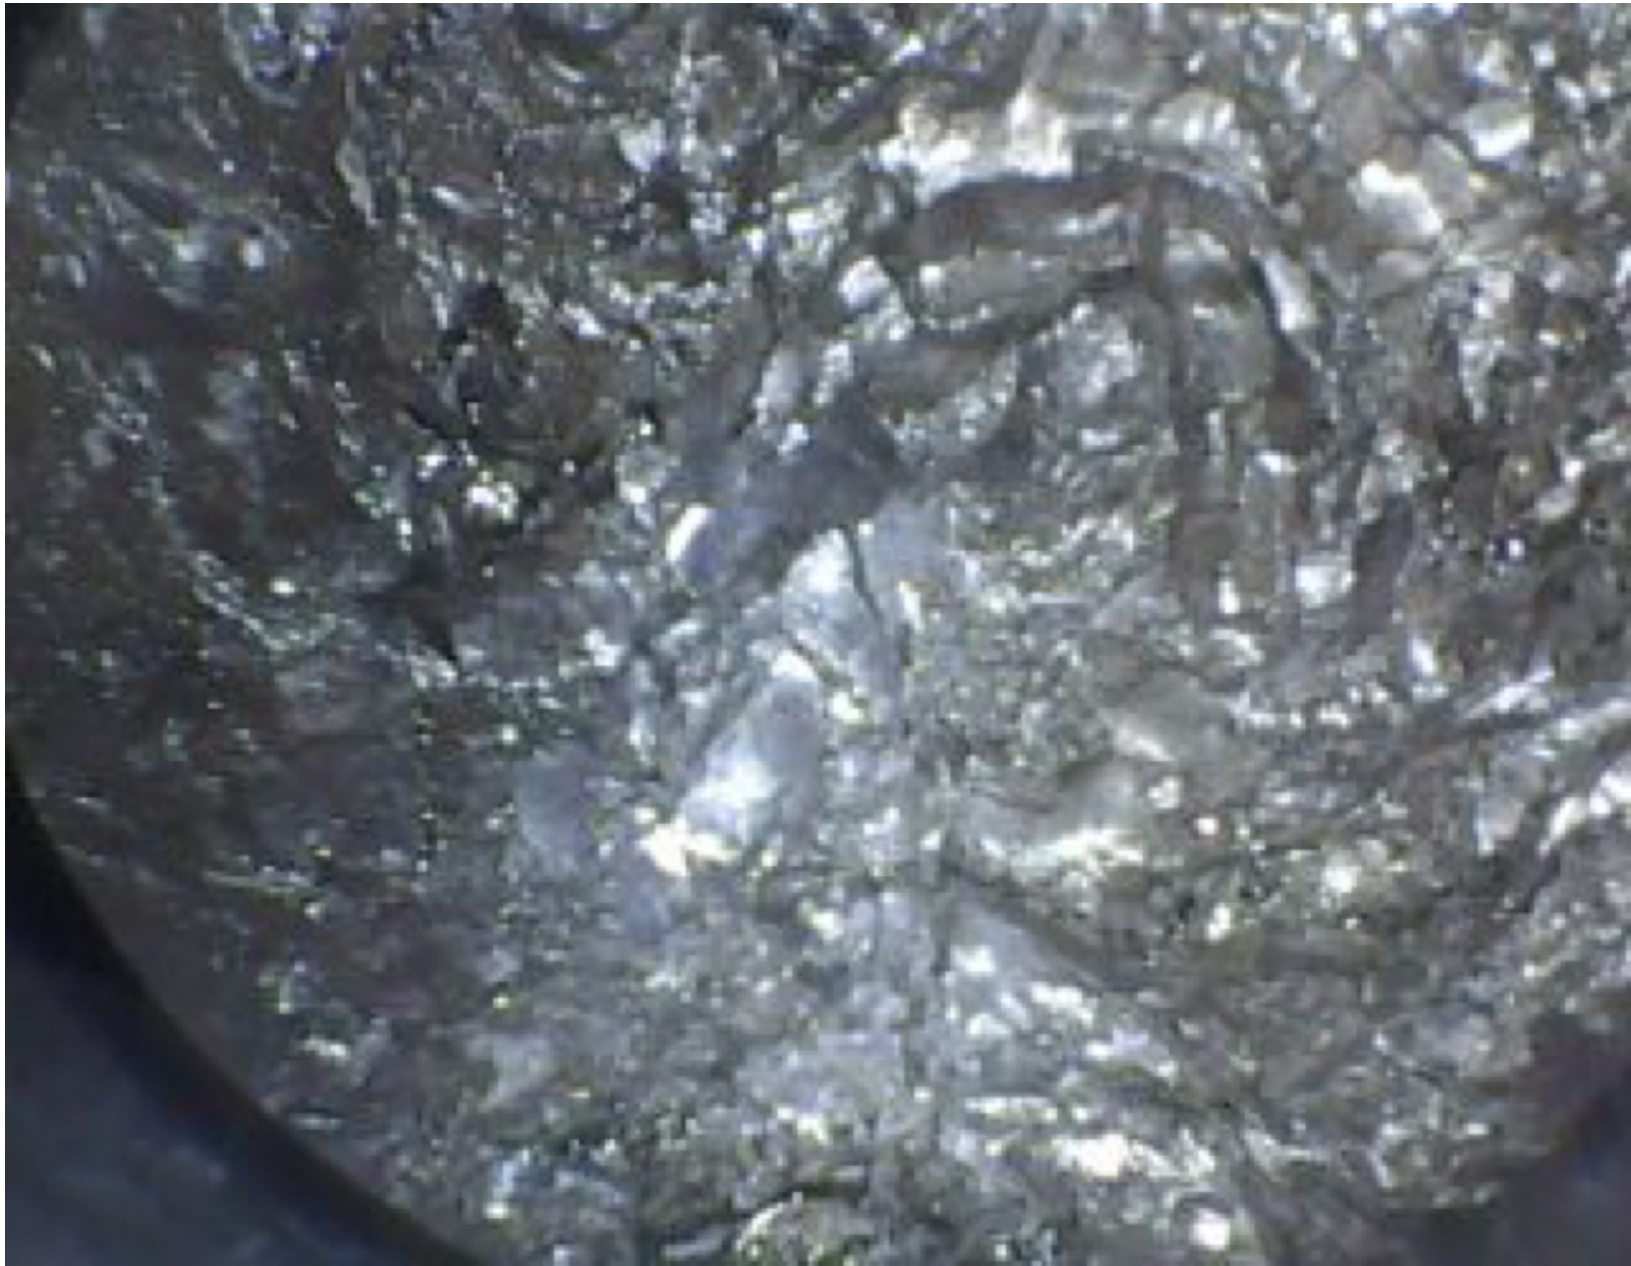
**Photo 3 - #4-cylinder, piston.**
