# NATIONAL TRANSPORTATION SAFETY BOARD

## Onboard Image, Audio, and Data Recorder

### Specialist's Factual Report

| Aircraft: | Airbus Helicopter AS350 B2 |

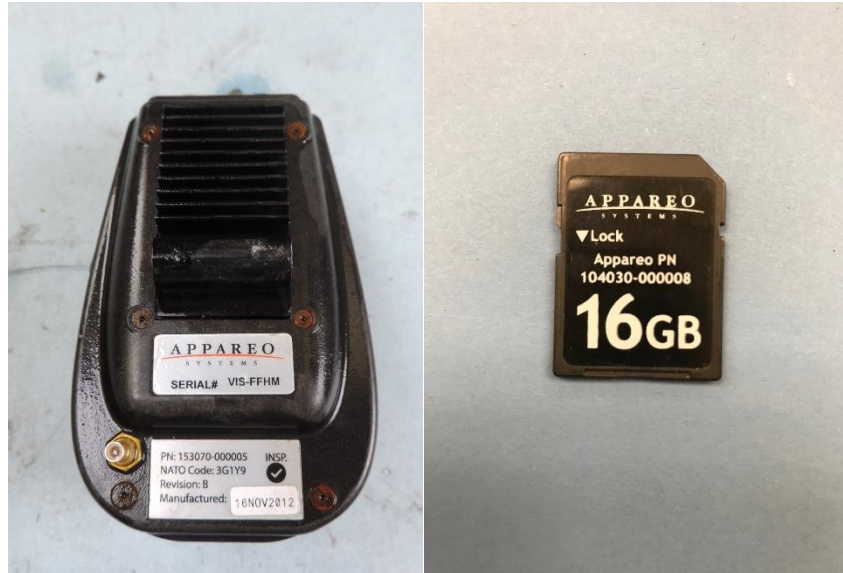
Upon arrival at the NTSB Vehicle Recorder Division, it was evident that the Vision 1000 device had been exposed to water. As a precaution, the device was placed in fresh water immediately after it was removed from the accident wreckage and was transported to the laboratory in water. An SD memory card was associated with the device and also transported to the laboratory in water.

**Figure 1. The Appareo Vision 1000 device and the associated SD card, as received. The photographs are not to scale.**

The Vision 1000 device and the SD card were cleaned and dried in accordance with NTSB laboratory procedures. The SD card was returned to a functional state. The separate internal memory from the Vision 1000 was later extracted and read out.

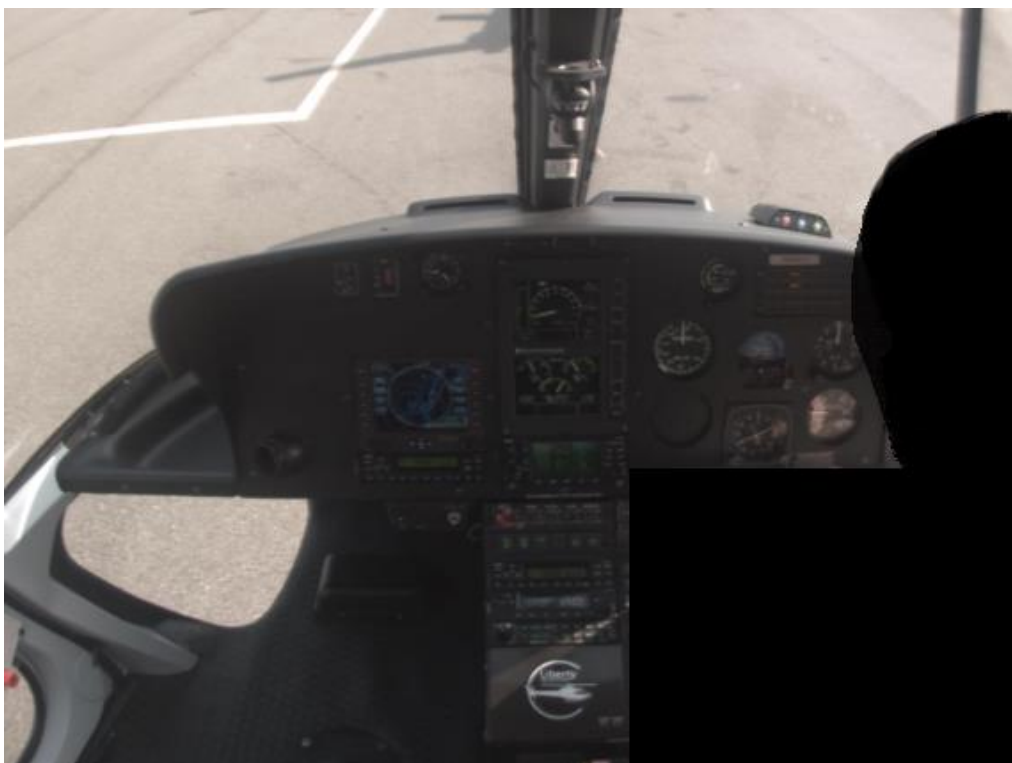
The SD card was read via a PC as per the manufacturer's guidelines. The SD card contained a number of Appareo formatted flight files associated with power cycles of the Vision 1000 device. The most recently recorded file was opened and contained image, audio and parametric data from the year 2014. Specifically, the last data point recorded was on July 1, 2014 at 12:51:41.5 UTC. Imagery contained in this file was not associated with the accident. Figure 2 is a screenshot of a recorded image from the Vision 1000 in the accident helicopter from 2014.

**Figure 2. An example image recorded by the Vision 1000 in the accident helicopter from 2014. The pilot has been redacted.**
