**NATIONAL TRANSPORTATION SAFETY BOARD**

## **Electronic Devices**

### **Specialist's Factual Report By Sean Payne**

Location: Culpeper, Virginia  
Date: October 12, 2018  
Aircraft: Vans Aircraft RV-8  
Registration: N804RL  
Operator: Private  
NTSB Number: ERA19FA010

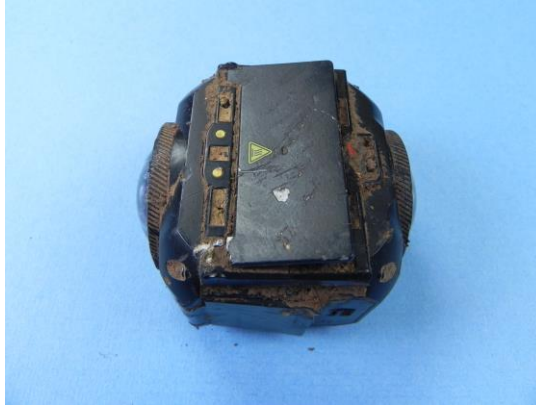
Upon arrival at the Vehicle Recorder Laboratory, an examination revealed the unit had sustained heavy impact damage. Figure 1 shows the condition of the device upon arrival to the laboratory. The door to the microSD card was opened and the microSD card was found impacted inside the camera's card slot. The camera was disassembled and the microSD card was removed. The microSD card was found to have been sheared near the rear of the card. Damage of this nature is catastrophic and the card is unable to be repaired. Additionally, the piece that was sheared off was missing. Despite this, the microSD card was arranged in such a way to fit into a microSD card reader. The microSD card was connected to a PC via this reader and the card was not recognized. Figure 2 shows the damage to the microSD card.

**Figure 1. Photo of damaged unit**

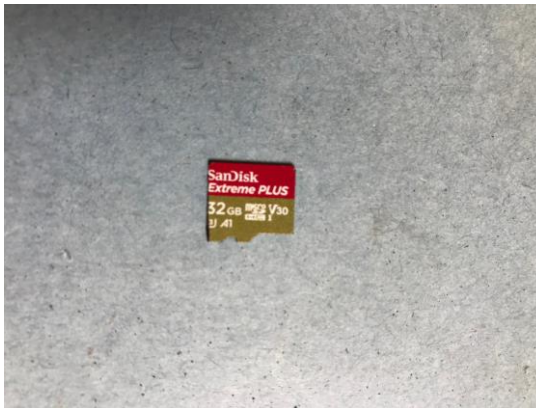
**Figure 2. Photo of damaged microSD card. Notice the left side of the card is sheared off and missing.**

The extent of the damage precluded normal recovery procedures and additional attempts were unsuccessful in yielding usable data. Therefore, no data pertinent to the event were recovered.
