# NATIONAL TRANSPORTATION SAFETY BOARD

## Global Positioning System

### Specialist's Factual Report by Alice Park

Location: Louisa, Virginia  
Date: November 4, 2018  
Aircraft: Titan Tornado 1  
Registration: N38FD  
Operator: Private  
NTSB Number: ERA19FA036

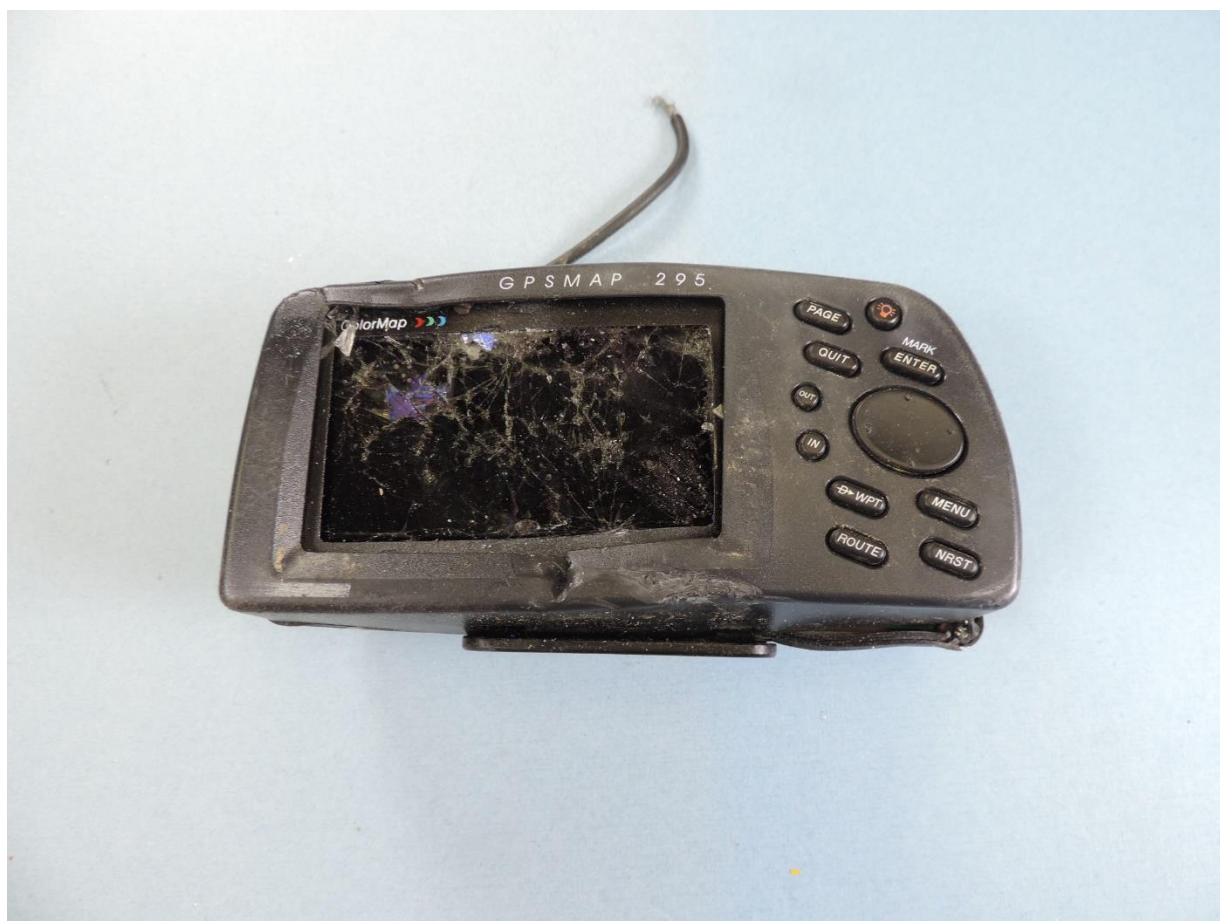
**Figure 1. External view of the Garmin GPSMAP 295 - front (s/n 98806849).**

Upon arrival at the Vehicle Recorder Laboratory, an exterior examination revealed that the unit had sustained impact damage during the accident and would not power on (Figures 1 and 2). It was disassembled for further examination.

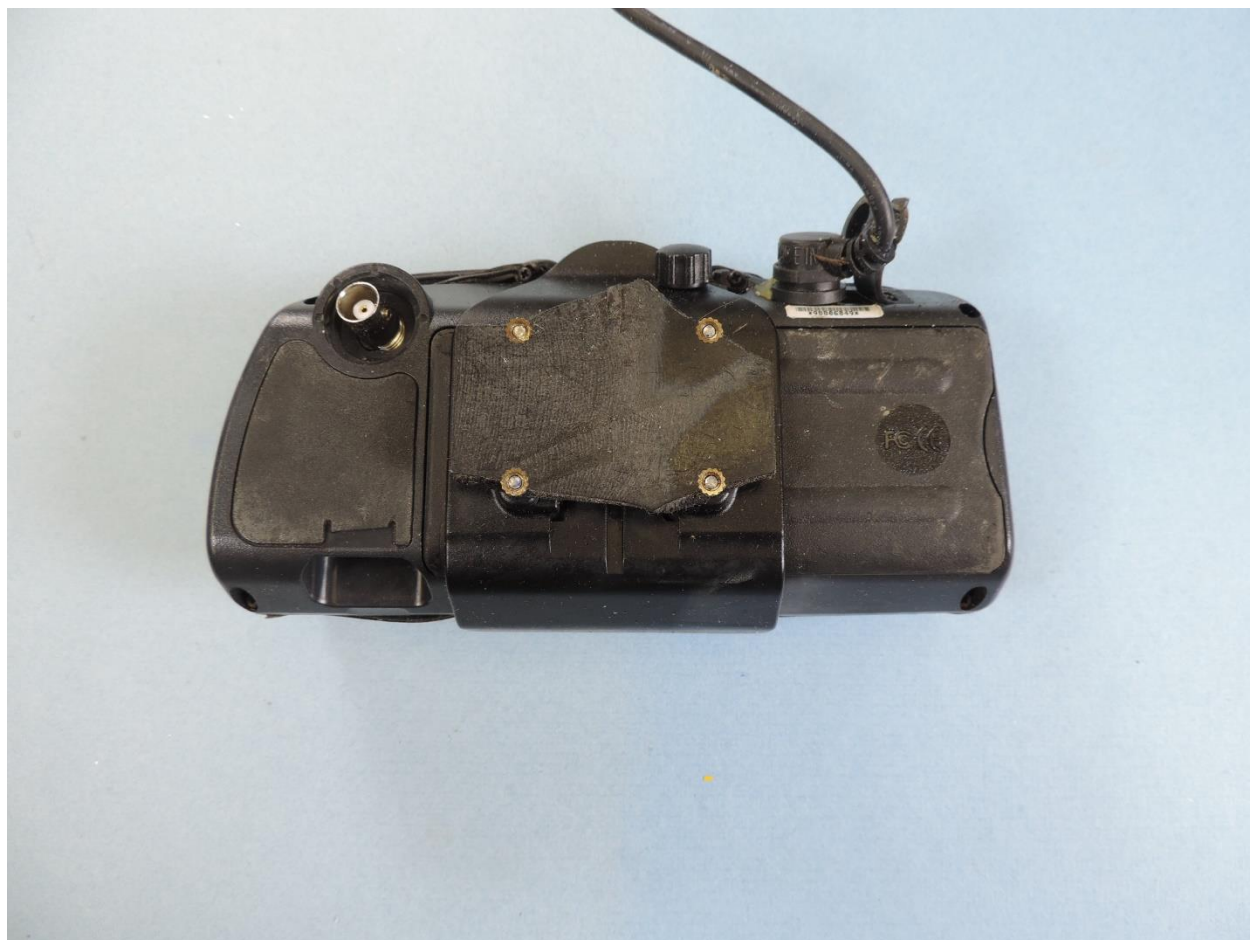
**Figure 2. External view of the Garmin GPSMAP 295 - back (s/n 98806849).**

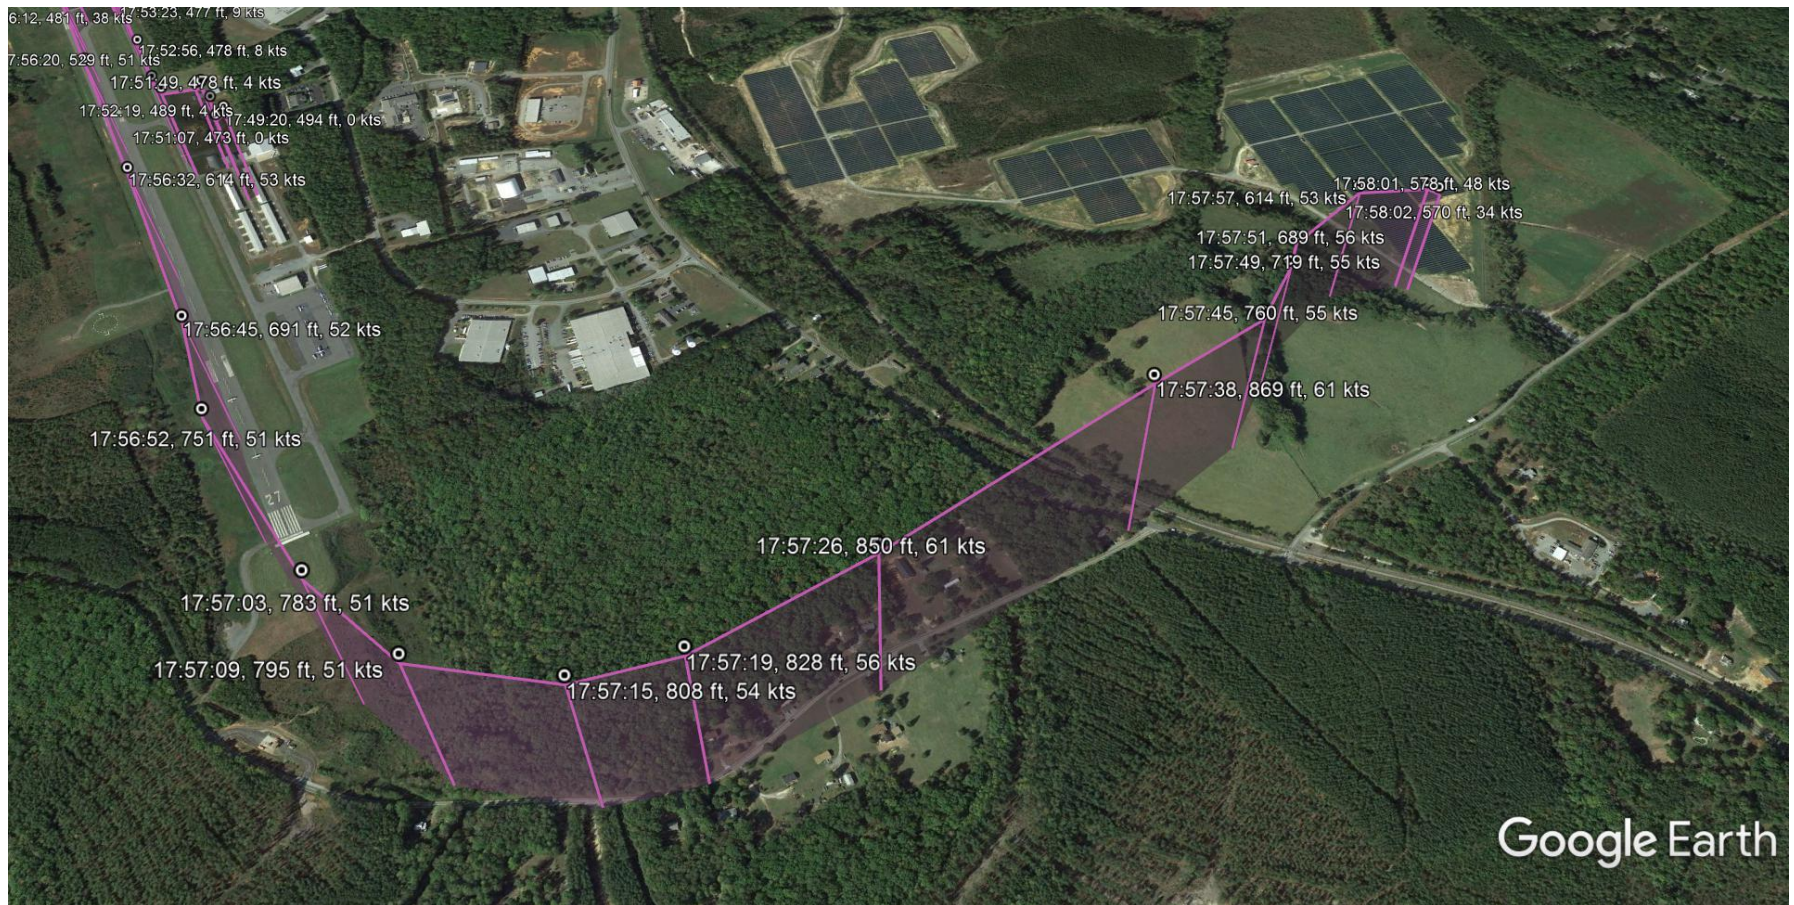
**Figure 5 Close view of the impact location**

The most recently recorded track log began at 1749:20 Universal Time Coordinated (UTC) on November 4, 2018, departing at Louisa County Airport (LKU), Louisa, Virginia. The accident flight turned north after takeoff and flew about a mile from the airport before the recording ended. The final position was recorded at 1758:02 UTC with an altitude about 570 feet. The computed average ground speed between the two recorded latitude and longitude points was 34 knots. Figure 3 and 4 show overhead view of the entire flight. Figure 5 displays close view of the accident location.
