NTSB | ERA19FA039

Walton, New York

Flight Track Figures and Overview of Accident Location

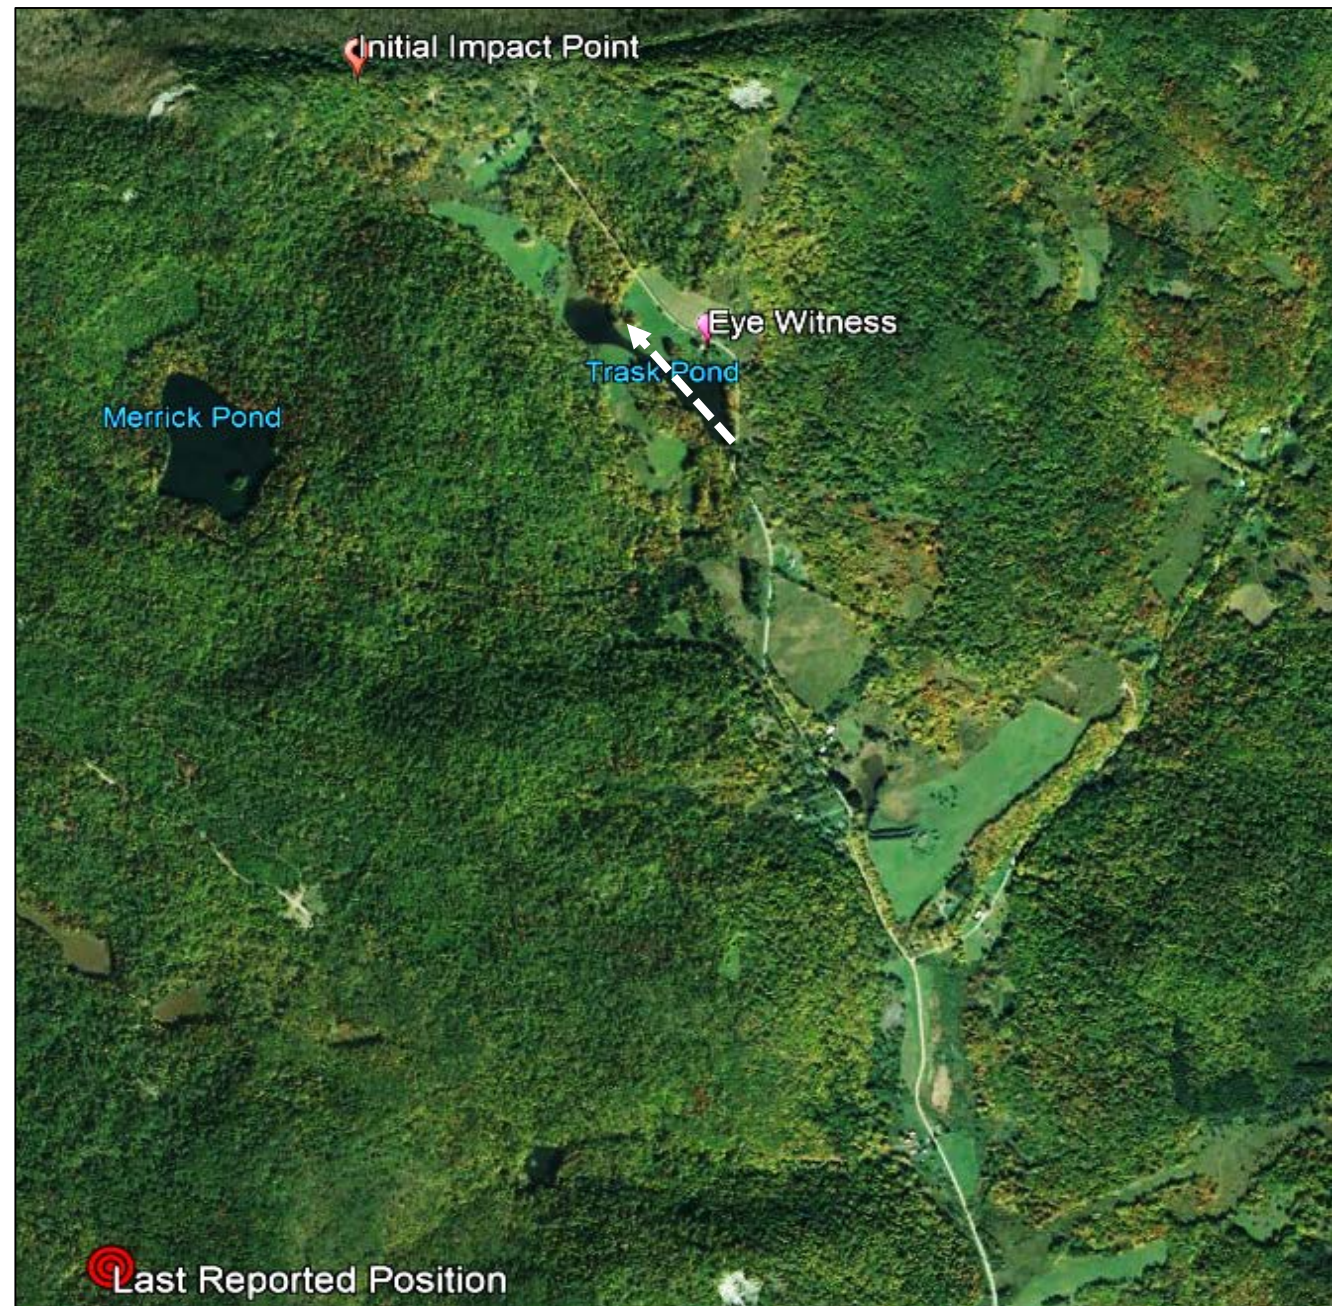
- The initial impact point is noted in the upper center section of the figure, which coincided with two 50 ft tall trees, which were atop a ridgeline that was about 2,000 ft msl.
- The eyewitness location is noted below and to the right of the initial impact point.
- According to the witness, the airplane was observed to fly in a straight-line right over the pond on her property, named Trask Pond.
- The white dashed arrow represents the estimated reported flight track, as reported from the eyewitness.
- The red dot in the lower left corner of the figure represents the airplane's last reported flight track position, which was at 1500:50 about 1.8 nautical miles from the initial impact point, where the airplane was at 7,350 ft, on a heading of 308°, at 151 knots groundspeed.

Figure 2 – The airplane's flight track as reported by an eyewitness.

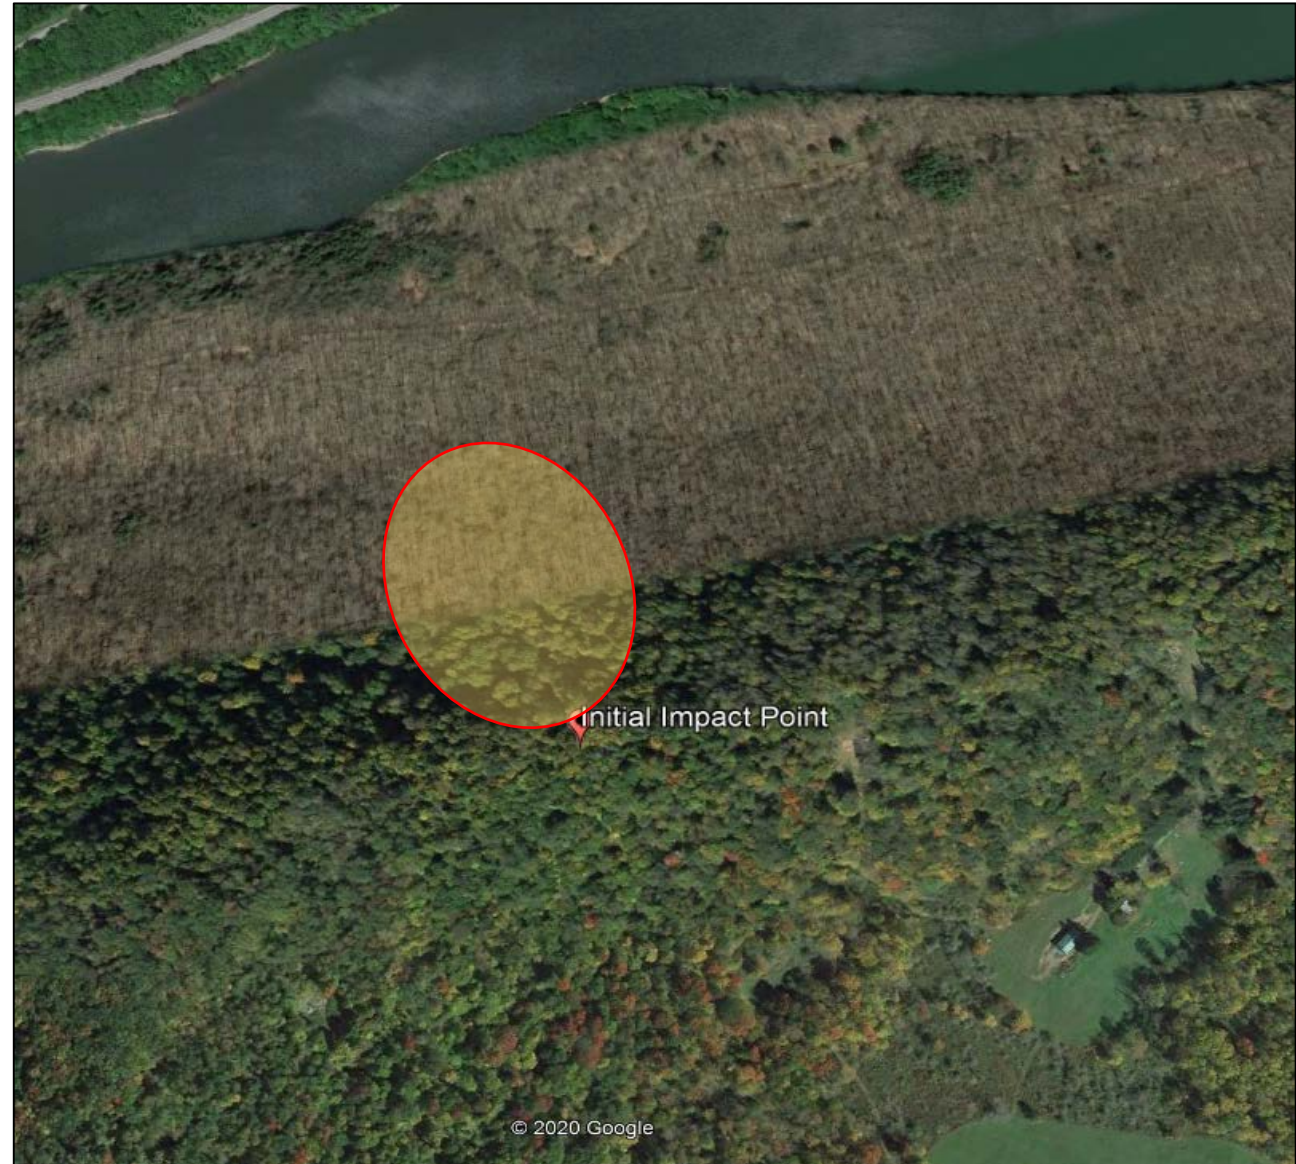
- The initial impact point is noted in the center of the figure, which coincided with two 50 ft tall trees, which were atop a ridgeline that was about 2,000 ft msl.
- The red circle and shaded area represents the general wreckage debris area.

Figure 3 – The initial impact point and wreckage debris area.
