**NATIONAL TRANSPORTATION SAFETY BOARD**  
Vehicle Recorder Division  
Washington, D.C. 20594

## **Cockpit Display – Recorded Flight Data**

**Specialist's Factual Report**  
**By Charles Cates**

Location: Niceville, FL  
Date: November 17, 2018  
Aircraft: Vans Aircraft RV-12  
Registration: N232VA  
Operator: Private  
NTSB Number: ERA19FA048

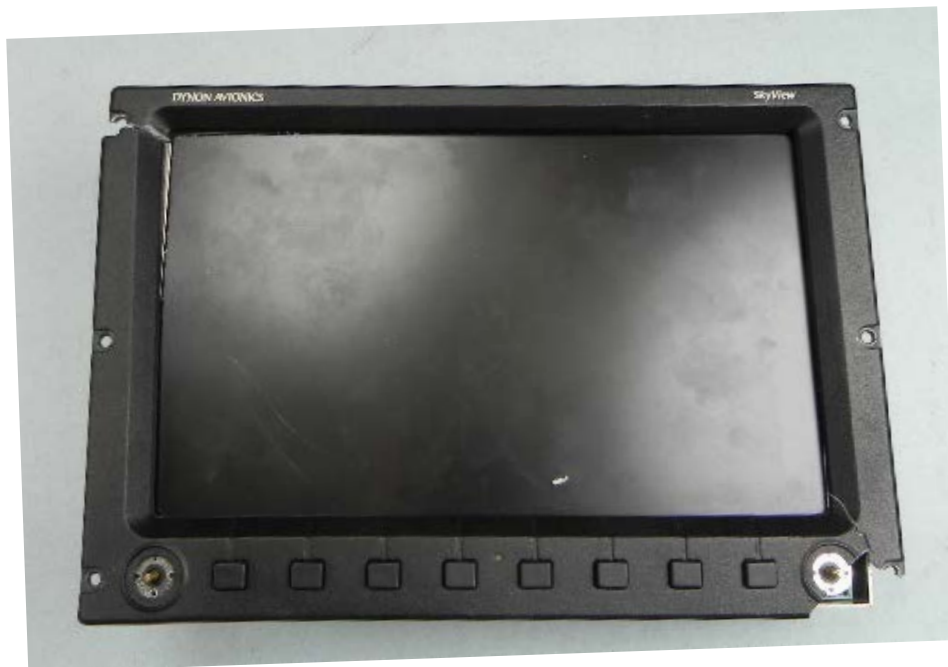
The recorder was damaged by mechanical impact forces in the event and the screen was cracked and not operational. The extent of the damage is shown in figure 1. The DOM memory module was removed and accessed using digital forensics software.

**Figure 1. Damaged exterior of flight recorder.**

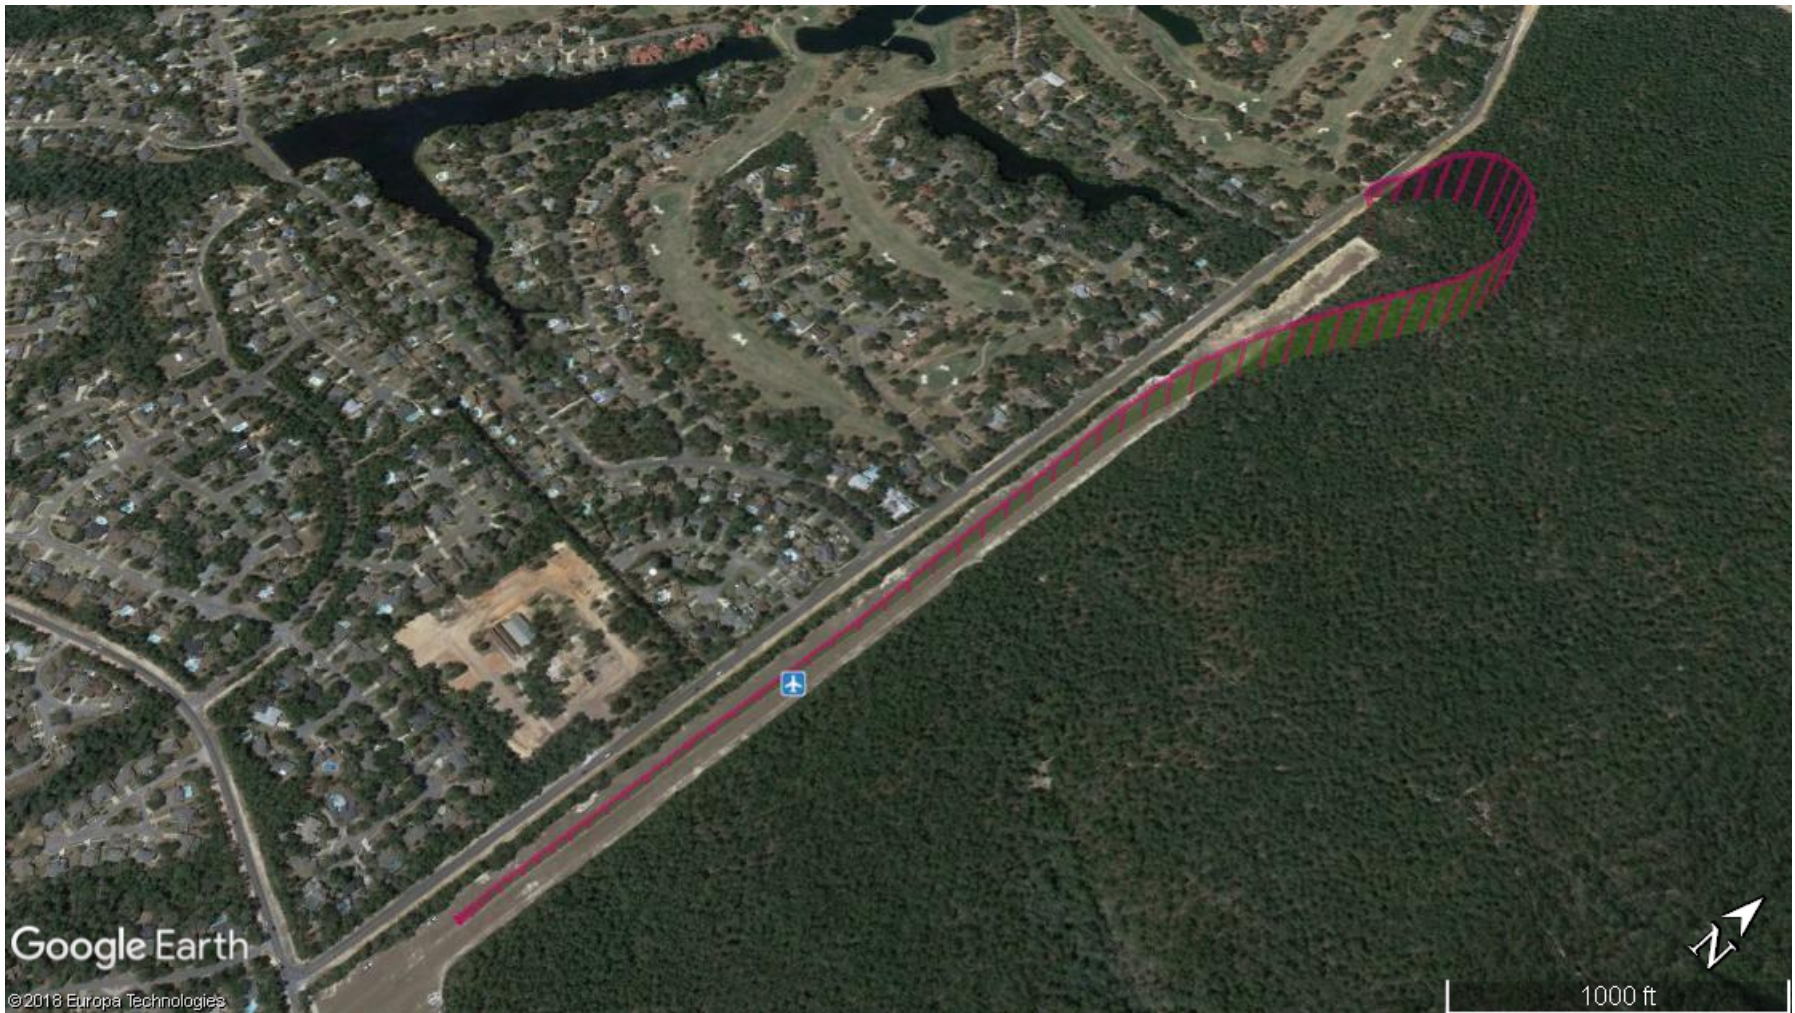
Figure 2 is a map overlay of the accident flight created using Google Earth. Note that lighting and atmospheric conditions depicted in Google Earth may not be representative of conditions during the accident flight.

Figure 2. Map overlay of accident flight.

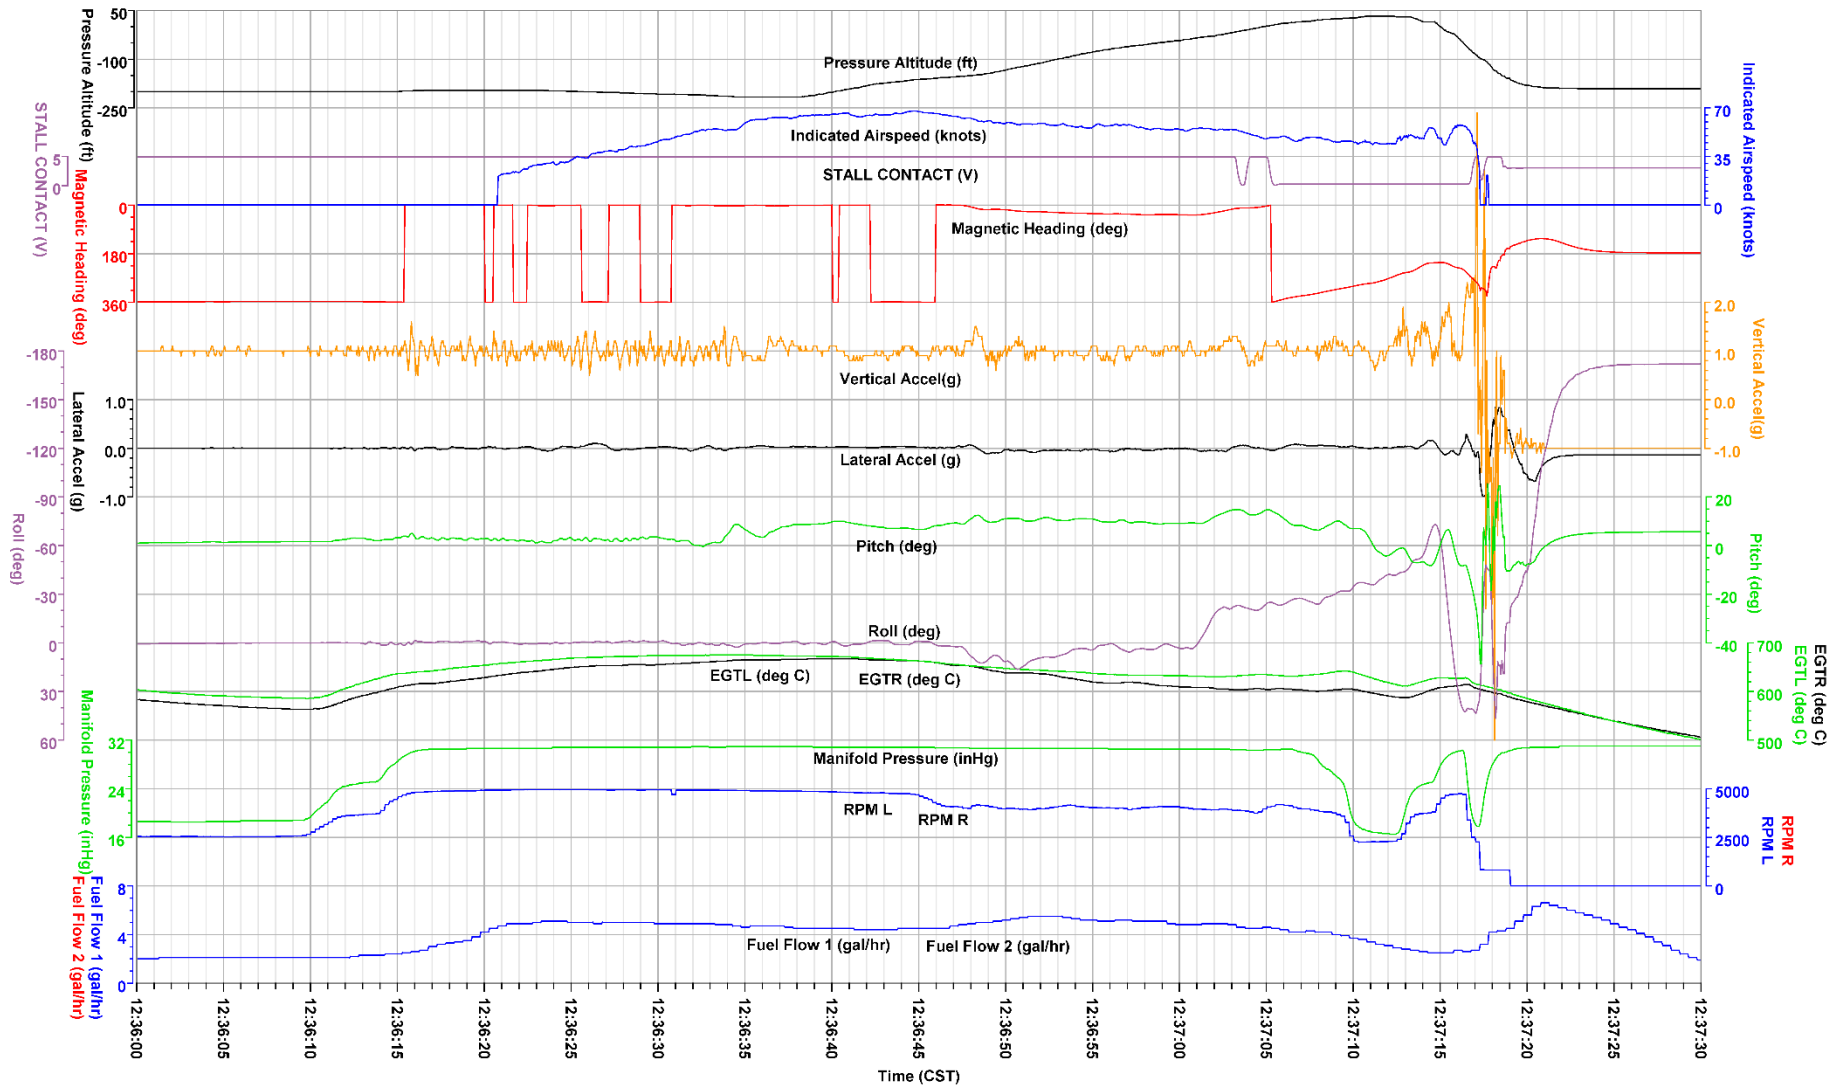
Figure 3 is a plot of aircraft basic parameters from the accident flight from the start of the takeoff roll until the aircraft was at rest.

Figure 3. Plot of aircraft basic parameters from event flight.

In brief, the engine was advanced to takeoff power starting at about 1236:10 CST. The engine stabilized at about 4,950 rpm at wide open throttle (WOT), however at 1236:31 the engine had a momentary reduction in power to 4,700 rpm and recovered to about 4925 rpm. At this time the engine began a slow reduction in speed until it was at 4,850 rpm and the aircraft began to climb at about 1236:37 CST at an indicated airspeed of about 65 knots.

At 1236:45 the aircraft reached a pressure altitude of -162 ft, about 55 ft above runway elevation, and the engine had a sudden reduction in speed to less than 4000 rpm without a corresponding change in manifold pressure. This is consistent with the throttle staying at WOT. Fuel flow also increased at this time. The aircraft continued to climb and airspeed began to reduce from its peak of 68 knots.

At 1236:04 a stall warning became active at -10 ft pressure altitude (about 207 ft above runway elevation), 51 knots, and 21 degrees of left bank. At 1237:07 manifold pressure reduced over three seconds consistent with the throttle being pulled back to idle and remained at idle for three seconds. During this time the aircraft reached its maximum altitude of 33 ft, about 250 ft above runway elevation, and airspeed was 44 knots. Vertical acceleration began to oscillate, and roll continued to bank to the left, reaching 68 degrees left wing down. The aircraft began to descend rapidly, and the manifold pressure then increased to 30 inHg, consistent with the throttle being advanced. The engine speed increased along with the increase in manifold pressure, reaching about 4,700 rpm. Shortly after, at 1237:17, excursions in acceleration forces consistent with impact were recorded.

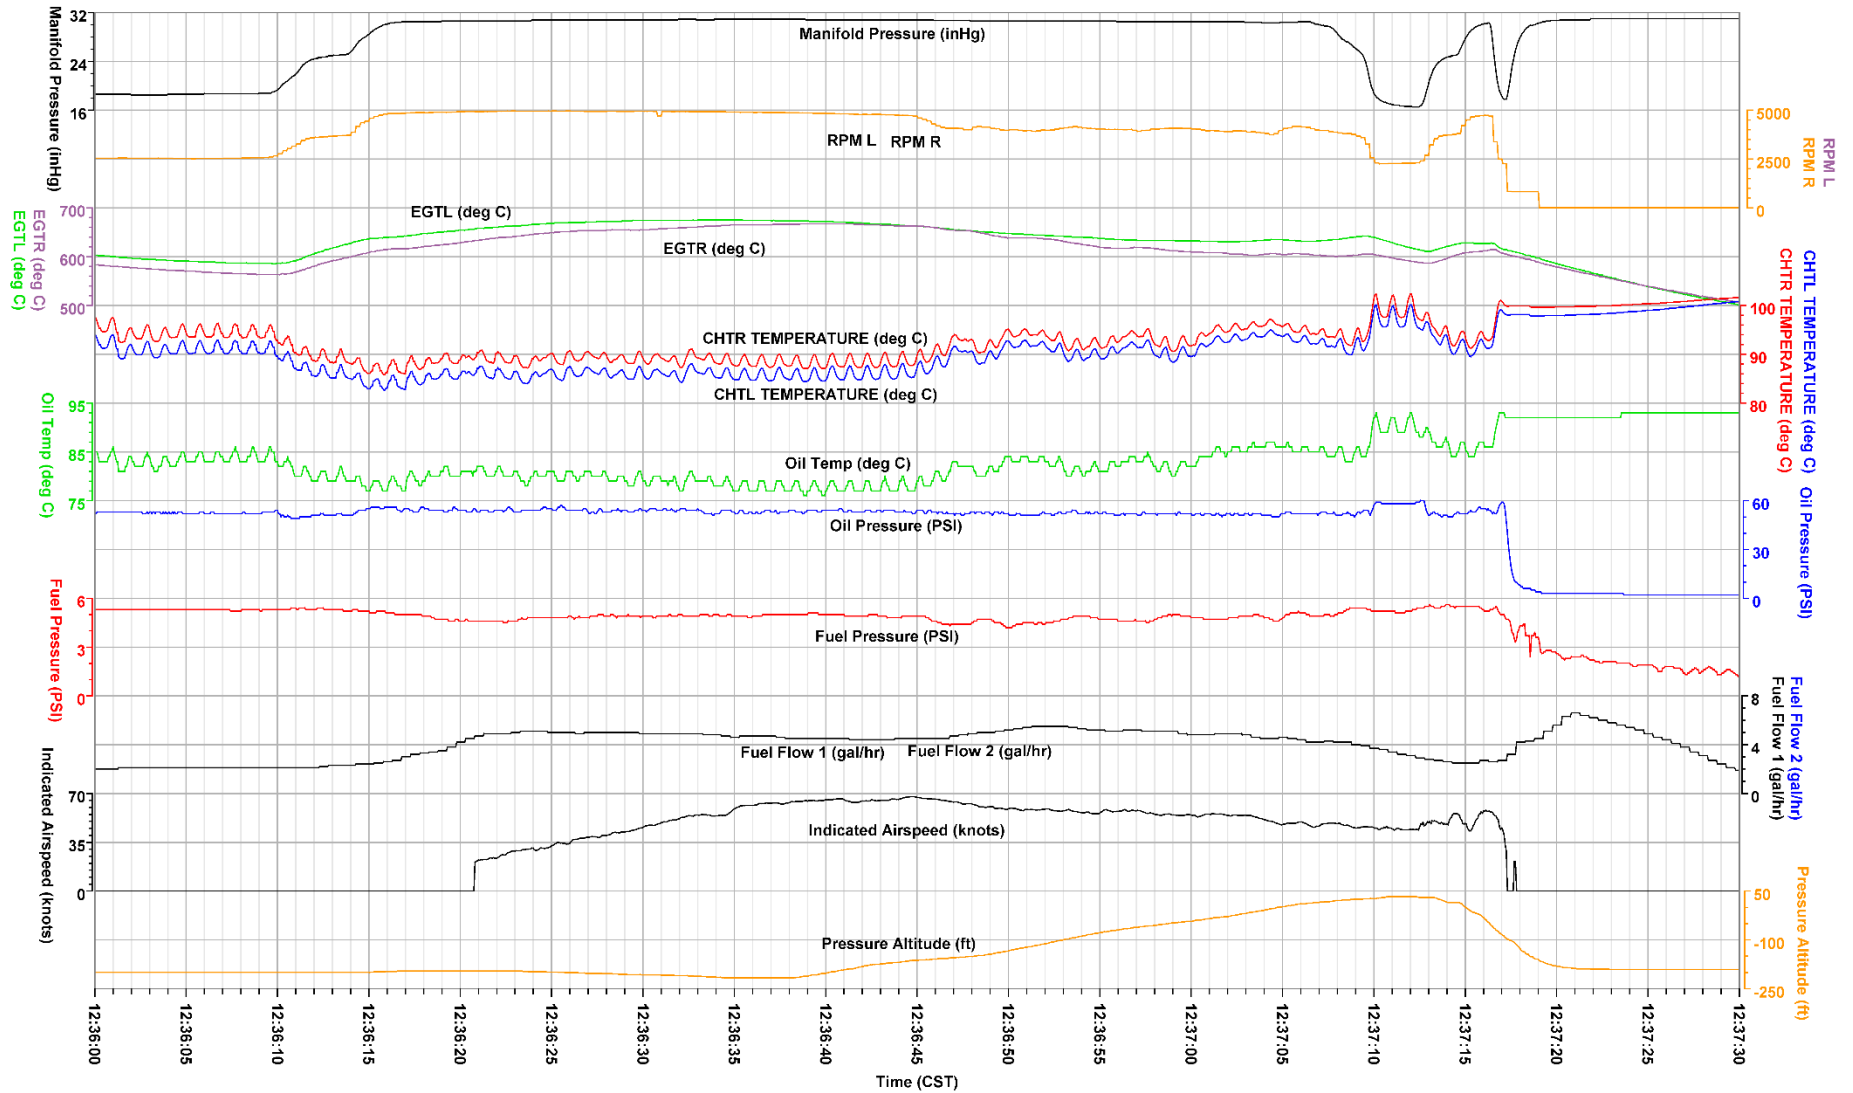
Figure 4 is a plot of engine parameters from the accident flight from the start of the takeoff roll until the aircraft was at rest.

Figure 4. Plot of engine parameters from accident flight.
