# ENGINE EXAMINATION REPORT

| <b>ENGINE MODEL</b> | IO520A (35) |
| <b>AIRCRAFT MAKE &amp; MODEL</b> | Cessna 210D |
| <b>FILE NUMBER</b> | 18-307 |

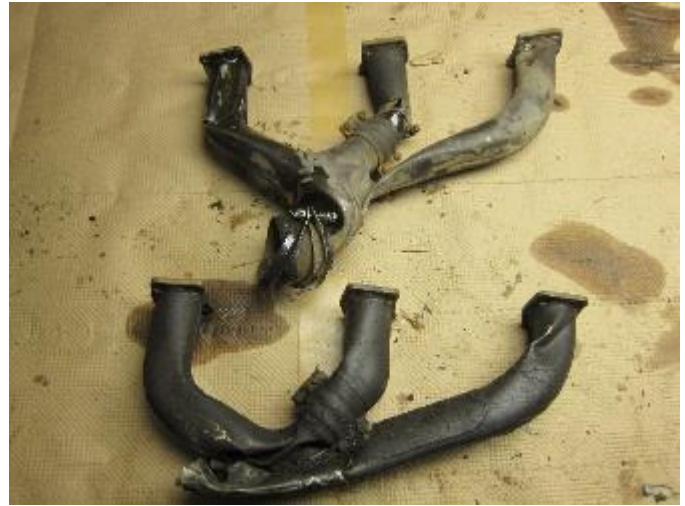
#### EXHAUST SYSTEM

The exhaust components were impact damaged.

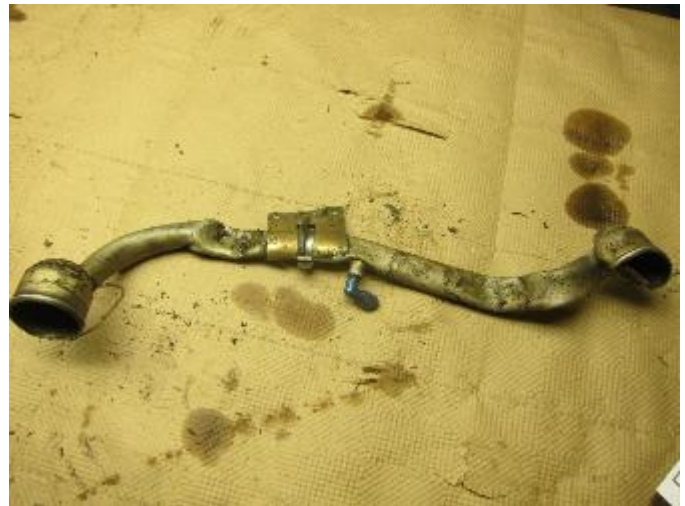
#### INDUCTION SYSTEM

The forward balance tube was crushed. The induction elbows and connectors were impact damaged.

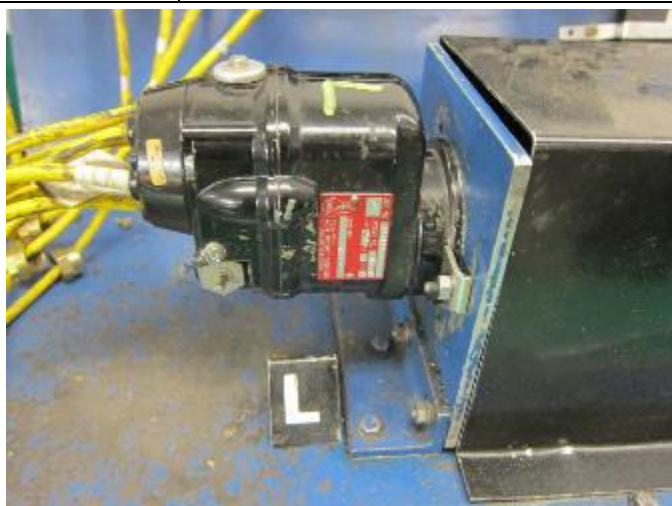
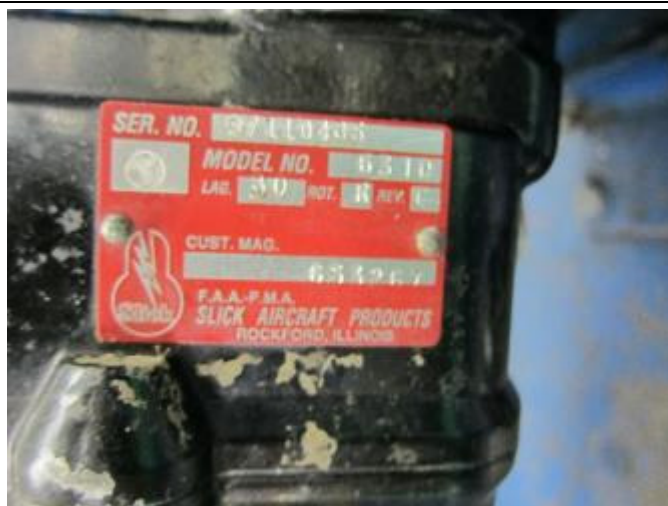
| MAGNETO-TO-ENGINE TIMING | Specification: 22 ° BTDC | L/H Magneto: ° | R/H Magneto: ° |
|---|---|---|---|
| Magneto points were open as received and ignition timing could not be determined. Points were cleaned after magnetos were removed and magnetos operated normally. | | | |
| Condition: | Magneto points were contaminated due to water immersion. Points were cleaned and the magneto produced spark at all ignition leads when bench tested. The impulse coupling released normally, | | |

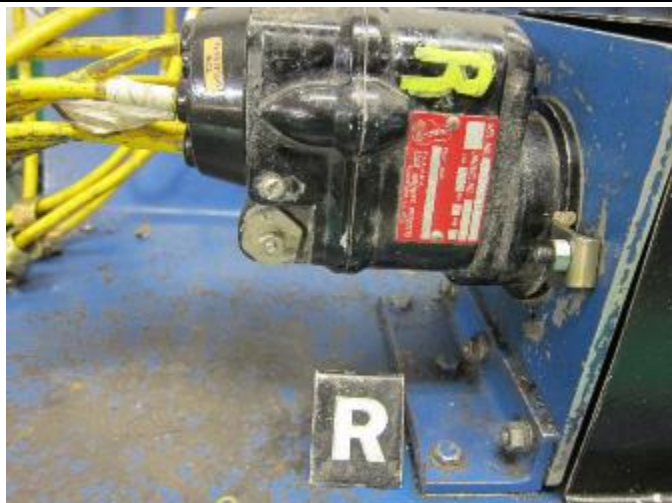
| RIGHT MAGNETO | Manufacturer: Slick Aircraft Products | M/N: 6310 | S/N: 97110438 |

| RIGHT MAGNETO | Manufacturer: Slick Aircraft Products | M/N: 6310 | S/N: 97110438 |
|---|---|---|---|
| Condition: | Magneto points were contaminated due to water immersion. Points were cleaned and the magneto produced spark at all ignition leads when bench tested. The impulse coupling released normally, | | |

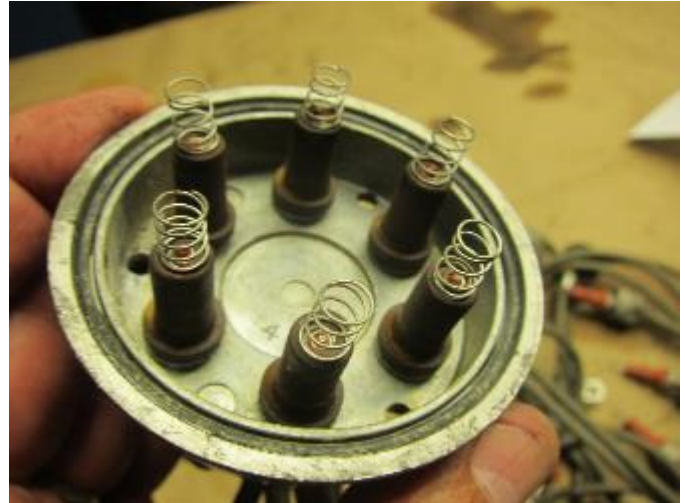
## IGNITION HARNESS

Condition: The ignition harness hardware exhibited corrosion due to salt water immersion.

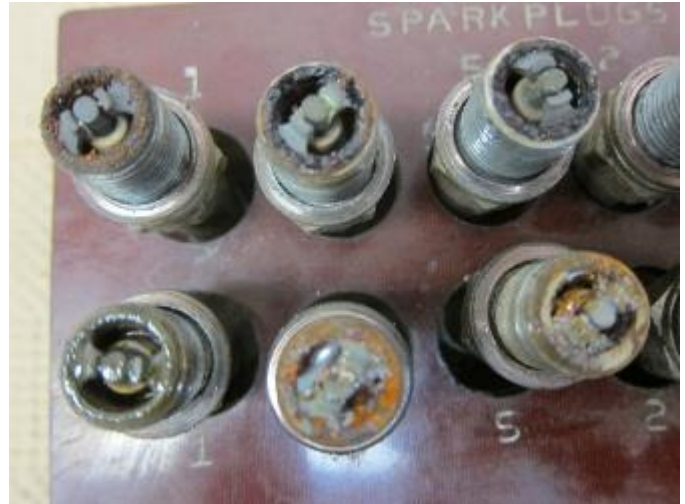
## SPARK PLUGS

Condition: All sparkplugs were contaminated with undetermined debris/sediment and corrosion due to salt water immersion.

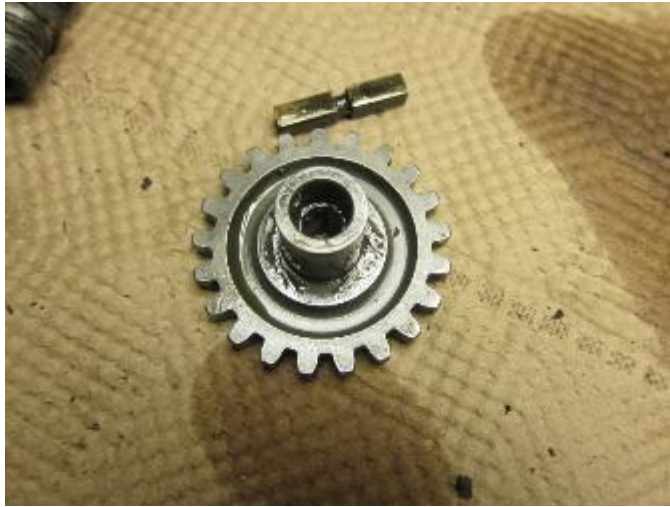
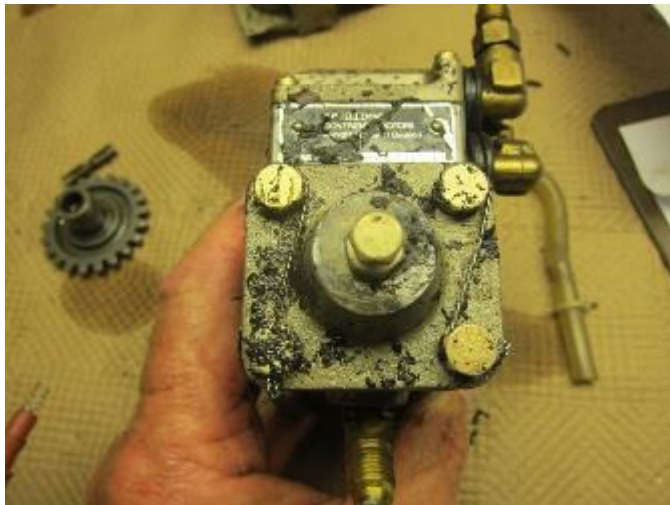
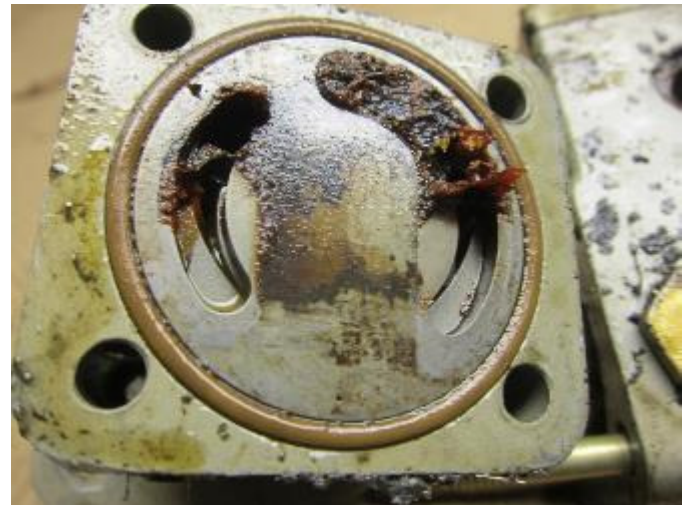
### FUEL PUMP

The drive gear and coupling were intact. The pump exhibited corrosion from salt water immersion and would not turn manually. Impeller blades were intact. Fuel fittings were impact separated.

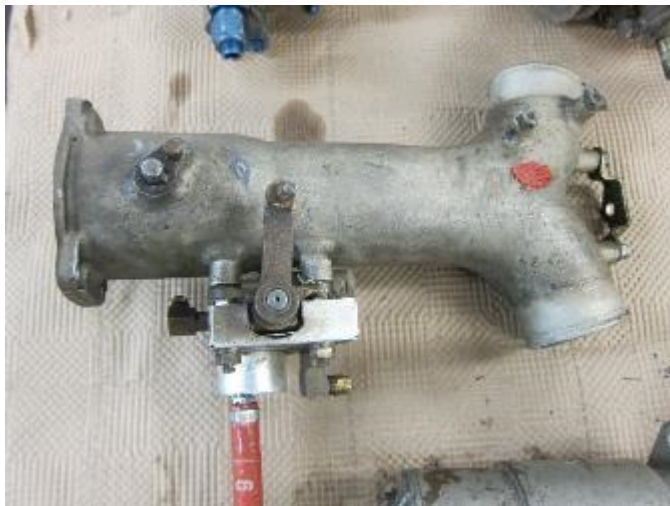
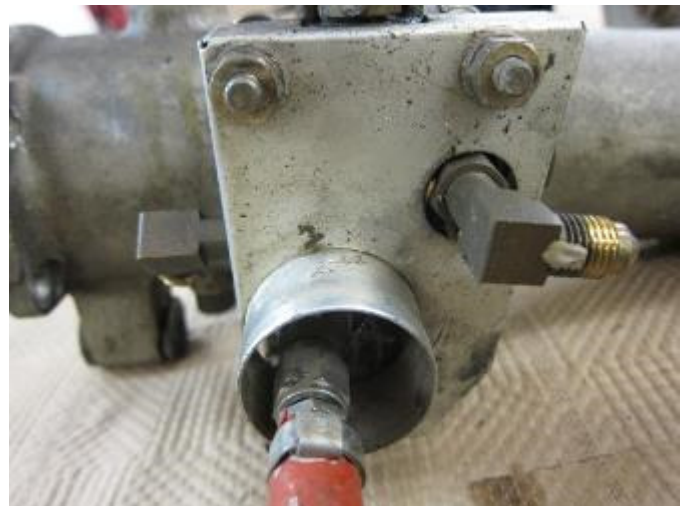
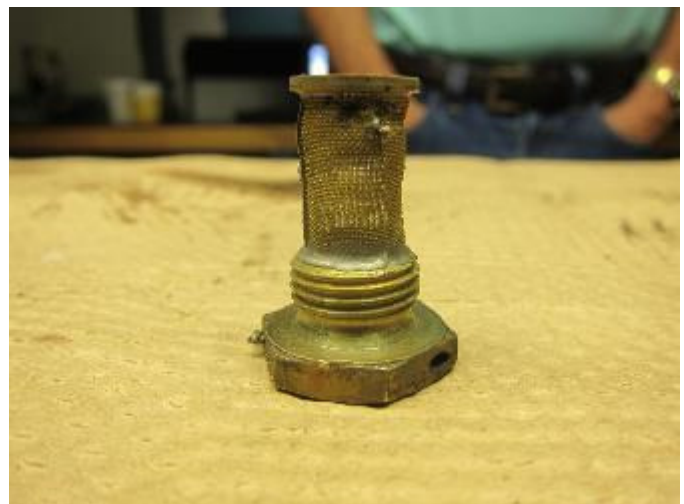
## THROTTLE BODY METERING UNIT

Condition: Control arms were secured, and the fuel screen was clean.

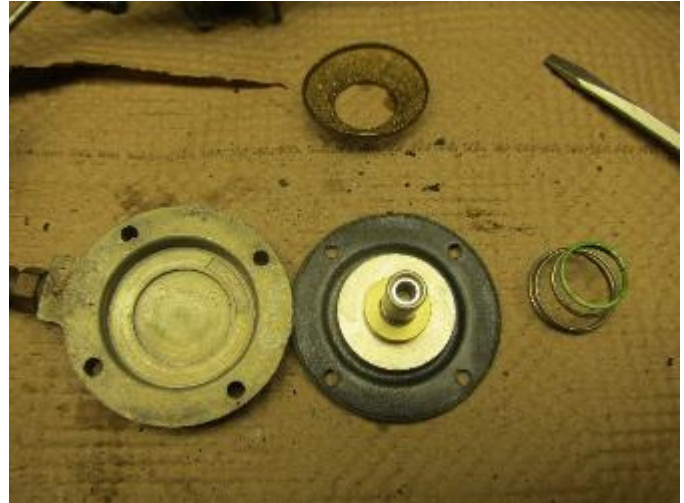
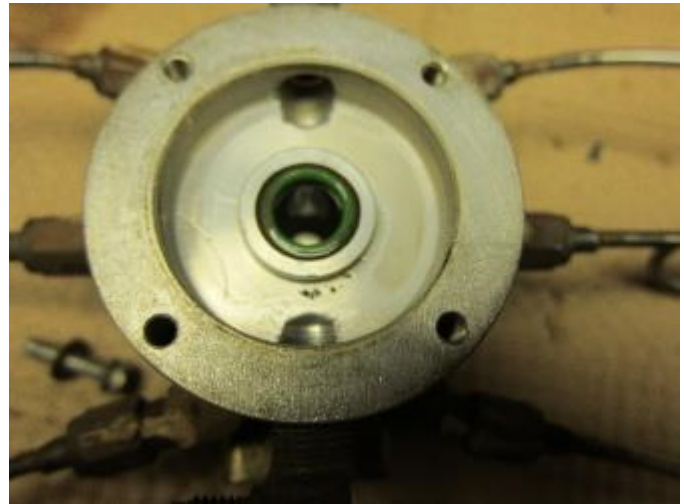
## FUEL MANIFOLD VALVE

Assembly screws were properly secured, and a lead seal was present. The spring, diaphragm and fuel screen were intact. A small amount of contamination was found in the valve body.

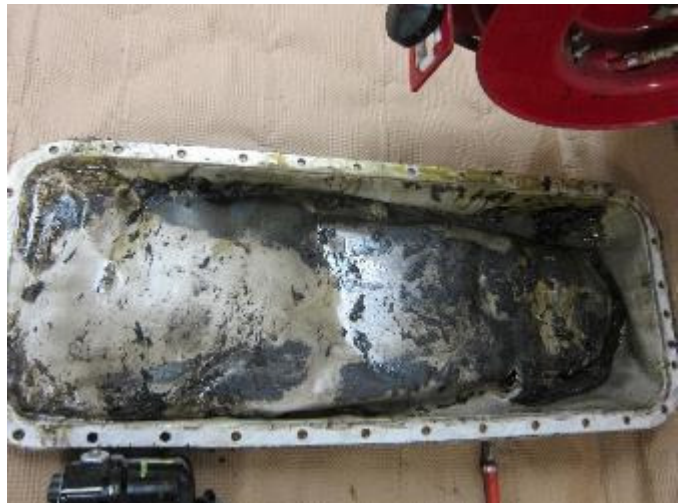
### OIL SUMP

Condition: The oil sump was impact damaged and the quick drain was partially separated.

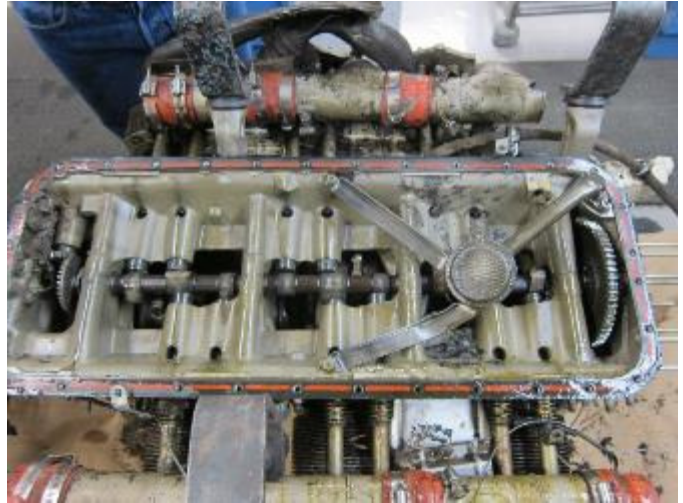
### OIL PICK-UP TUBE & SCREEN

The pick-up screen was clean, but the mounting brace was impact damaged.

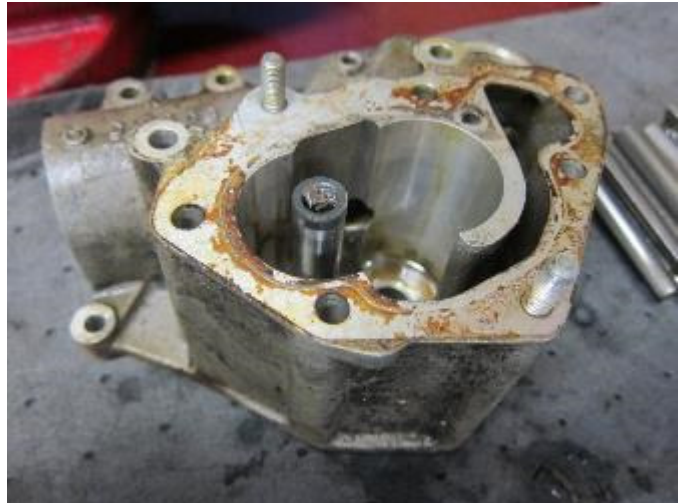
### OIL PUMP

The oil pump exhibited normal wear with no evidence of hard particle passage. Pump gears, relief valve and spring were intact.

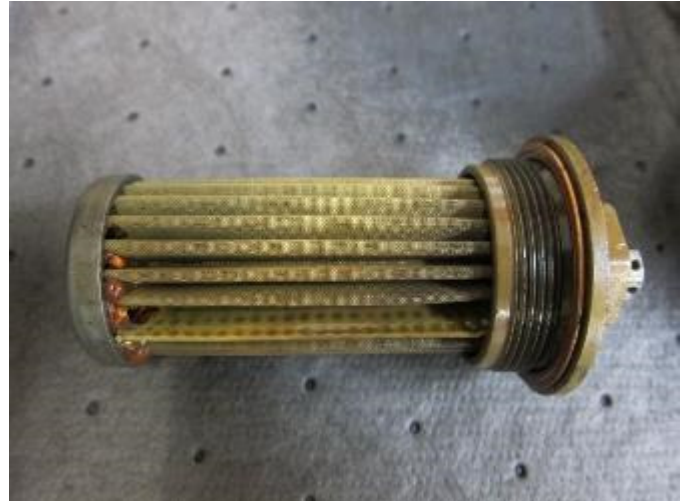
### OIL SCREEN

The oil screen was clean with no metal contamination. A small amount of undetermined contamination was present due to salt water immersion.

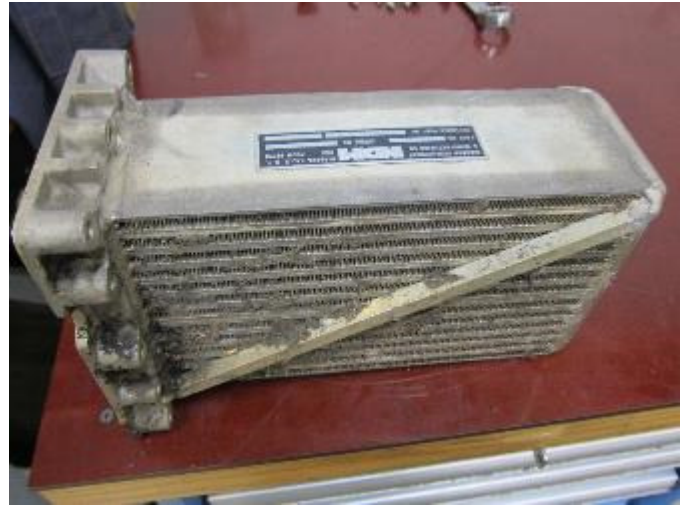
### OIL COOLER

Condition: The oil cooler coils were contaminated with mud, but no impact damage was noted.

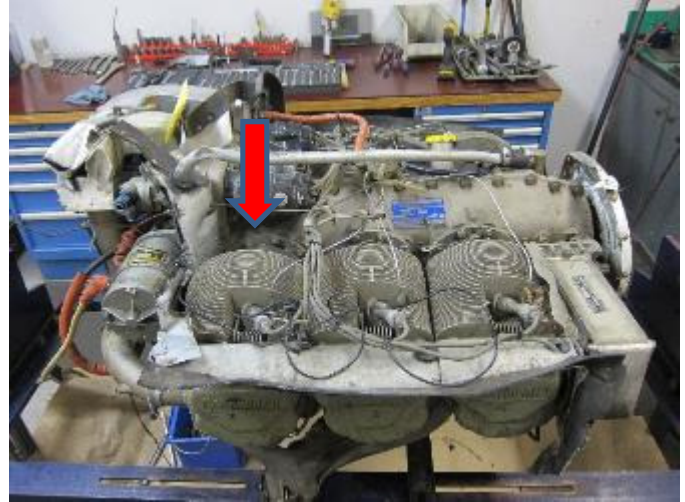
| <b>CYLINDER #1</b> | P/N: ECI-AEC631397 | S/N: NA | Head Date: NA |

| Condition: | Other than debris in the cooling fins and corrosion damage to cylinder wall surfaces, the cylinder was unremarkable. | | |

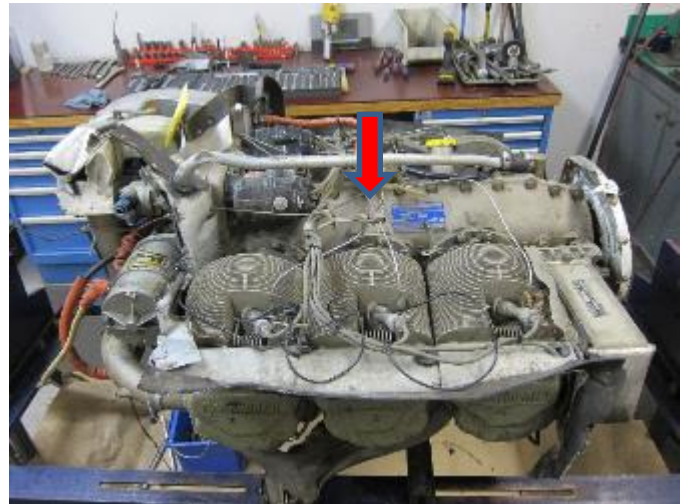
| <b>CYLINDER #3</b> | P/N: ECI-AEC631397 | S/N: NA | Head Date: NA |

| Condition: | Other than debris in the cooling fins and corrosion damage to cylinder wall surfaces, the cylinder was unremarkable. | | |

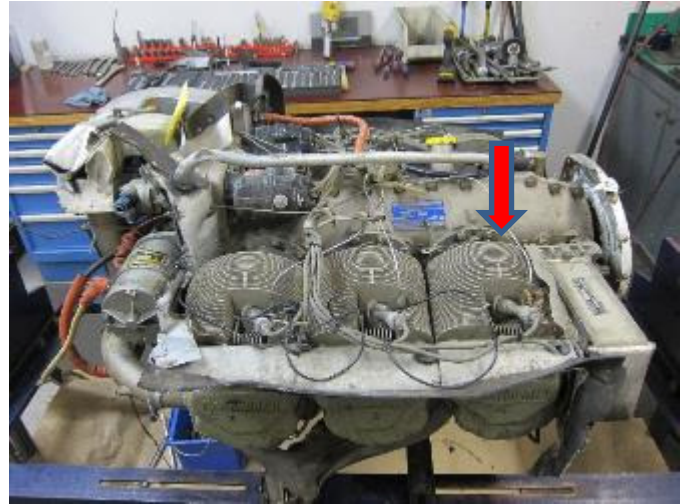
CYLINDER #5

Other than debris in the cooling fins and corrosion damage to cylinder wall surfaces, the cylinder was unremarkable.

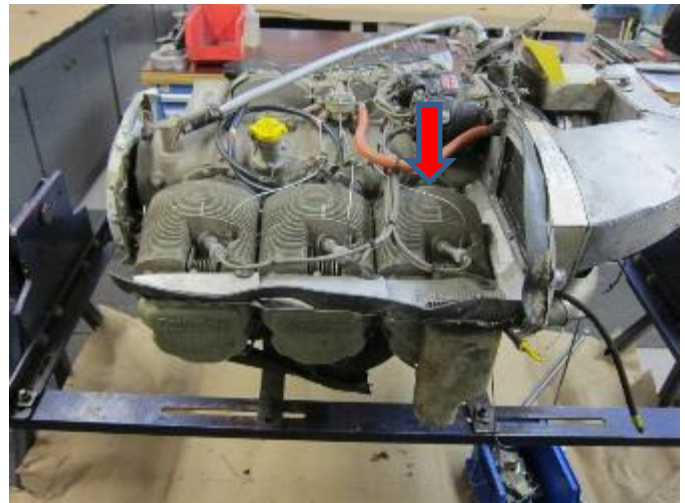
CYLINDER #2

Other than debris in the cooling fins and corrosion damage to cylinder wall surfaces, the cylinder was unremarkable.

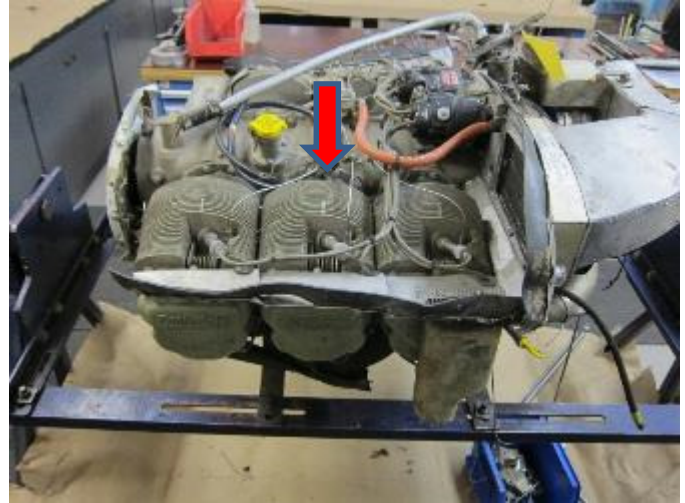
| CYLINDER #4 | P/N: ECI-AEC631397 | S/N: NA | Head Date: NA |

| Condition: | Other than debris in the cooling fins and corrosion damage to cylinder wall surfaces, the cylinder was unremarkable. | | |

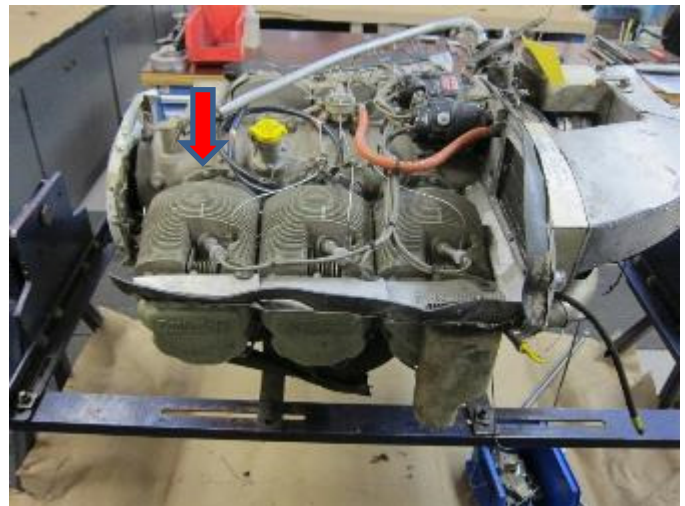
| CYLINDER #6 | P/N: ECI-AEC631397 | S/N: NA | Head Date: NA |

| Condition: | Other than debris in the cooling fins and corrosion damage to cylinder wall surfaces, the cylinder was unremarkable. | | |

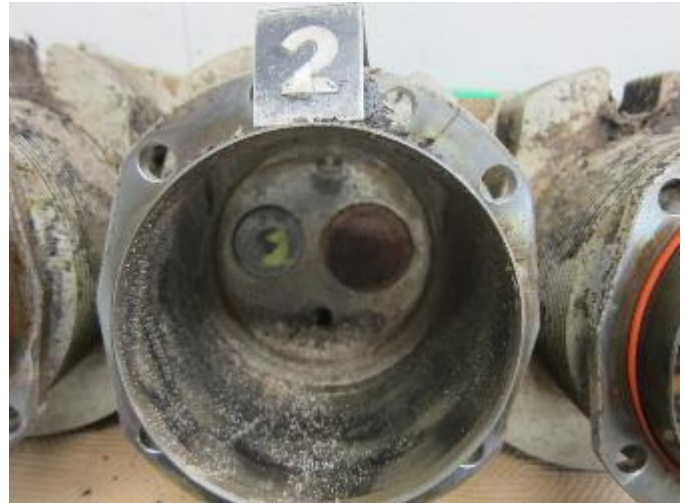
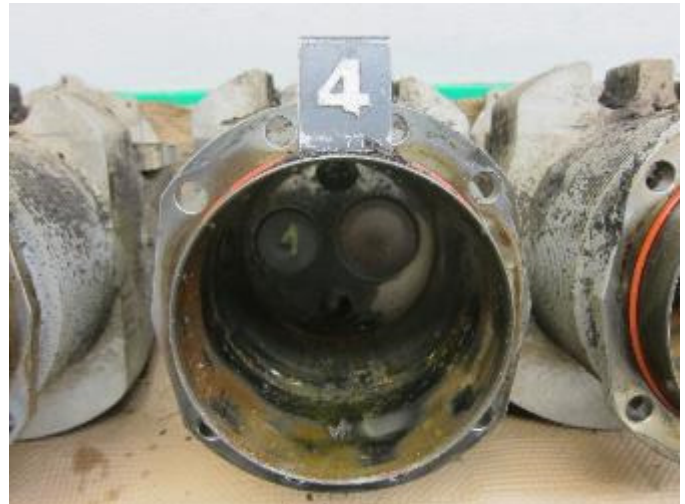
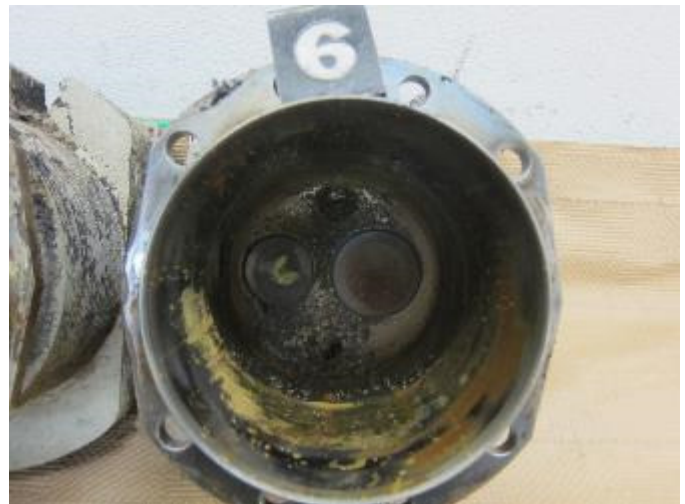
### VALVES AND GUIDES

All valves were intact and exhibited normal combustion deposits

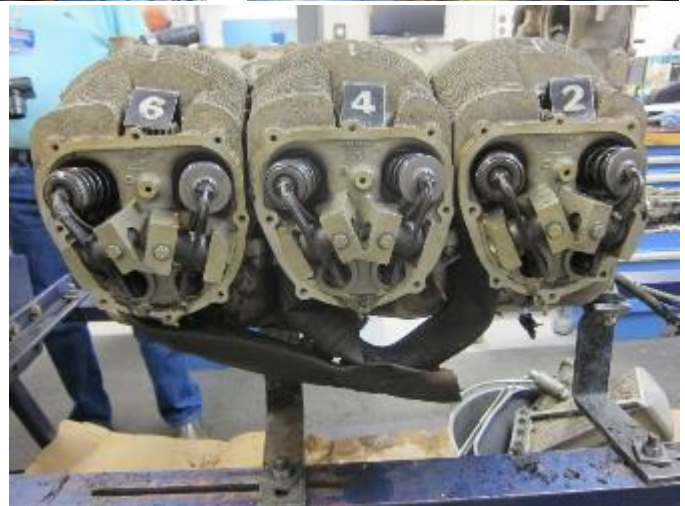
### ROCKER ARMS AND SHAFTS

All rocker arms, shafts, valves springs and retainers were intact.

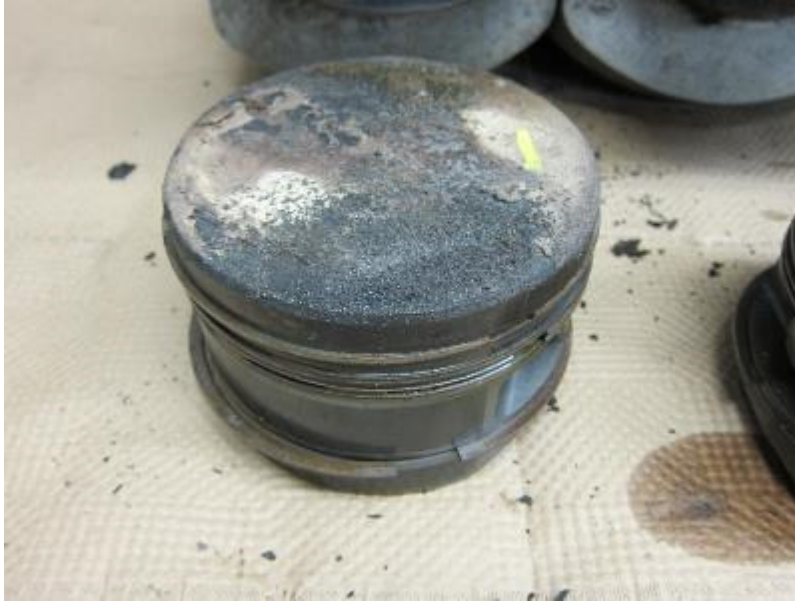
### #1 PISTON, RINGS AND PIN

| <b>Condition:</b> | The piston exhibited normal combustion deposits. Rings exhibited corrosion due to salt water immersion. |

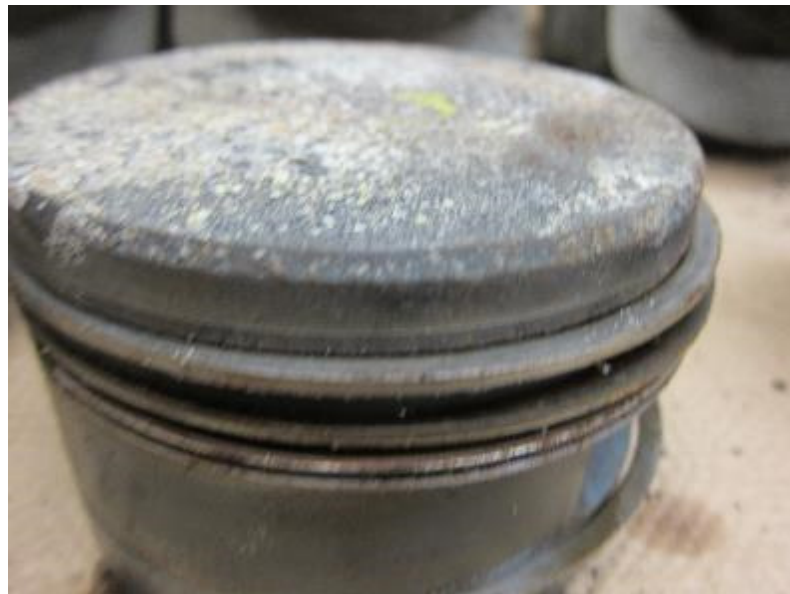
### #3 PISTON, RINGS AND PIN

| <b>Condition:</b> | The piston exhibited normal combustion deposits. Rings exhibited corrosion due to salt water immersion. |

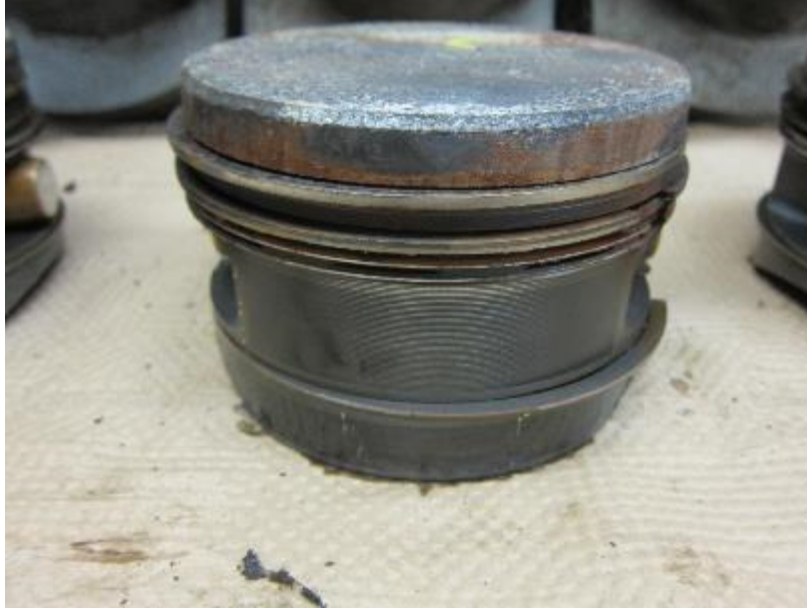
## #5 PISTON, RINGS AND PIN

The piston exhibited normal combustion deposits. Rings exhibited corrosion due to salt water immersion.

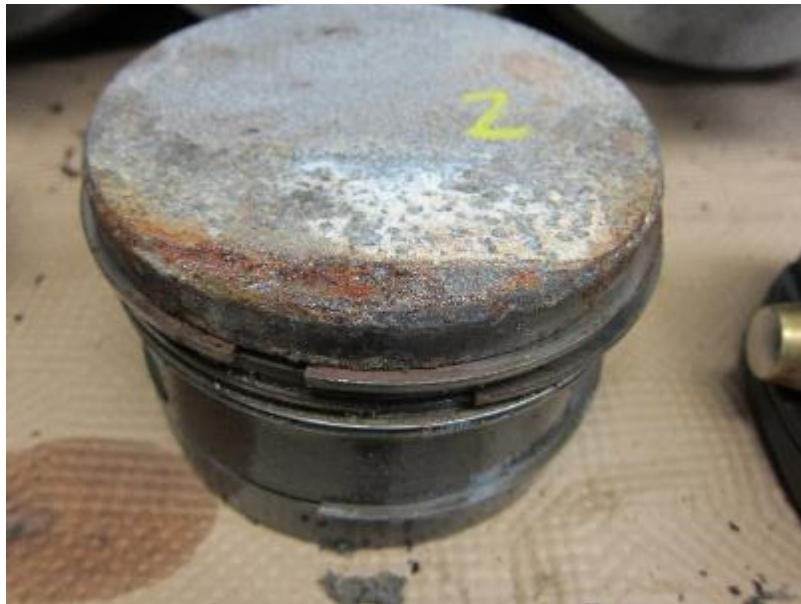
## #2 PISTON, RINGS AND PIN

The piston exhibited normal combustion deposits. Rings exhibited corrosion due to salt water immersion.

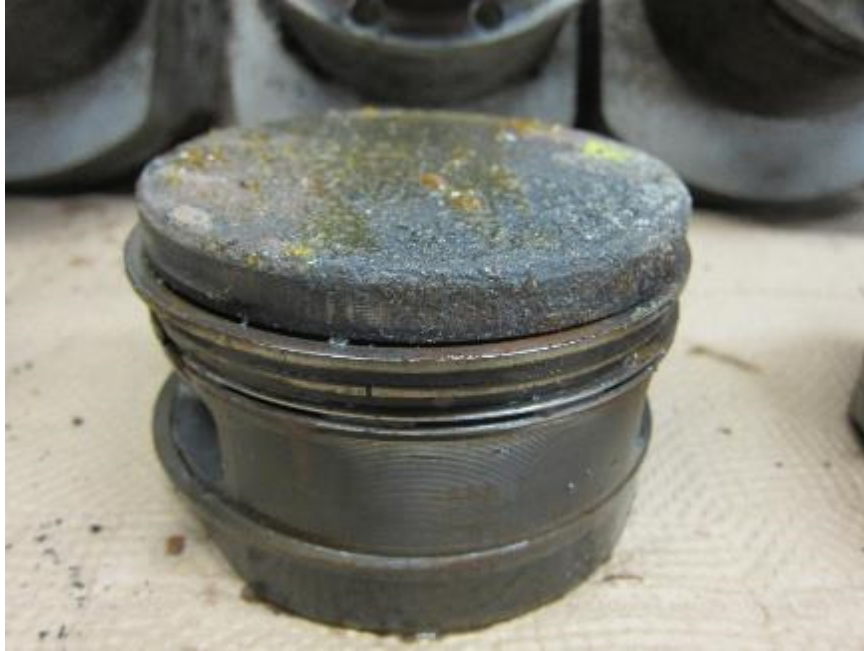
### #4 PISTON, RINGS AND PIN

The piston exhibited normal combustion deposits. Rings exhibited corrosion due to salt water immersion.

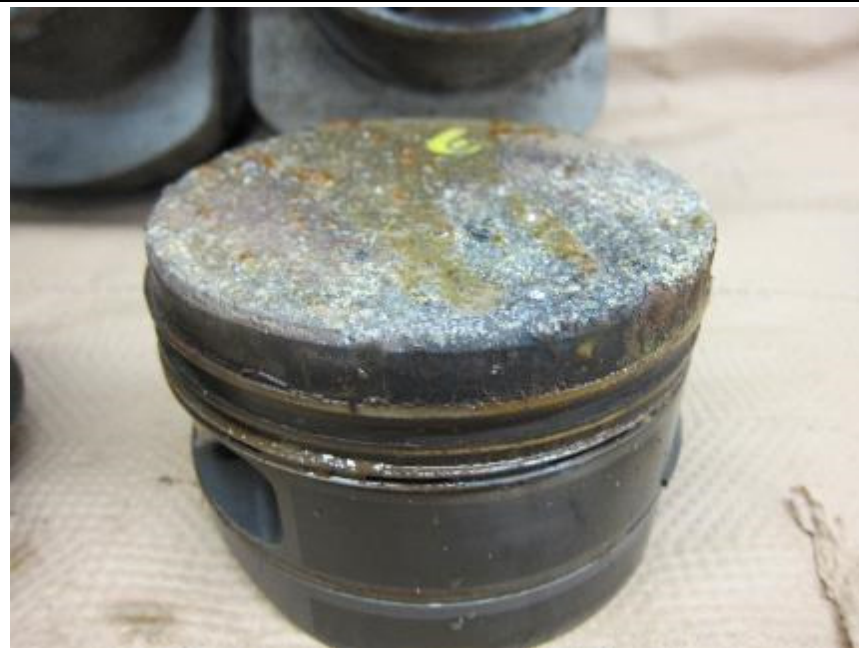
### #6 PISTON, RINGS AND PIN

The piston exhibited normal combustion deposits. Rings exhibited corrosion due to salt water immersion.

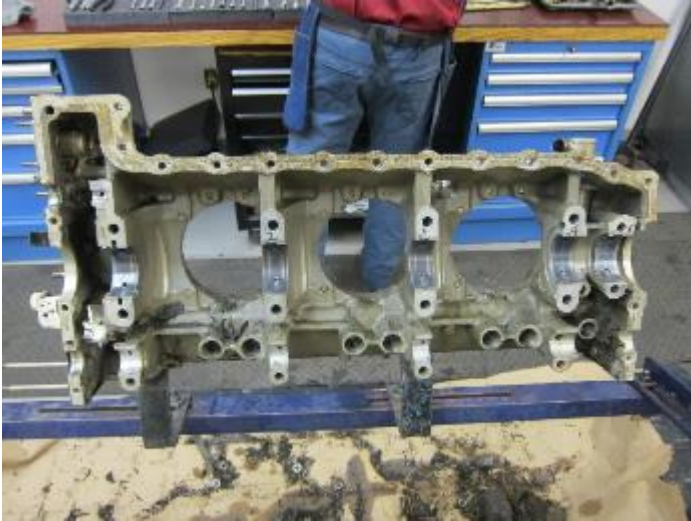
### CRANKCASE ASSEMBLY

| Condition: | The crankcase assembly was unremarkable. | | | |

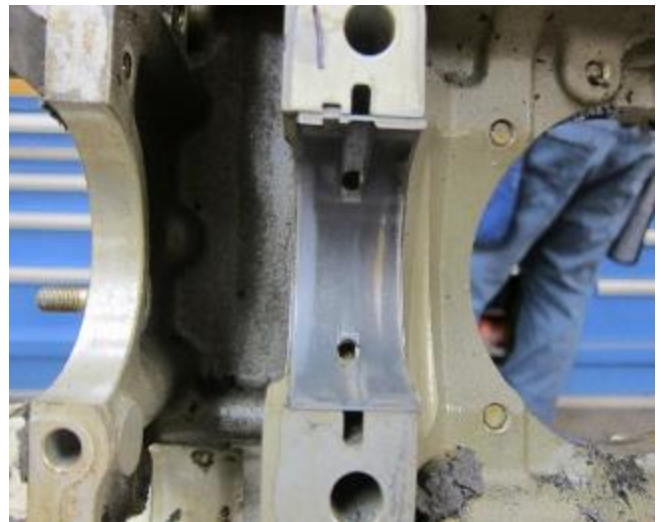
| <b>#1 MAIN BEARINGS</b> | P/N: 653547 | Date Code: 9/97 |

| Condition: | The bearing exhibited normal wear patterns. | |

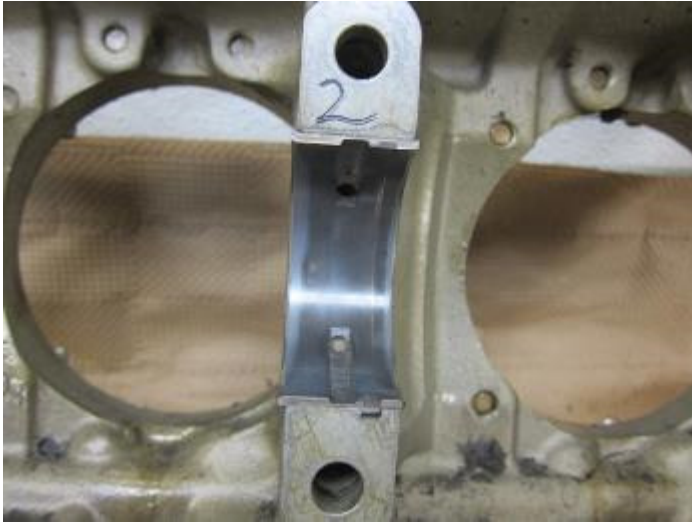
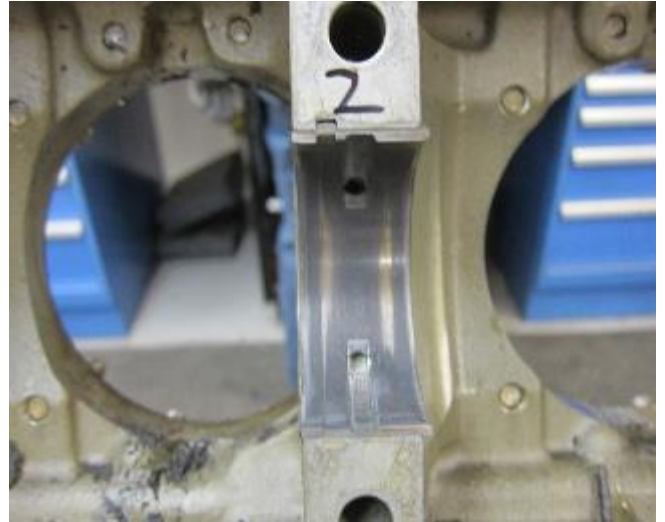
## #2 MAIN BEARINGS

Condition: The bearing exhibited normal wear patterns.

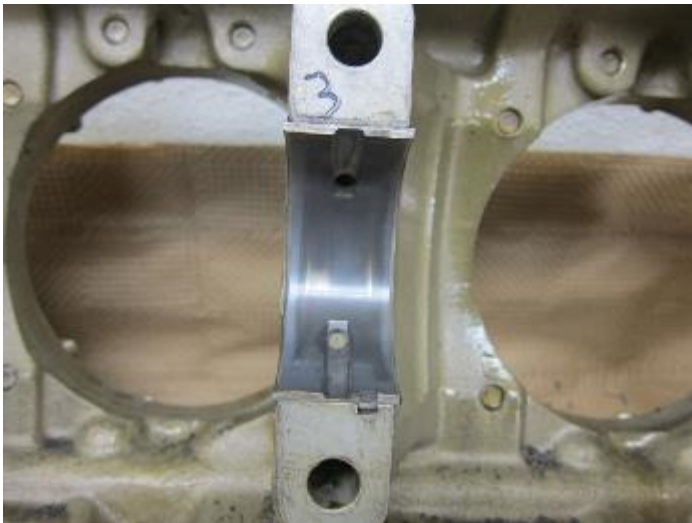
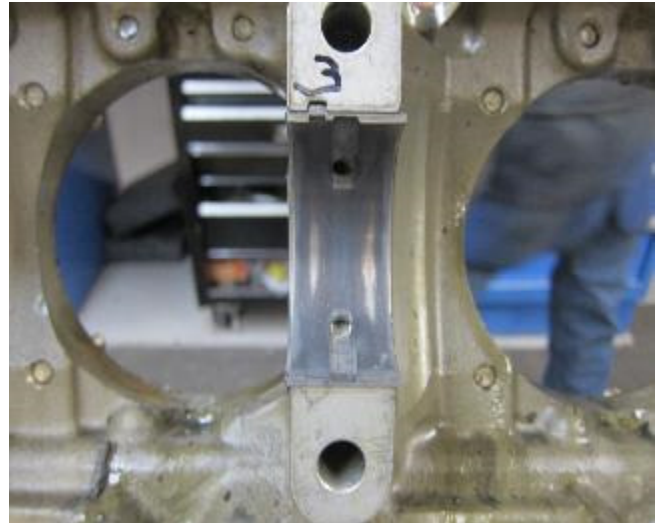
## #3 MAIN BEARINGS

Condition: The bearing exhibited normal wear patterns.

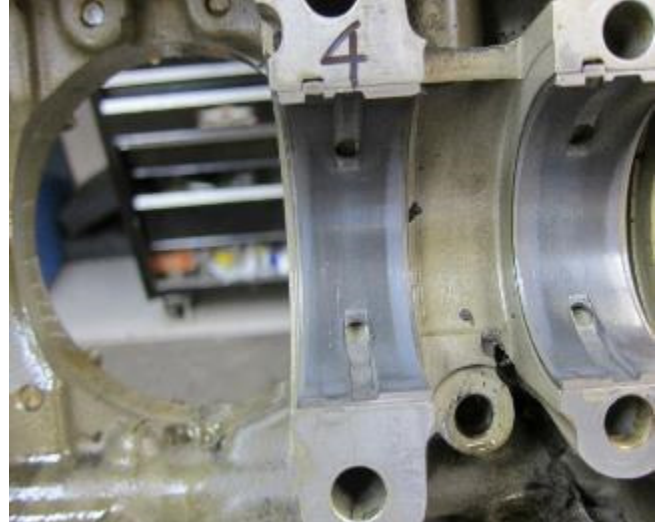
## #4 MAIN BEARINGS

The bearing exhibited normal wear patterns.

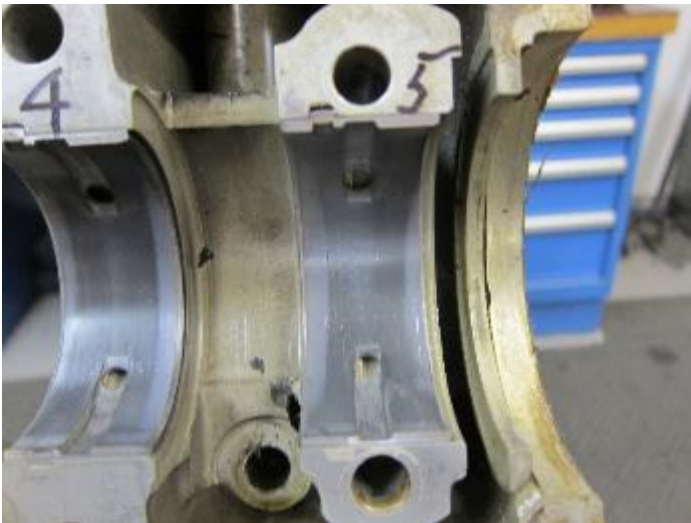
## #5 MAIN BEARINGS

The bearing exhibited normal wear patterns.

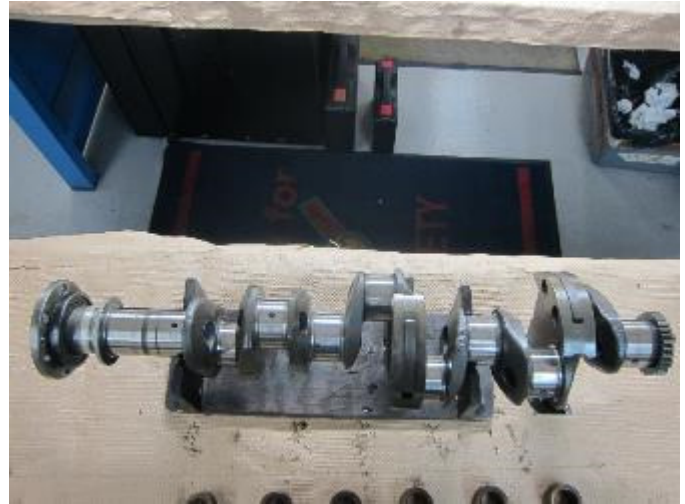
**CRANKSHAFT**

The crankshaft exhibited normal wear on bearing surfaces with a small amount of corrosion damage due to salt water immersion.

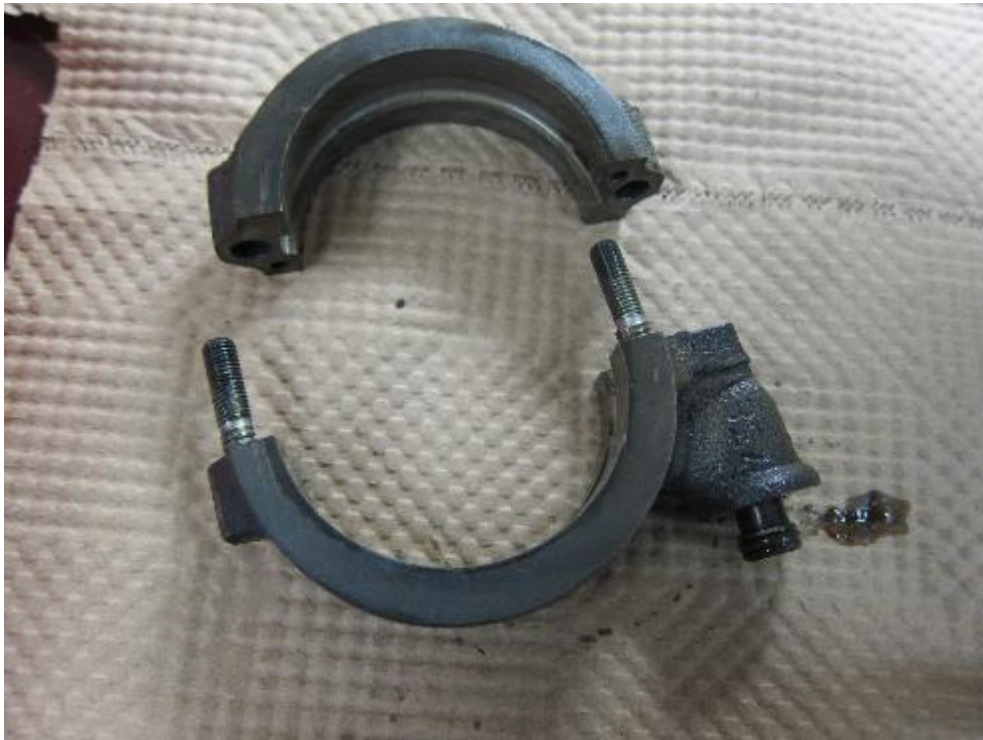
**TRANSFER COLLAR****Condition:**

Unremarkable. The bearing surfaces were normal.

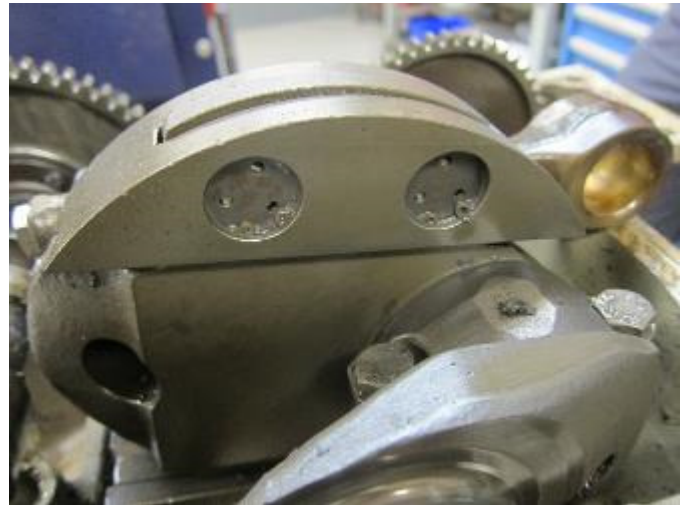
### COUNTER WEIGHTS

The counter weights were intact and moved freely on pins. All clips and plates were intact and unremarkable.

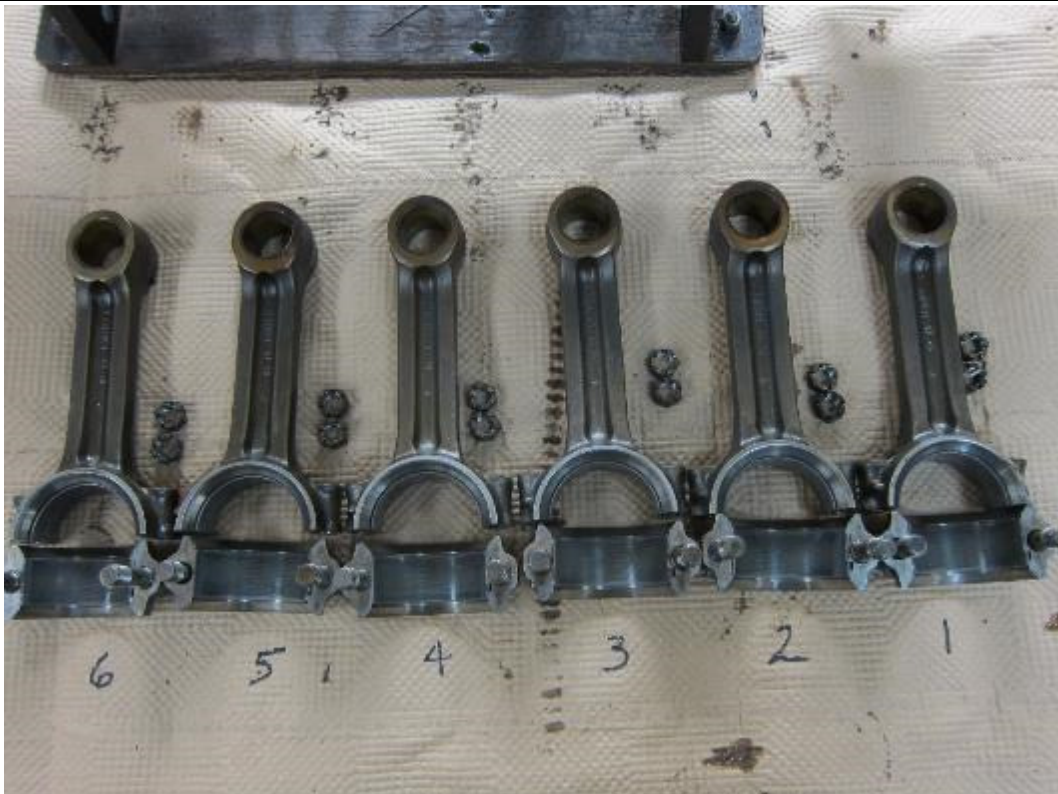
### CONNECTING RODS

All connecting rods, bolts and nuts were intact and unremarkable.

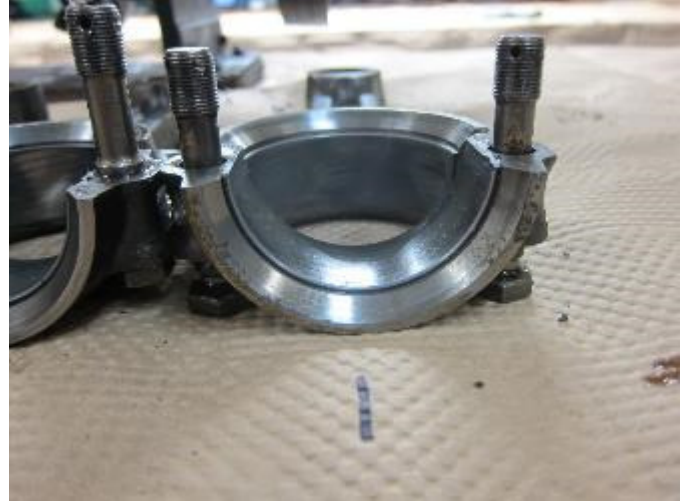
## #1 CONNECTING ROD BEARING

The rod bearings exhibited normal wear patterns.

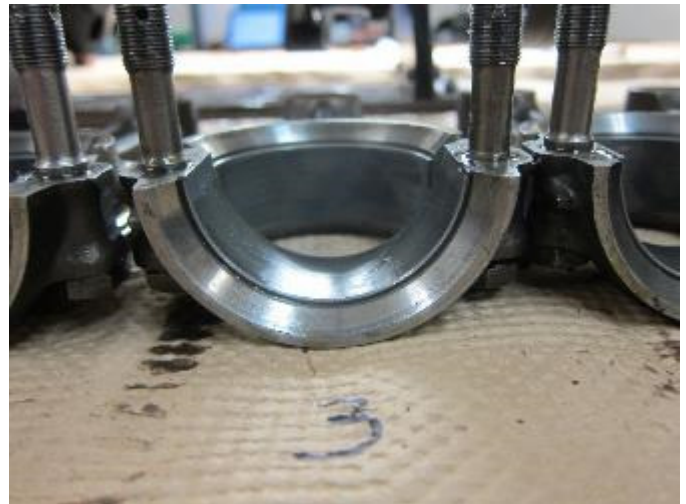
## #3 CONNECTING ROD BEARING

The rod bearings exhibited normal wear patterns.

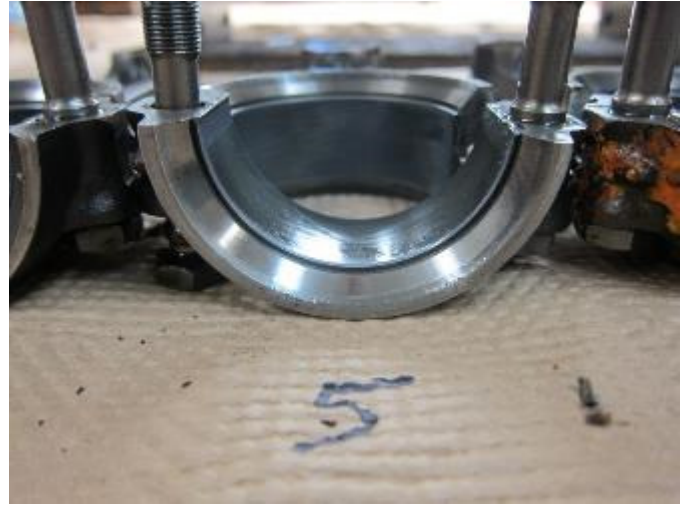
## #5 CONNECTING ROD BEARING

The rod bearings exhibited normal wear patterns.

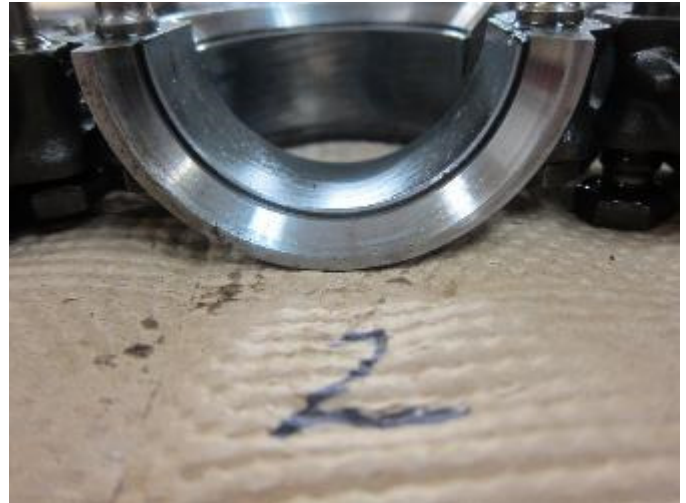
## #2 CONNECTING ROD BEARING

The rod bearings exhibited normal wear patterns.

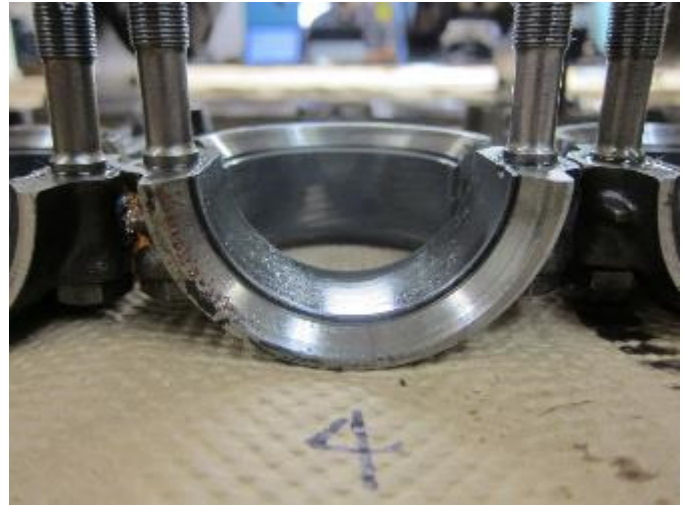
## #4 CONNECTING ROD BEARING

The rod bearings exhibited normal wear patterns.

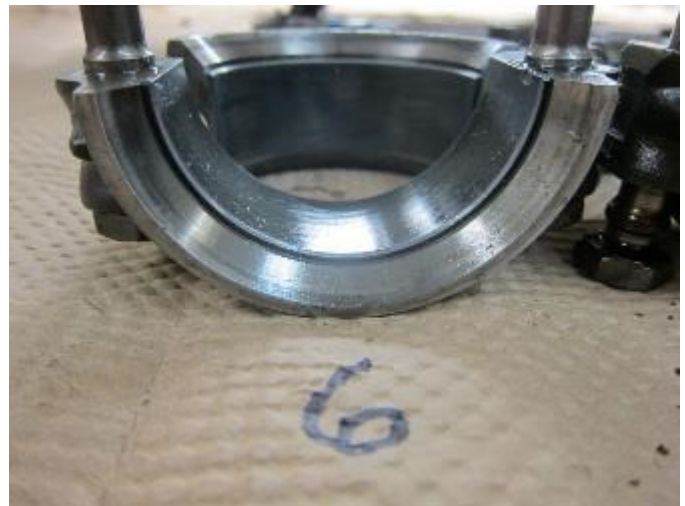
## #6 CONNECTING ROD BEARING

The rod bearings exhibited normal wear patterns.

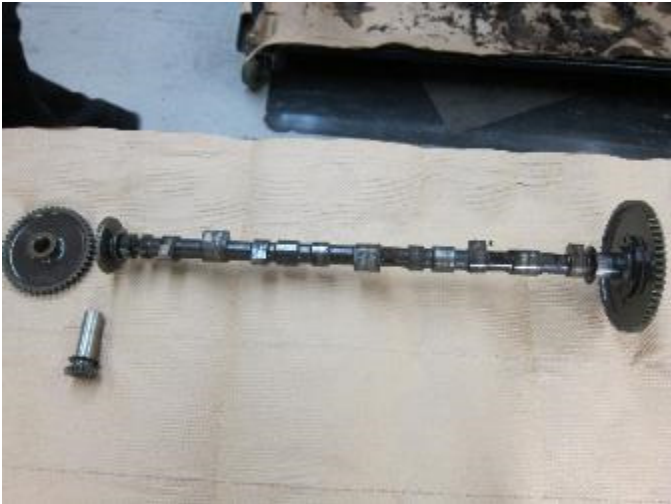
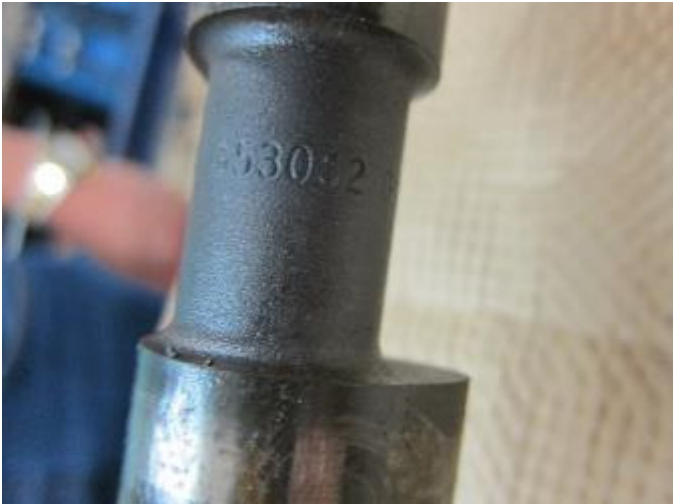
CAMSHAFT

| Condition: | The lobe bearing surfaces exhibited pitting from corrosion. | |
