# ENGINE EXAMINATION REPORT

| <b>ENGINE MODEL</b> | IO520A (35) |
| <b>AIRCRAFT MAKE &amp; MODEL</b> | Cessna 210D |
| <b>FILE NUMBER</b> | 18-307 |

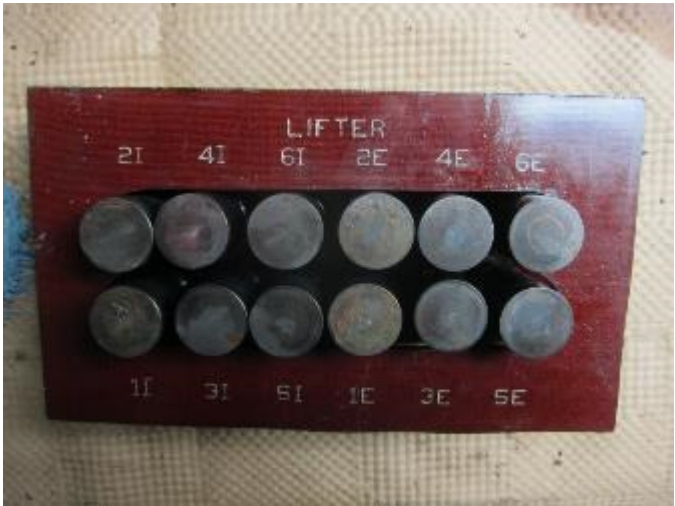
| LIFTERS | #1 | #3 | #5 | #2 | #4 | #6 |
|---|---|---|---|---|---|---|
| Condition: | Lifter faces exhibited a slight amount of surface pitting.<br>Intake Lifter Part Number: SA628488<br>Exhaust Lifter Part Number: SA646277 | | | | | |

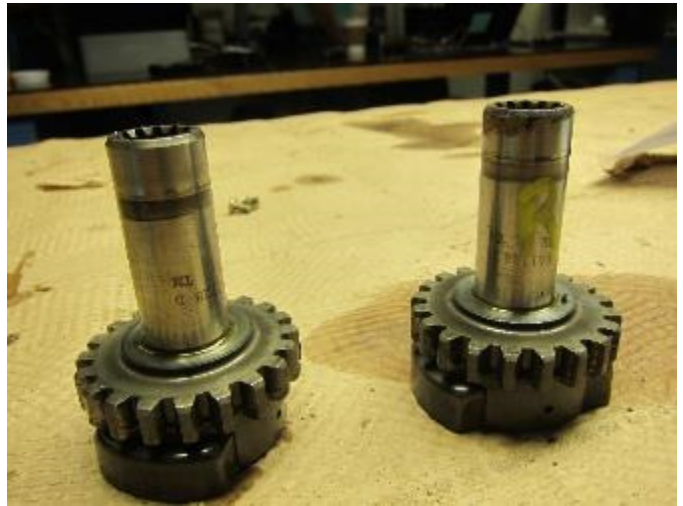
| ACCESSORY GEARS | |

| Condition: | Accessory gears were unremarkable. |

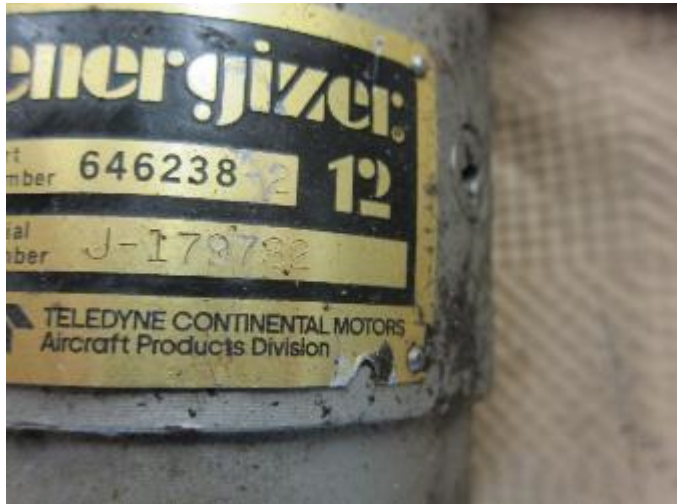
| STARTER | Manufacturer: CMI Energizer | P/N: 646238-2 | S/N: J-179782 |
| Condition: | The starter motor would not rotate manually due to salt water immersion. | | |

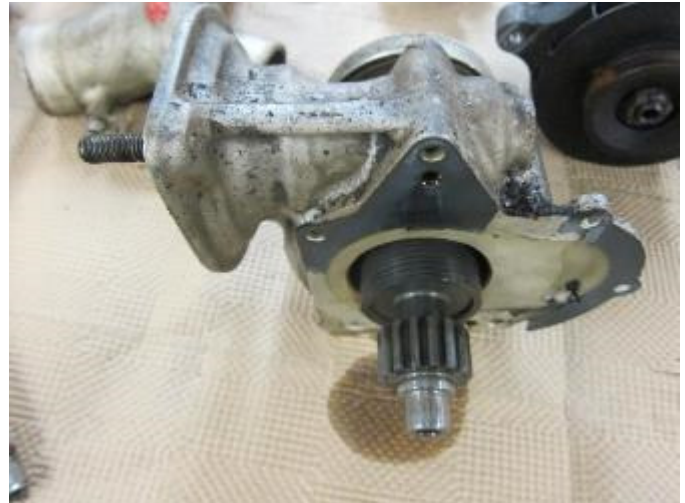
## STARTER ADAPTER

Condition: Unremarkable

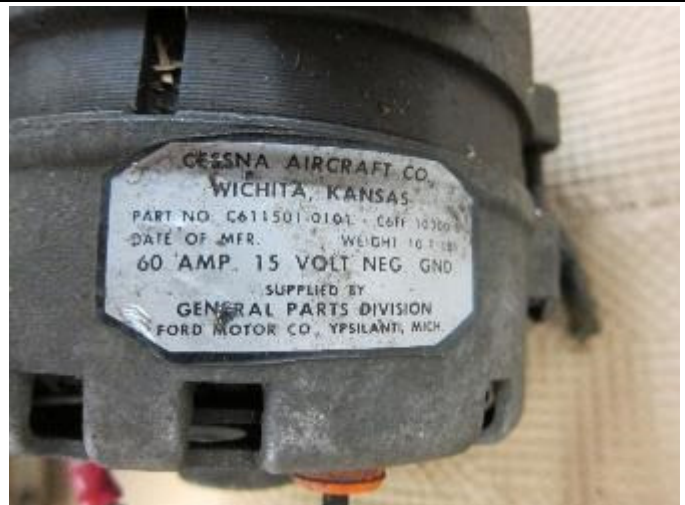
## ALT #1

Condition: Unremarkable

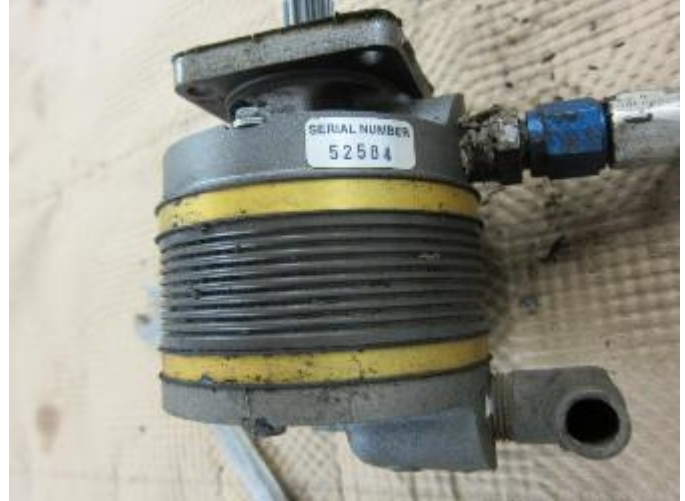
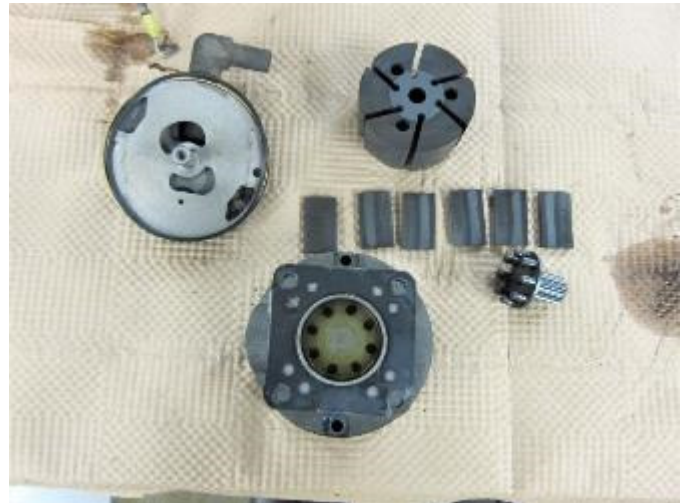
## VACUUM PUMP

Condition: The vacuum pump rotated manually, and shear drive couplings were intact. The carbon rotor and individual vanes were intact.

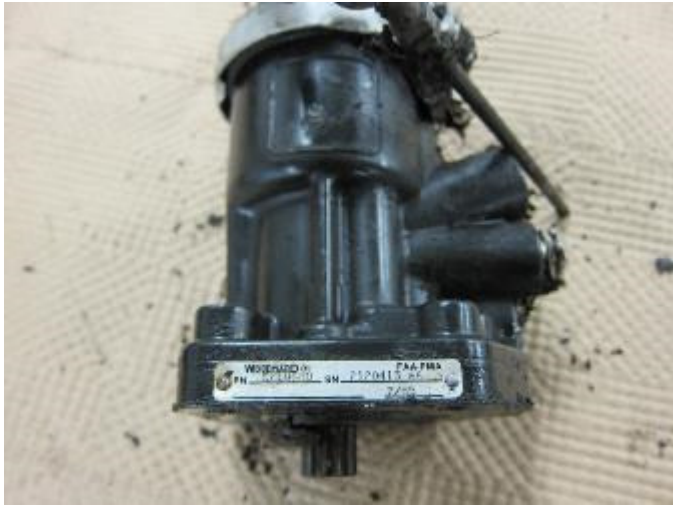
| PROPELLER GOVERNOR | Manufacturer: Woodward | P/N: C210680 | S/N: 2120413AA |
| Condition: | Unremarkable. | | |
