**NATIONAL TRANSPORTATION SAFETY BOARD**

**Global Positioning System (GPS) & Attitude Heading  
Reference System (AHRS) Device**

**Specialist's Factual Report**

Location: Fort Lauderdale, FL  
Date: December 1, 2018  
Aircraft: Cessna 335  
Registration: N79HP  
Operator: Private  
NTSB Number: ERA19FA060

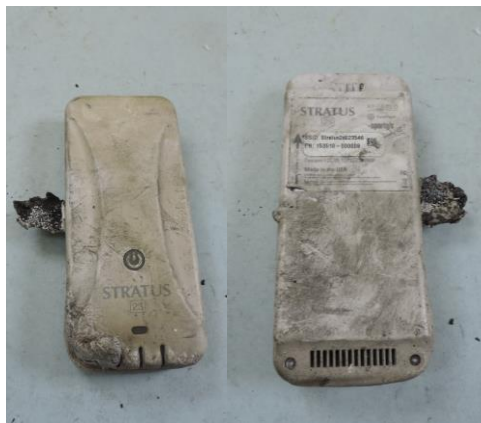
Upon arrival at the Vehicle Recorder Laboratory, an examination revealed the unit had sustained impact and fire damage. The unit is shown in figure 1.

Figure 1. Photo of unit.

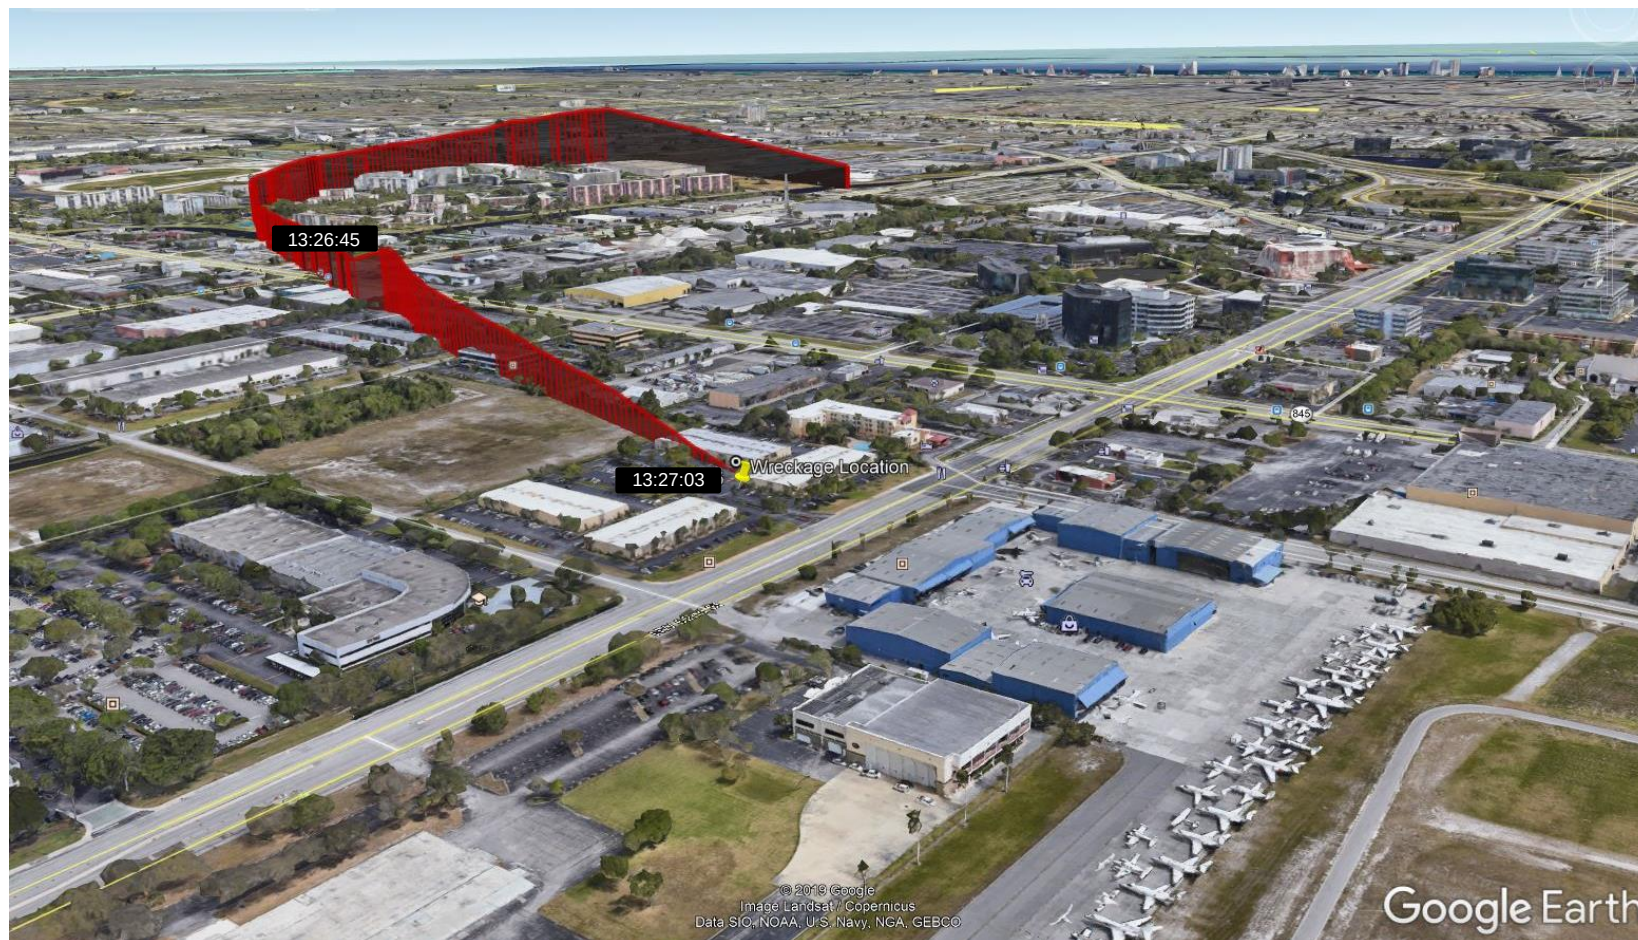
Figure 7 is a detailed view of the overall flight path.

Figure 7. A detailed overall view of the recorded flight data.
