**NATIONAL TRANSPORTATION SAFETY BOARD**

## **Global Positioning System**

**Factual Report**  
**By Heidi Kemner**

Location: Blairsville, Georgia  
Date: December 19, 2018  
Aircraft: Piper PA-28-181  
Registration: N6143J  
NTSB Number: ERA19FA070

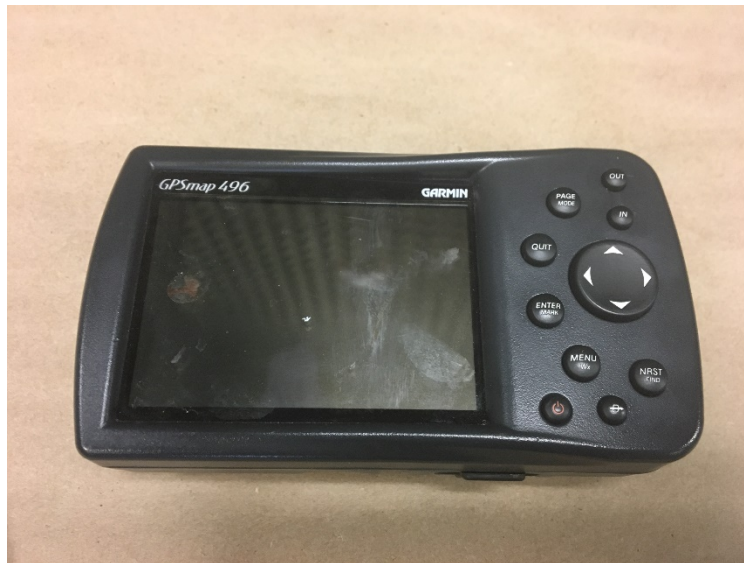
The device was undamaged and was downloaded normally using the manufacturer's software. Figures 1 and 2 show the front and back of the device.

**Figure 1. Photo of undamaged device.**

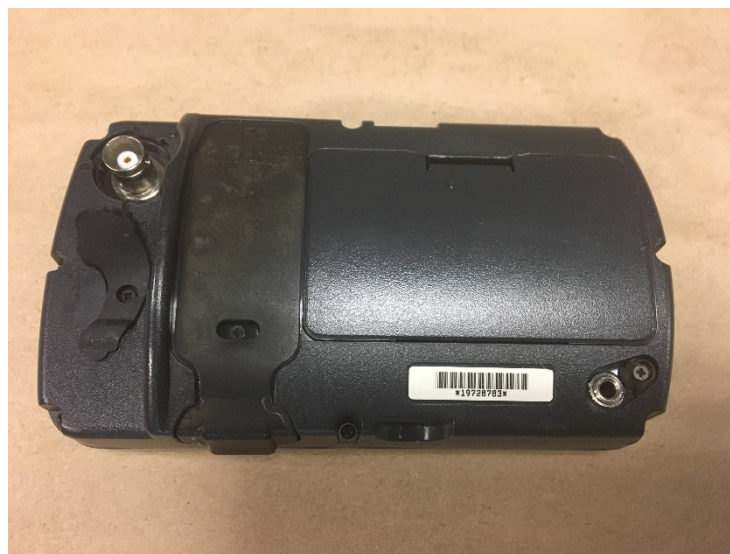
**Figure 2. View of back of GPS**

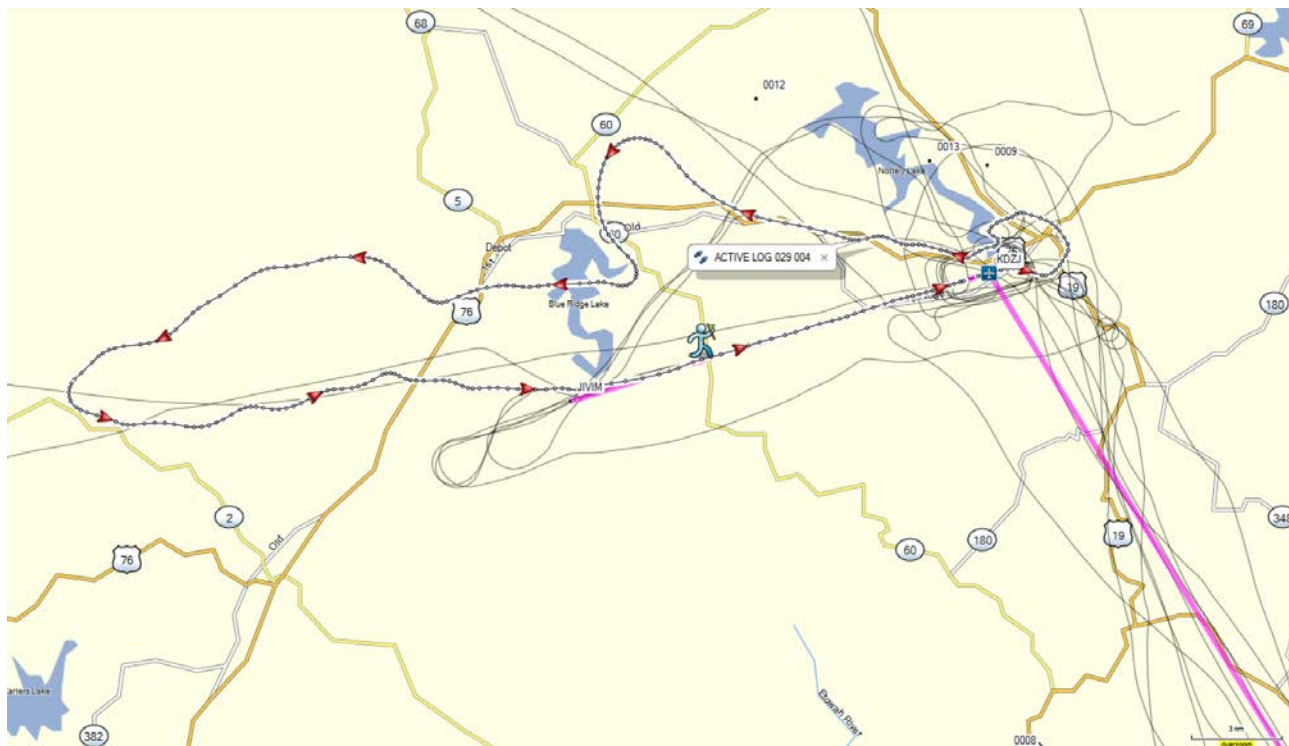
Figure 4. View of accident flight route.

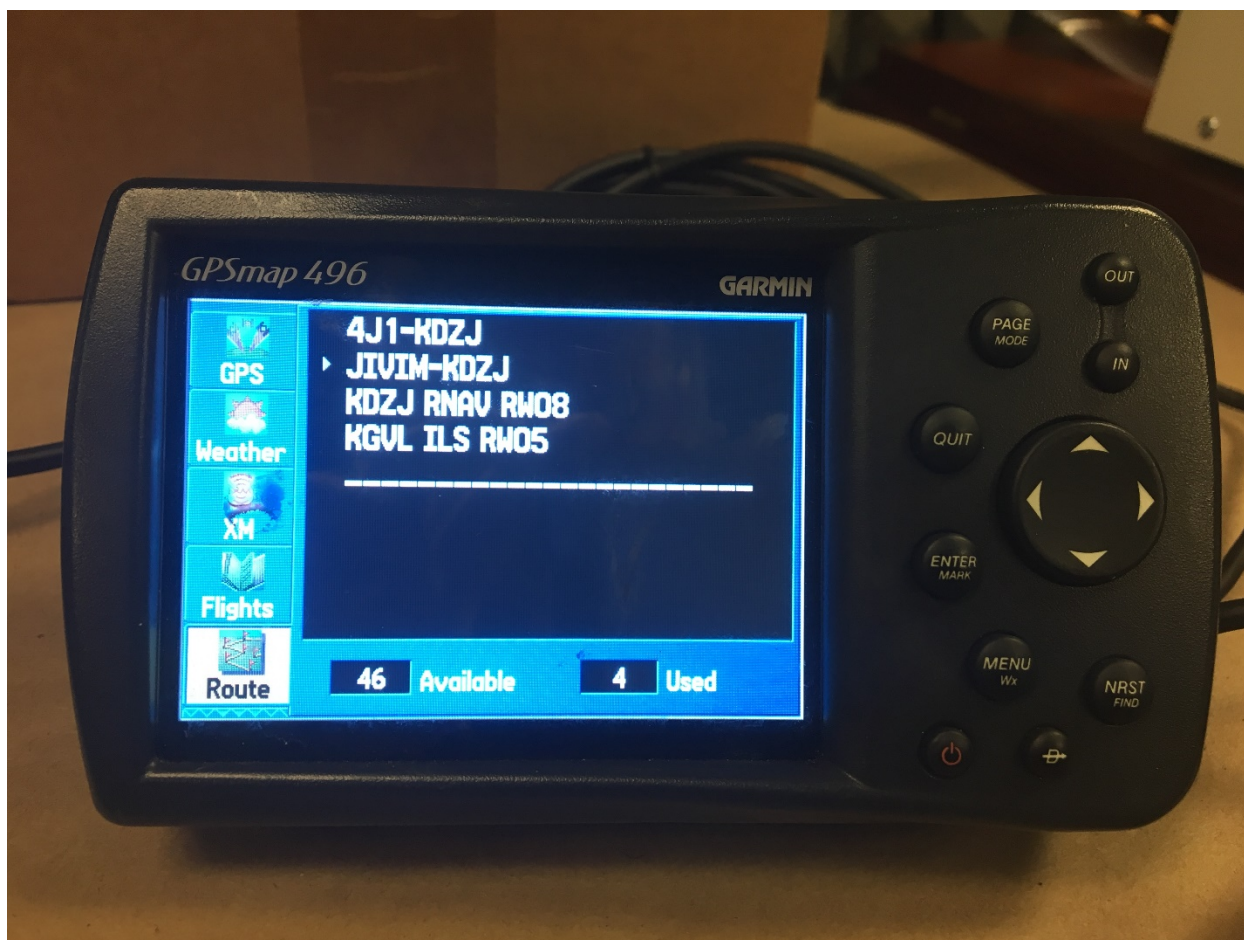
The Garmin unit was examined and there were 4 routes programed into the GPS. See Figure 5.

Figure 5. View of routes programed into Garmin GPS Map 496.

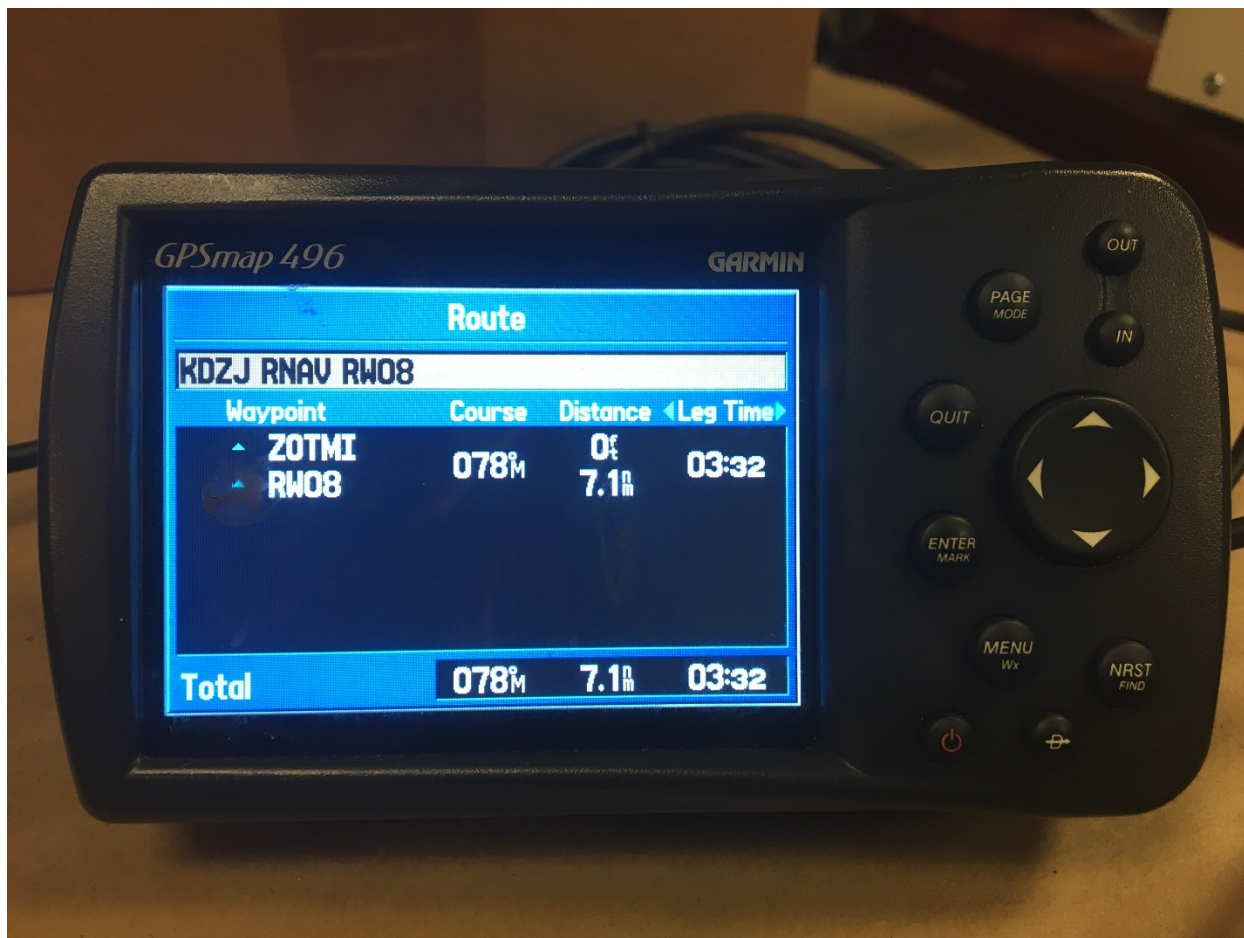
Further examination of the KDZJ RNAV RW08 route revealed that there were two waypoints noted in the route. They were ZOTMI and RW 08 at DZJ. See figure 7.

Figure 7. View of KDZJ RNAV RW08 route programed into GPS.
