## **NATIONAL TRANSPORTATION SAFETY BOARD**

### **Factual Report**

# **METEOROLOGY**

ERA19FA113

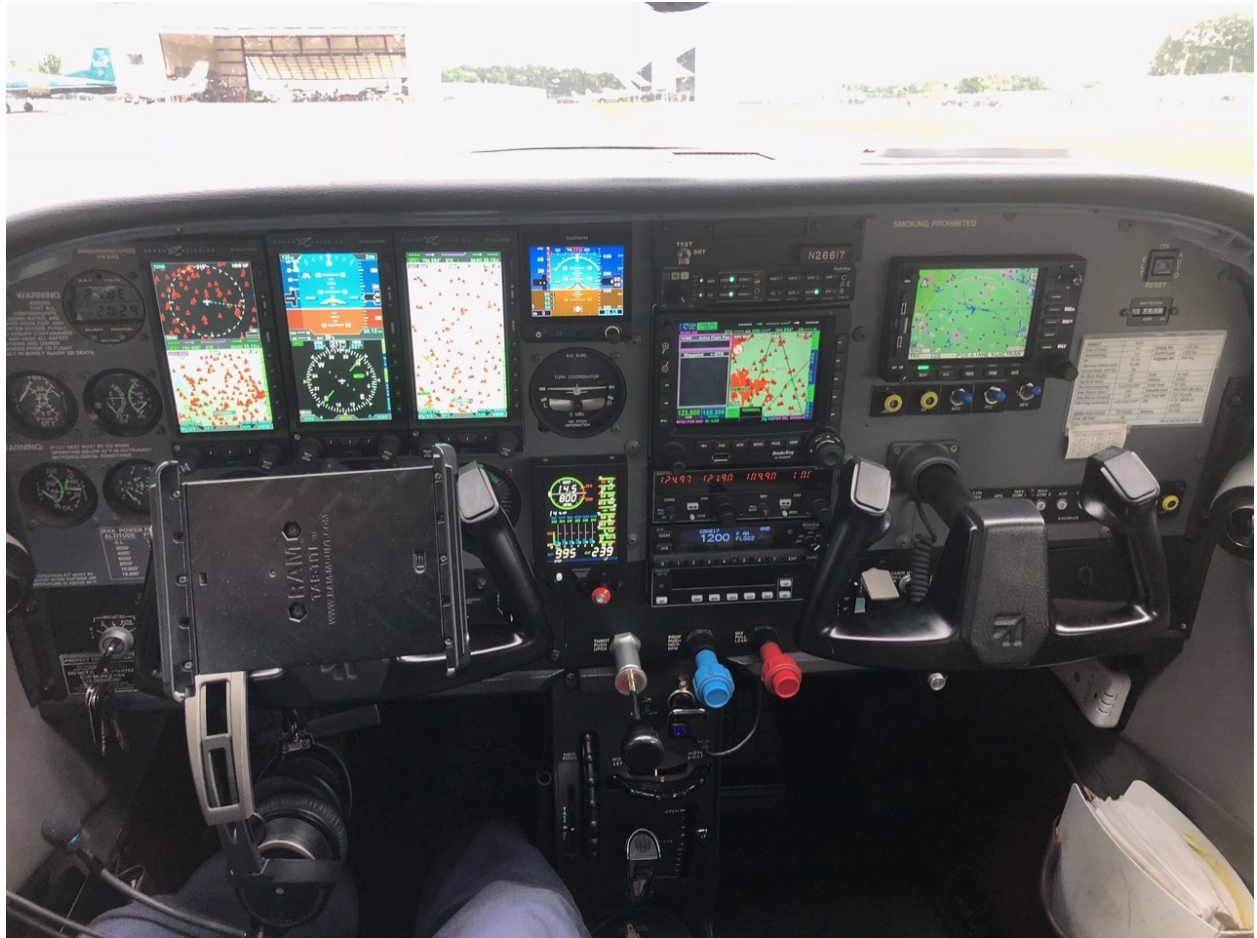
**Figure 18 – Exemplar cockpit image of the accident aircraft**

The airplane was equipped with a glass cockpit<sup>25</sup> (exemplar image in figure 18), which could be optionally fitted to be able to display XM Weather information with a subscription. If the accident pilot had been viewing XM Weather composite radar information he would have had a chance to view something similar to figures 19 through 22 (time in figures in CST), which was XM Weather composite radar information available around and before the accident time. The scale used in the XM Weather composite radar information is located in figure 23. There was an unknown time delay of the XM weather composite images made available to the accident pilot in the cockpit.<sup>26</sup> The XM Weather composite radar images from 1914 through 1929 EST displayed 20 to 30 dBZ values above the accident site. For additional information regarding the XM Weather composite radar data please see attachment 6.
