# NTSB MEMORANDUM FOR RECORD

**Date: July 17<sup>th</sup>, 2019**  
**Person Contacted: Jordan Paskevich (Rotax Engines)**  
**NTSB Accident Number: ERA19FA200**

## Follow-up Engine Examination Notes (FAA, Rotax Engines)

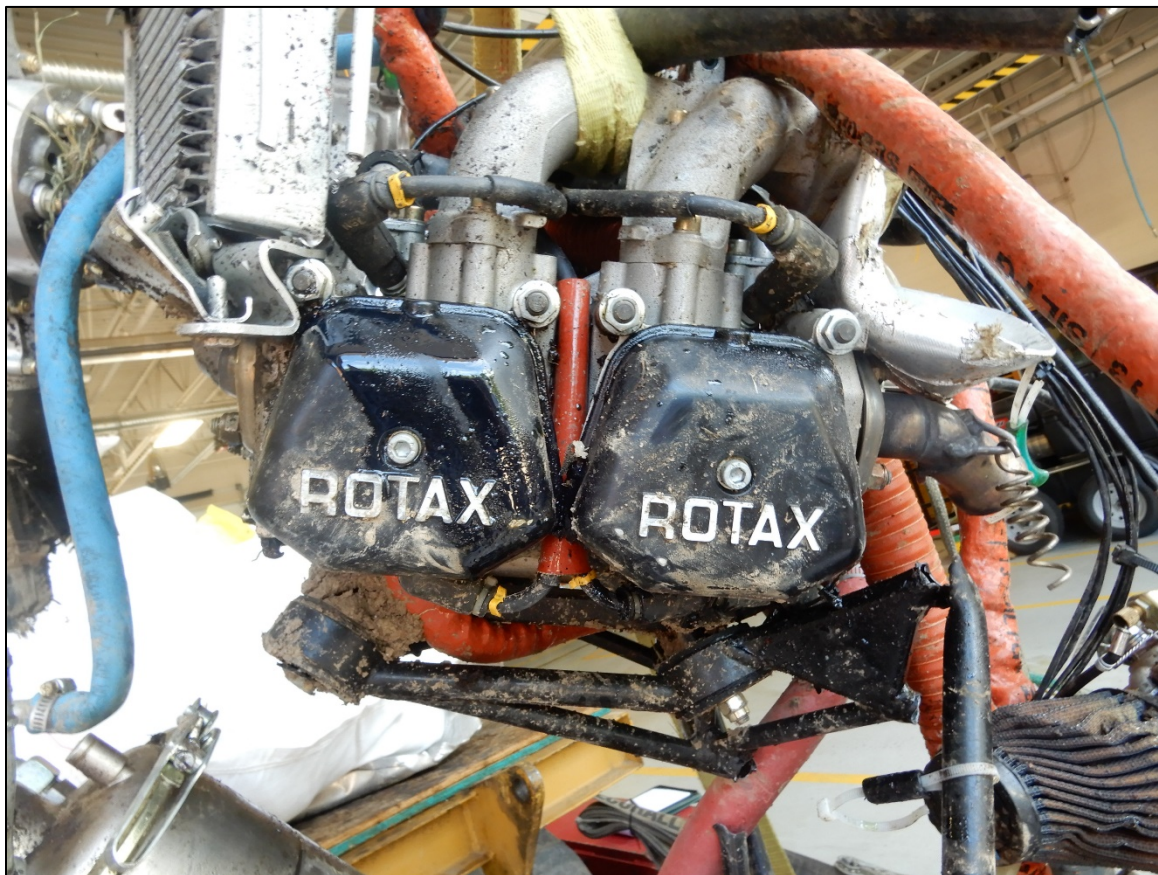
Photo 1: View of the left side of the engine

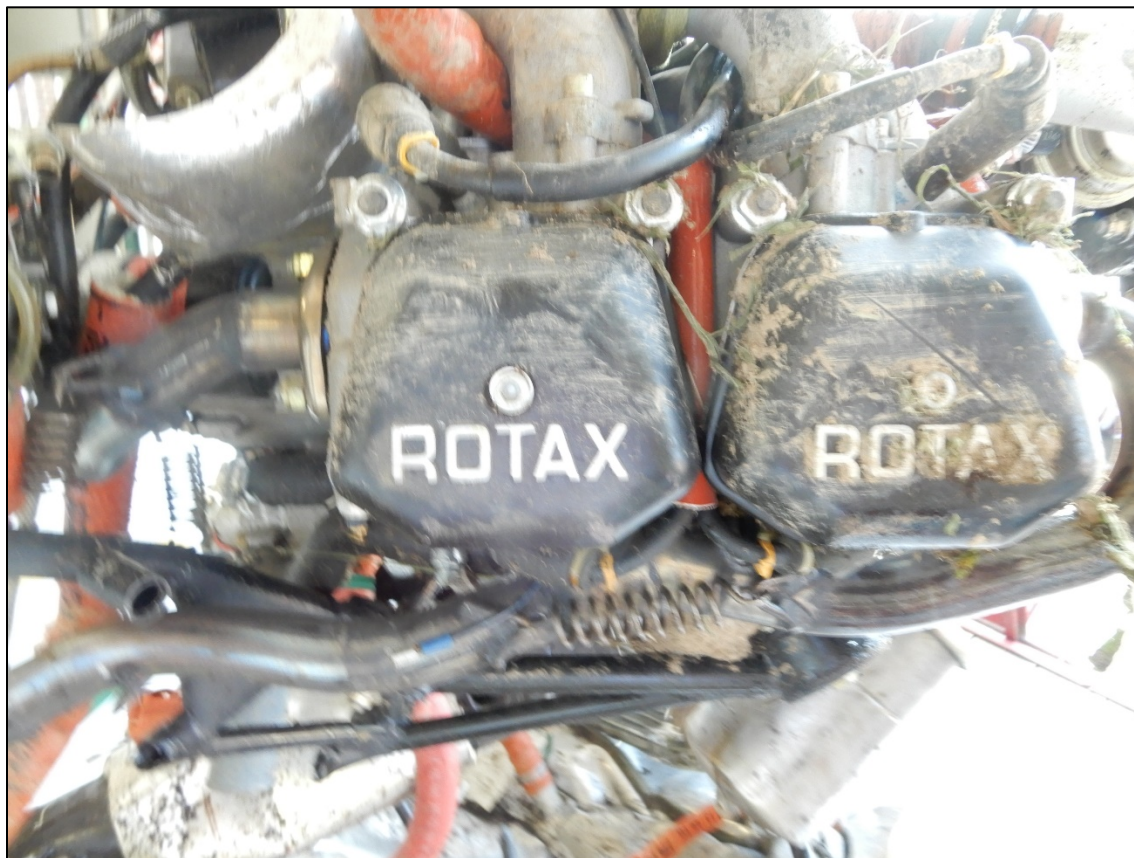
Photo 2:View of the right side of the engine

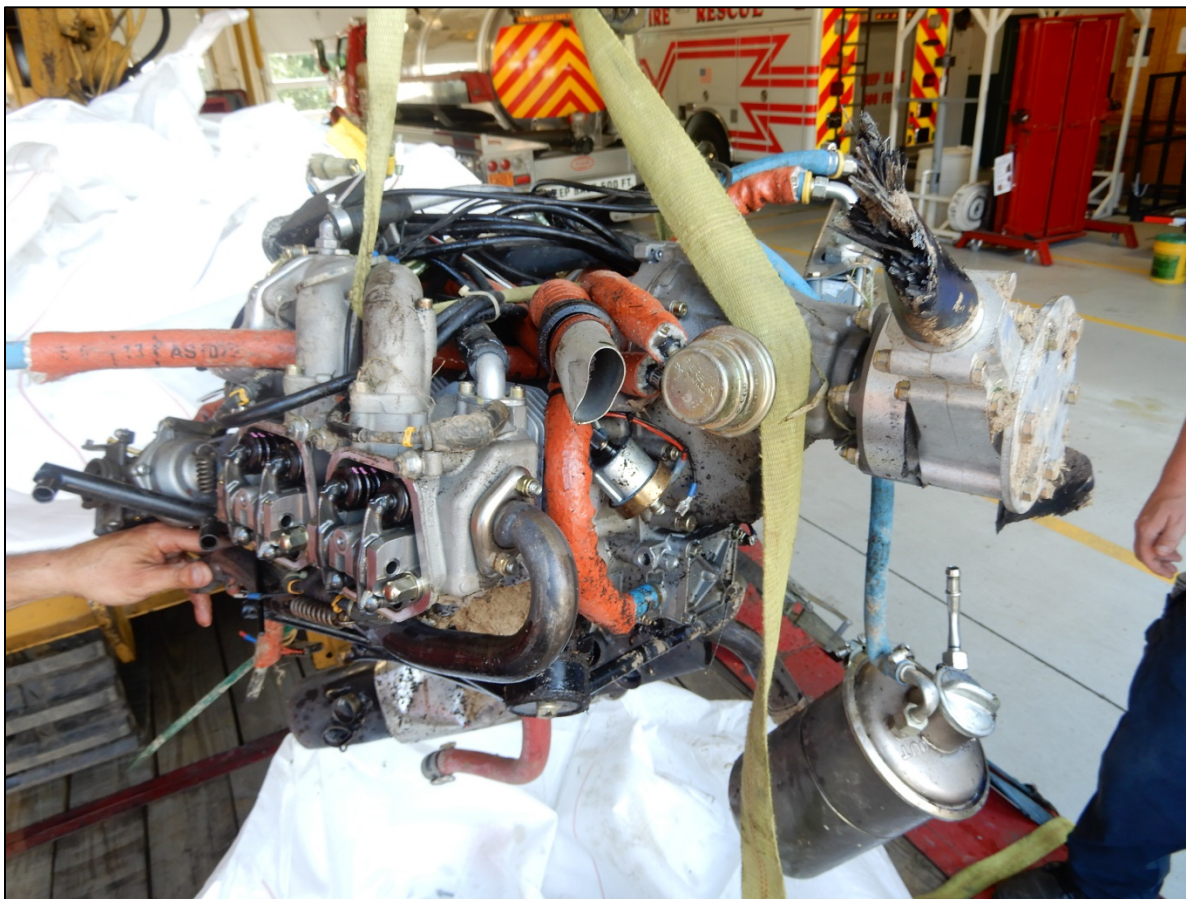
Photo 3: View of the right side of the engine and the propeller fragments

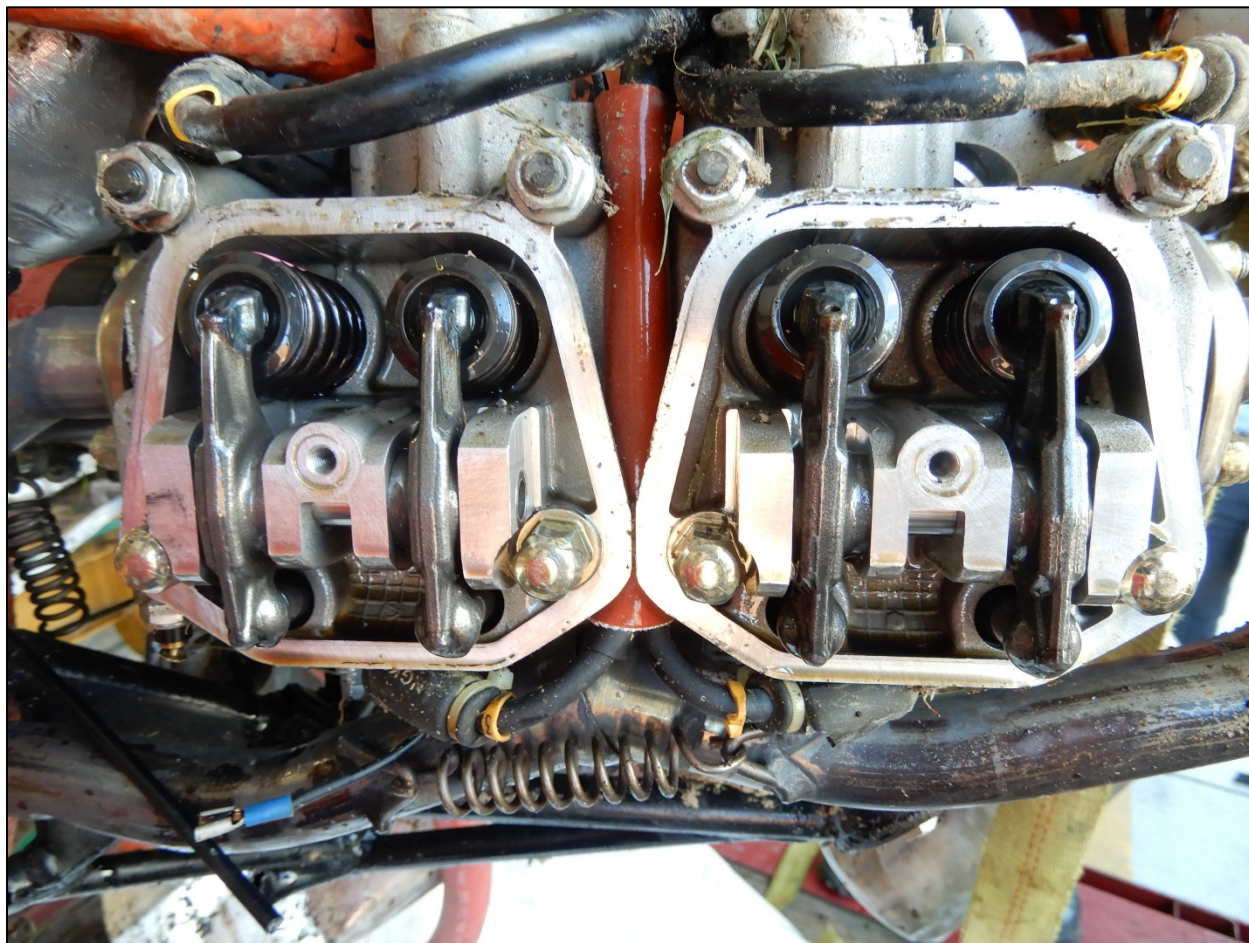
Photo 4: View of the right side of the engine with the cylinder covers removed

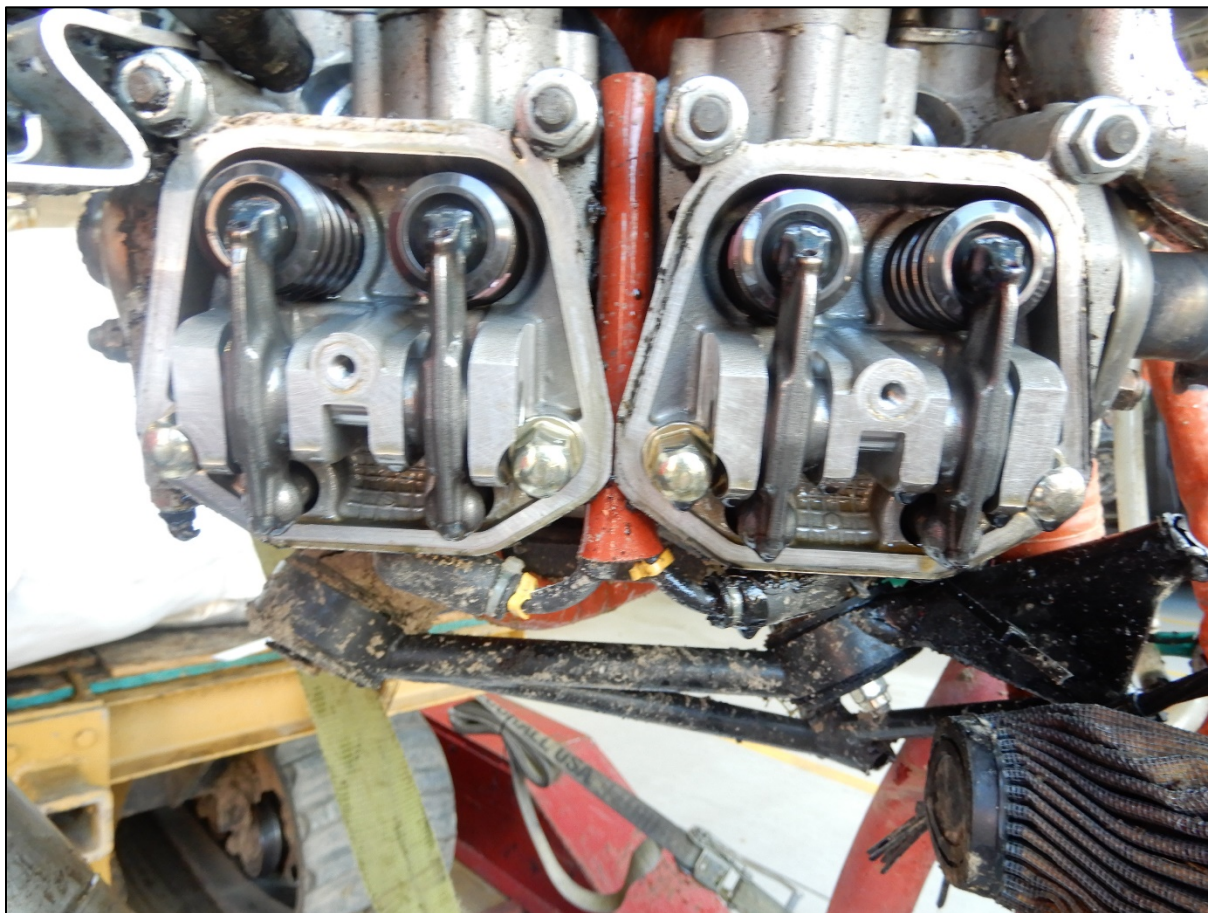
Photo 5: View of the left side of the engine with the cylinder covers removed

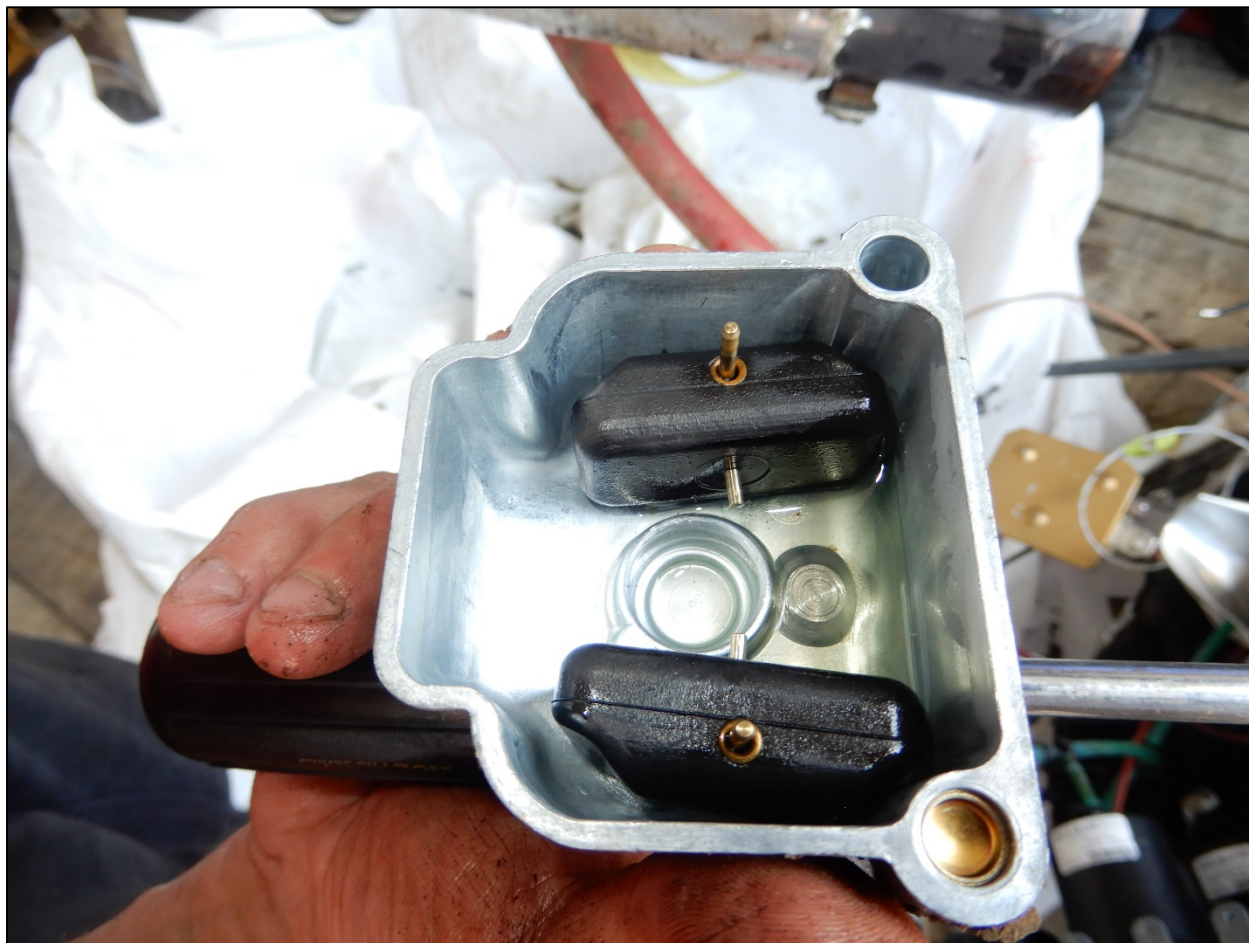
Both carburetor float bowls were free of debris and contamination. Both carburetor butterfly valves sustained impact damage. The pierburg fuel pump functioned normally during the engine test run.

Photo 6: View of the carburetor float bowl with remnants of fuel inside

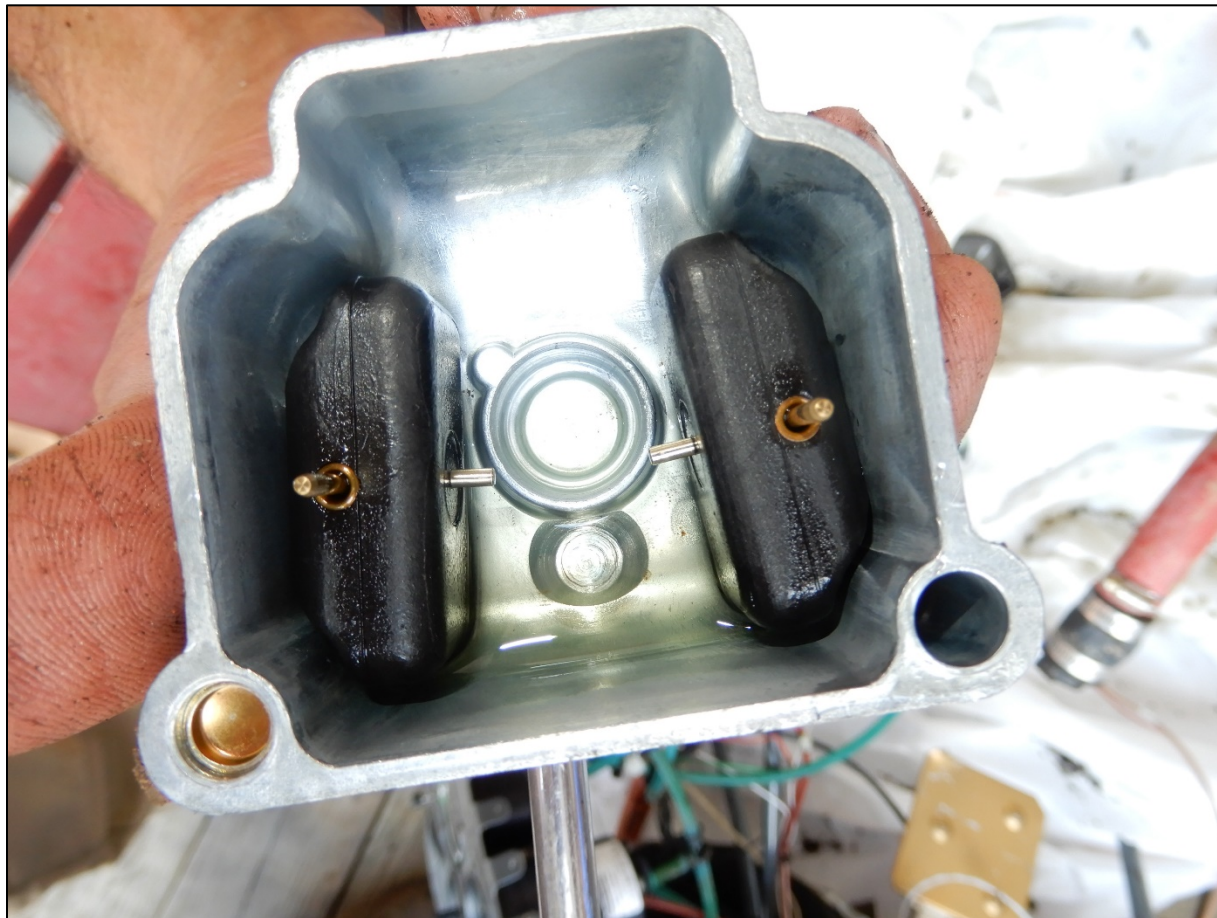
Photo 7: View of the carburetor float bowl with remnants of fuel inside
