# Wreckage Path Images

ERA19FA240 | N4082S

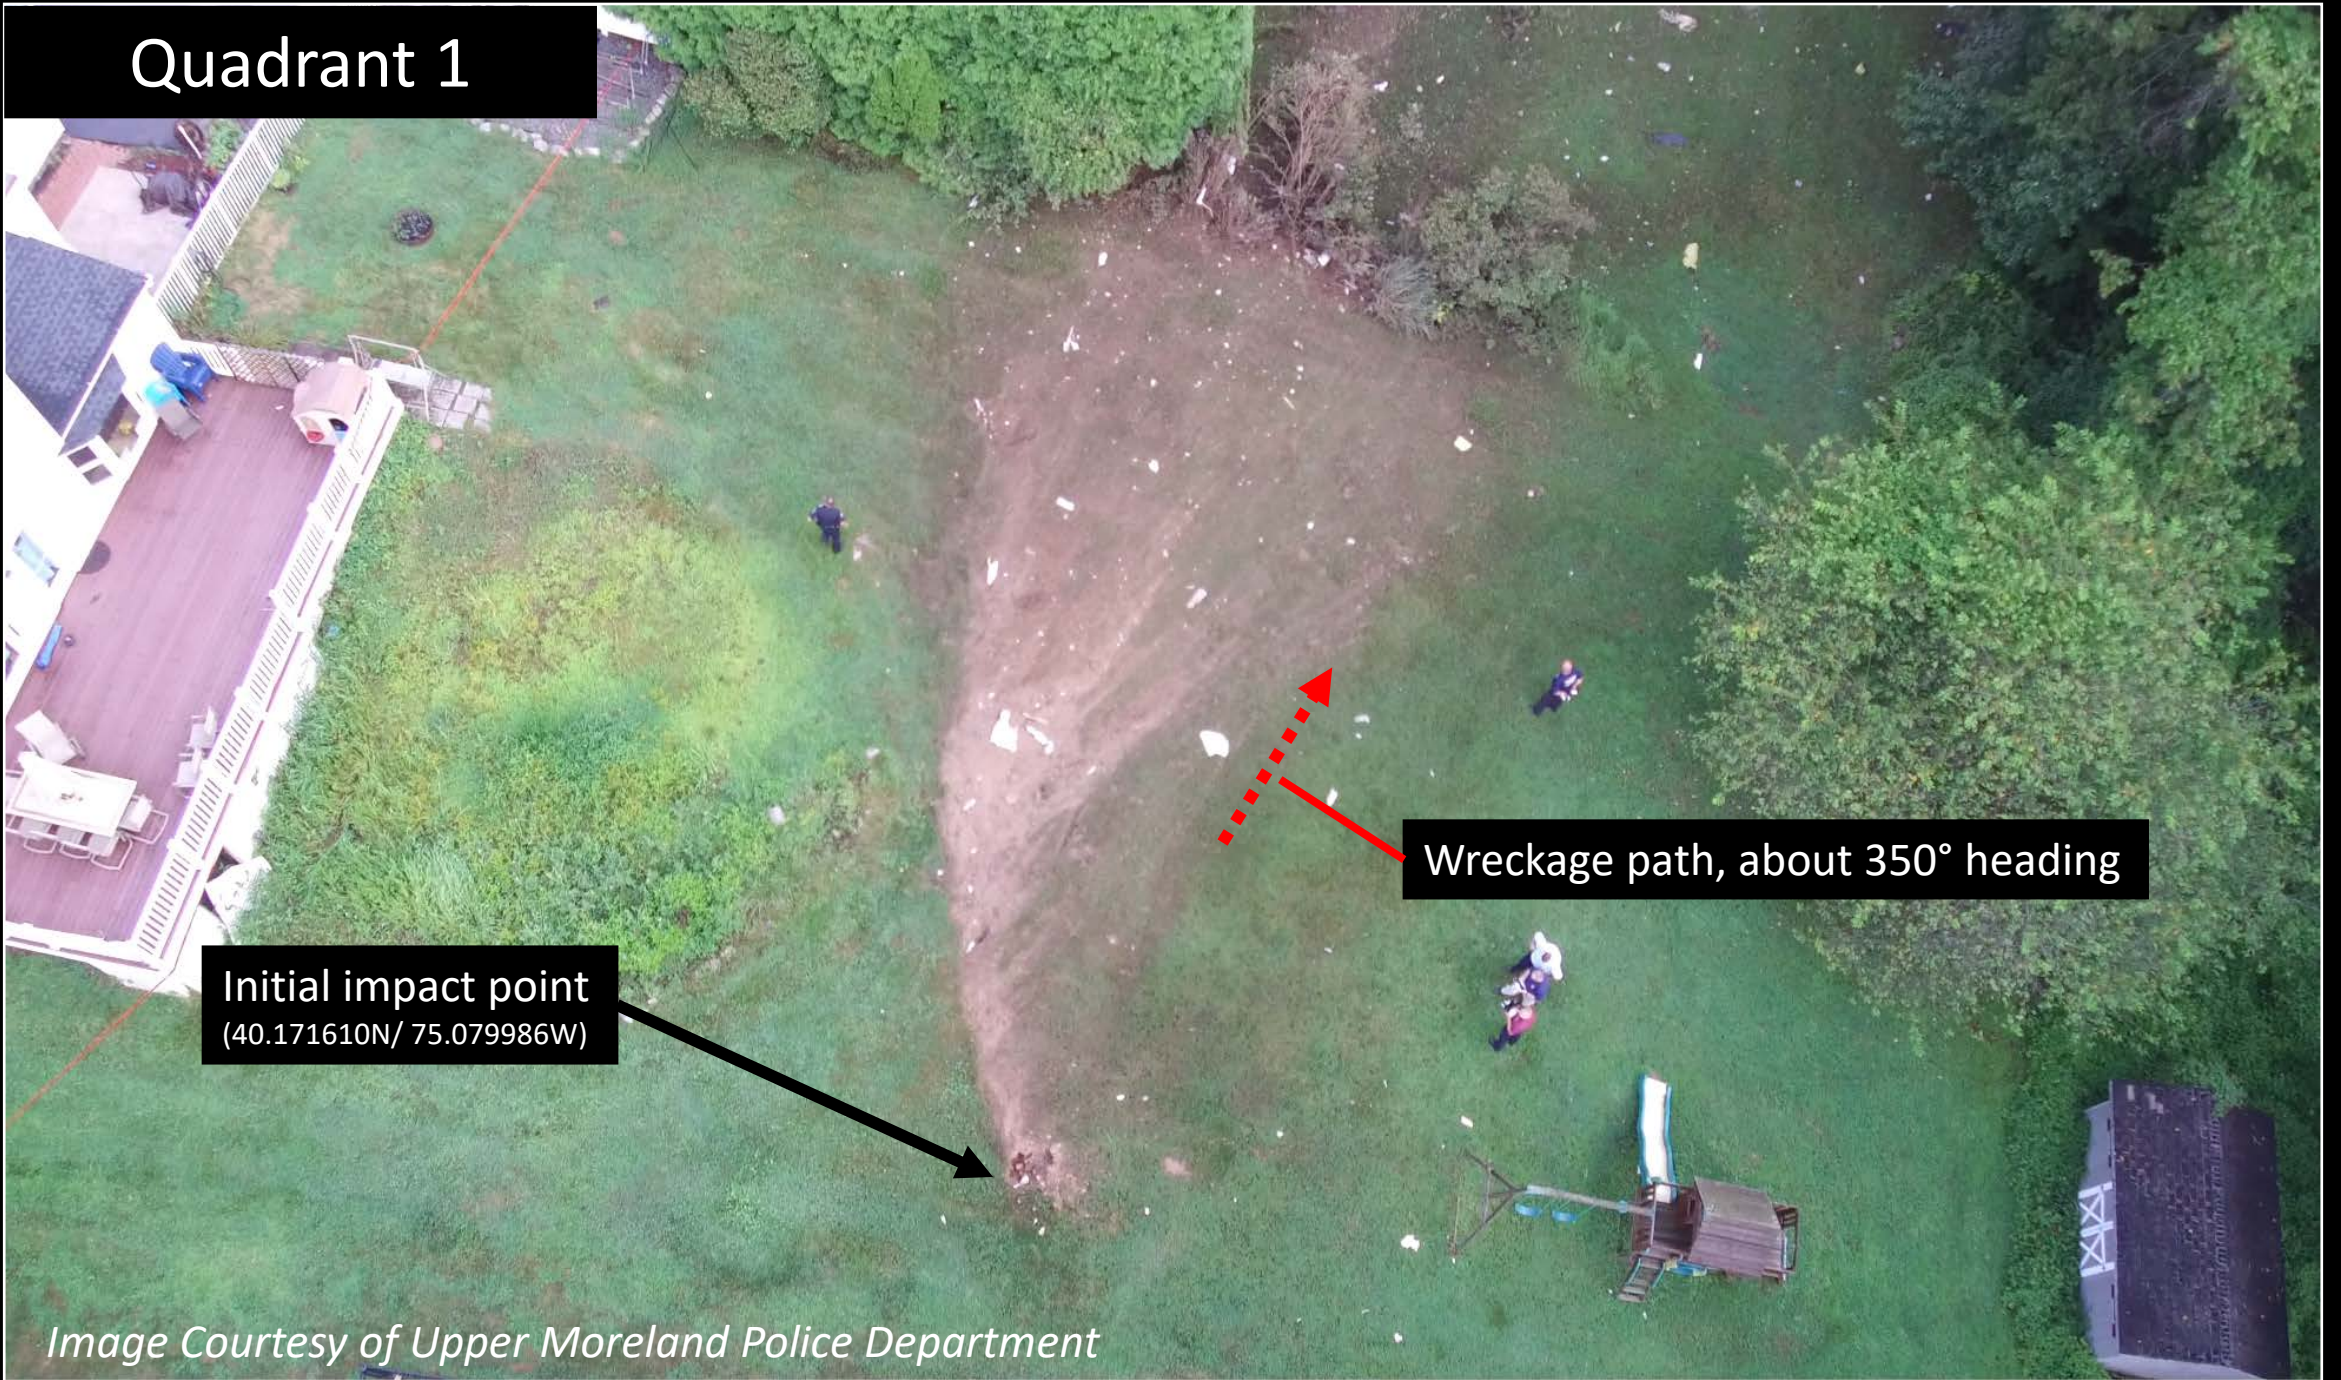
# Quadrant 1

Initial impact point  
(40.171610N/ 75.079986W)

Wreckage path, about 350° heading

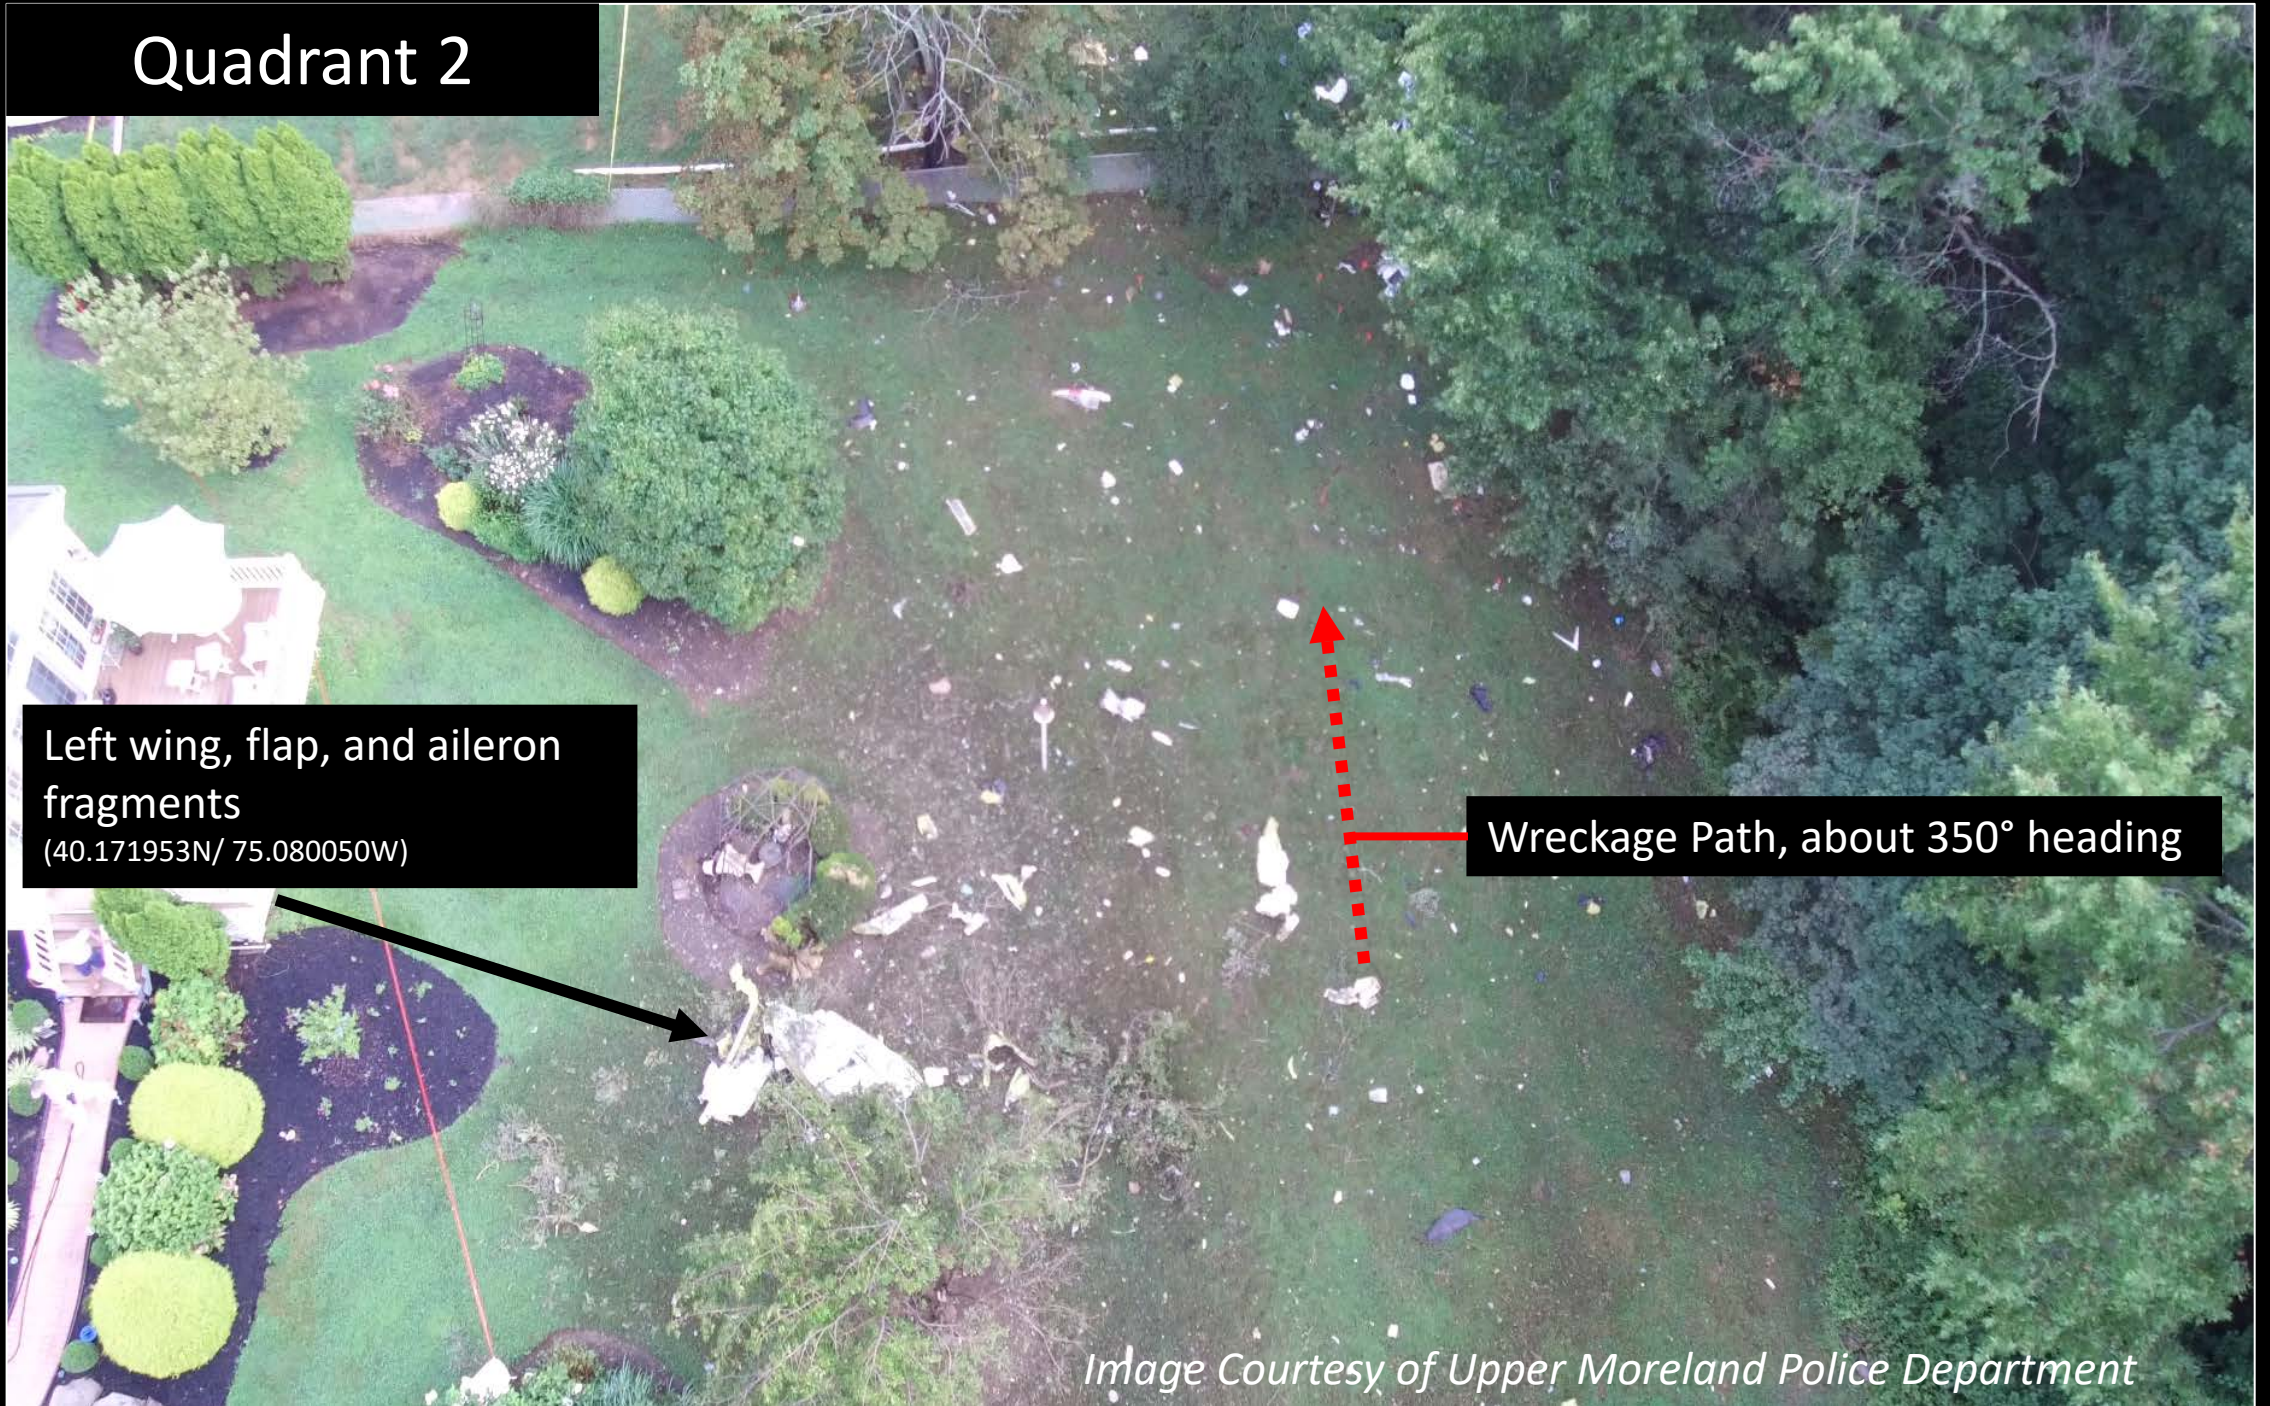
## Quadrant 2

Left wing, flap, and aileron  
fragments

(40.171953N/ 75.080050W)

Wreckage Path, about 350° heading

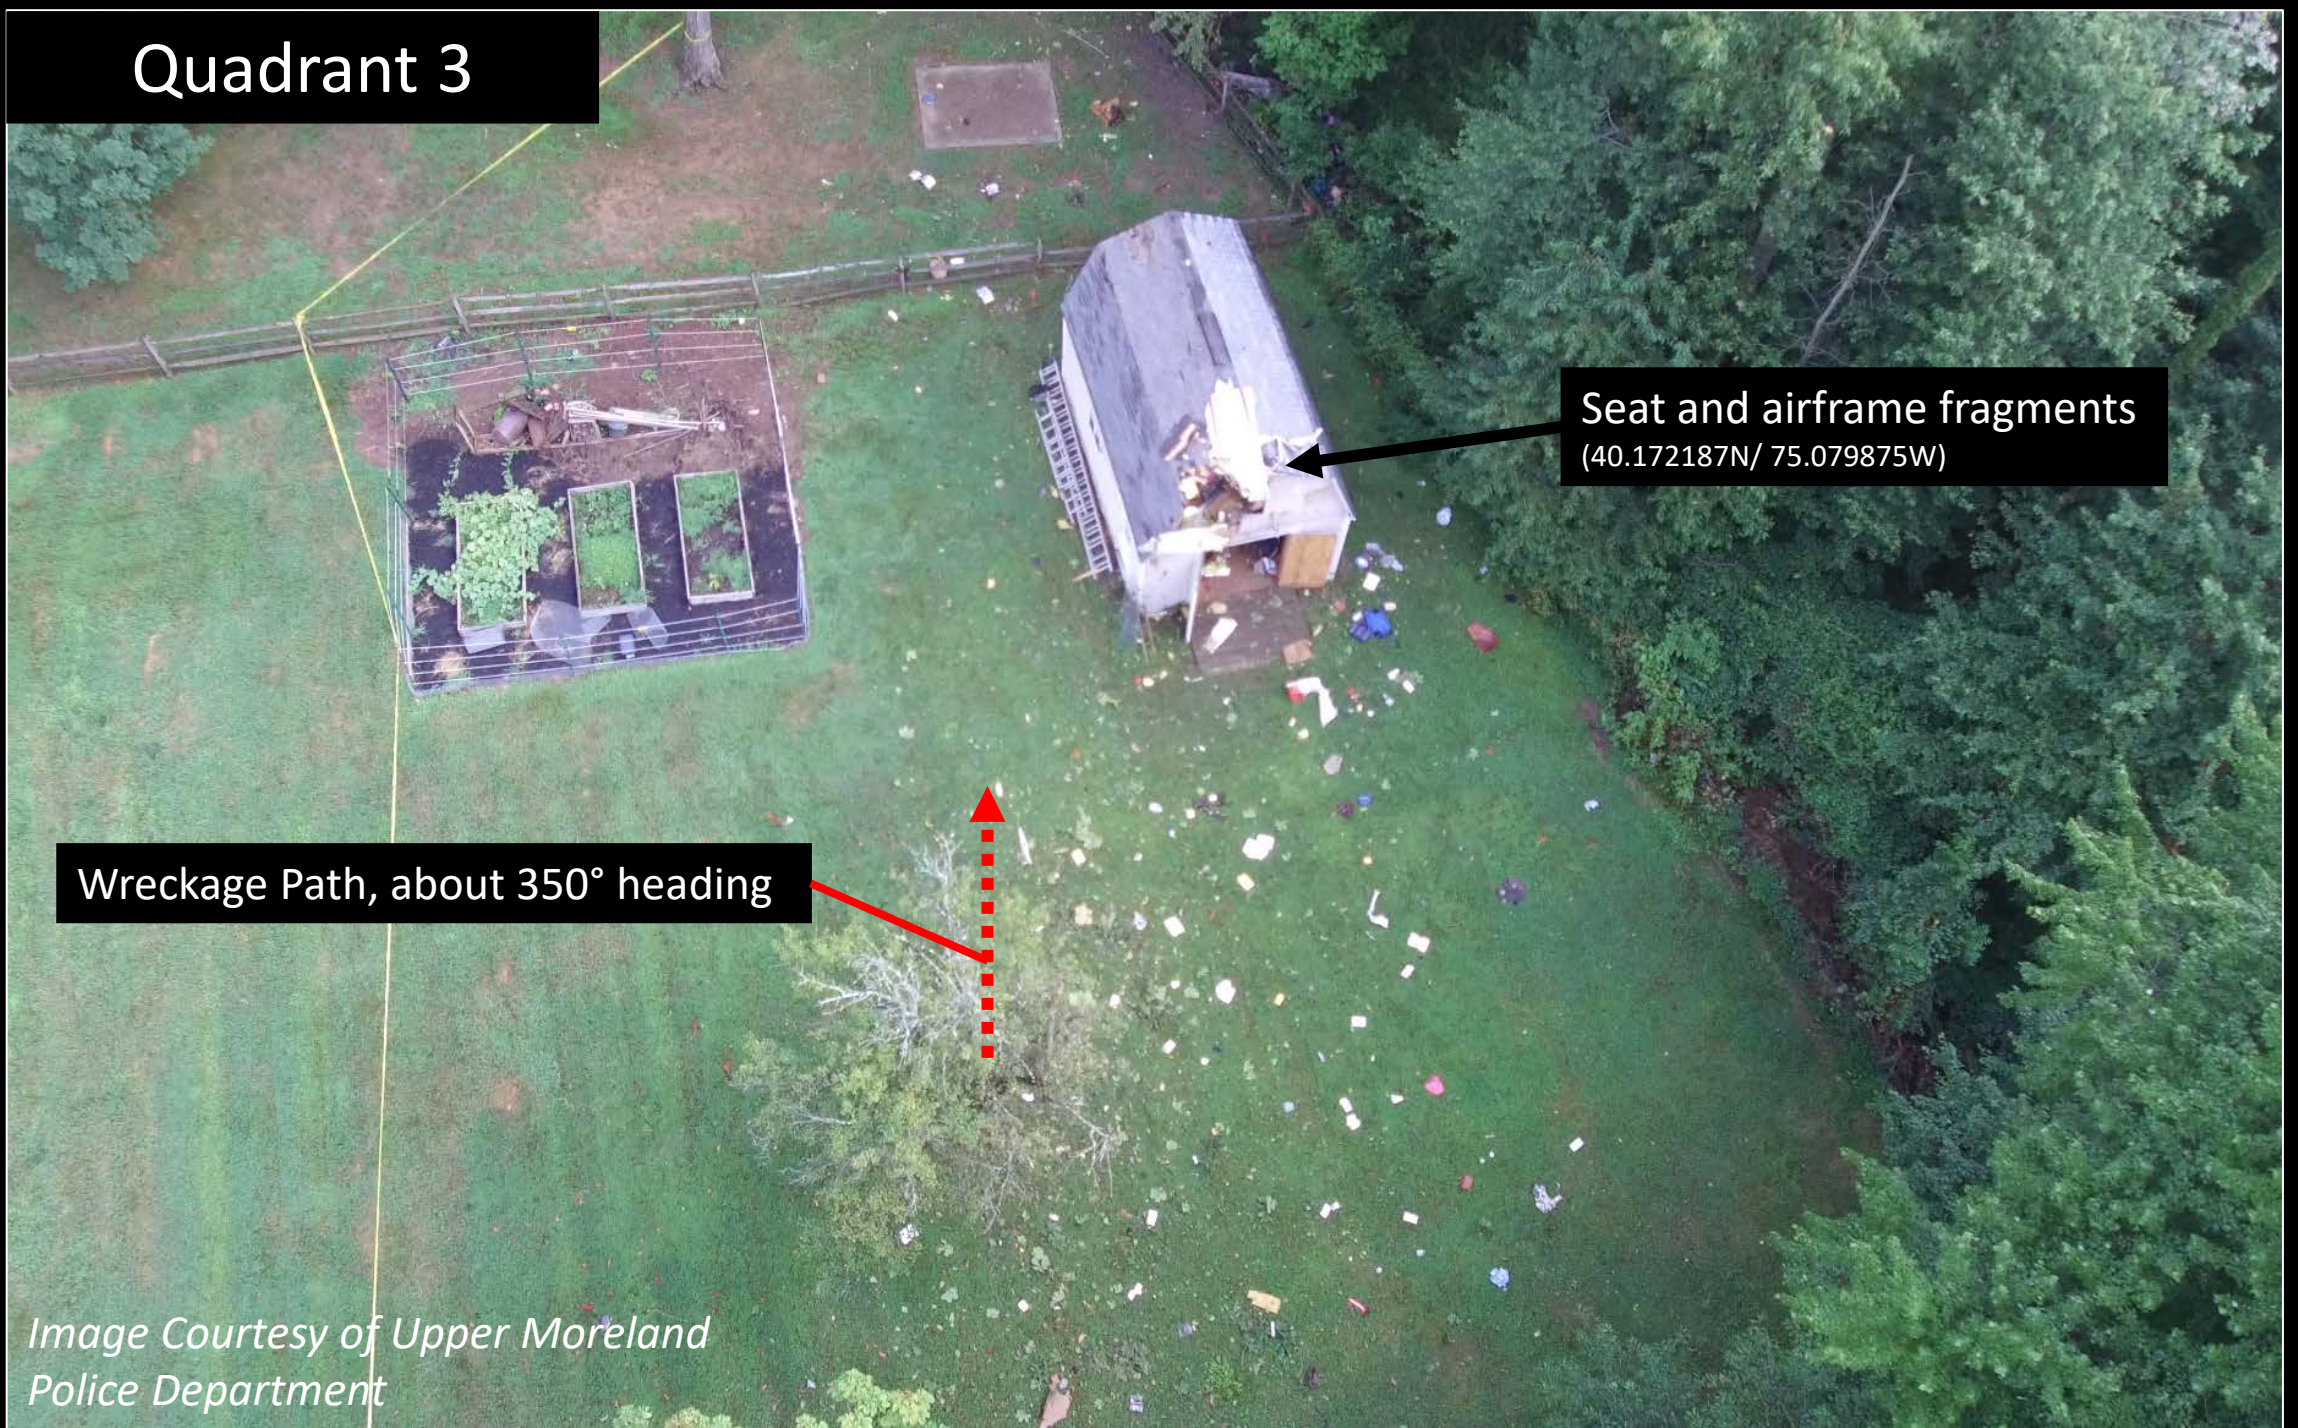
# Quadrant 3

Seat and airframe fragments  
(40.172187N/ 75.079875W)

Wreckage Path, about 350° heading

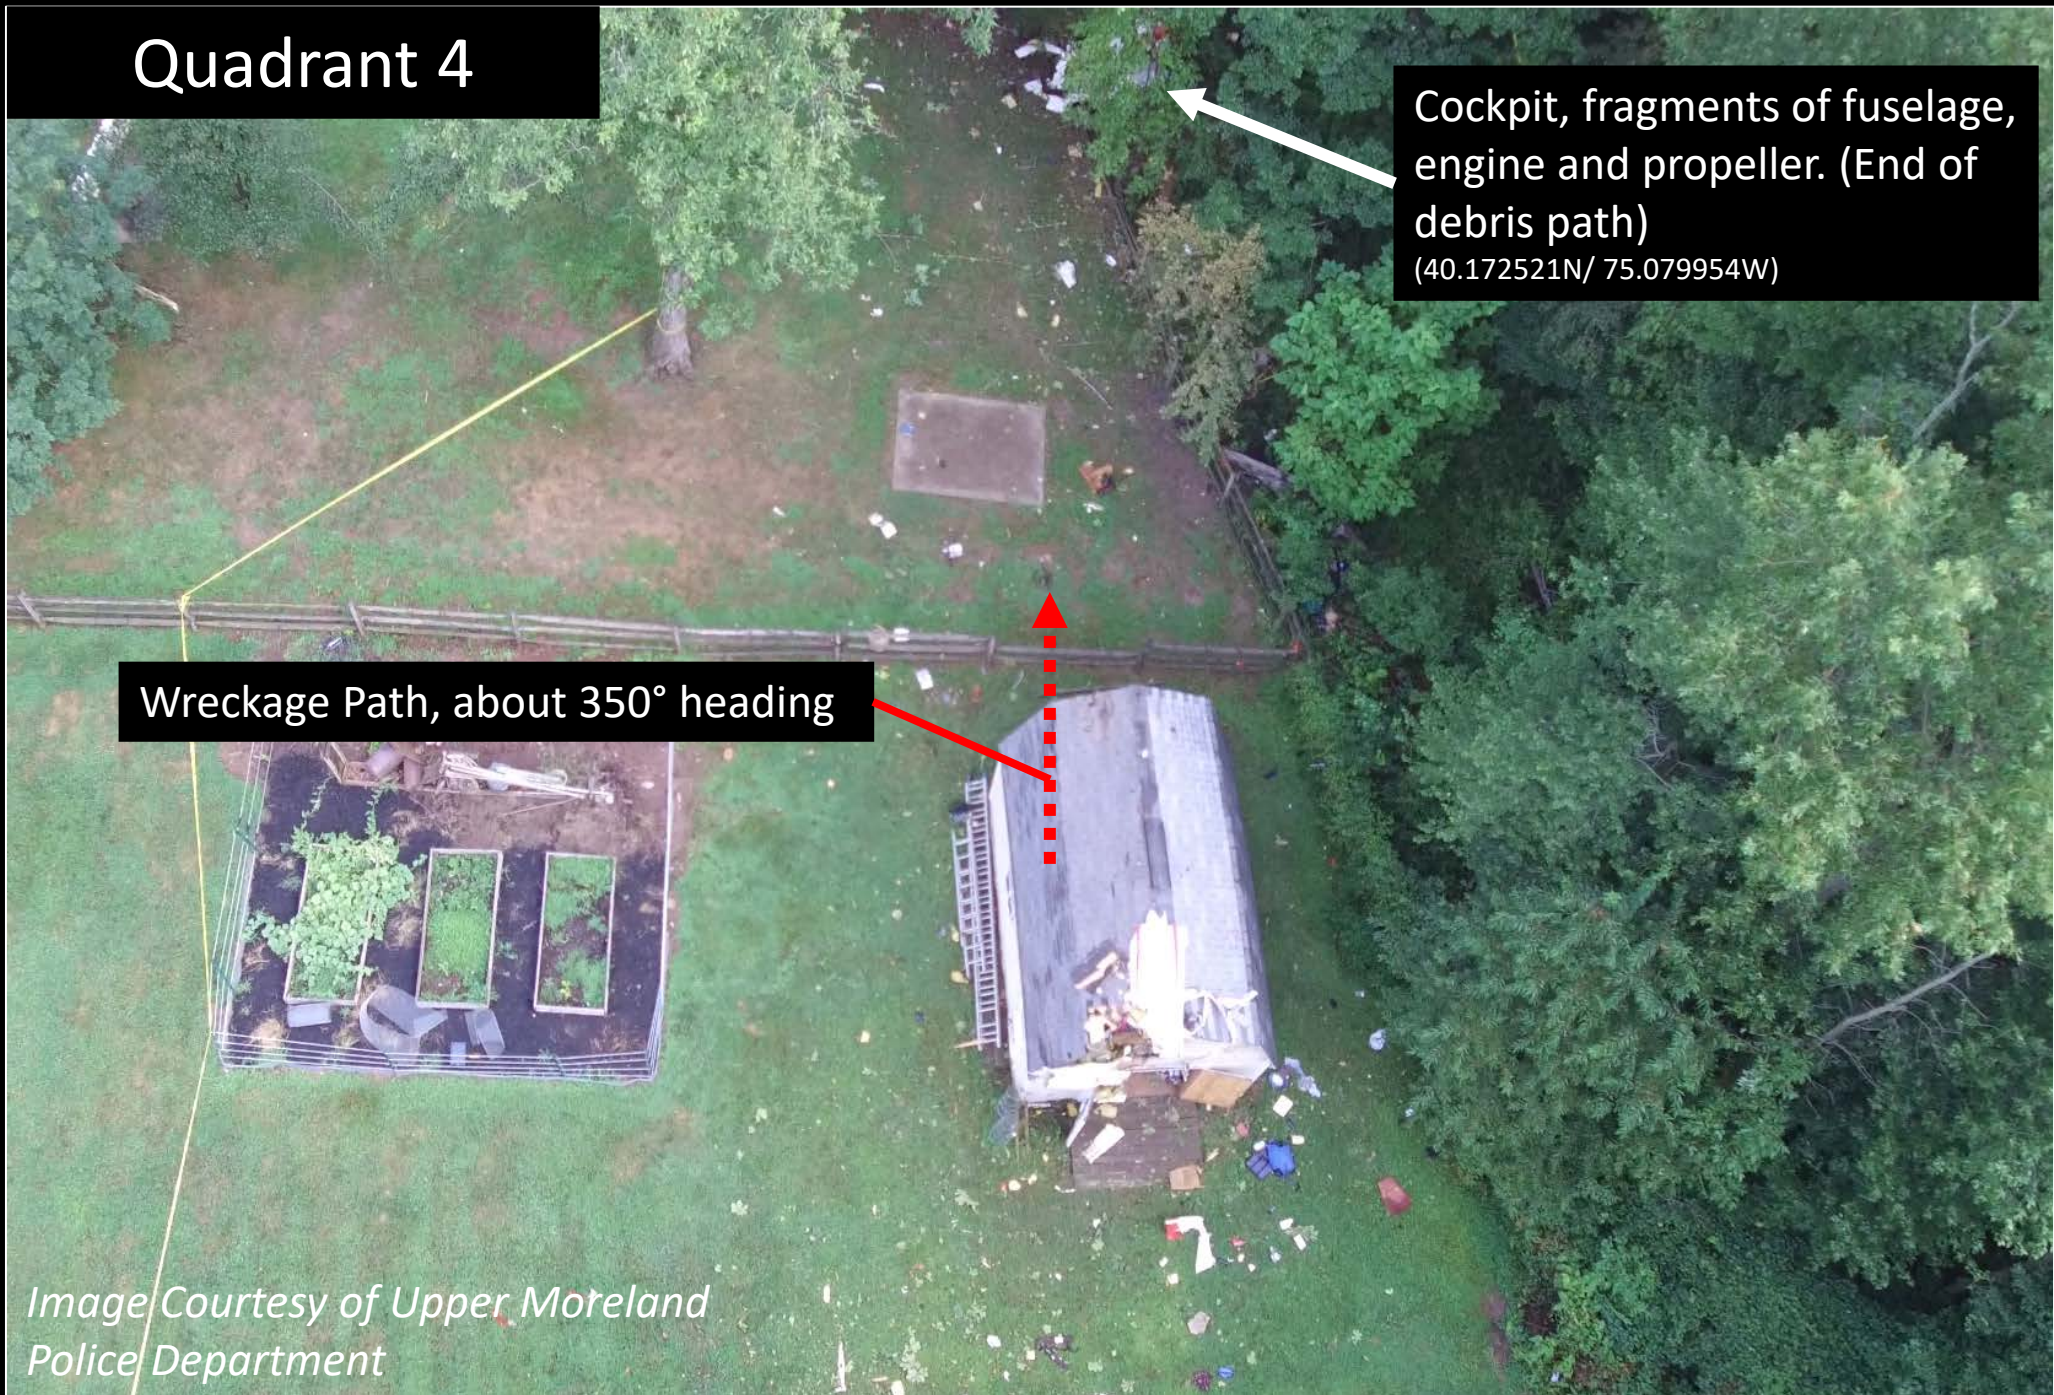
## Quadrant 4

Cockpit, fragments of fuselage,  
engine and propeller. (End of  
debris path)

(40.172521N/ 75.079954W)

Wreckage Path, about 350° heading
