**NATIONAL TRANSPORTATION SAFETY BOARD**  
Vehicle Recorder Division

### **Specialist's Factual Report by Christopher Babcock**

Location: Mayport, Florida  
Date: December 20, 2018  
Aircraft: Piper PA-46-350P  
Registration: N307JM  
Operator: Private  
NTSB Number: ERA19LA072

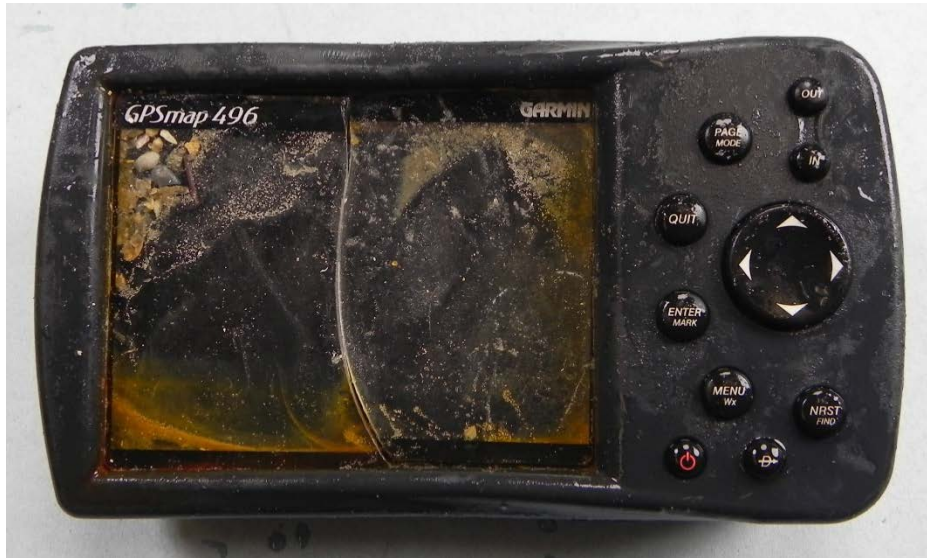
**Figure 1.** Front of device, as received.

The device was severely damaged by impact and water immersion during the accident sequence. Upon recovery, the device was resubmerged and shipped to the Vehicle Recorder Laboratory where it was cleaned, rinsed, and dried in a controlled environment. Figures 1 and 2 show the condition of the device upon receipt in the laboratory. Due to the impact damage, the device would not power up and the memory chip was removed and imaged to retrieve the data.

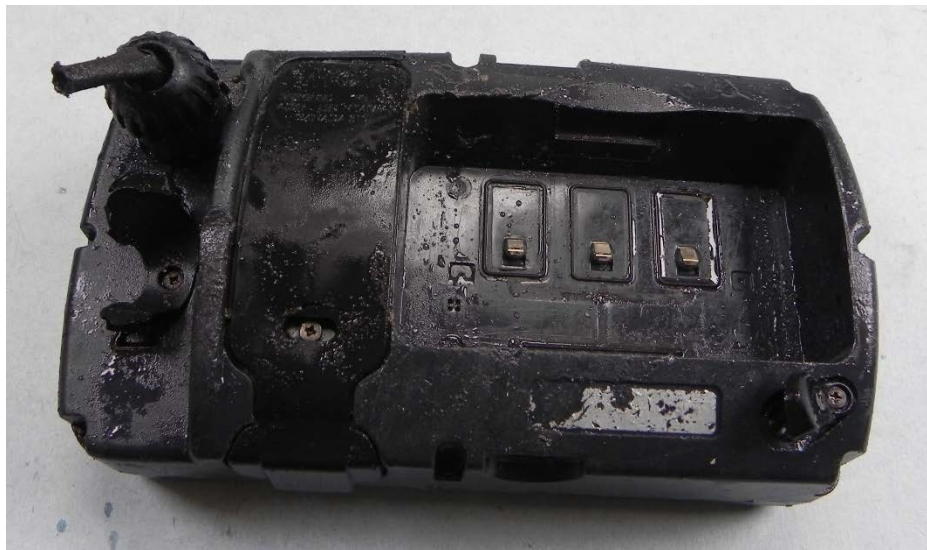
**Figure 2.** Rear of device, as received.

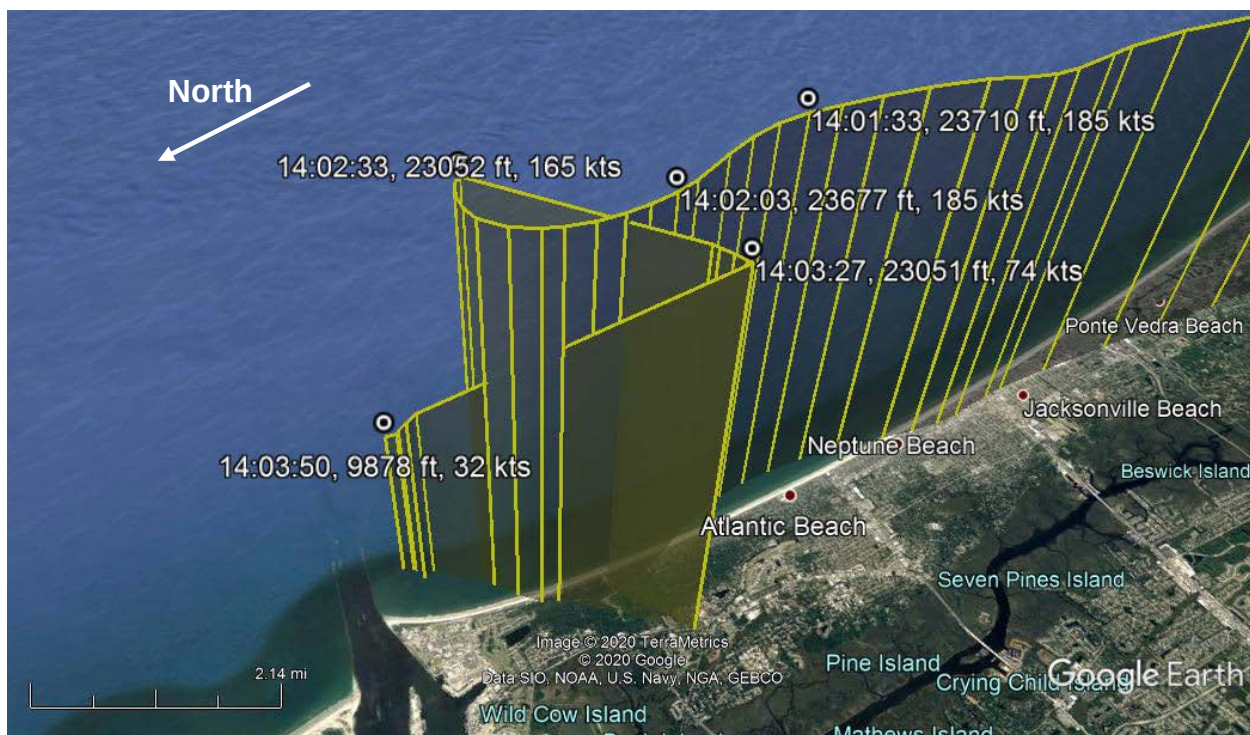
**Figure 4.** Overlay of GPS data at end of accident flight (Times UTC).

The data extracted included 65 sessions from February 2, 2018, through December 20, 2018.<sup>2</sup> The accident flight was the last session, recorded starting at 12:55:49 UTC and ending at 14:03:50 UTC on December 20, 2018 (223 total data points). The aircraft departed Kissimmee Gateway Airport at about 08:21 EST (13:21 UTC) and headed northbound. The aircraft climbed to about 20,000 feet GPS altitude at 08:50 EST (13:50 UTC). The aircraft began climbing to about 23,000 feet GPS altitude at 08:54 EST (13:54 UTC). At 9:02 EST, the aircraft began turning to the right, descending, and accelerating. The last data point was recorded at 9:03:50 EST at a GPS altitude of 9878 ft and a ground speed of 32 knots. Figure 5 shows an overlay of GPS data for the entire accident flight. The overlay does not necessarily depict the weather or visibility conditions that existed on the day of the accident. Figure 6 shows an overlay of the GPS data at the end of the flight. Figure 7 contains a plot of data from the GPS for the entire accident flight and Figure 8 contains GPS data from the end of the accident flight.
