## ENGINE RUN REPORT

| ENGINE MODEL | TSIO550C11B |
| FILE NUMBER | 18-343 |

| <b>EXAMINATION</b> | | <b>ACCIDENT DATA</b> | |
|---|---|---|---|
| <b>DATE</b> | 05/28/2019 | <b>NTSB ACCIDENT #</b> | ERA19LA081 |

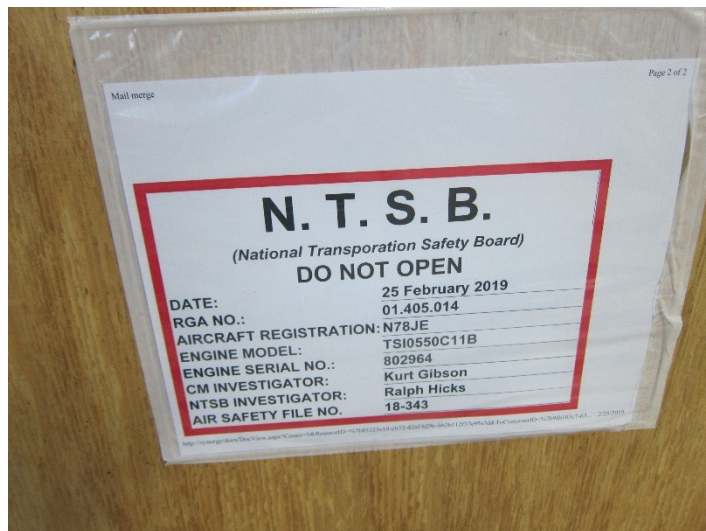
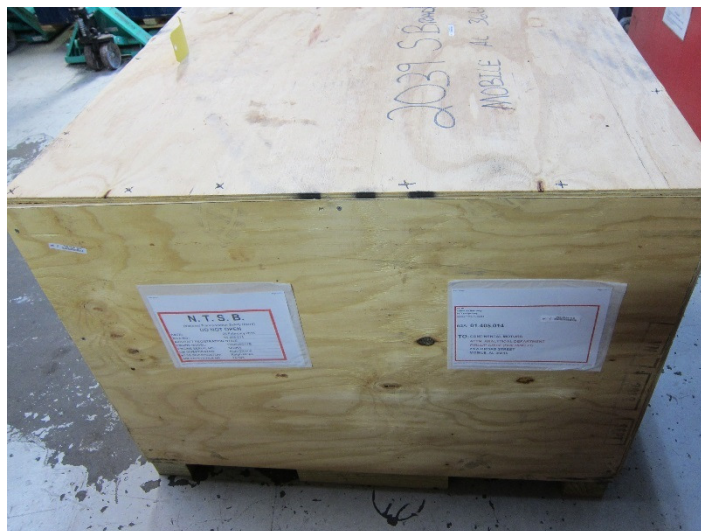
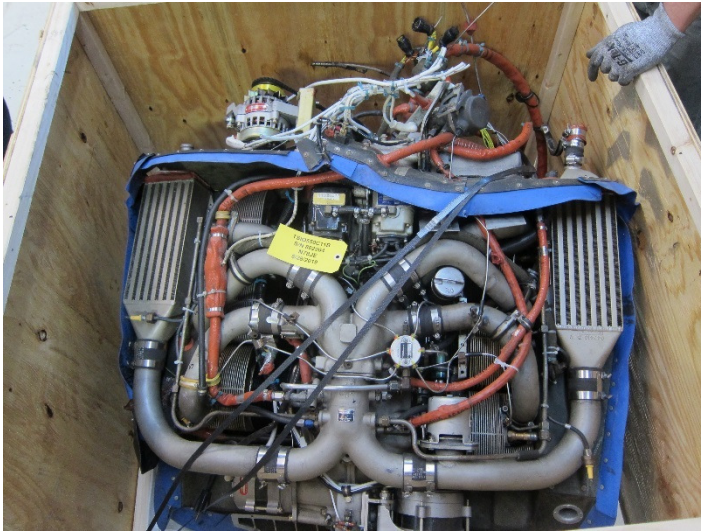
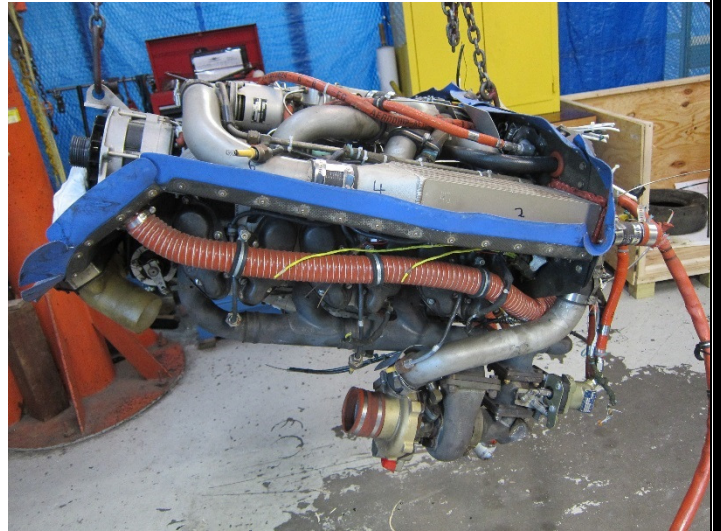
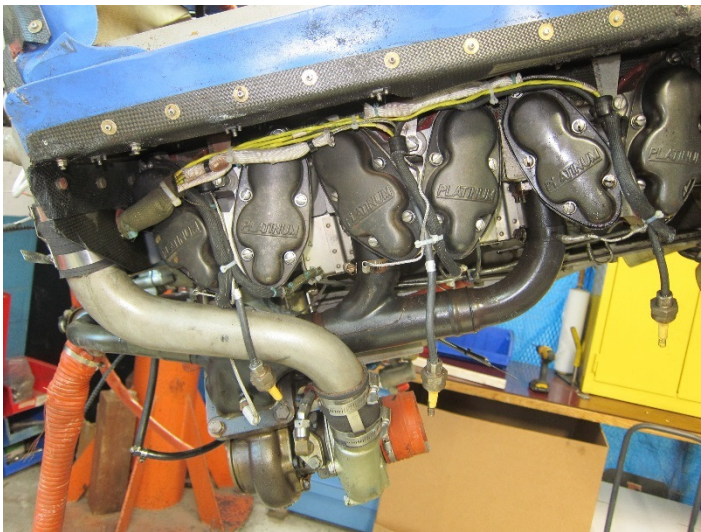
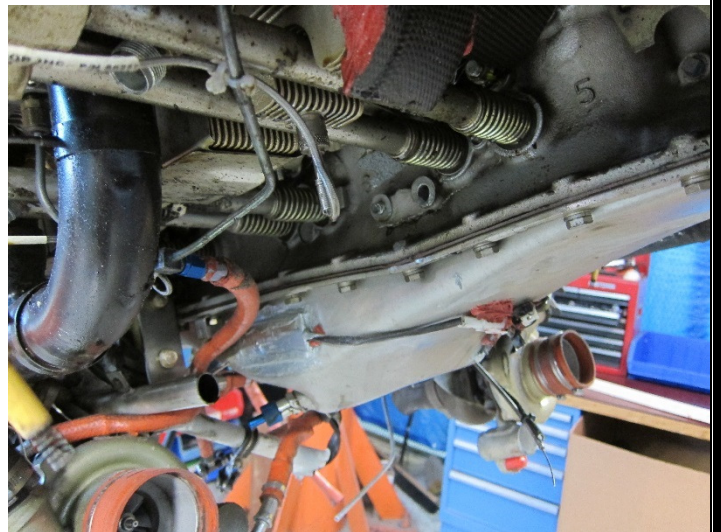
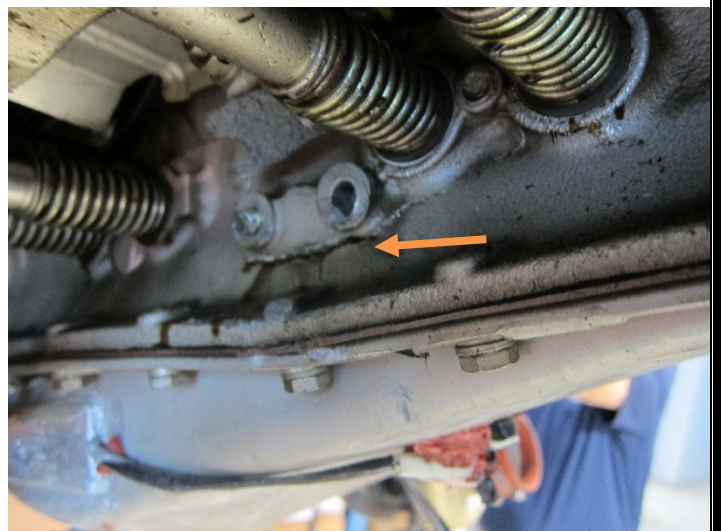
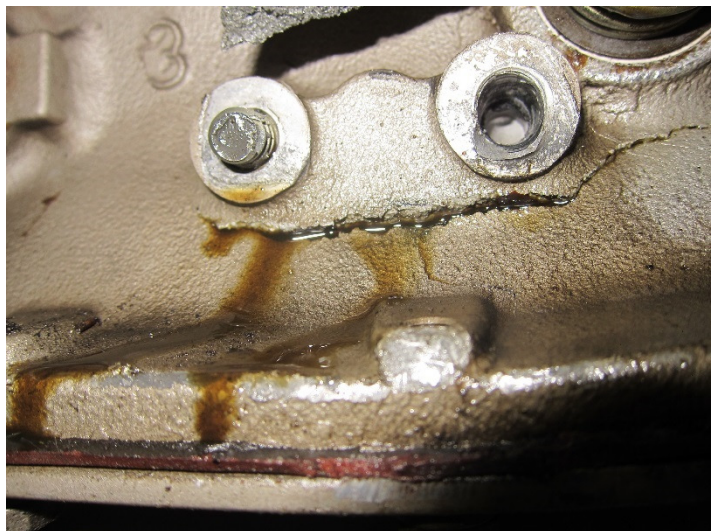
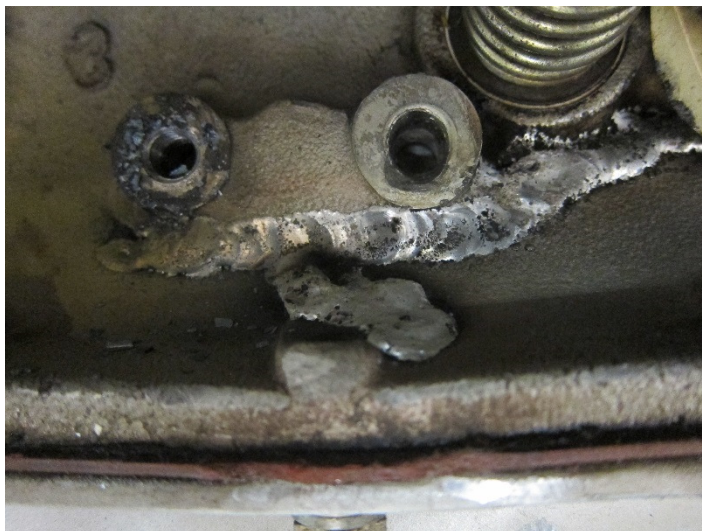
**EXTERNAL INSPECTION OF ENGINE**

The engine required a weld repair due to impact damaged. The engine started and ran well on the engine test cell.

The following substitute or repaired parts were required for engine operation: Starter adapter, Starter Motor. Both 2,4,6 side mount legs, front mount leg on the 1,3,5 side of the engine. Turbo charger oil sump can.
