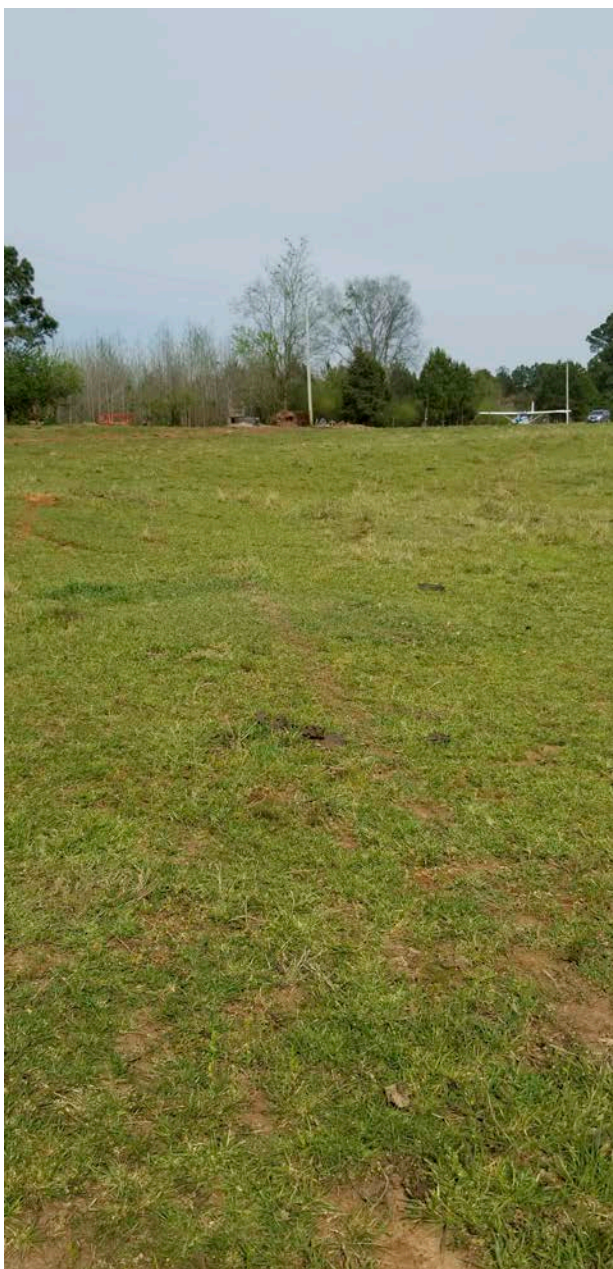
**Photo 1 – FAA Digital Photograph. View Taken from Initial Touchdown in Field Looking Towards Contacted Pole. The Airplane Had Been Moved in this Photograph.**

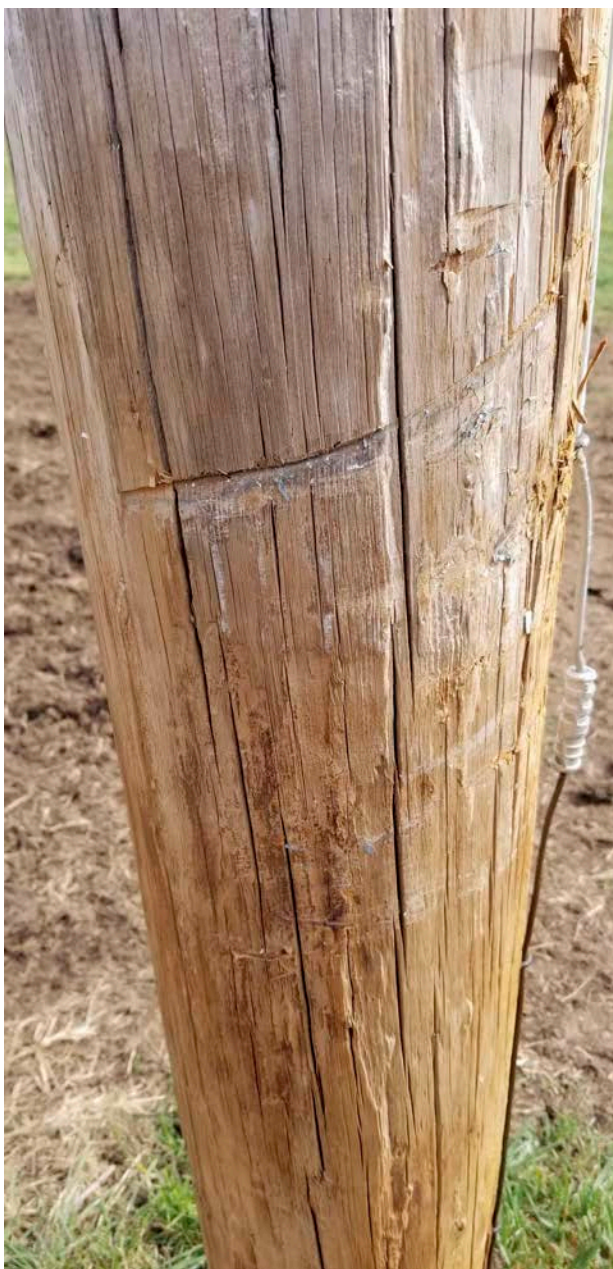
**Photo 2 – FAA Digital Photograph. View of the Power Pole Contacted By the Left Wing.**

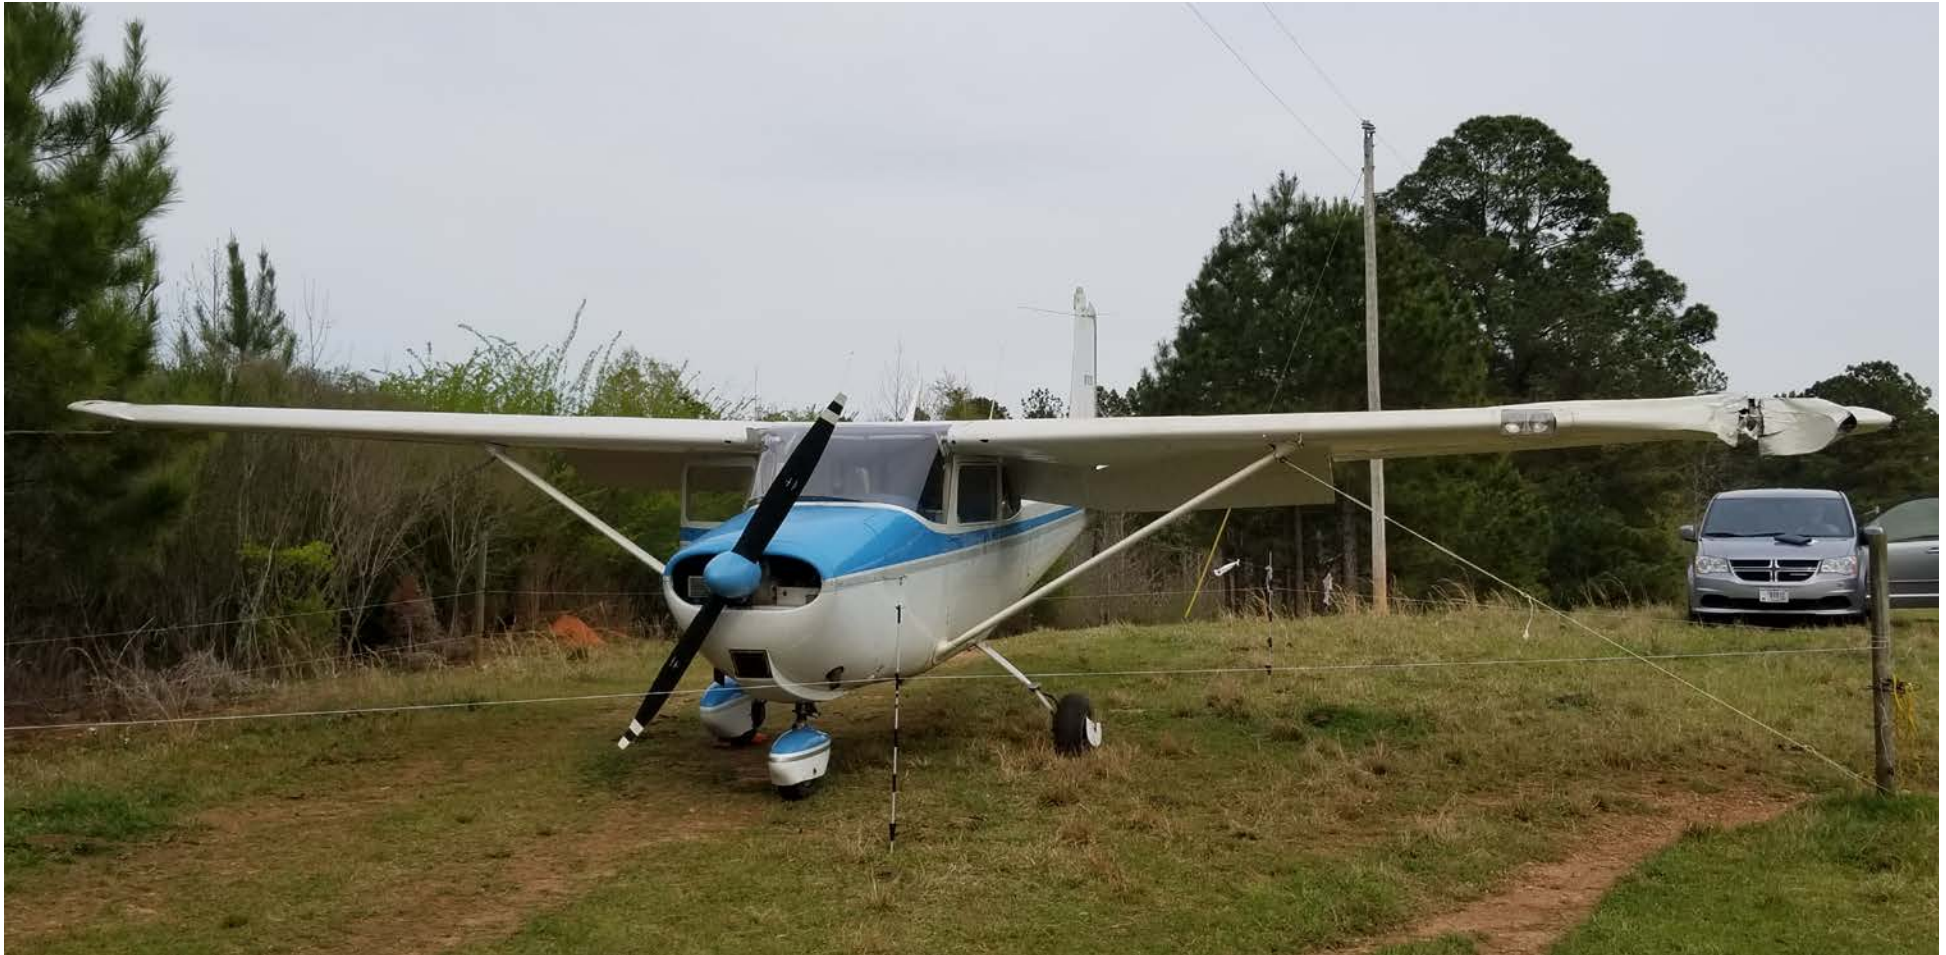
**Photo 3 - FAA Digital Photograph. Forward View of the Airplane. Note the Damage to the Outer Portion of the Left Wing Due to Contact with the Power Pole.**

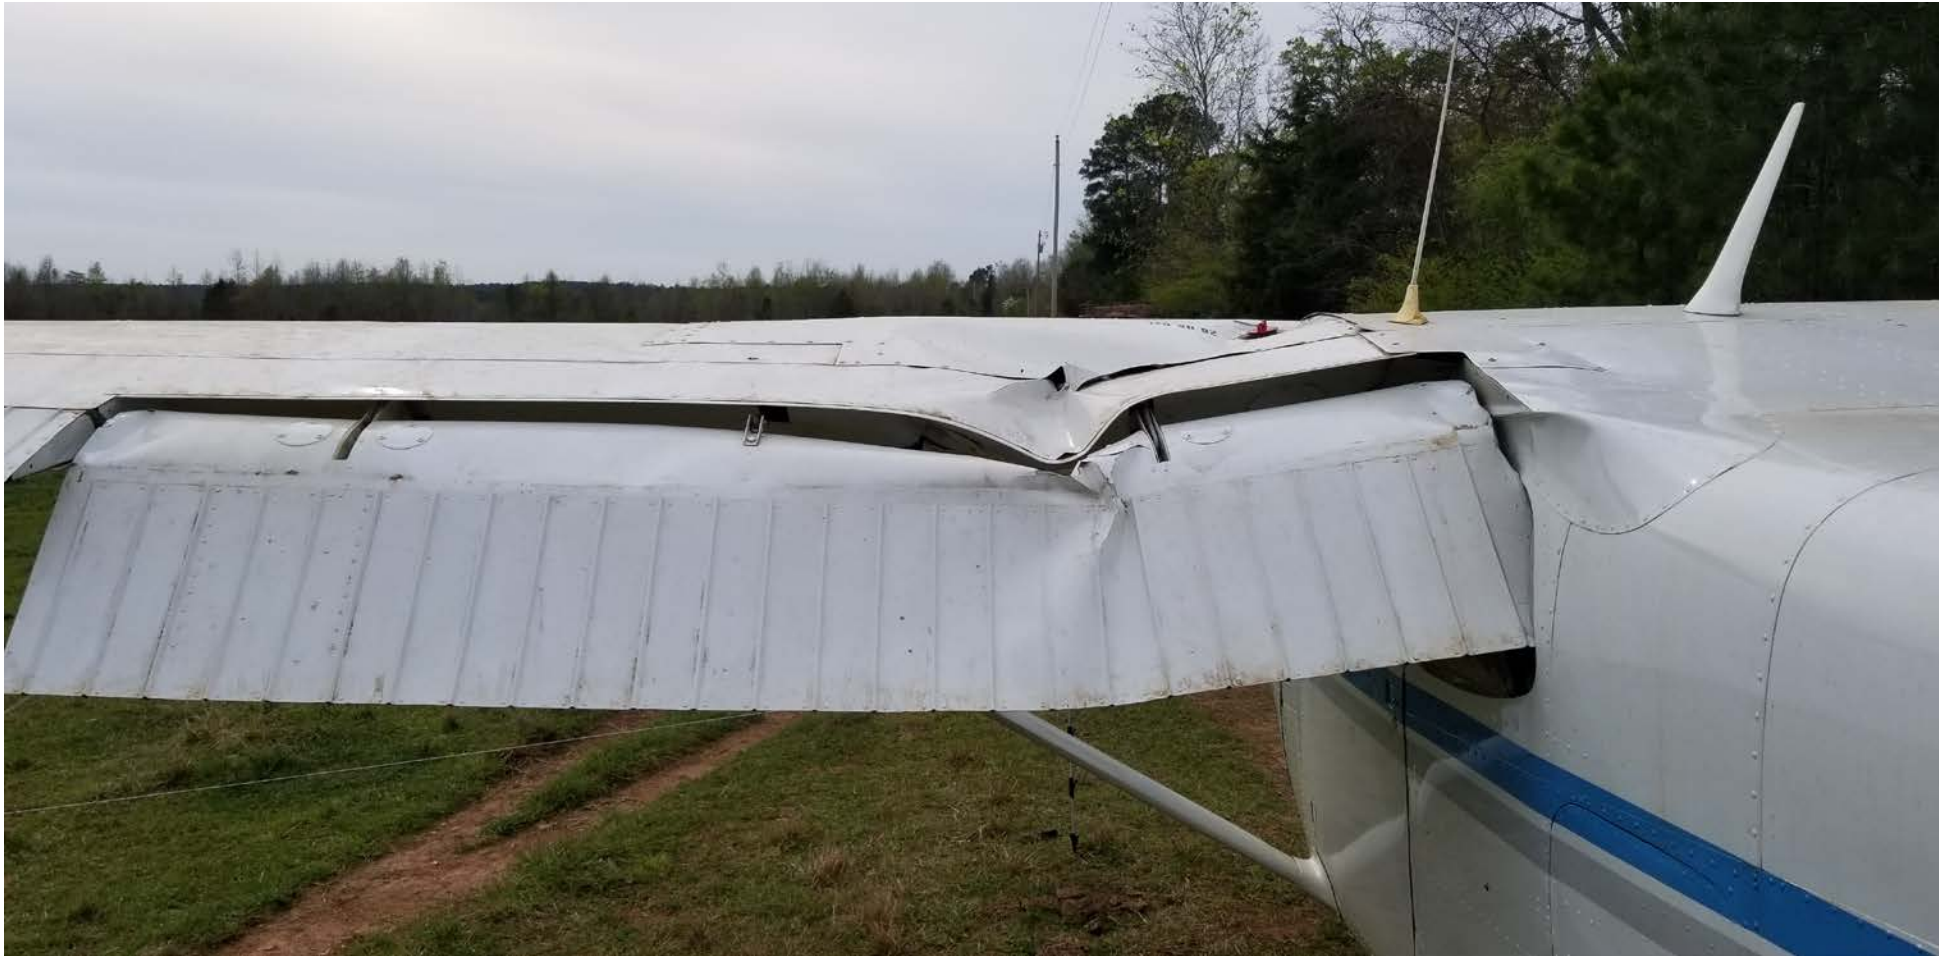
**Photo 4 - FAA Digital Photograph. View taken Aft of the Left Wing Looking Forward Depicting the Inboard Portion of the Wing. Note the Compression Buckle on the Upper Wing Skin and Displacement of the Wing.**

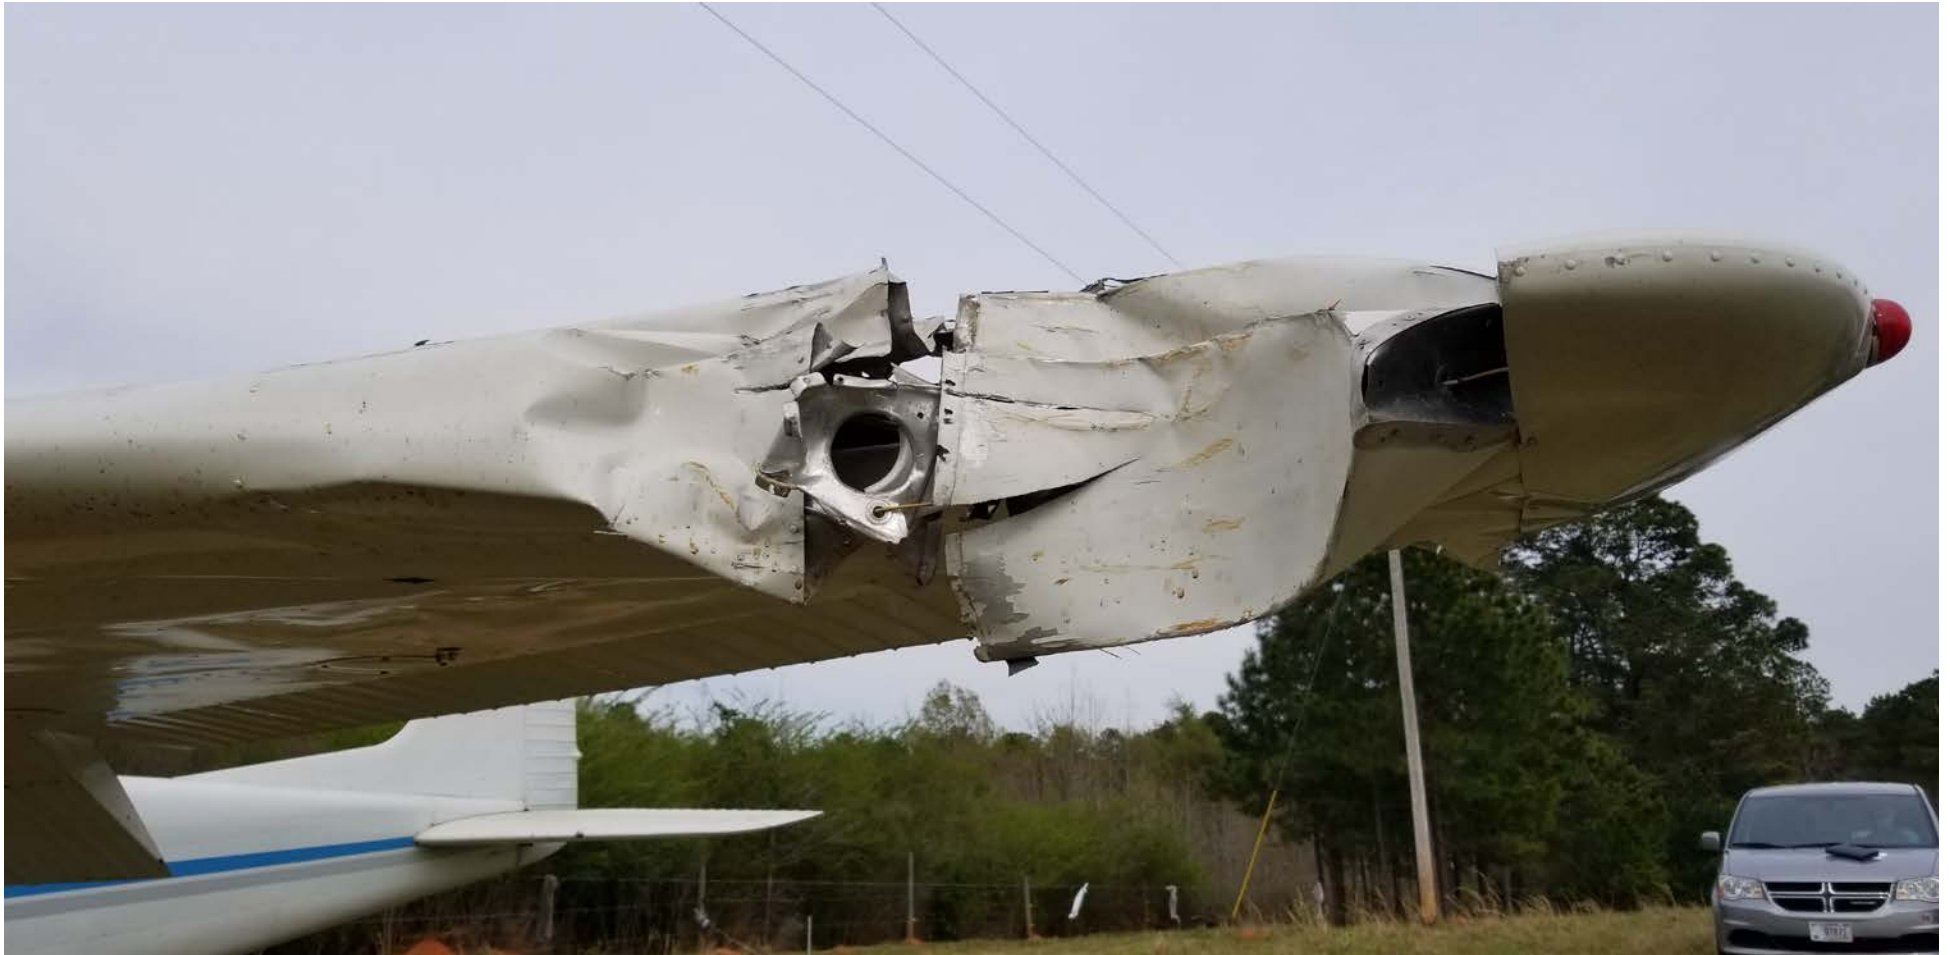
**Photo 5 - FAA Digital Photograph. View Depicting the Damage to the Outer Leading Edge of the Left Wing.**
