# NATIONAL TRANSPORTATION SAFETY BOARD

## Flight Display Factual Report

Location: Poughkeepsie, NY  
Date: July 19, 2019  
Aircraft: Piper PA-46-310P  
Registration: N811SK  
Operator: Private  
NTSB Number: ERA19LA231

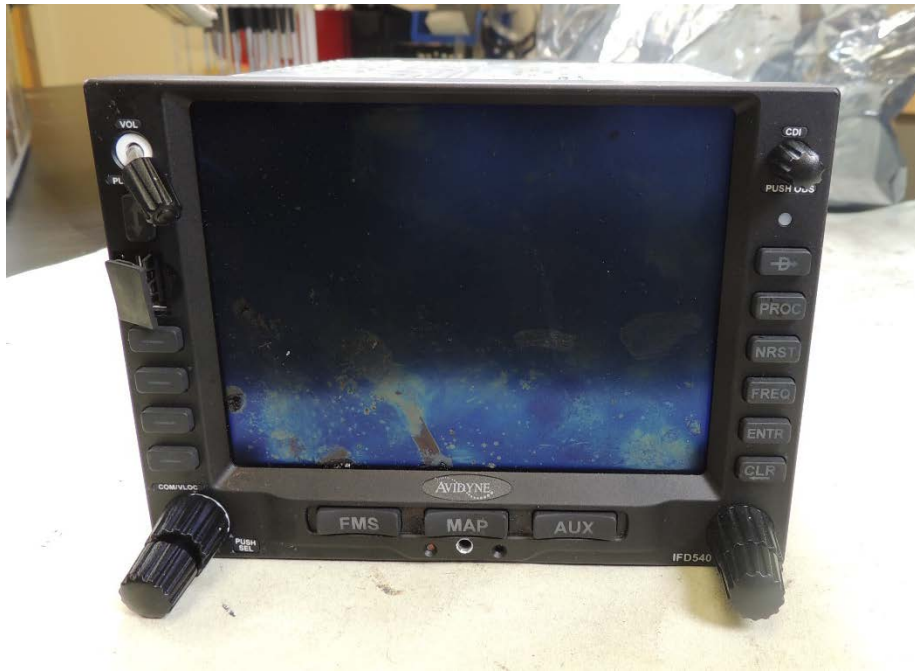
Figure 1. Exterior damage to IFD 540 (device 1)

Upon arrival at the Vehicle Recorder Division, an exterior examination revealed the units had not sustained any significant damage and information was extracted using the manufacturer's download procedure, without difficulty. The condition of the devices is shown in Figure 1 and Figure 2 below.

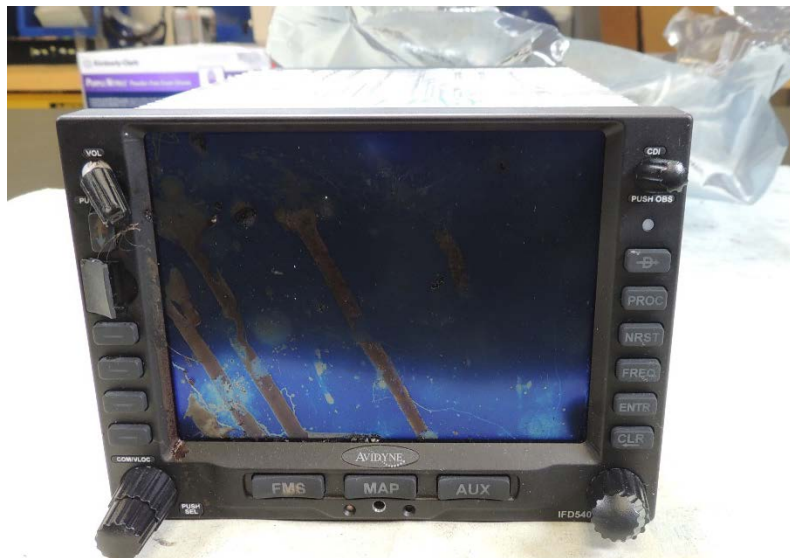
Figure 2. Exterior damage to IFD 540 (device 2)
