**NATIONAL TRANSPORTATION SAFETY BOARD**  
Vehicle Recorder Division  
Washington, D.C. 20594

## **Engine Data Monitor (EDM)**

**Specialist's Factual Report**  
**By Gerald Kawamoto**

Location: Poughkeepsie, NY  
Date: July 19, 2019  
Aircraft: Piper PA-46-310P  
Registration: N811SK  
Operator: Private  
NTSB Number: ERA19LA231

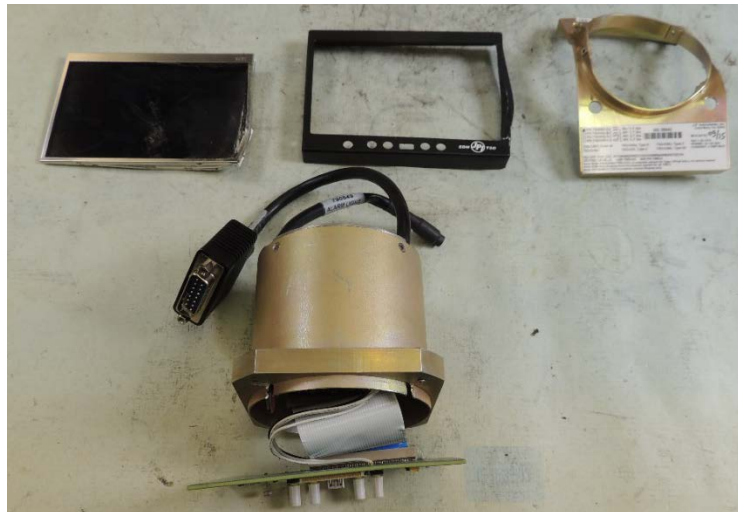
**Figure 1. JPI EDM-900 as received.**

Upon arrival at the Vehicle Recorder Laboratory, an external examination revealed damage to the unit's display, as shown in Figure 1. The unit was otherwise in good condition and powered on normally with a surrogate display. Data was extracted normally using the manufacturer's tools.

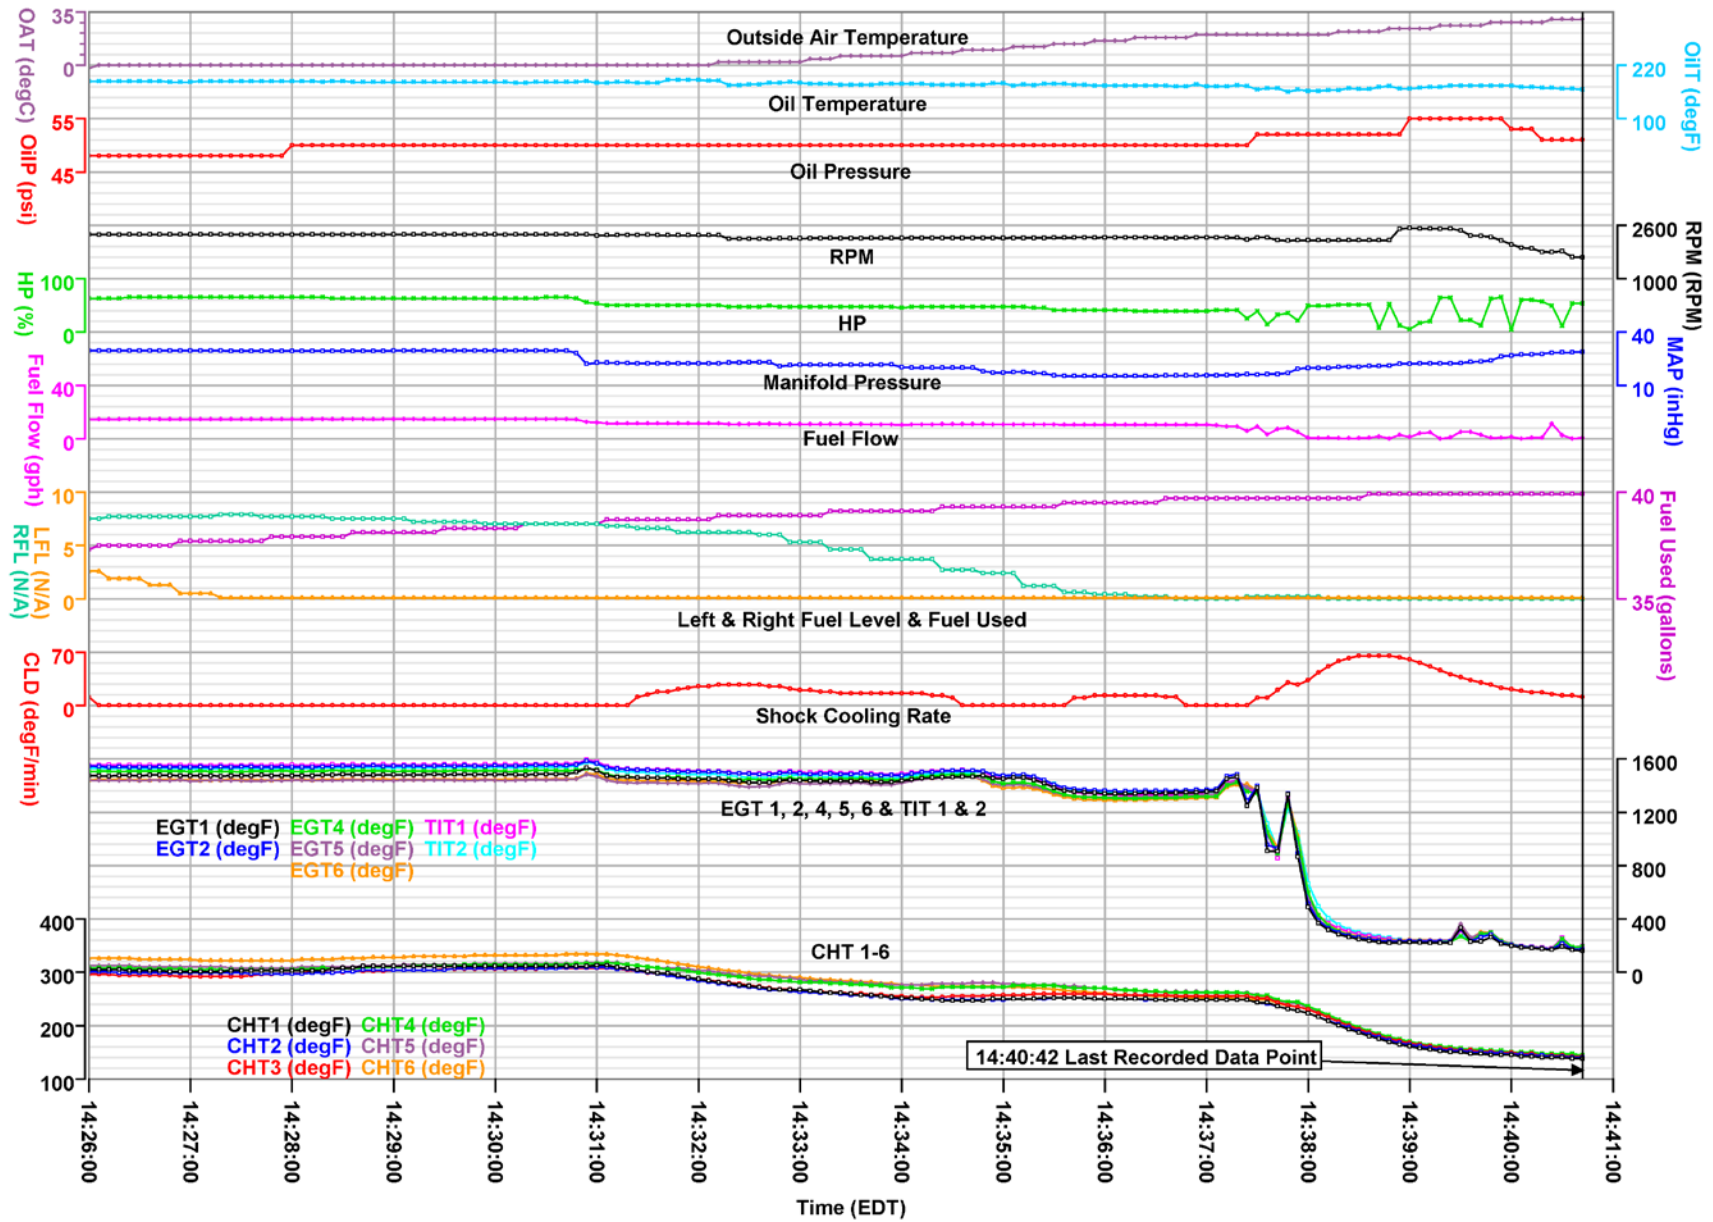
Figure 2. Plot of JPI EDM-900 parameters at the end of the accident flight.

Figure 3 is a plot of parameters recorded by the JPI EDM-900 for the last 15 minutes of the accident flight. The time interval displayed is 14:26:00 EDT to 14:41:00 EDT.

Between 14:27 and 14:28, LFL reached 0 and Oil Pressure increased from 46 to 48 psi. About 14:31, values for MAP, HP, RPM, EGT and CHT began to decrease. Between 14:36 and 14:37, RFL reached 0. Between 14:37 and 14:38, Oil Pressure increased from 48 to 50 psi, values for HP and Fuel Flow became erratic, EGT values for all cylinders became erratic then decreased rapidly, CHT values for all cylinders began to decrease, and MAP began to increase. From 14:38 until the end of the recording at 14:40:42, CHT values for all cylinders decreased rapidly, MAP continued to increase, HP was erratic, Oil Pressure and RPM increased then decreased, and Fuel Flow hovered around 0 gph.
