**Photo 1 – GPS Track Cruise Flight and Descent Profile**

**Photo 2 – View of Airplane as Found (U.S. Park Service)**

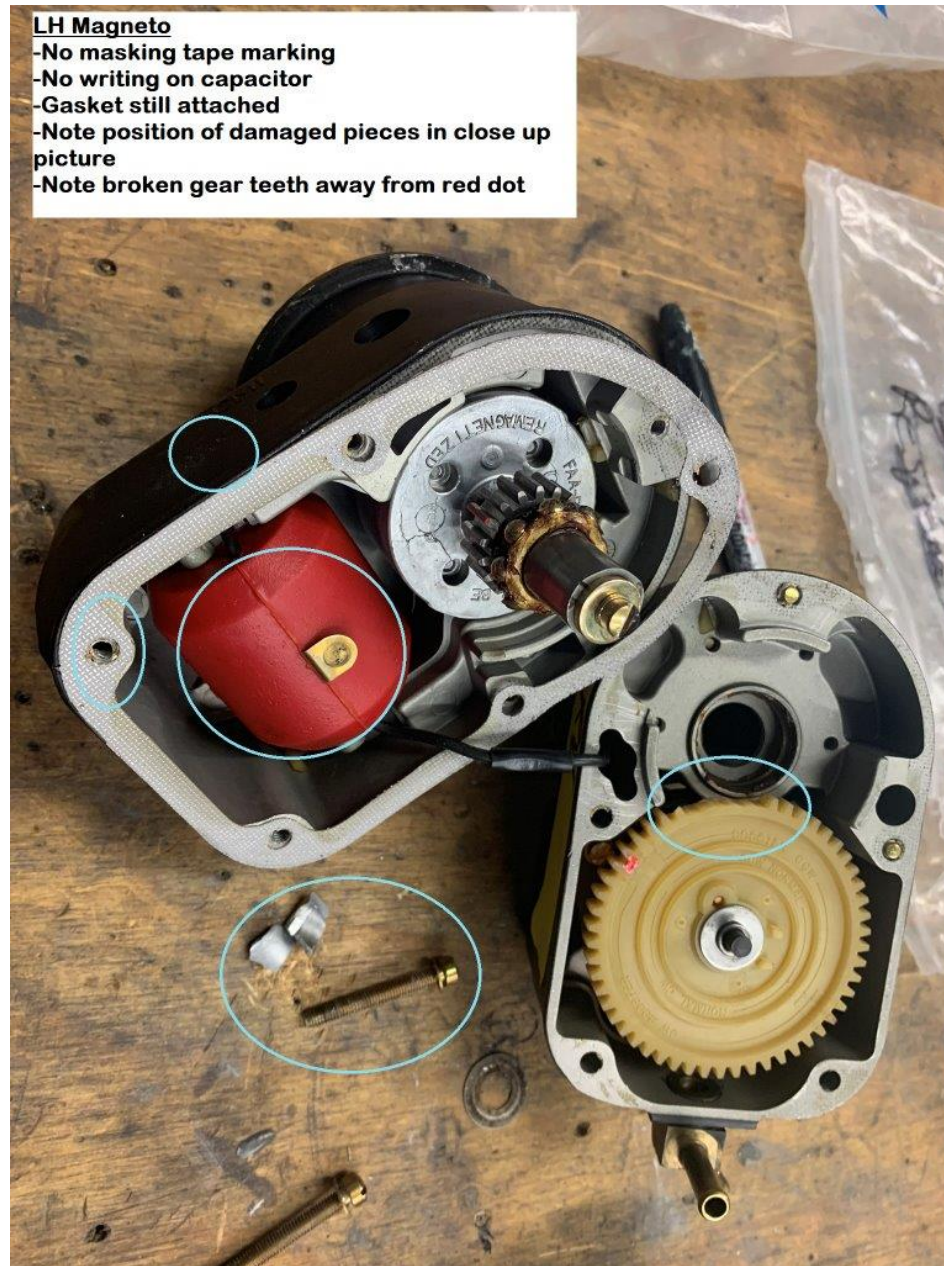
**LH Magneto**

- No masking tape marking
- No writing on capacitor
- Gasket still attached
- Note position of damaged pieces in close up picture
- Note broken gear teeth away from red dot

**Photo 3 – View of Left Magneto During Disassembly (Myers Aviation)**

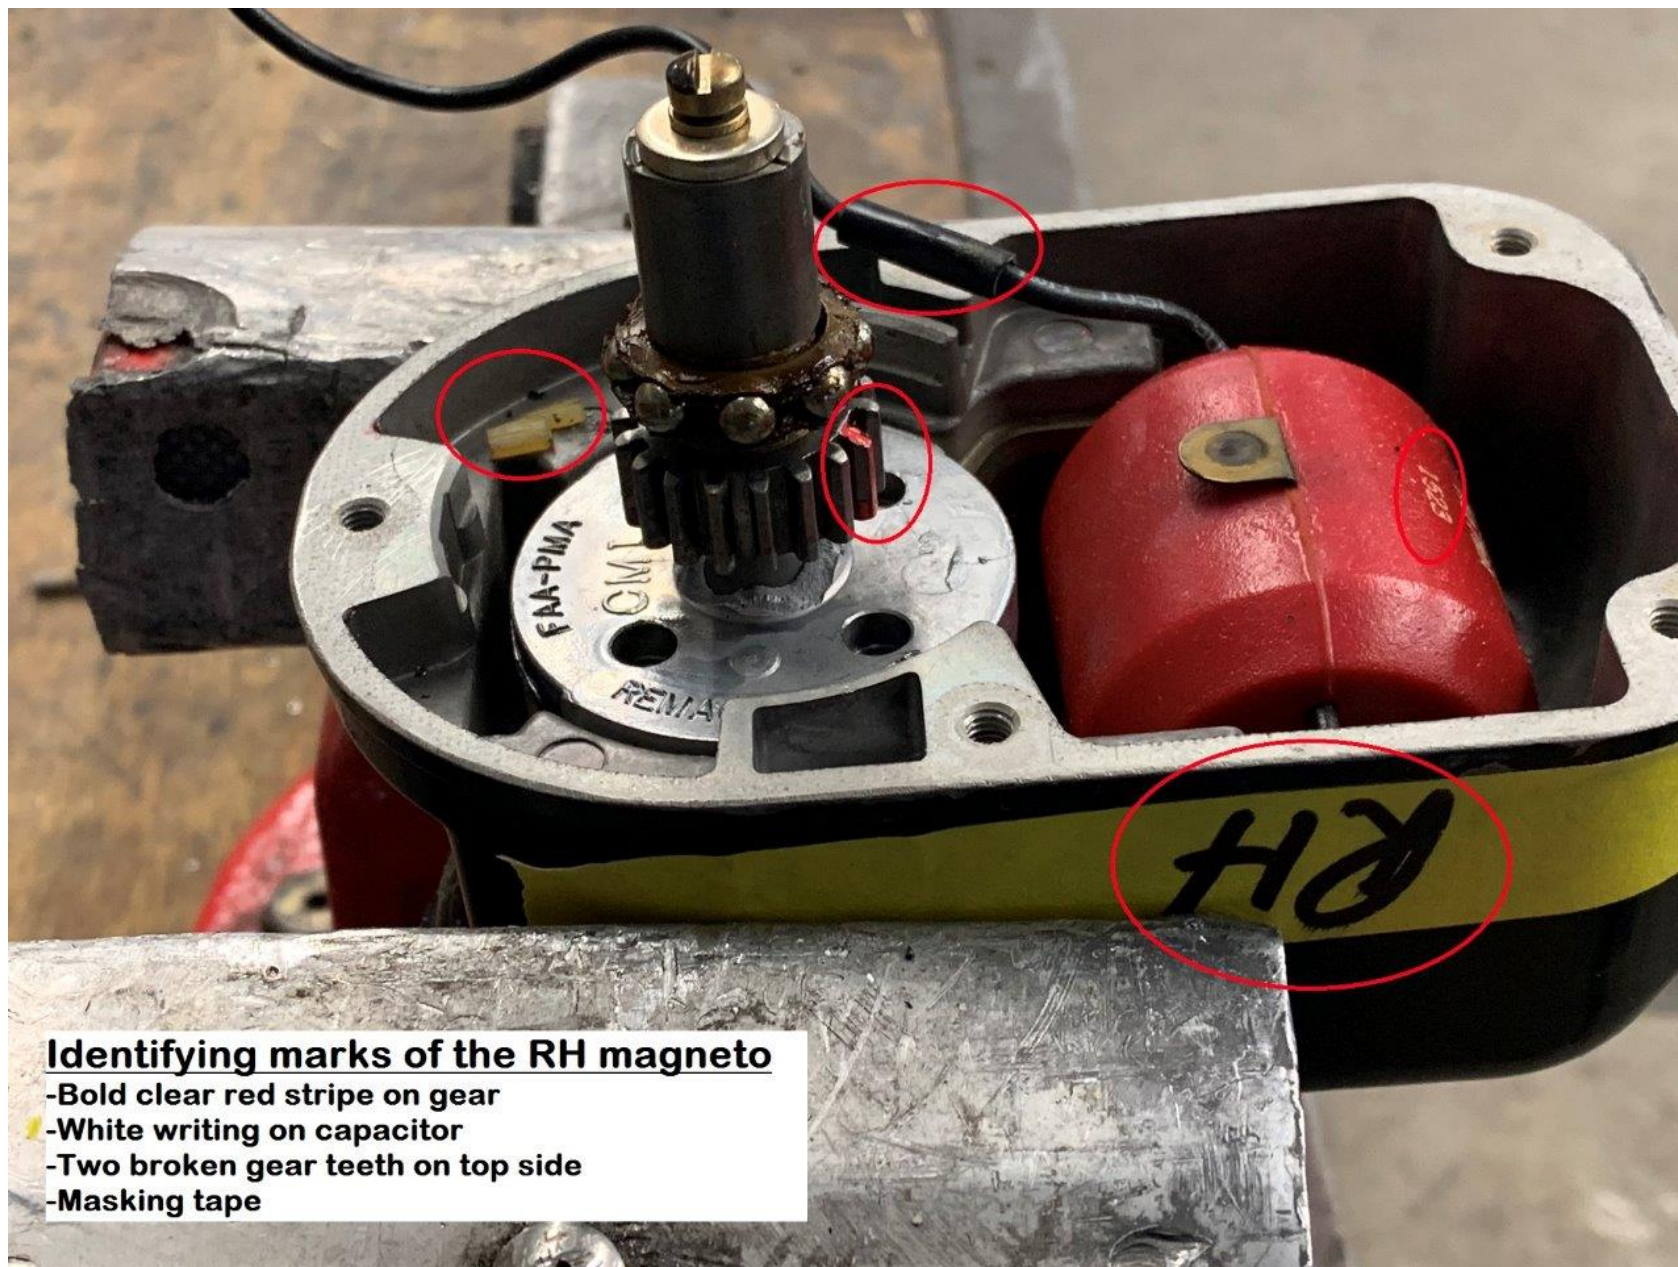
**Identifying marks of the RH magneto**

- Bold clear red stripe on gear
- White writing on capacitor
- Two broken gear teeth on top side
- Masking tape

**Photo 4 – View of Right Magneto During Disassembly (Myers Aviation)**
