# NTSB Review of Surveillance Video

ERA19LA285

Video courtesy of the Bloomsburg Fair, Bloomsburg, Pennsylvania

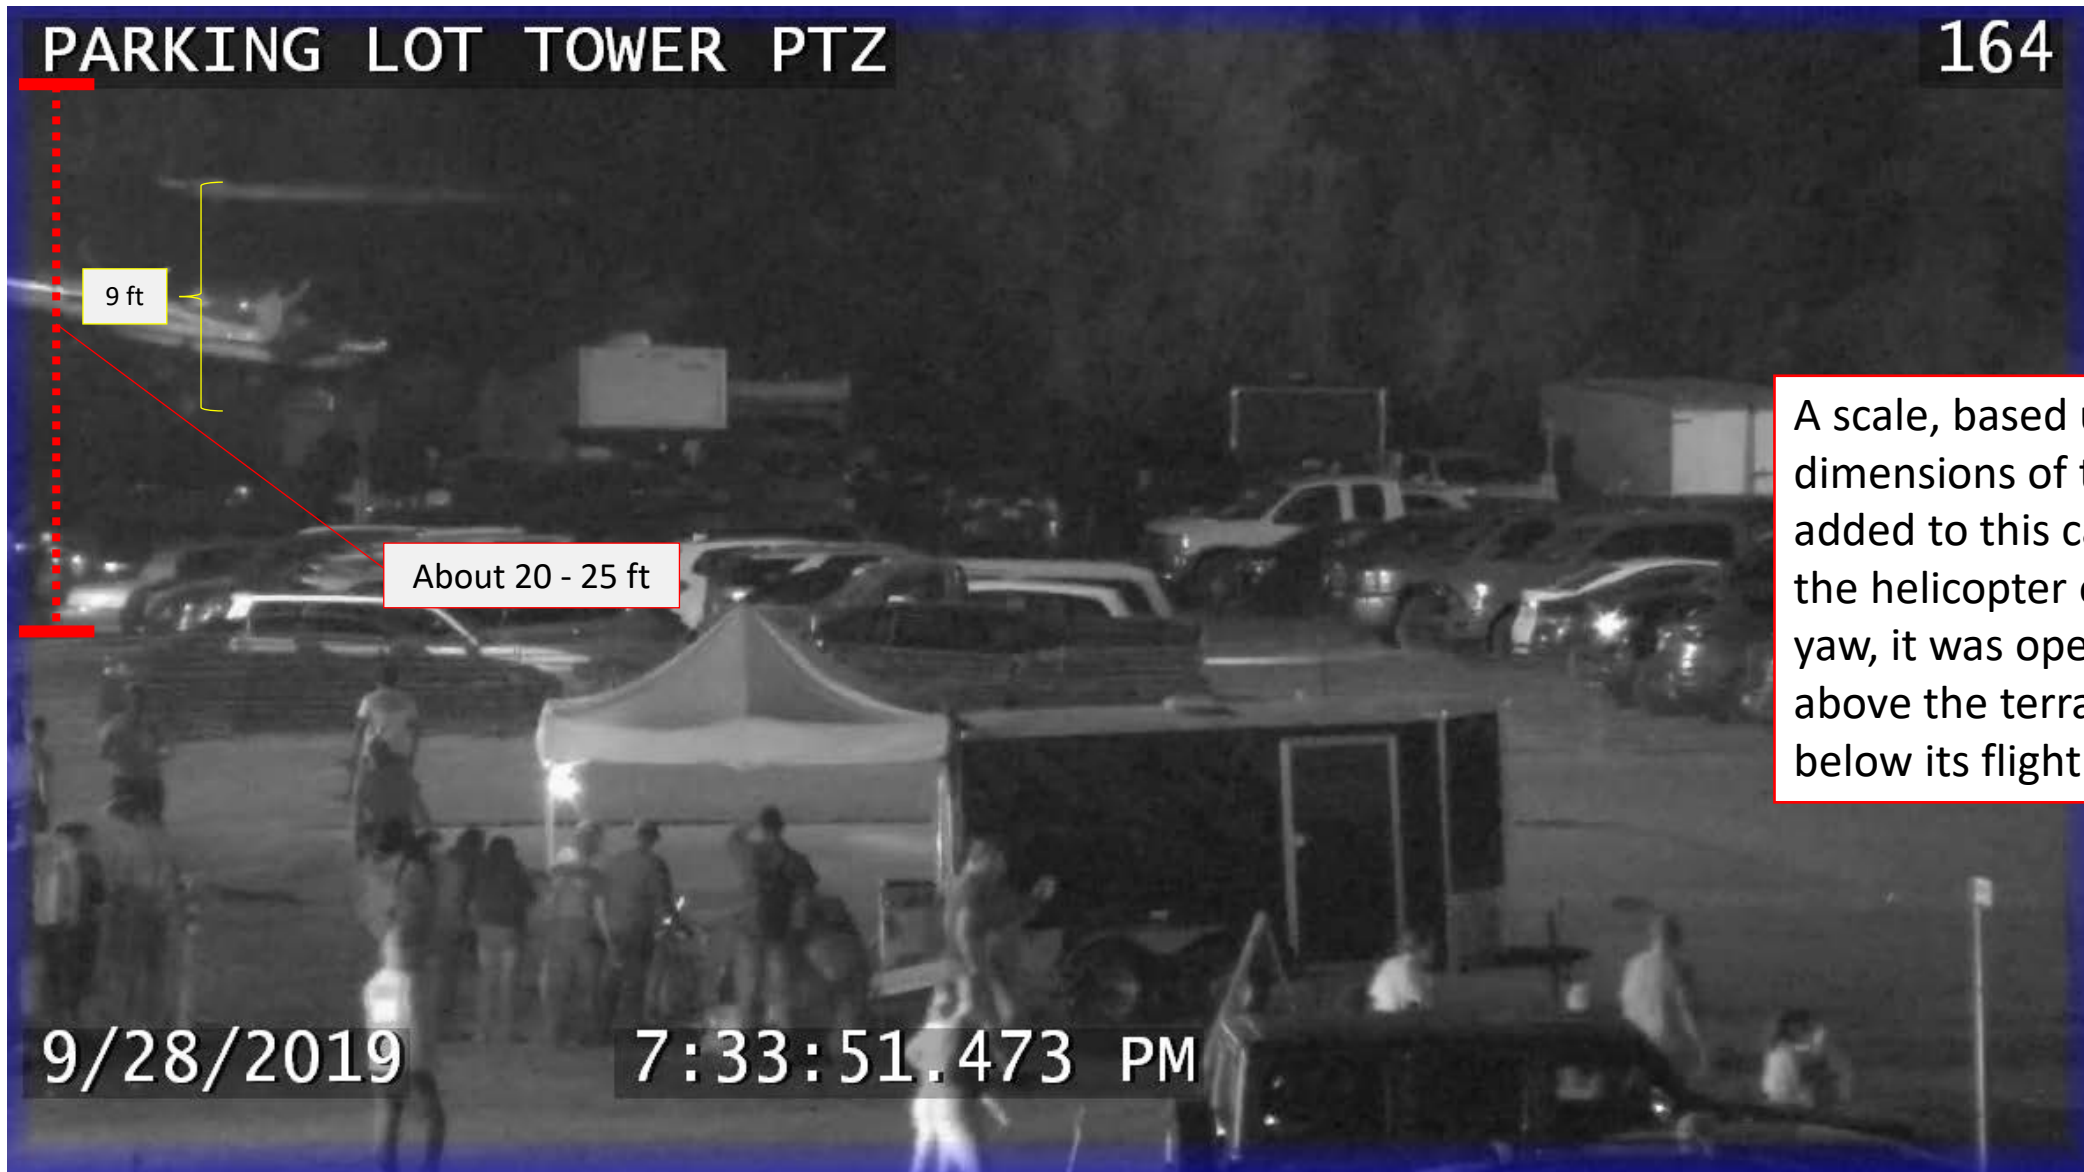
Figure 4 – View of the helicopter and its estimated height above ground

This camera view shows the helicopter, seconds before its impact with the cars below the flight path. According to the Pilot's Operating Handbook, the length is 9 ft from the landing skids to the top of the main rotor mast

This camera view shows the helicopter, at the moment it impacted the car below its flight path.

Figure 4 – View of the helicopter at the moment it impacted terrain and vehicles
