# NATIONAL TRANSPORTATION SAFETY BOARD

## Global Positioning System

**Factual Report**  
**By Adam M. Gerhardt**

Location: Cameron, North Carolina  
Date: October 14, 2019  
Aircraft: Vans Aircraft RV-4  
Registration: N4332J  
Operator: Individual  
NTSB Number: ERA20FA009

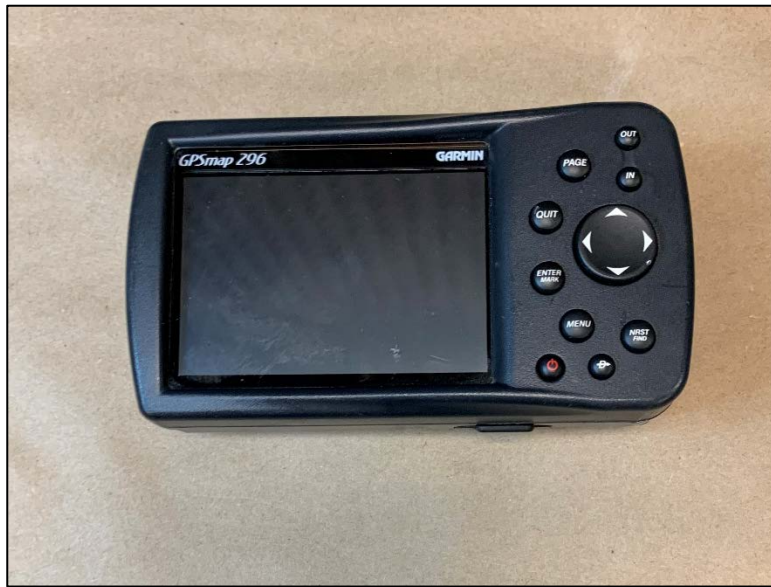
Figure 1: Front of GPS Unit

The device was undamaged and was downloaded normally using the manufacturer's software. Figures 1 and 2 show the front and back of the device.

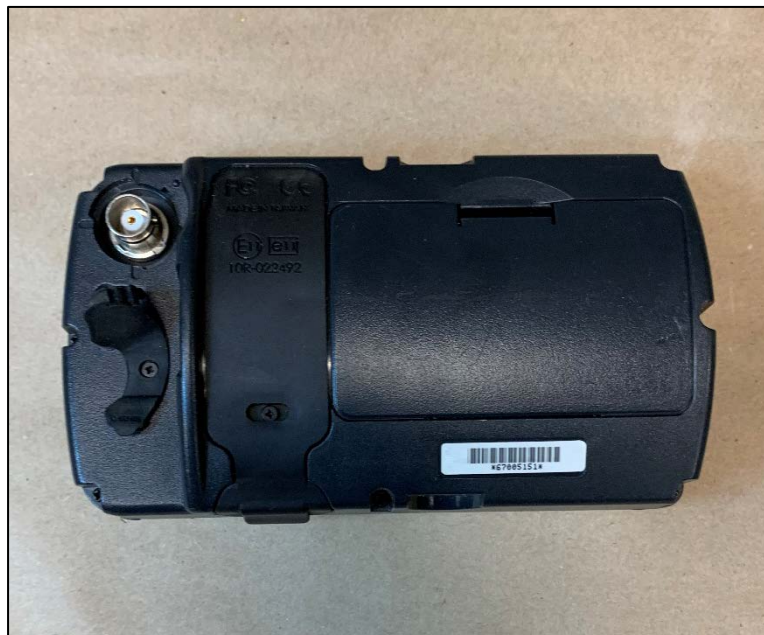
Figure 2: Back of GPS Unit
