# NATIONAL TRANSPORTATION SAFETY BOARD

Specialist's Factual Report  
by Michael Portman

### 1. EVENT

Location: Tamaqua, PA  
Date: October 18, 2019  
Aircraft: Sportine Aviacija Lak-17B  
Registration: N830DK  
Operator: Private  
NTSB Number: ERA20FA013

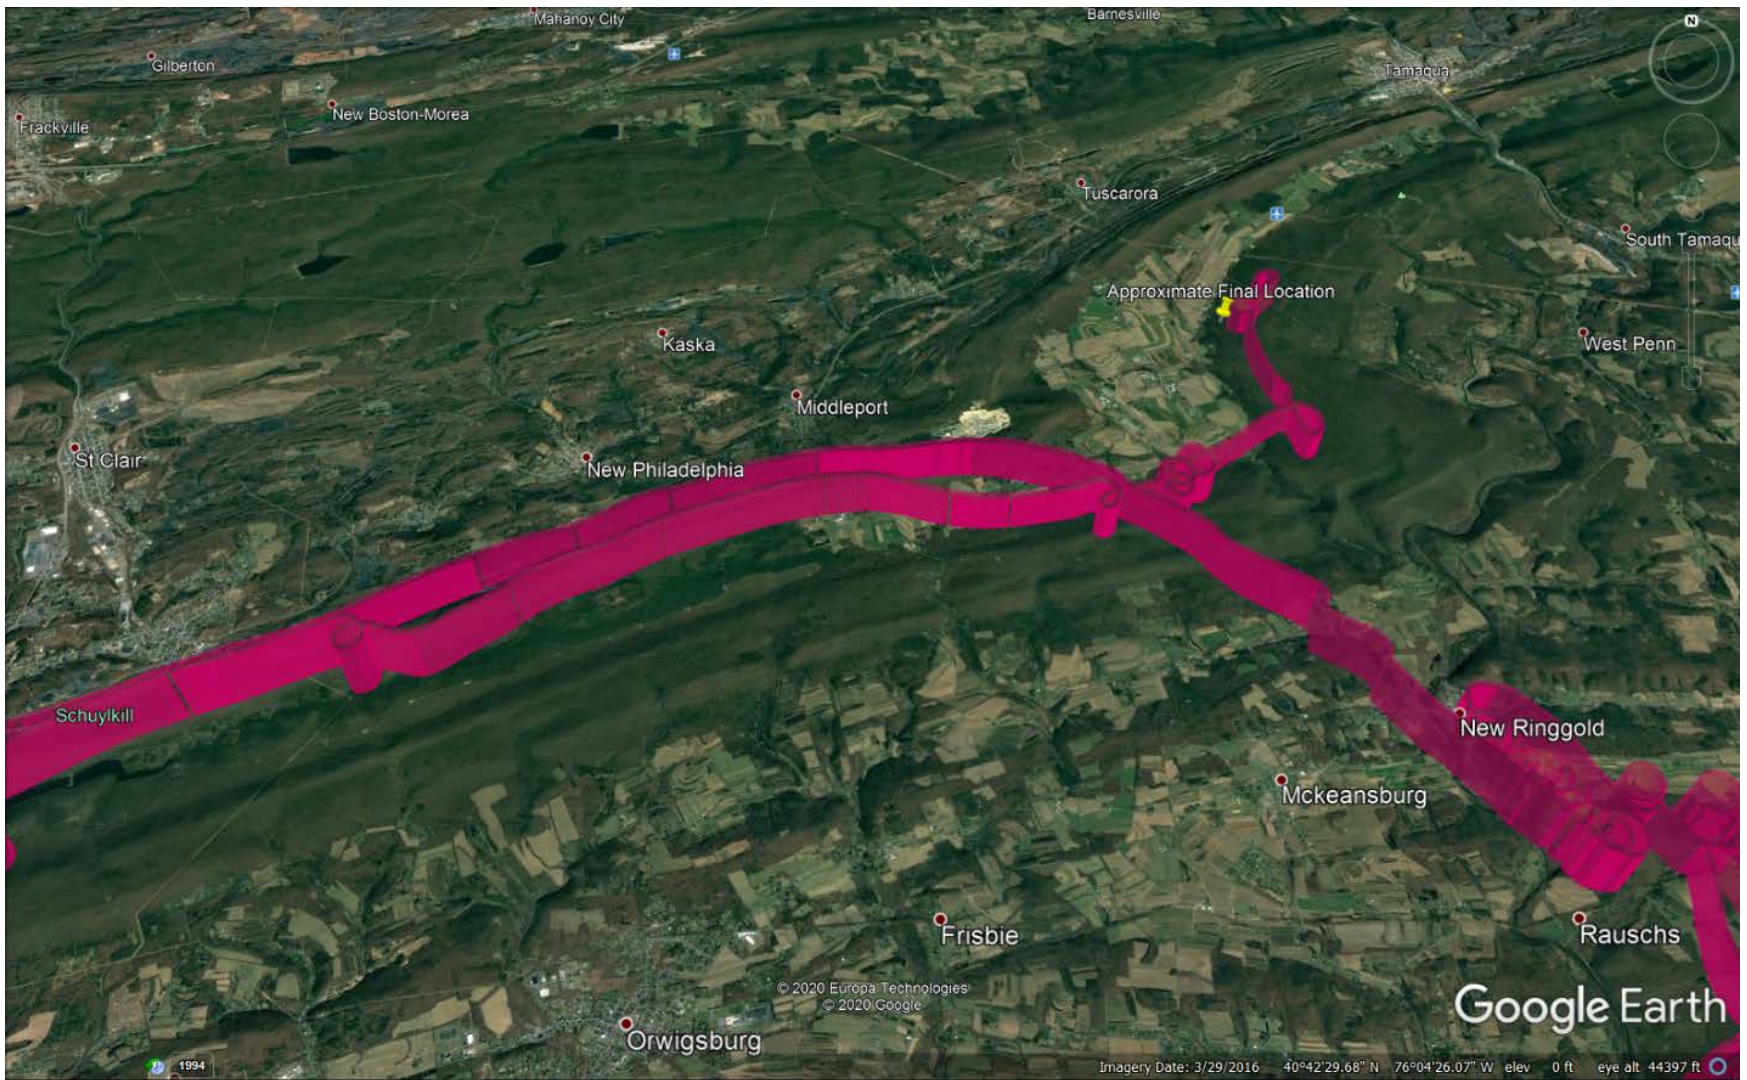
Figure 5. Google Earth overlay of latter portion of the flight.

Figures 4 through 6 are graphical overlays generated using Google Earth showing the accident flight. The altitudes plotted are GPS altitudes. The weather and lighting conditions in Google Earth are not necessarily the weather and lighting conditions present at the time of the recording.

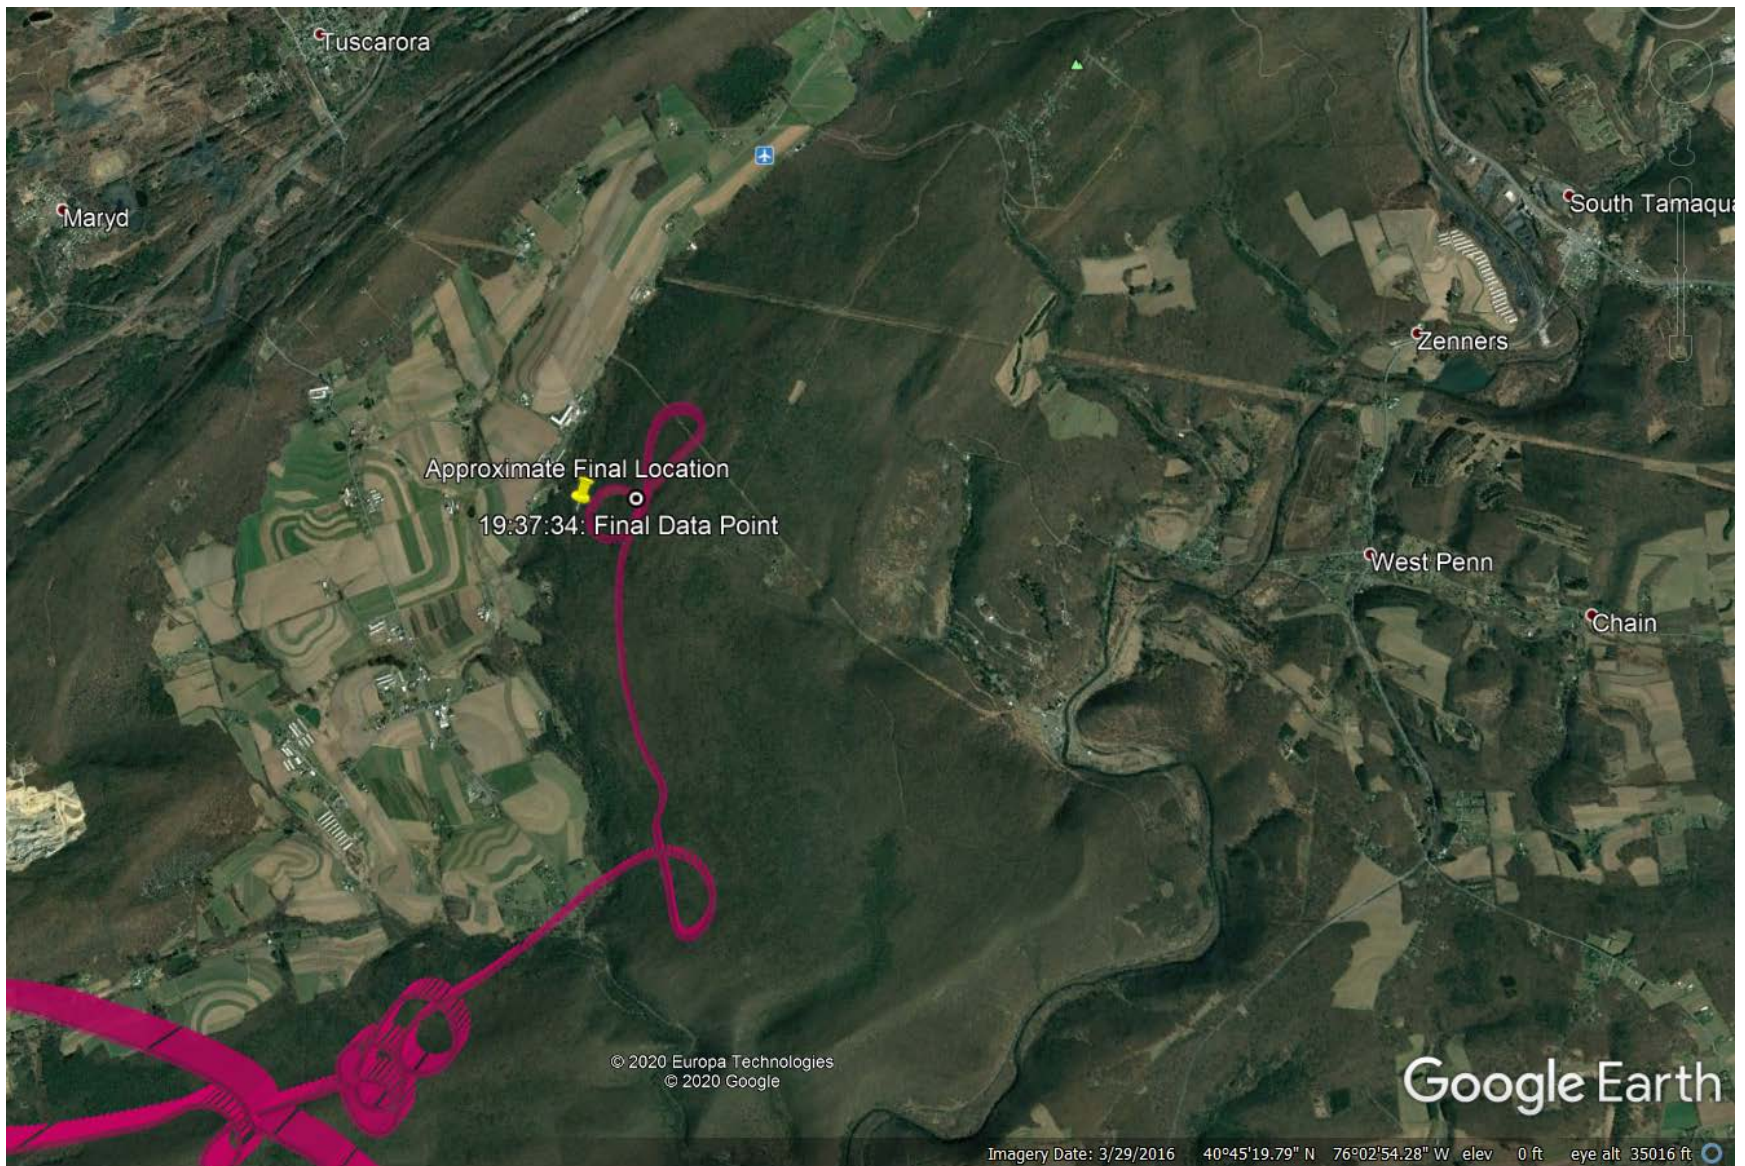
Figure 6. Google Earth overlay of final moments of the flight, including approximate wreckage location denoted by the yellow pin.
