**Photo 1 – Front Right View of Airplane at Accident Site**

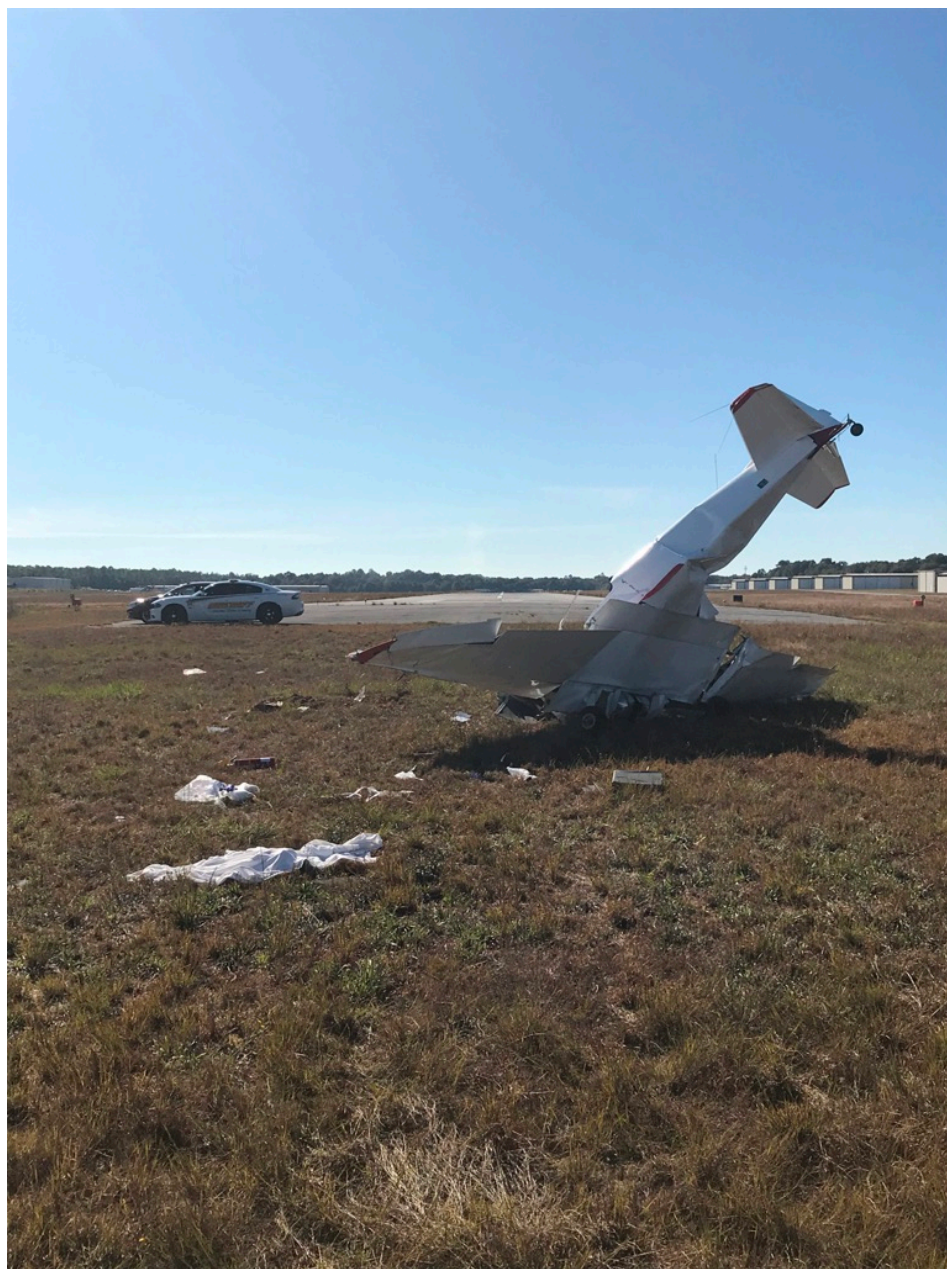
**Photo 2 – Rear View of Airplane at Accident Site**

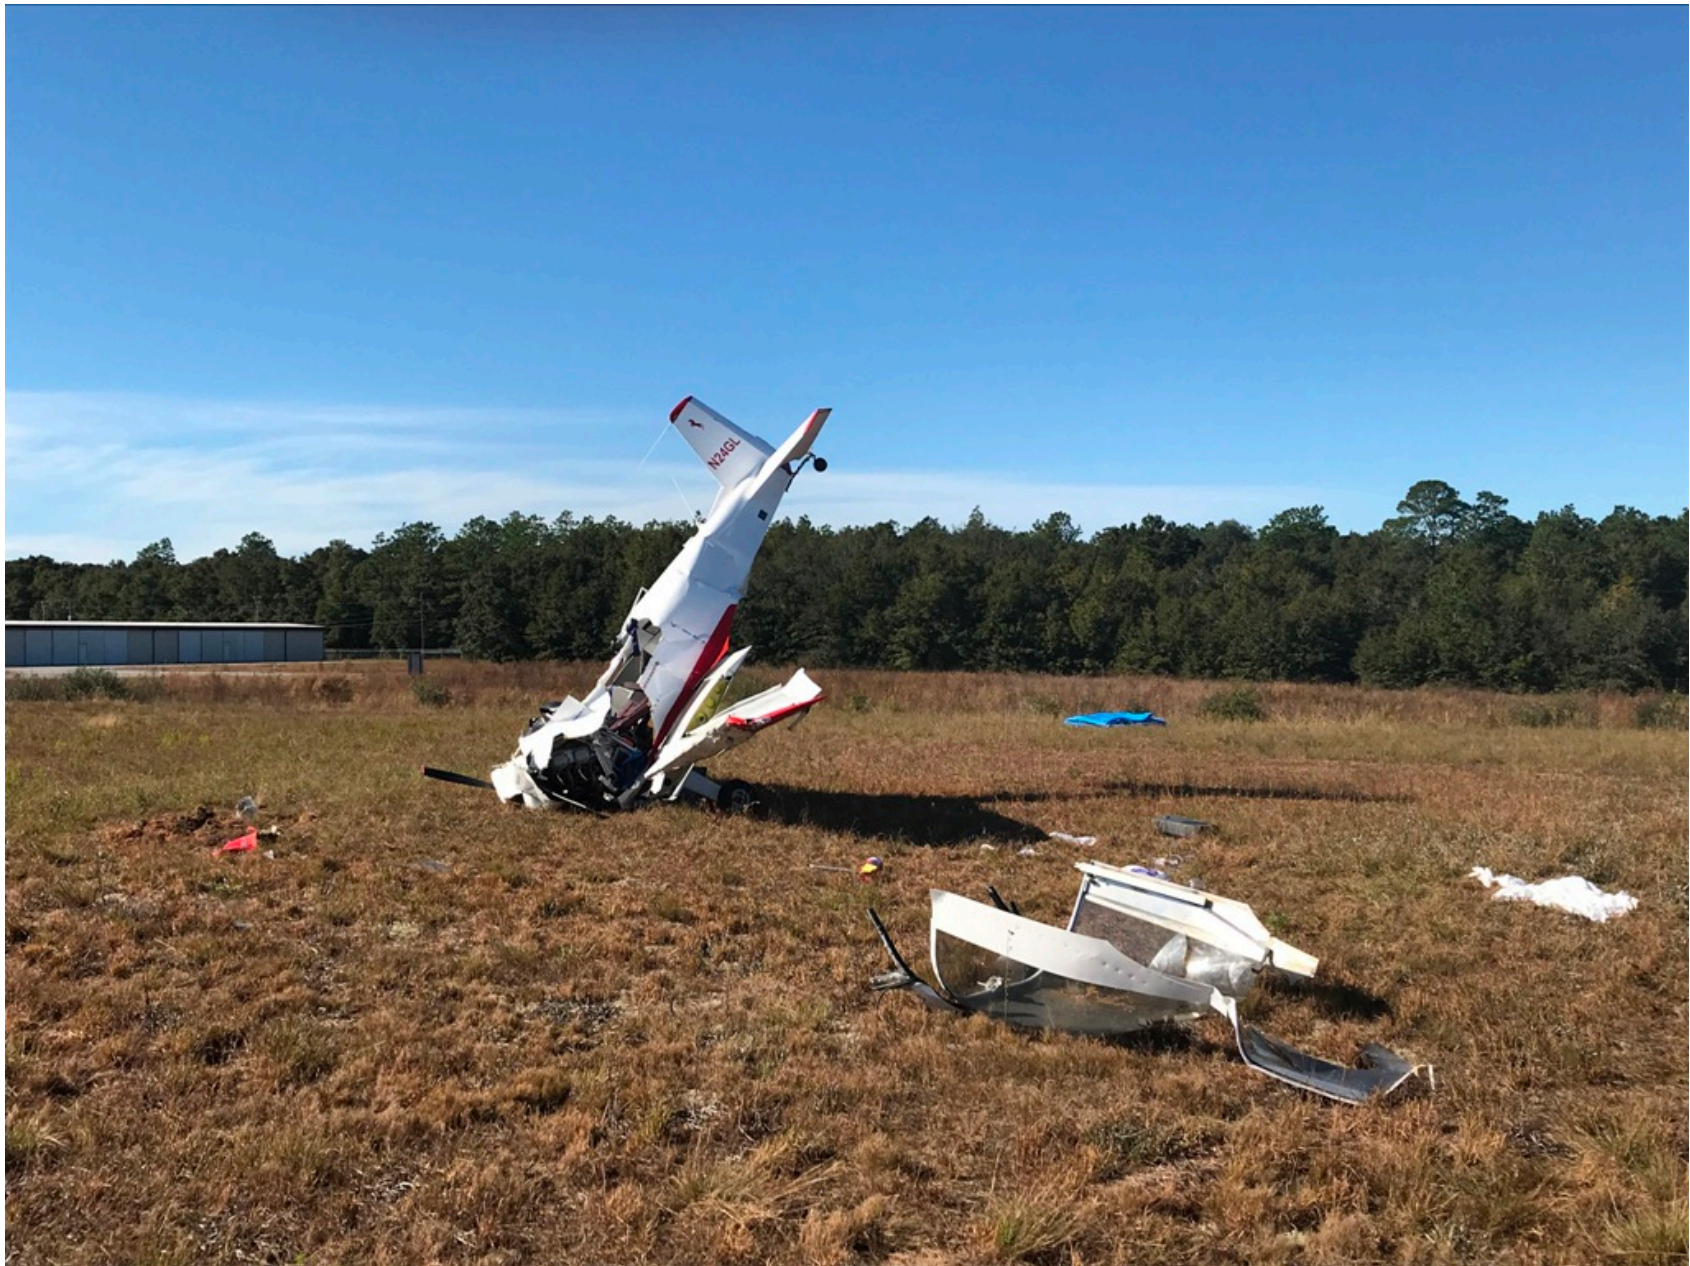
**Photo 3 – Front Right View of Airplane and Canopy at Accident Site**

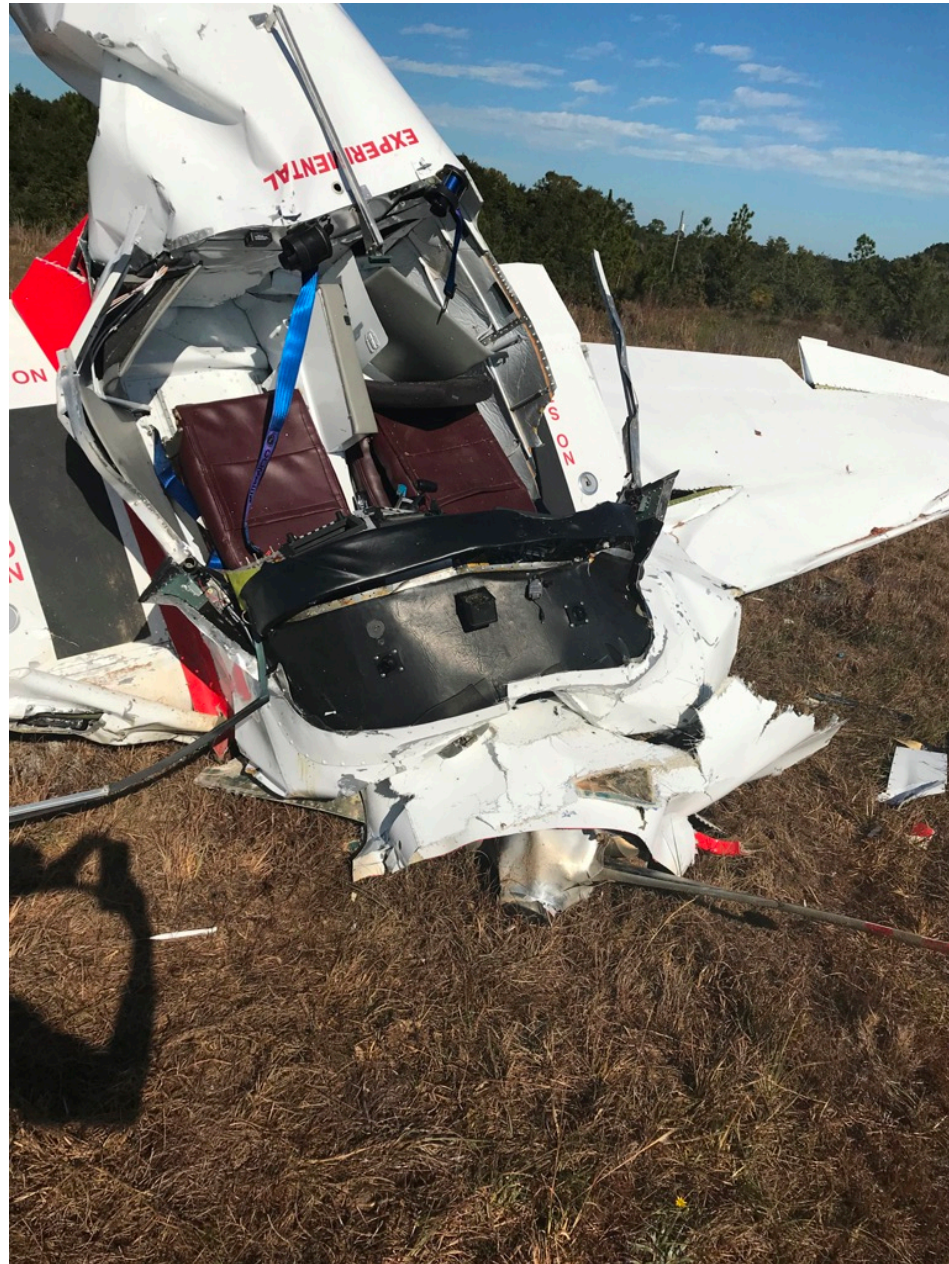
**Photo 4 – Cockpit Area**

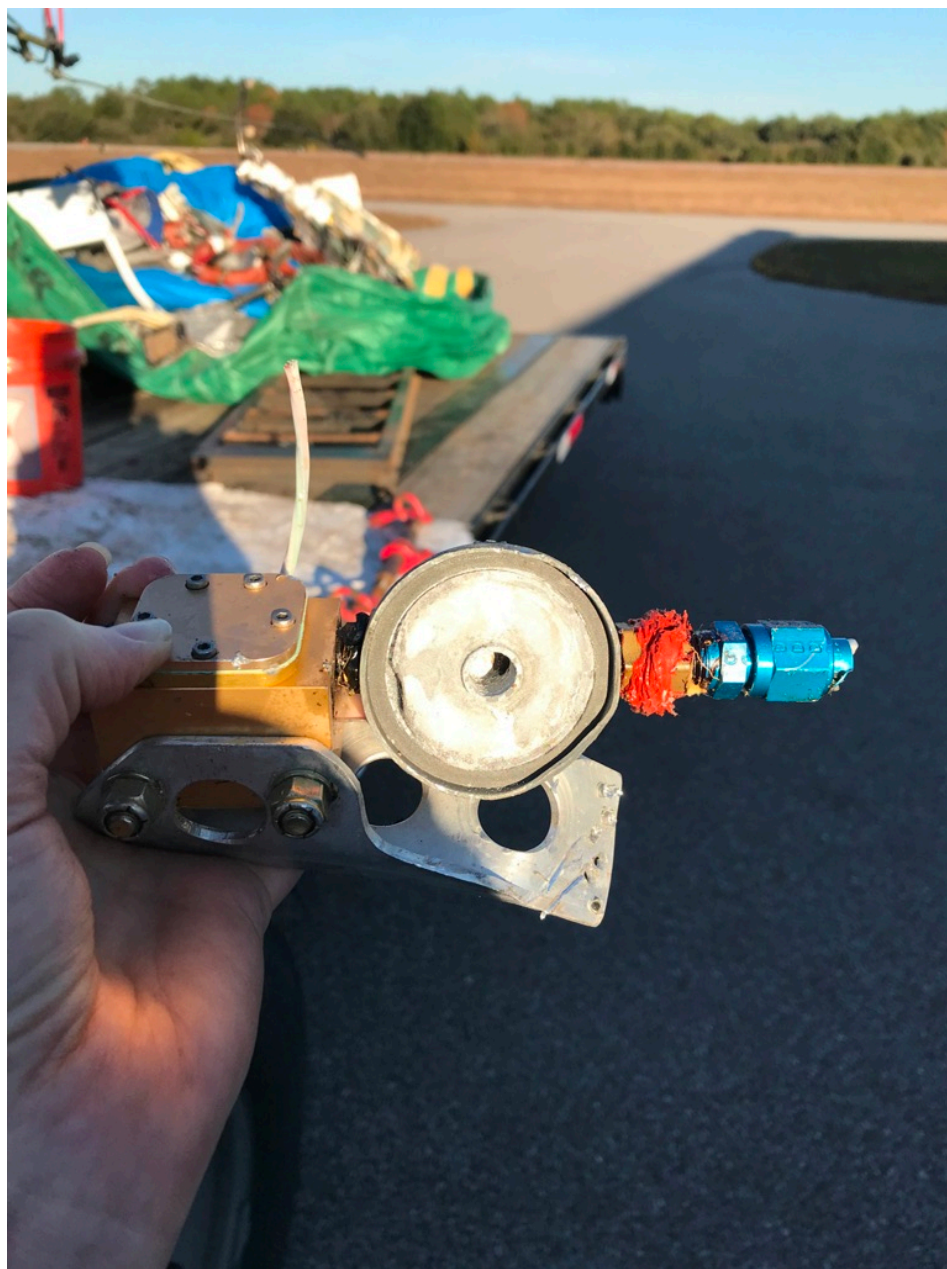
**Photo 5 – Fuel Filter Screen**

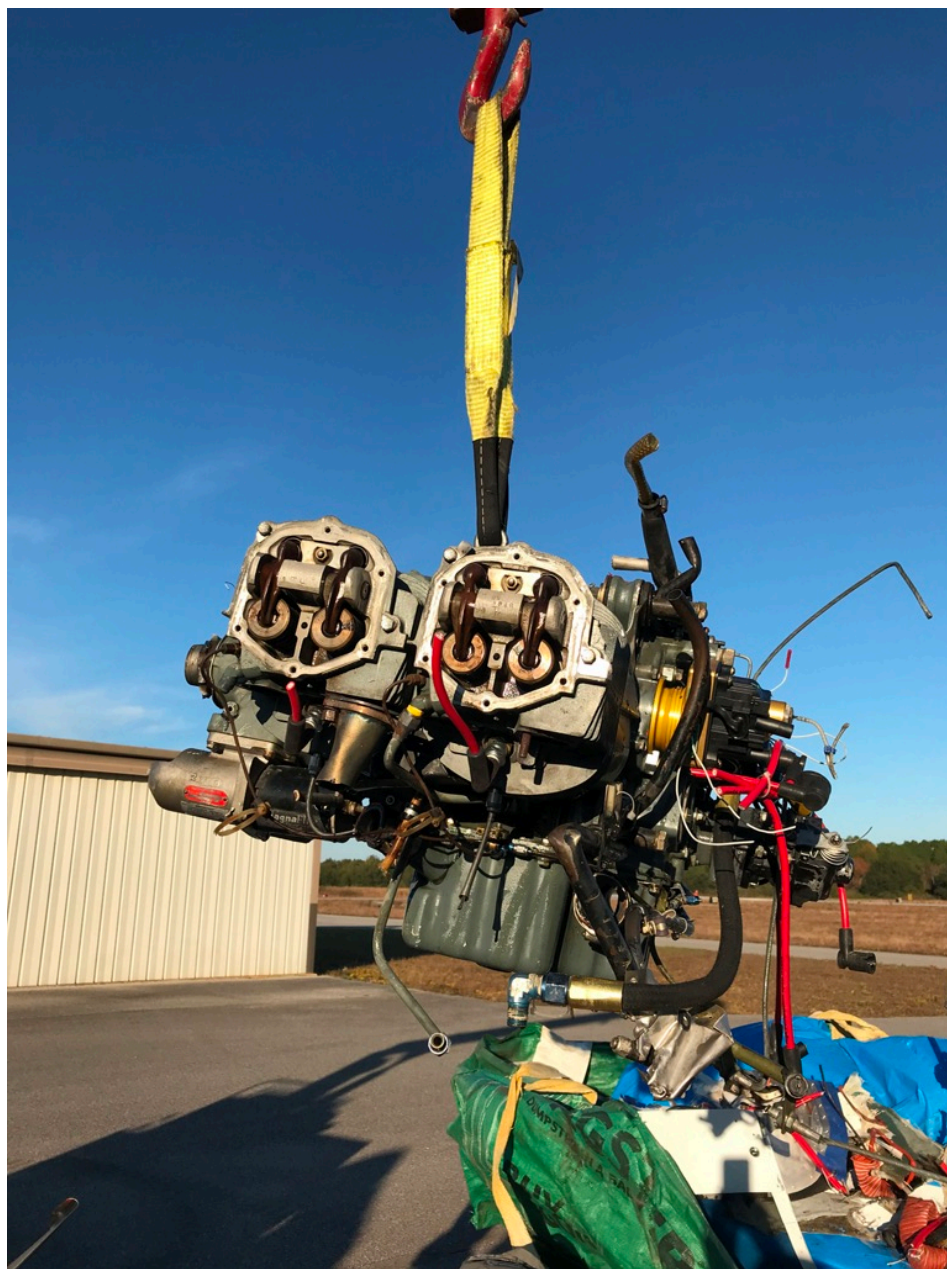
**Photo 6 – Left Side View of Engine**

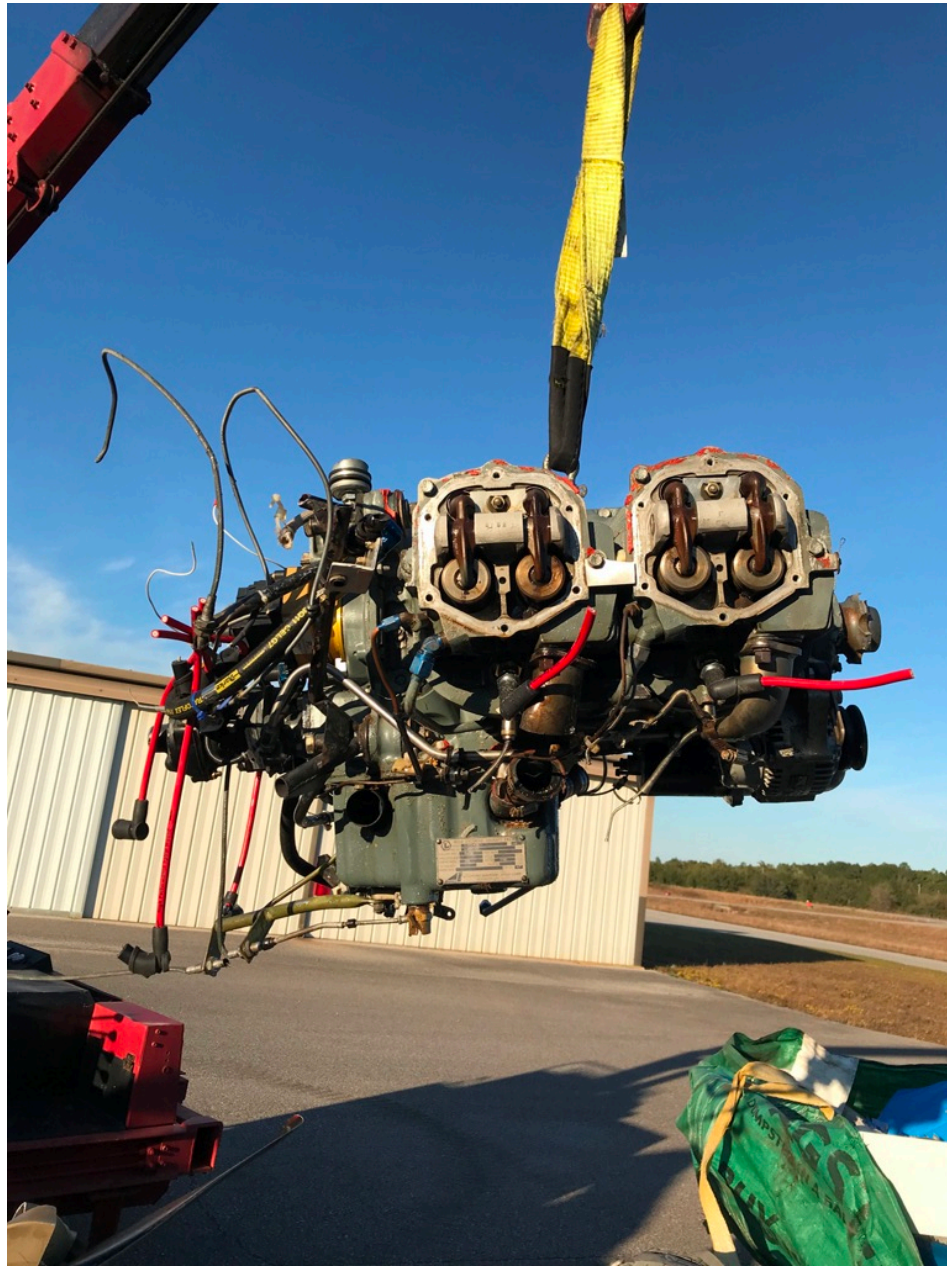
**Photo 7 – Right Side View of Engine**

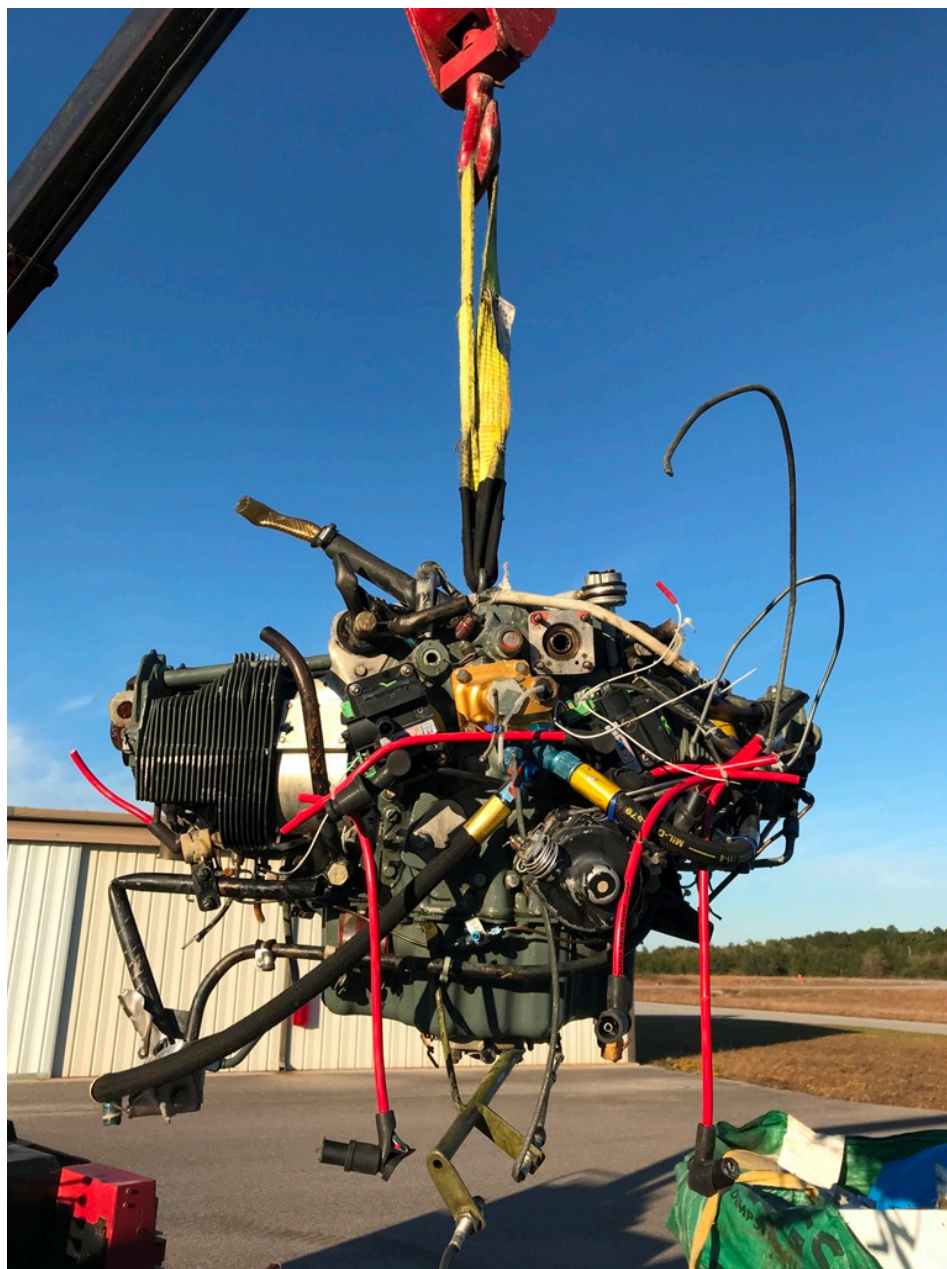
**Photo 8 – Rear View of Engine**

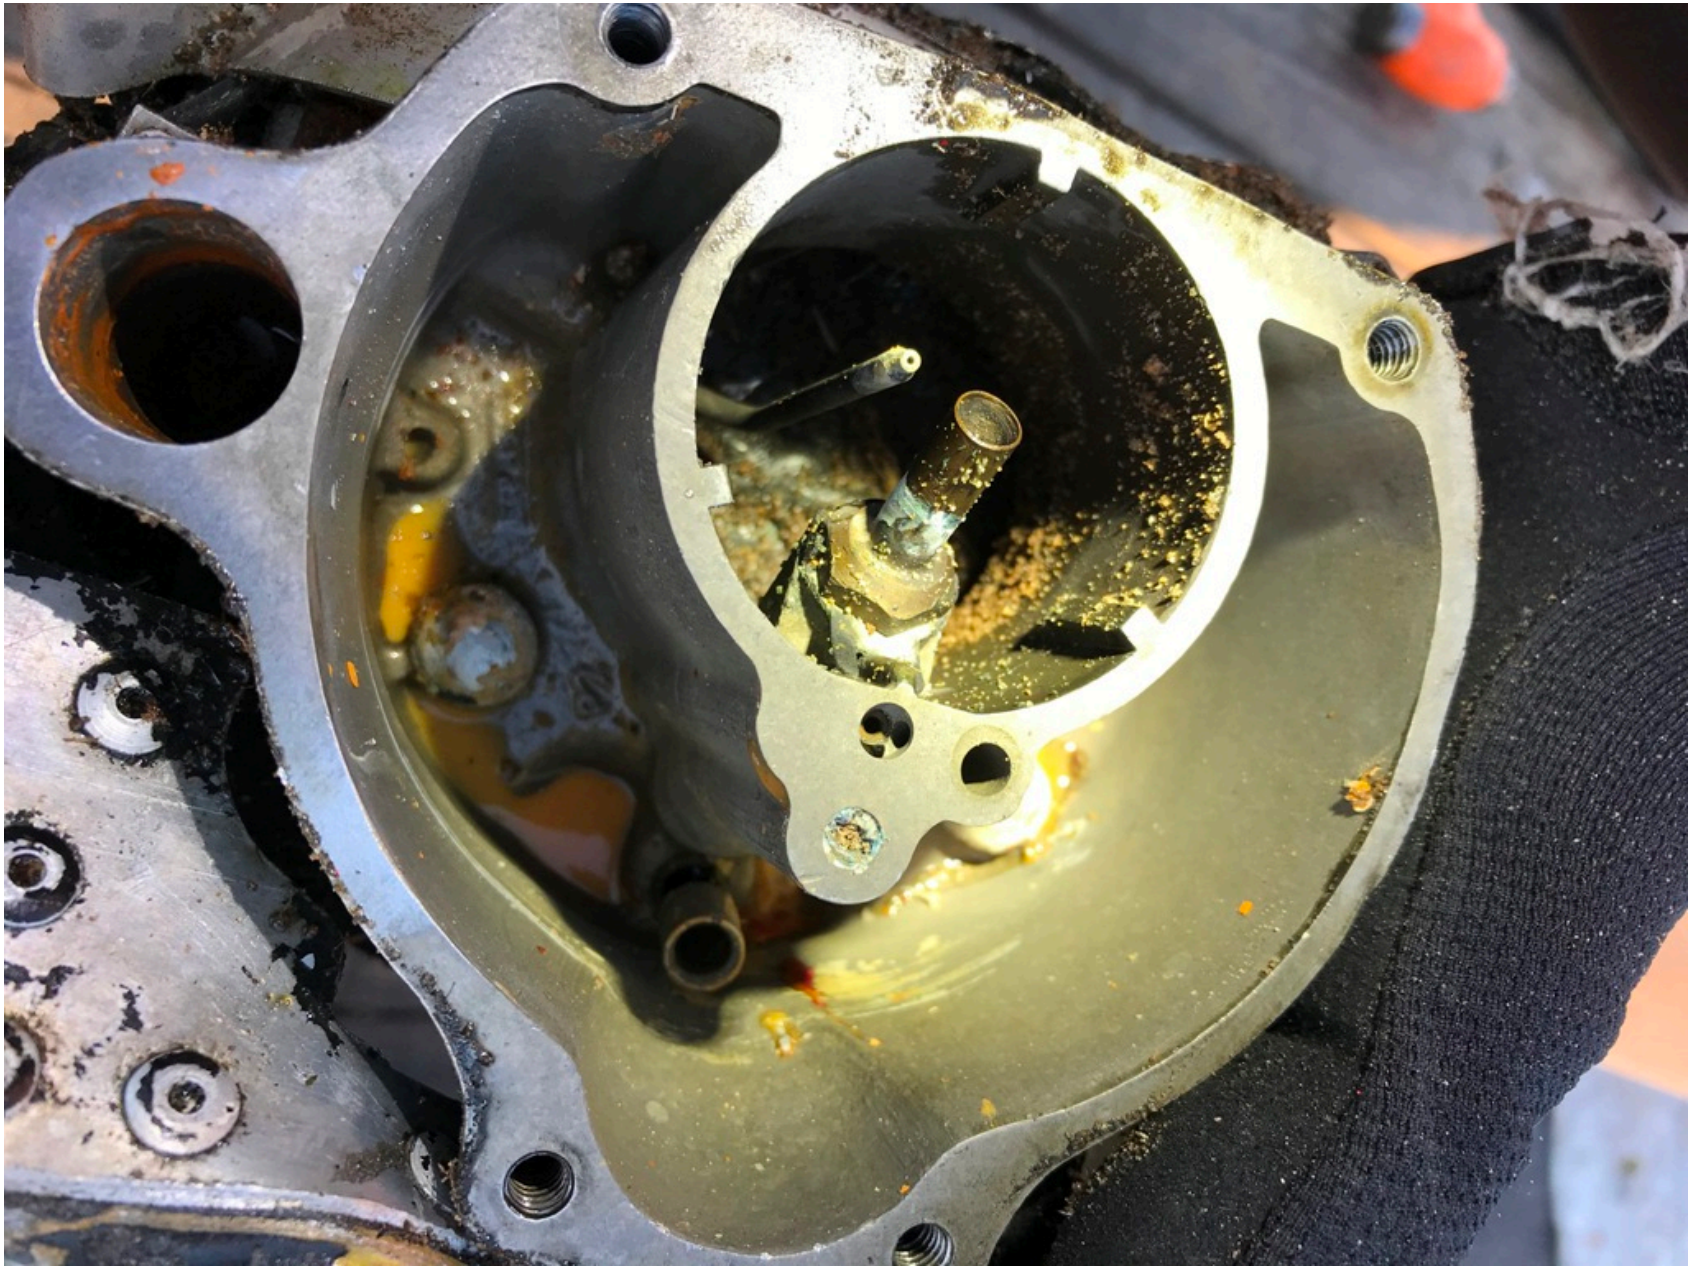
**Photo 9 – Carburetor Bowl**

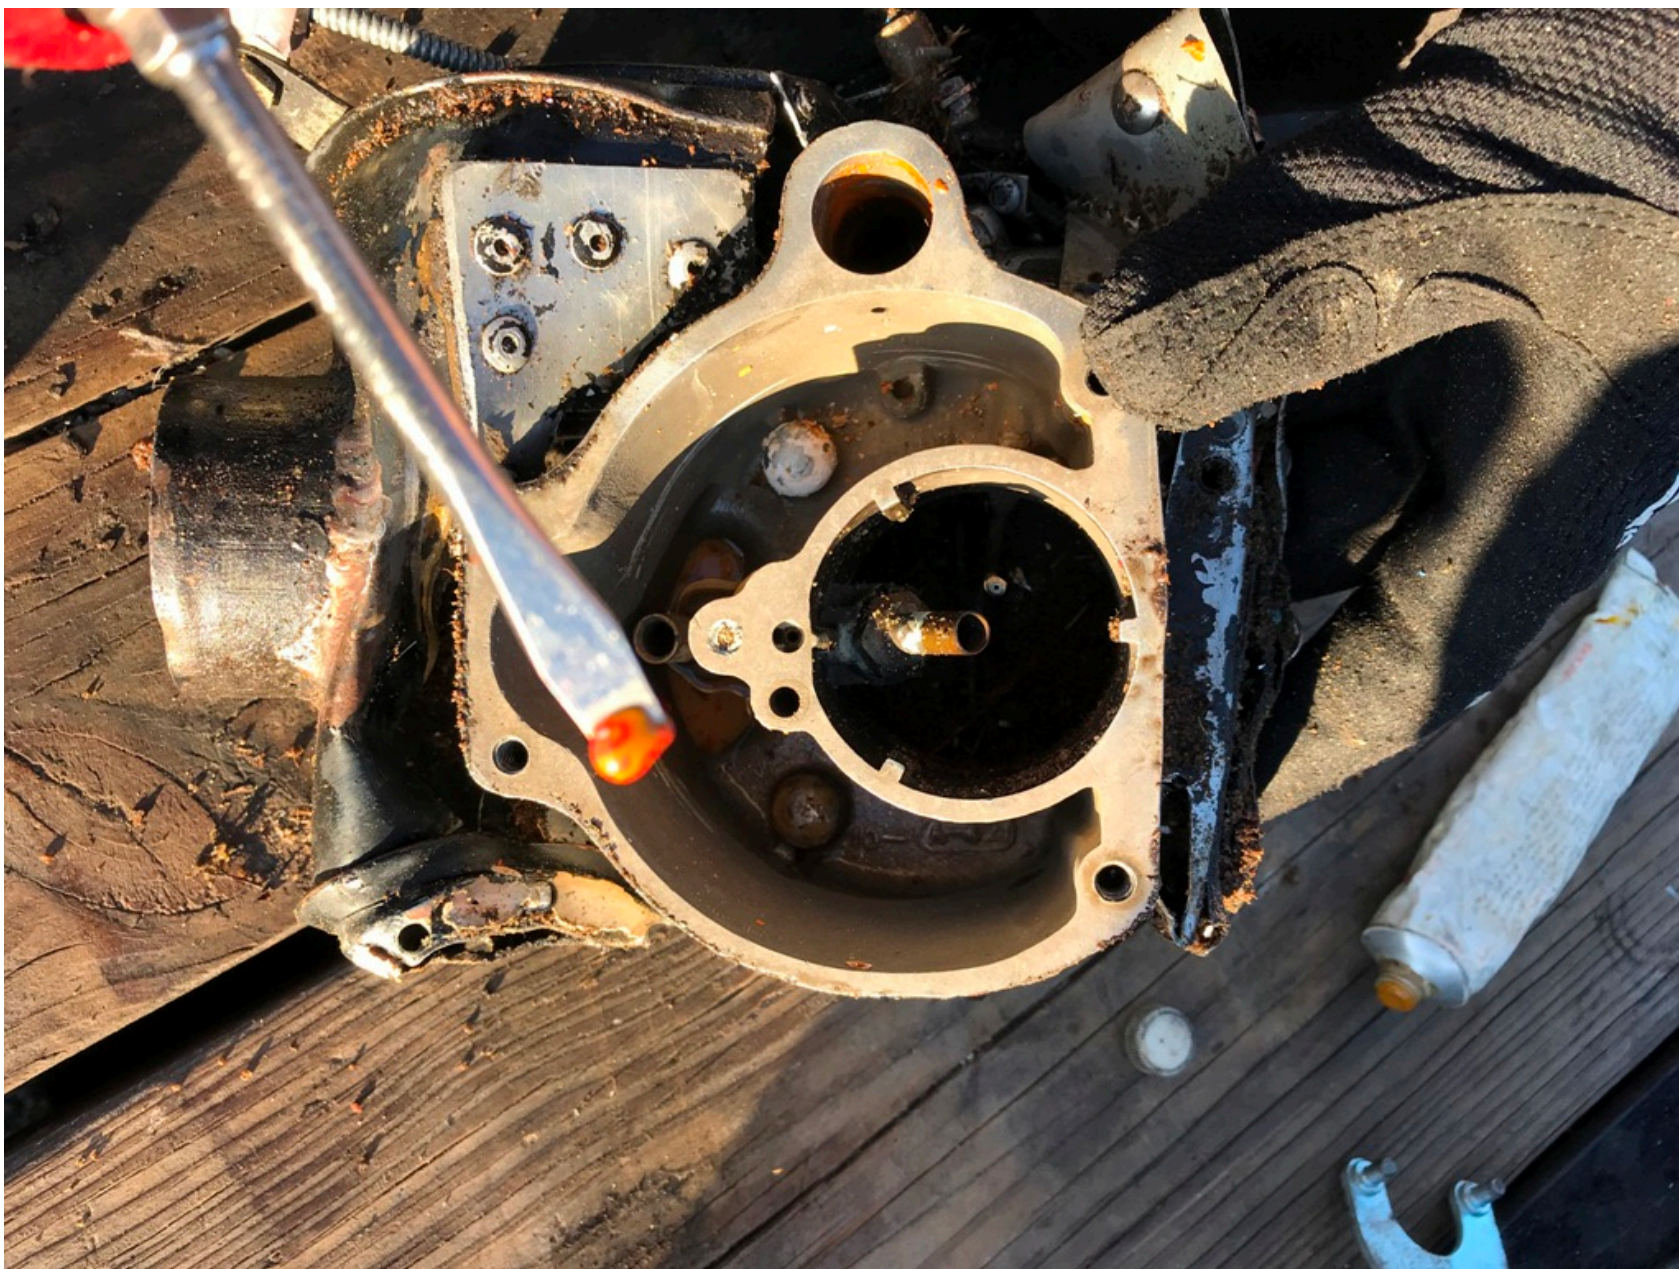
**Photo 10 –Water Finding Paste Tests Positive (paste turns pink) in Carburetor Bowl**

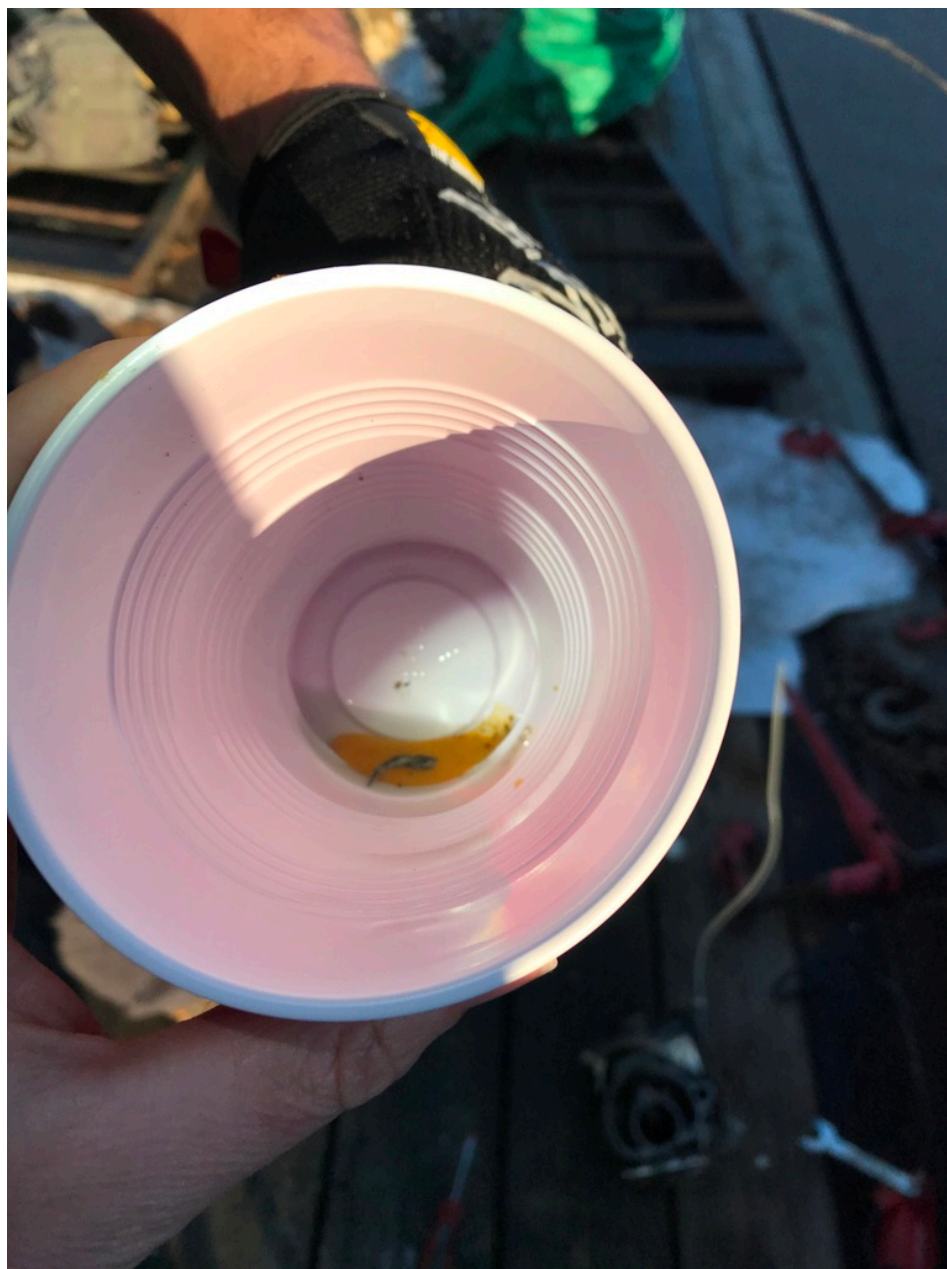
**Photo 11 – Rust Colored Fluid drained from Carburetor Bowl**
