**NATIONAL TRANSPORTATION SAFETY BOARD**  
Vehicle Recorder Division  
Washington, D.C. 20594

## **Global Positioning System Devices**

### **Specialist's Factual Report** **By W. Deven Chen**

Location: Mechanicsburg, Pennsylvania  
Date: January 9, 2020  
Aircraft: Robinson R66  
Registration: N450MC  
Operator: Private  
NTSB Number: ERA20FA074

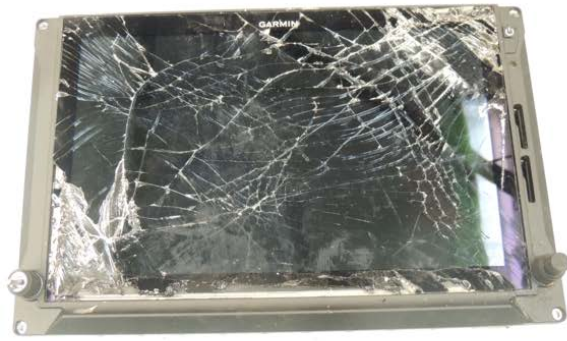
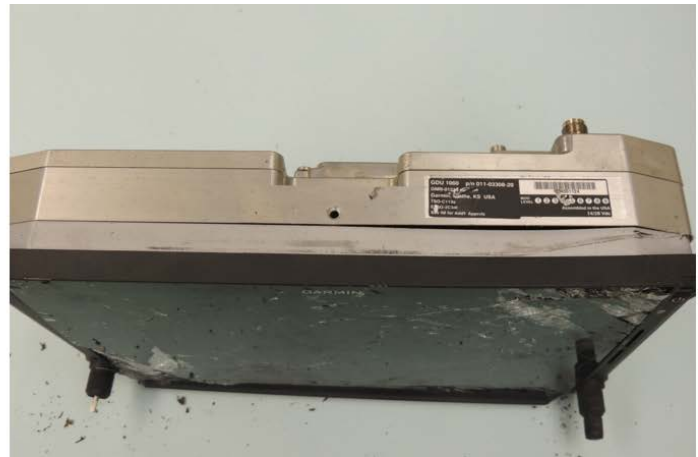
Upon arrival at the Vehicle Recorder Division, an exterior examination revealed the device sustained impact damage, as shown in Figure 2. There was no flight data SD card found on the unit. The internal circuit board containing the NVM chip was sent to the manufacturer for a retrieval of the data contents. The manufacturer then sent back the extracted data electronically.

**Figure 2: Front and side views of the Garmin GDU 1060 as received.**

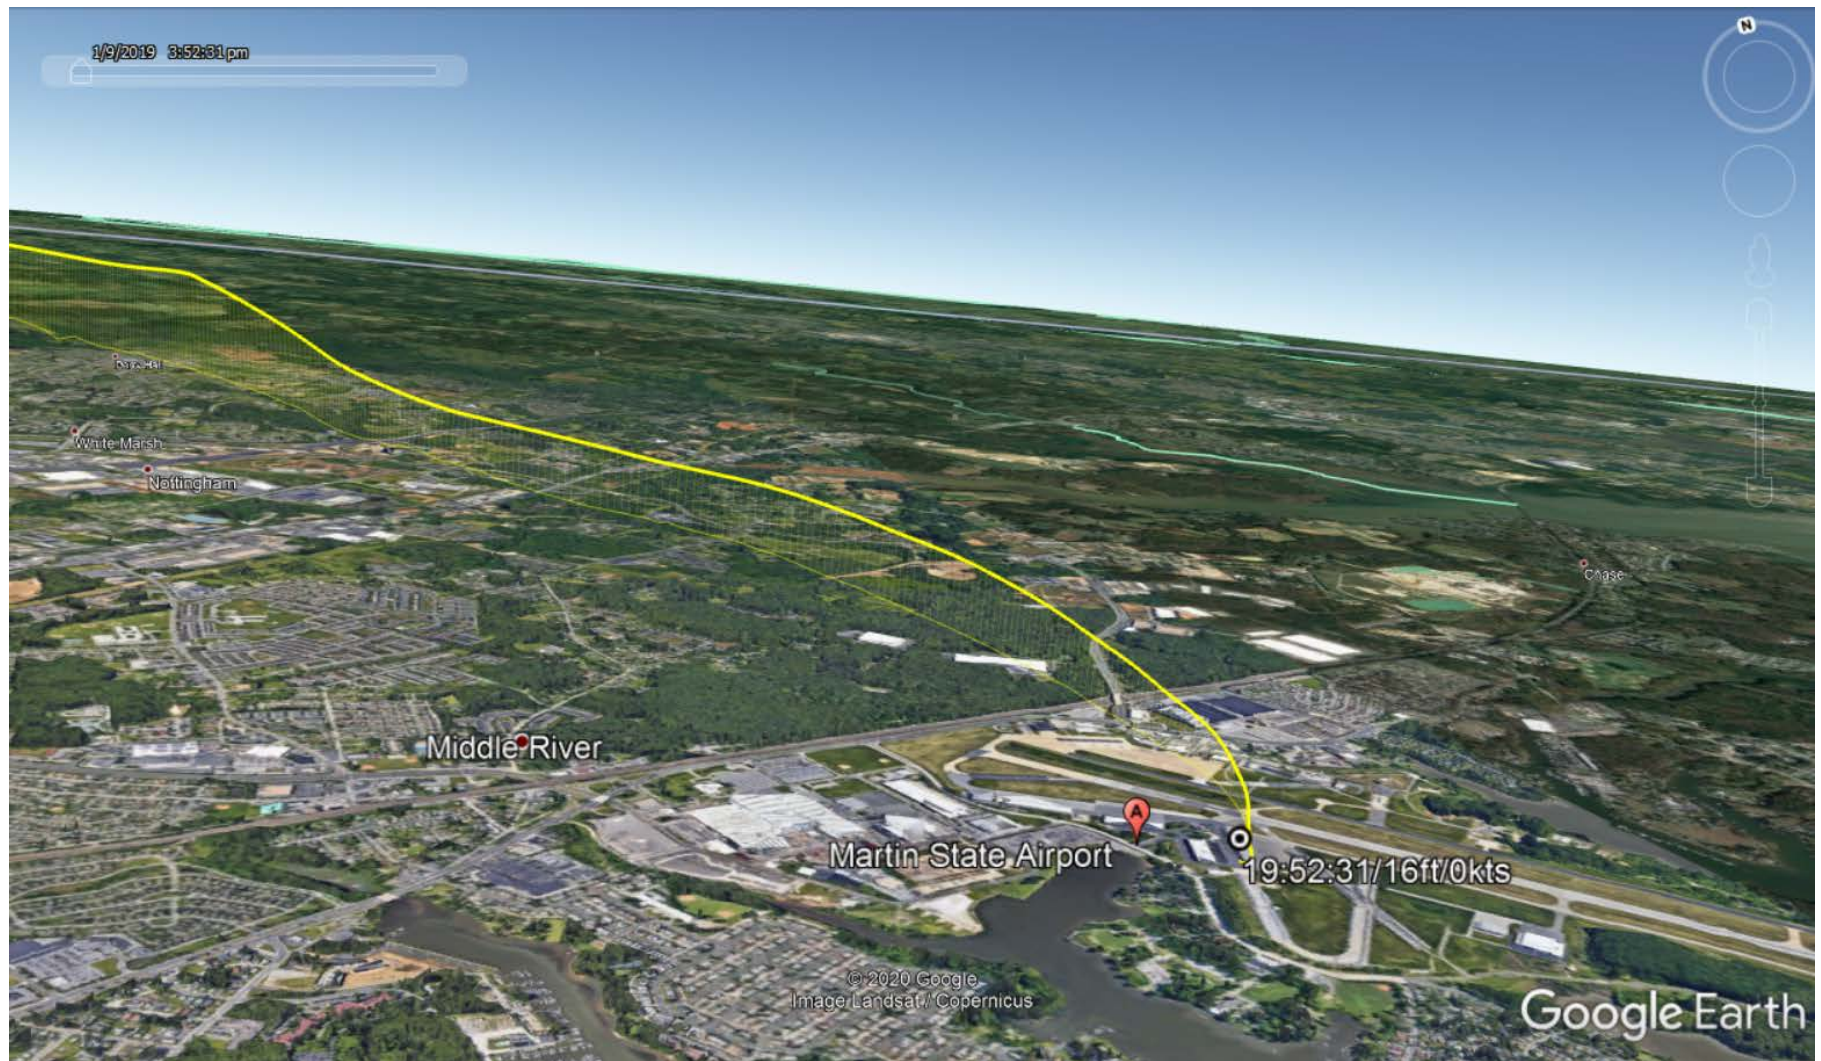
Figure 4 is a Google Earth overlay showing the aircraft took off at Martin State Airport at about 19:52:31 EST.

Figure 4: Google Earth overlay showing the start of the accident flight.

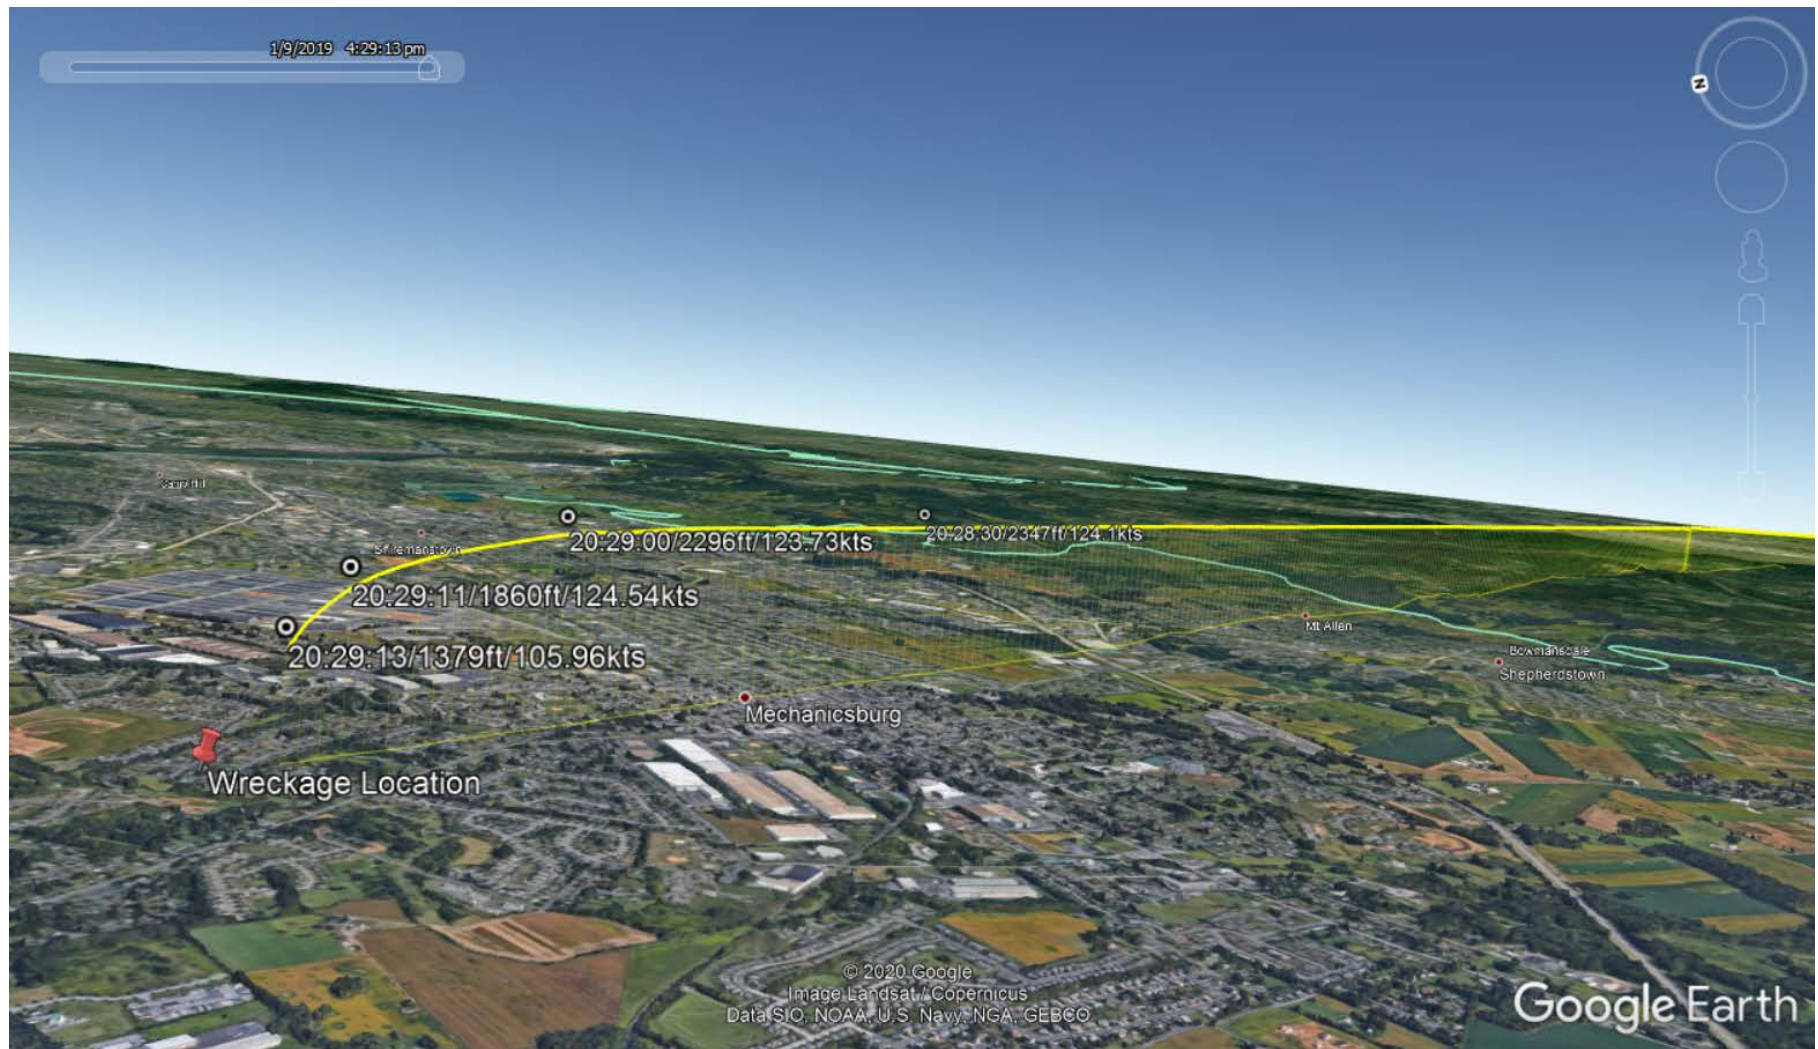
Figure 5 is a Google Earth overlay showing the aircraft's descent to the accident location. The aircraft was last recorded in Mechanicsburg, PA at 20:29:13 EST. The reported wreckage location is shown with a red pin.

Figure 5: Google Earth overlay showing the aircraft's descent to the accident location.
